# National Transportation Safety Board

ERA24LA128

## **WRECKAGE EXAMINATION REPORT**

Location: Edgewater, FL  
Date: 03/01/2024  
Time: 1243 EST  
1743 UTC  
Airplane: Cub Crafters PA-18-150

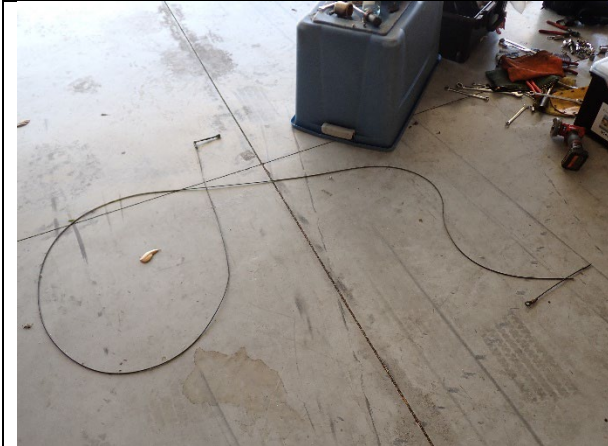
Flight control continuity was established for the right aileron, elevator, and the rudder. Flight control continuity for the left aileron was able to be established for the left aileron balance cable which was continuous to the right aileron. The left aileron direct control cable was fractured at the pulley at the outboard, lower fuselage where

the cable exits the fuselage and is guided along the wing strut. The fracture was consistent with a preaccident fracture. The control cable was removed and visually inspected, there were several sections of cable that were corroded. It was observed that near the fracture area there were flat spots in the cable on both sides of the cable.

Figure 1: Both sides of the fractured left aileron direct cable

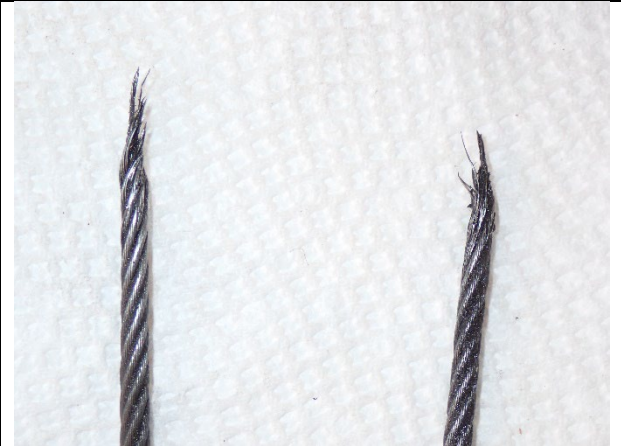
The examination of the wreckage revealed that the left aileron direct control cable was fractured. The fracture was consistent with a pre-accident fracture. The control cable and the pulley located at the fractured section of the control cable displayed corrosion and wear and the pulley would not rotate smoothly and would occasionally bind.

Figure 2: Both fractured ends of the left aileron direct cable

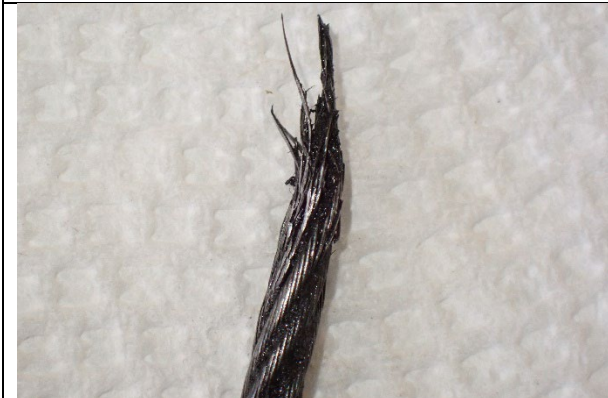
Figure 3: Fractured end of left aileron direct cable (control stick side of the cable)

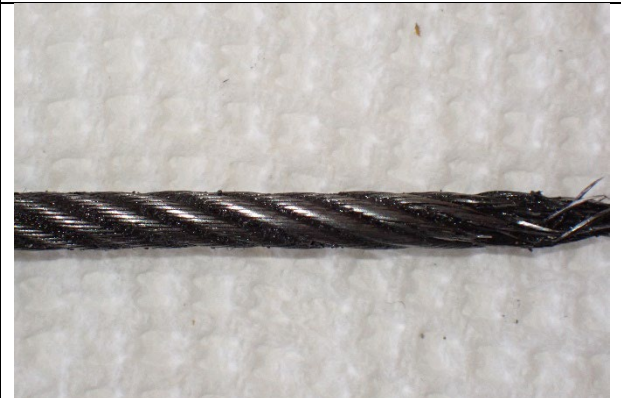
Figure 4: Wear spots on left aileron direct cable (control stick side of the cable)

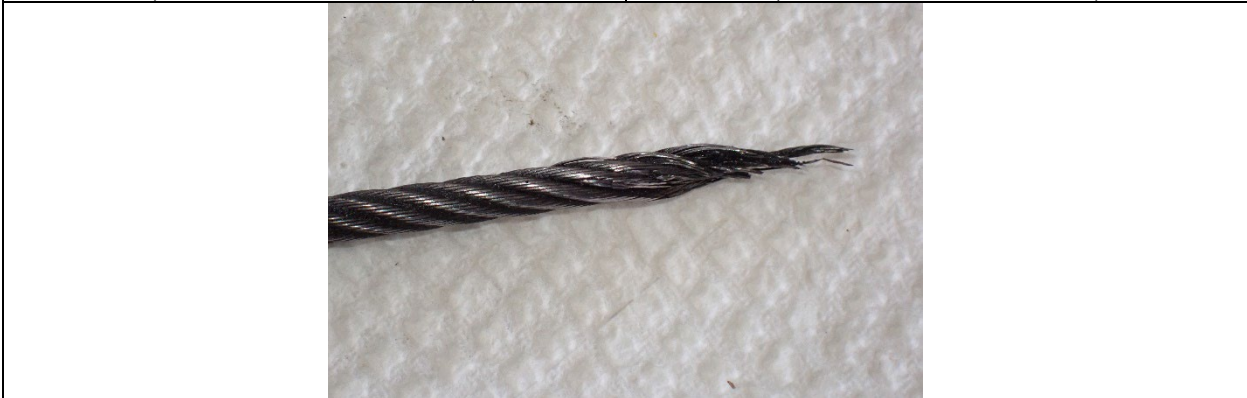
Figure 5: Fractured end of the left aileron direct cable (aileron side of the cable)

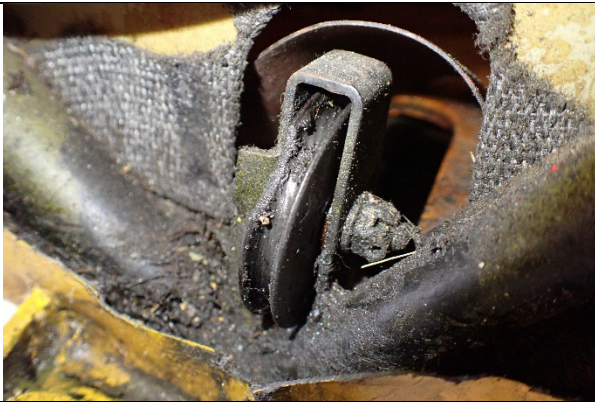
The pulley that was located at the fractured section of the left aileron direct cable was noted to have a small section of the pulley that was fracture separated, the

fracture area displayed an accumulation of dirt and grease. When manually rotating the pulley by hand, the pulley would not rotate freely and would occasionally bind. The pulley was removed, and it was observed that the bolt, bushing, and bushing housing were corroded. Further inspection of the pulley revealed that the channel of the pulley had a section that was visibly worn compared to the rest of the pulley which is consistent with the pulley not rotating during operation of the control cable. Inspection of the rudder cables and the aileron balance cables revealed additional corrosion to the portions of the cables that were external to the primary airplane structure.

Figure 6: Left aileron direct cable pulley

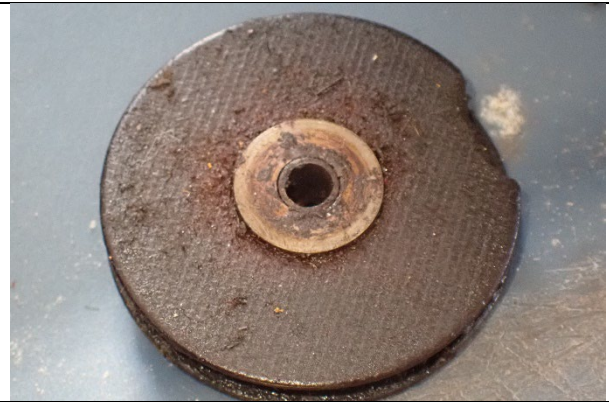
Figure 7: Left aileron direct cable pulley with visible corrosion

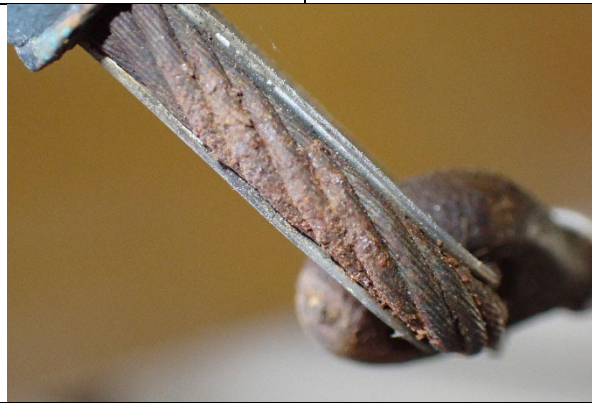
Figure 8: Left aileron balance cable eye end

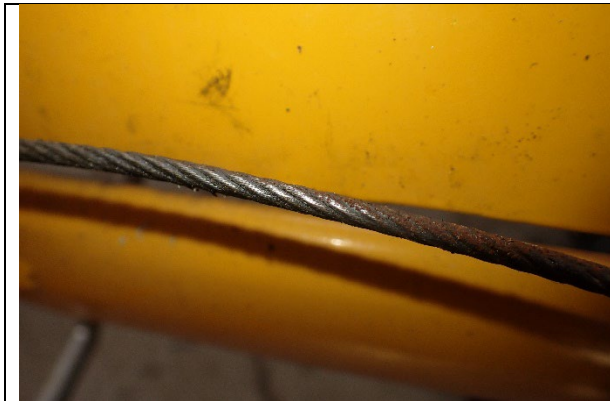
The right aileron direct cable was visually examined, and it was observed that the portion of the cable that exited the lower fuselage displayed a significant amount of corrosion. Tension was removed from the cable and the cable was bent by this investigator to facilitate inspection for broken wire strands. It was observed that at the corroded portion of the cable, the cable was inflexible, and when bent flakes of rust would fall off the cable. The cable was inspected in multiple locations around the corroded areas and approximately 10 broken wire strands were found in the right aileron direct cable. The right direct cable pulley in the lower right portion of the fuselage was examined while still installed in the airplane. The pulley was capable of rotating freely and there was no binding; however, it was observed that the pulley

channel had a worn-out area of the channel which was consistent with the cable rubbing in the channel without the pulley rotating during operation.

Figure 9: Right aileron direct cable with visible corrosion and wear marks

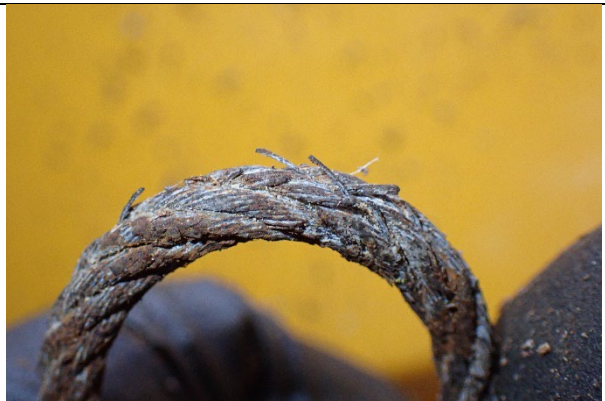
Figure 10: Right aileron direct cable with visible corrosion and broken wire strands

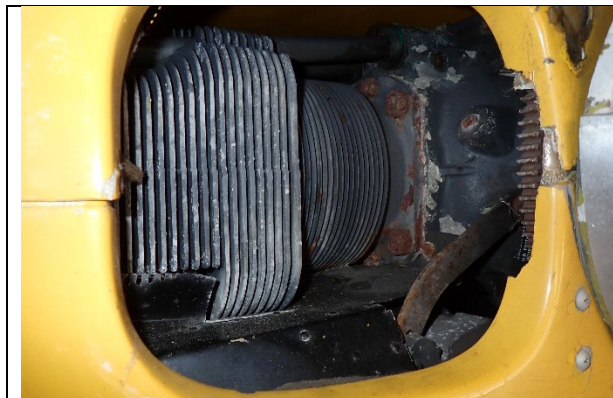
The external portions of the engine displayed signs of untreated corrosion with the most corrosion occurring around the cylinder bases. The top spark plugs were removed from their respective cylinders and the crankshaft was rotated manually. All four cylinders displayed good thumb compression and suction and the crankshaft rotated normally without any binding. The rocker box covers were removed and the overhead components (rocker arms, valve springs, and valves) displayed normal lubrication signatures. It was observed that several of the valve springs were corroded; however, none of the valve springs were fractured. During crankshaft rotation, all the rocker arms and valves operated normally.

Figure 11: No. 1 Cylinder with visible corrosion at the cylinder base

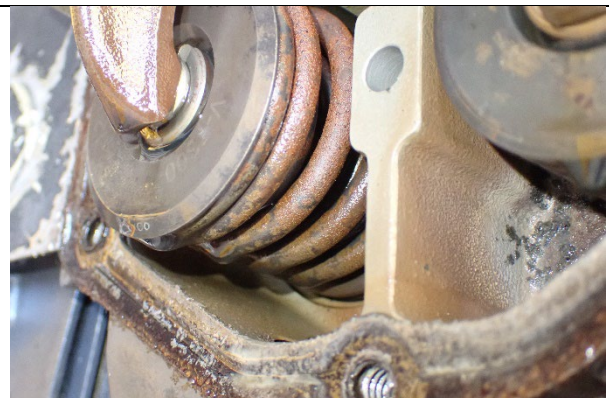
Figure 12: No. 1 Cylinder intake valve springs with visible corrosion

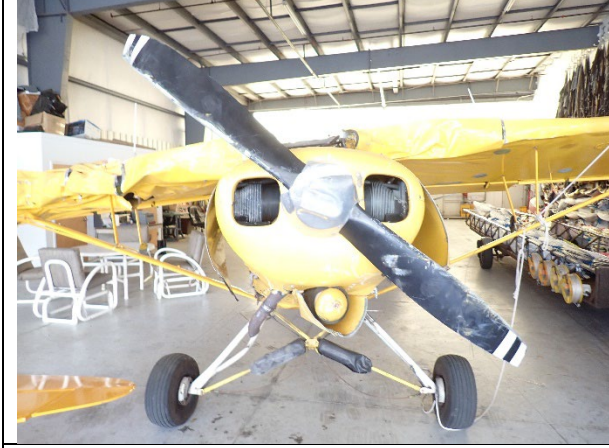
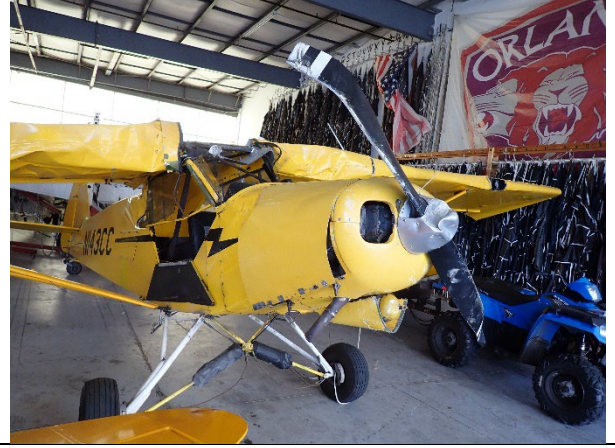
The two-bladed, fixed-pitch propeller remained attached to the crankshaft and displayed impact damage to both of the propeller blades. Both of the propeller blades displayed leading edge polishing, and both blade tips were bent aft.
