ERA24LA128

## INVESTIGATION PHOTOGRAPHS

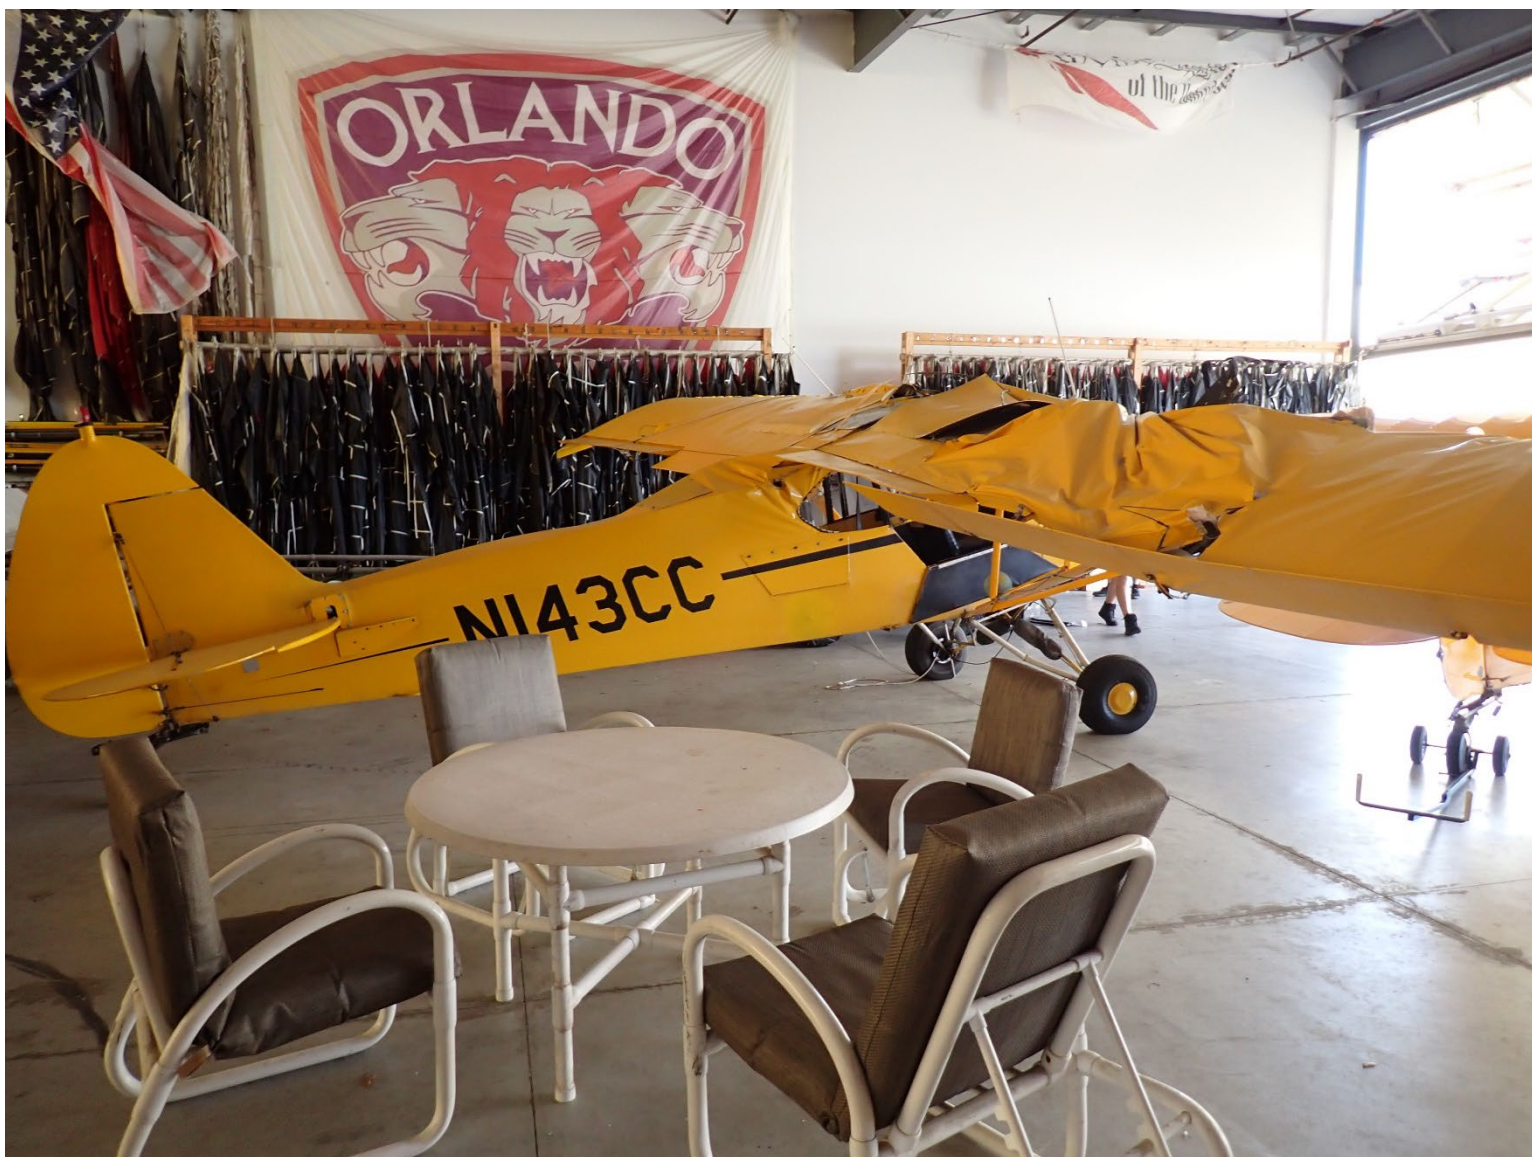
**Photograph 1 - Airframe overview**

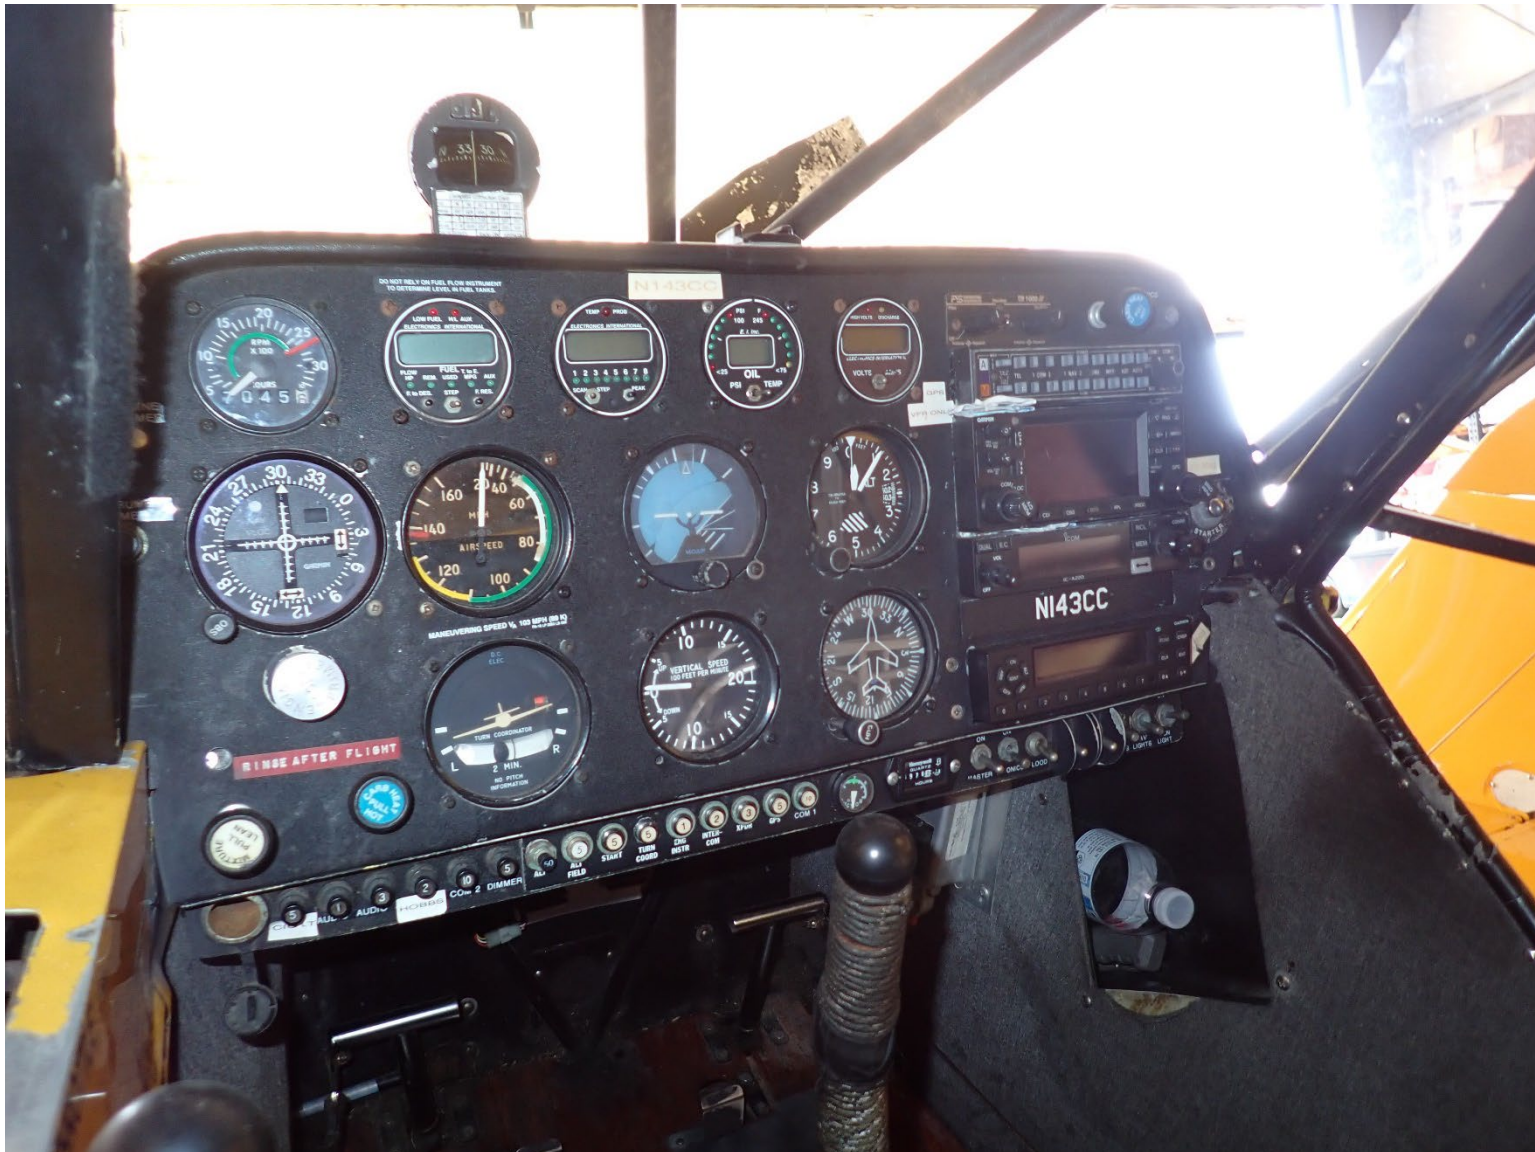
**Photograph 2 - Instrument panel overview**

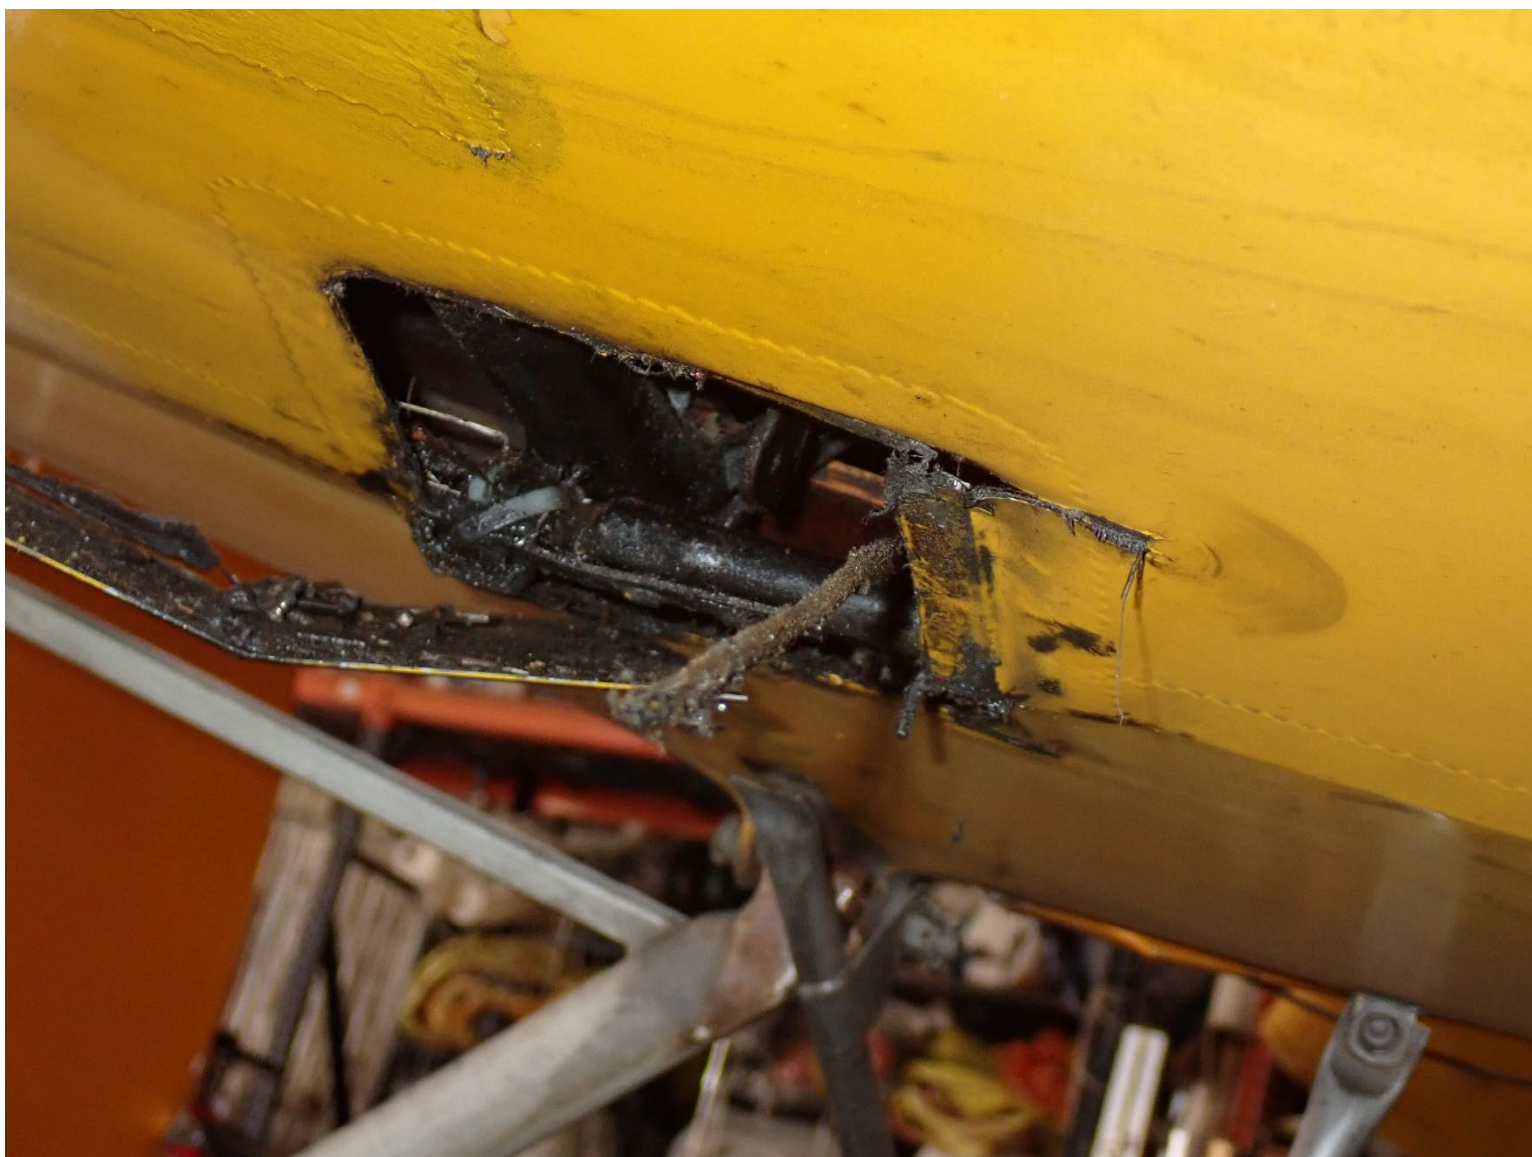
**Photograph 3 - Broken aileron cable at fuselage**

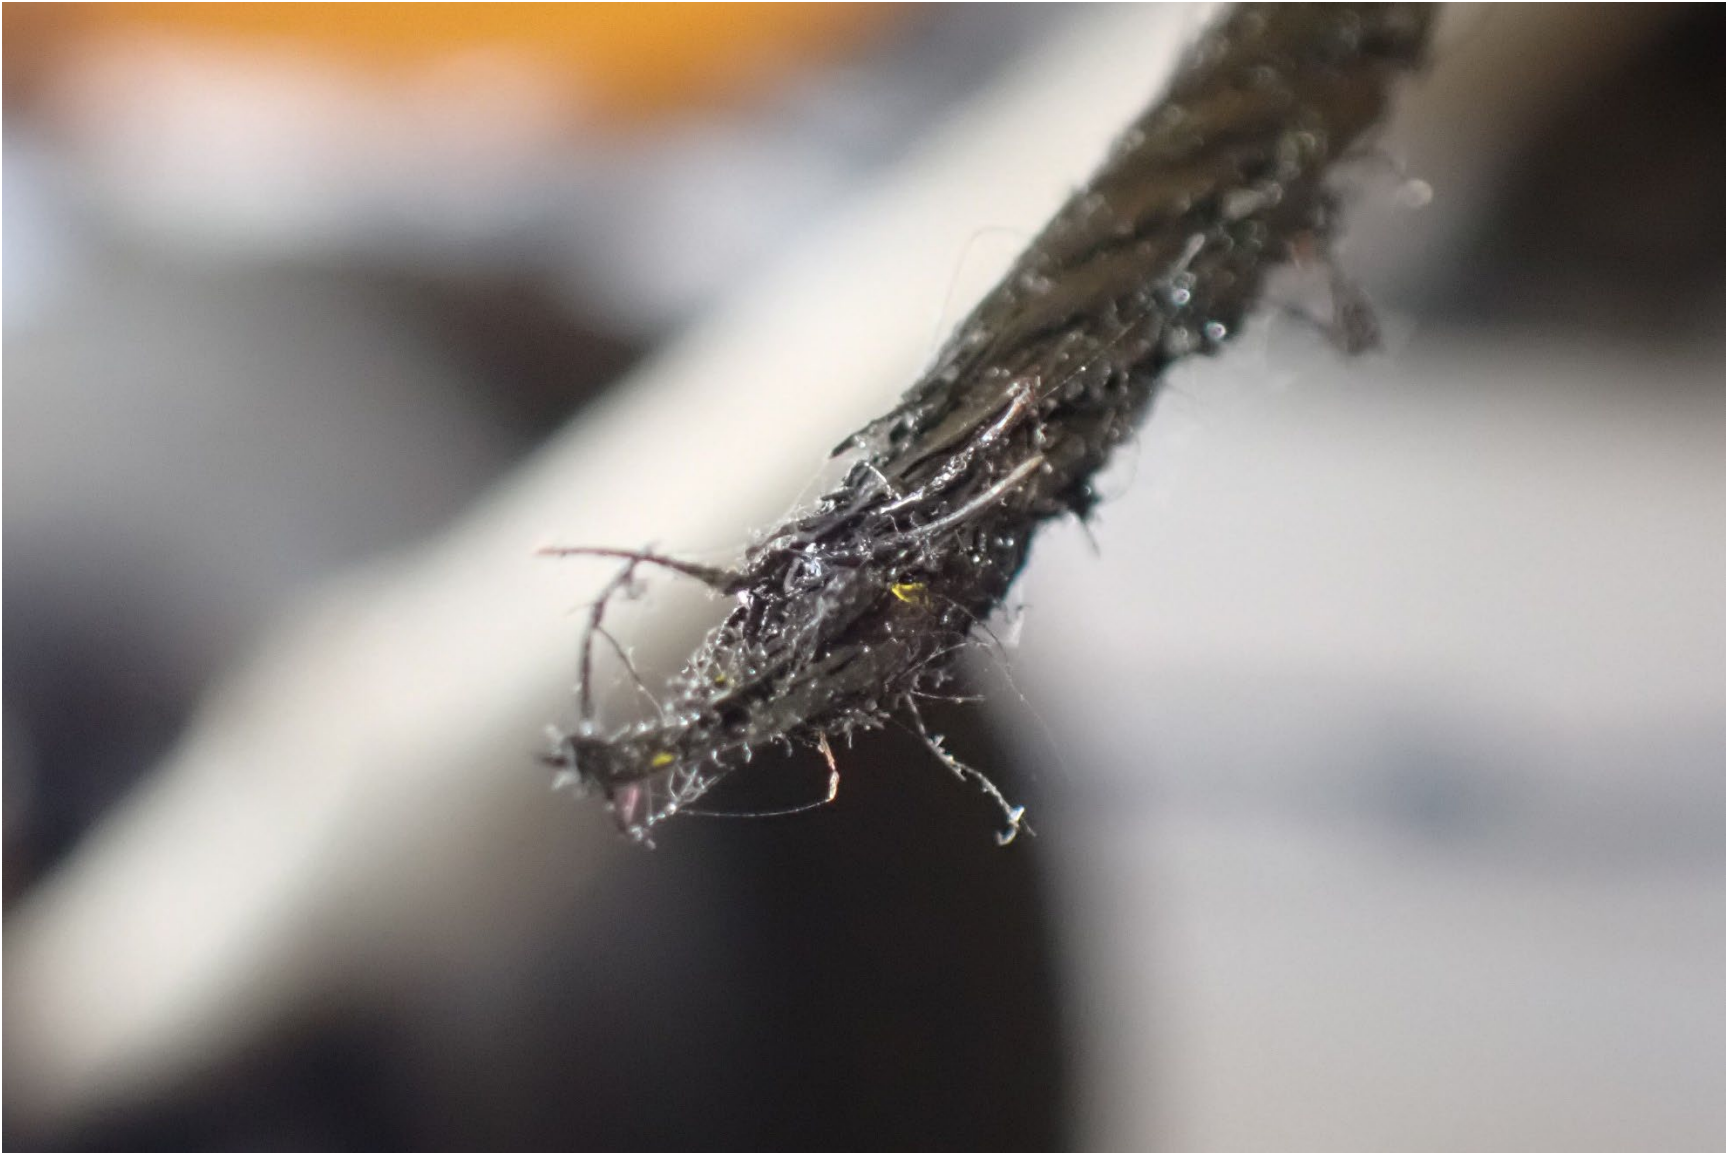
**Photograph 4 - Broken aileron cable at fuselage**

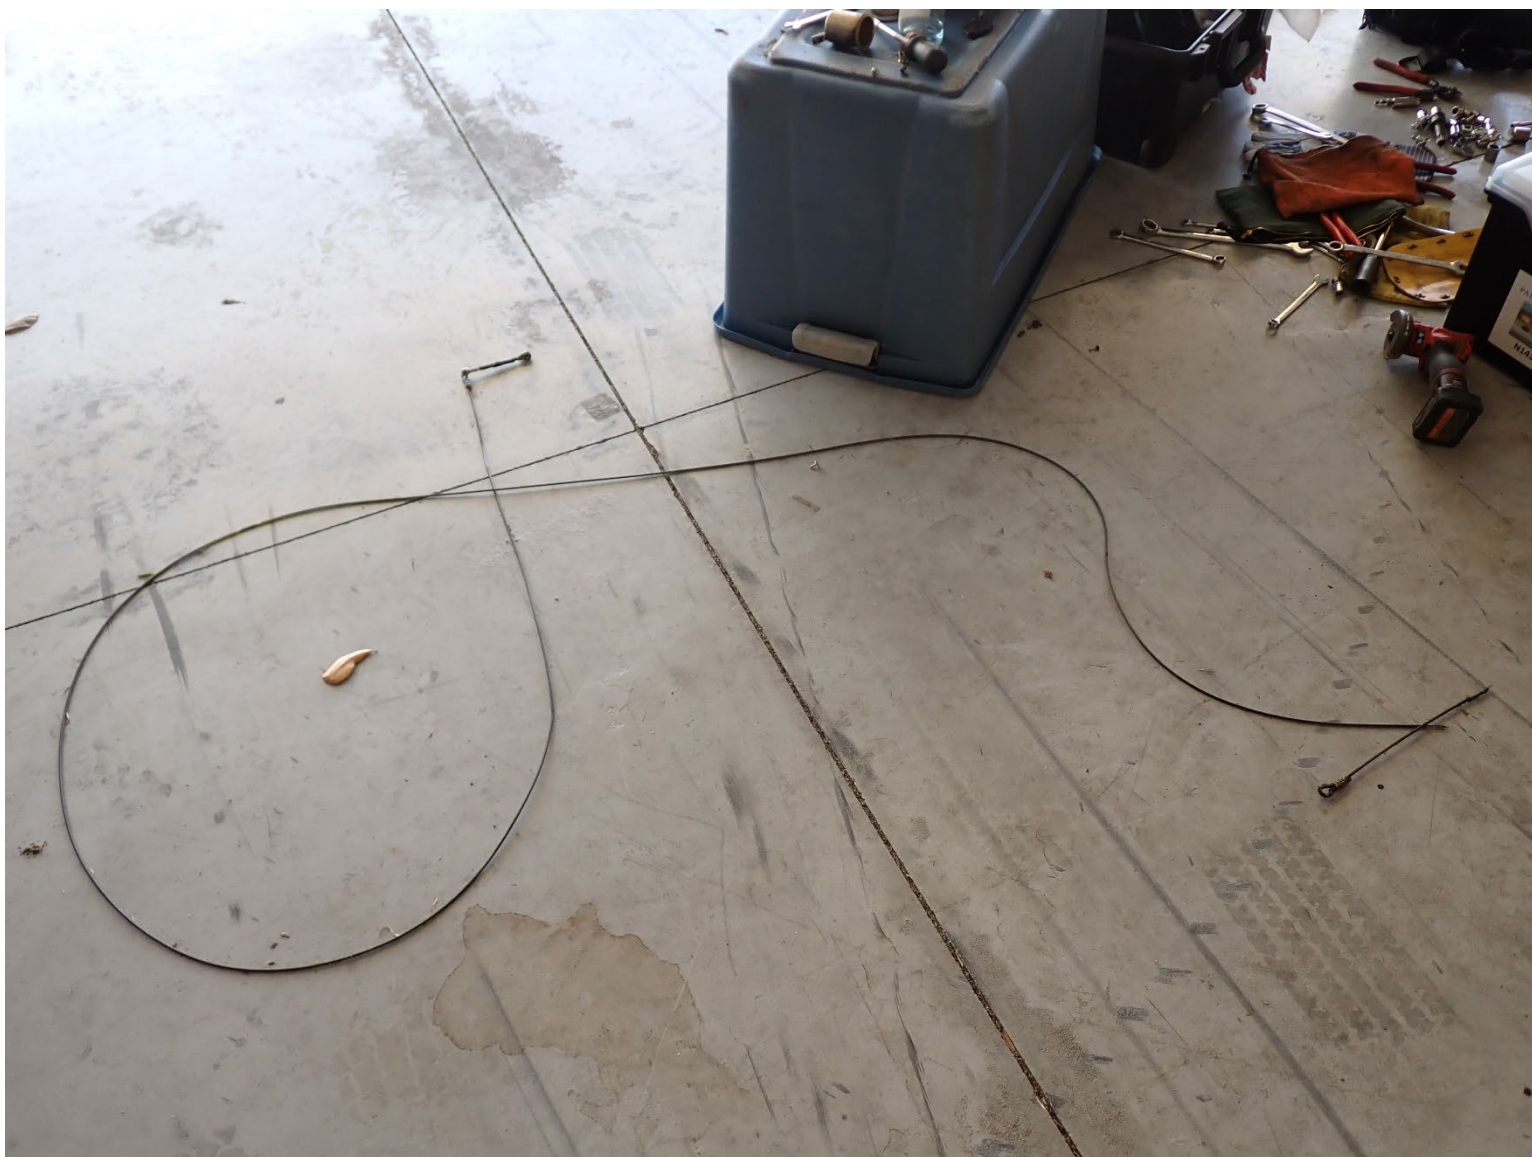
**Photograph 5 - Broken aileron cable**

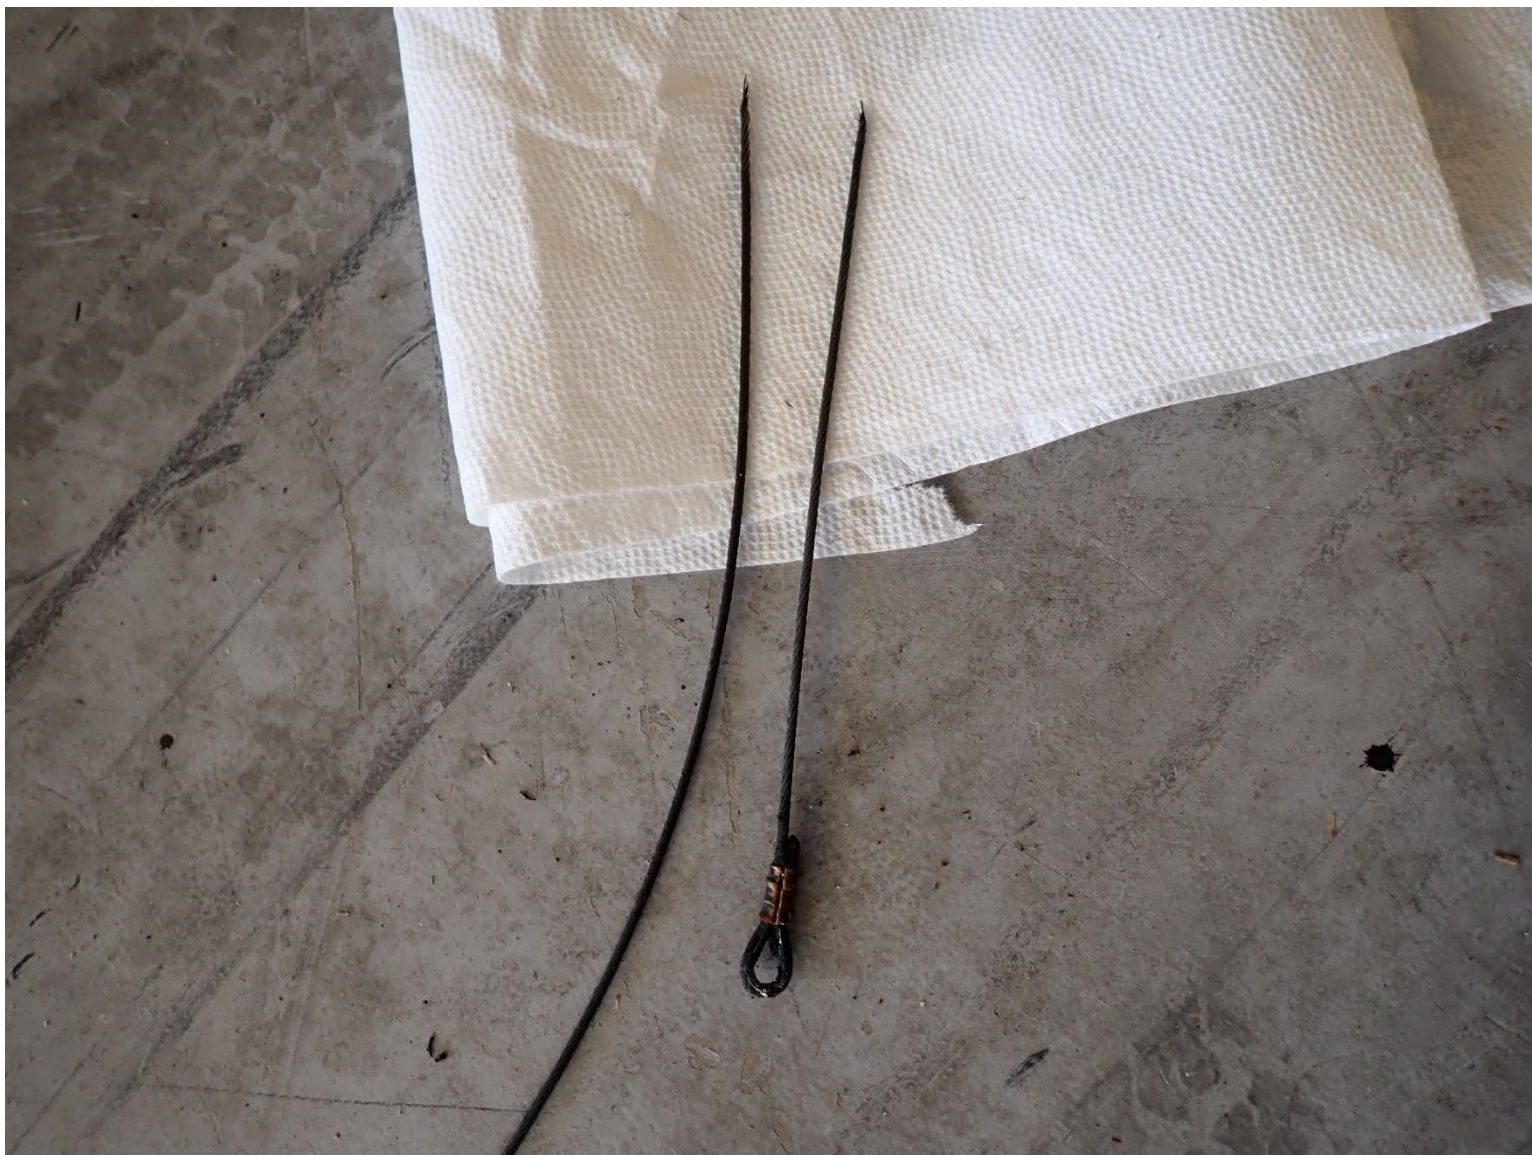
**Photograph 6 - Both sides of the broken aileron cable**

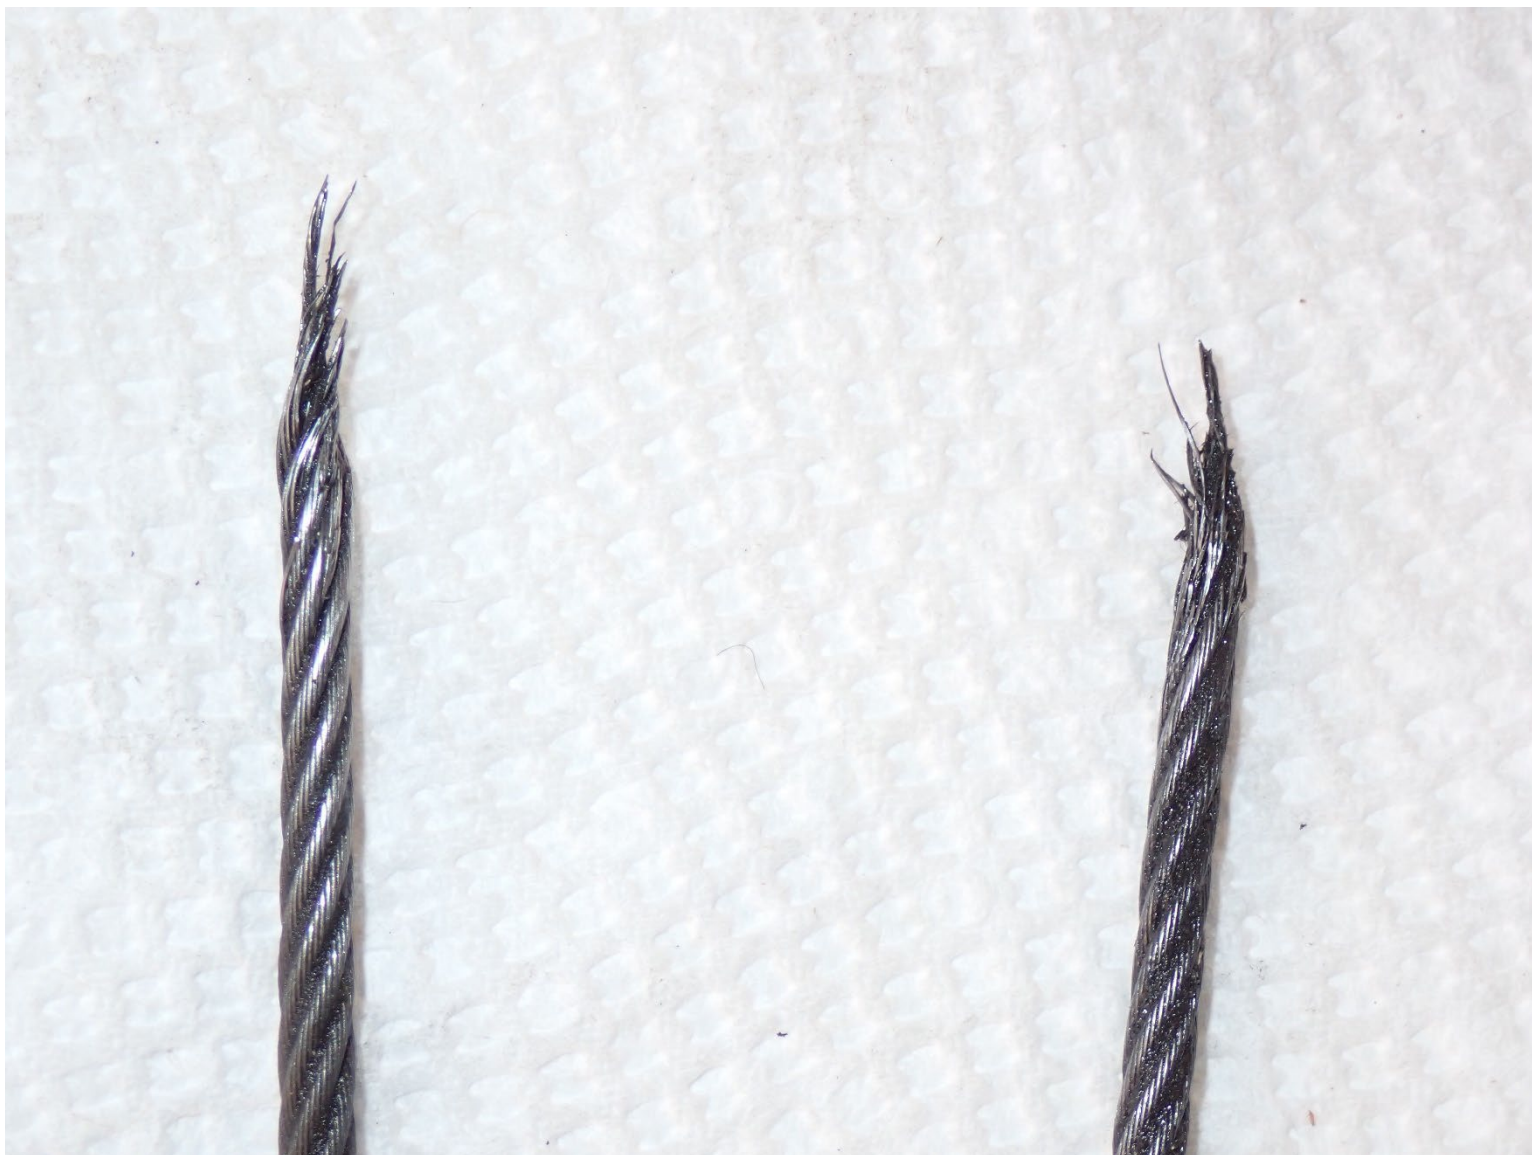
**Photograph 7 - Close up view of broken aileron cable**

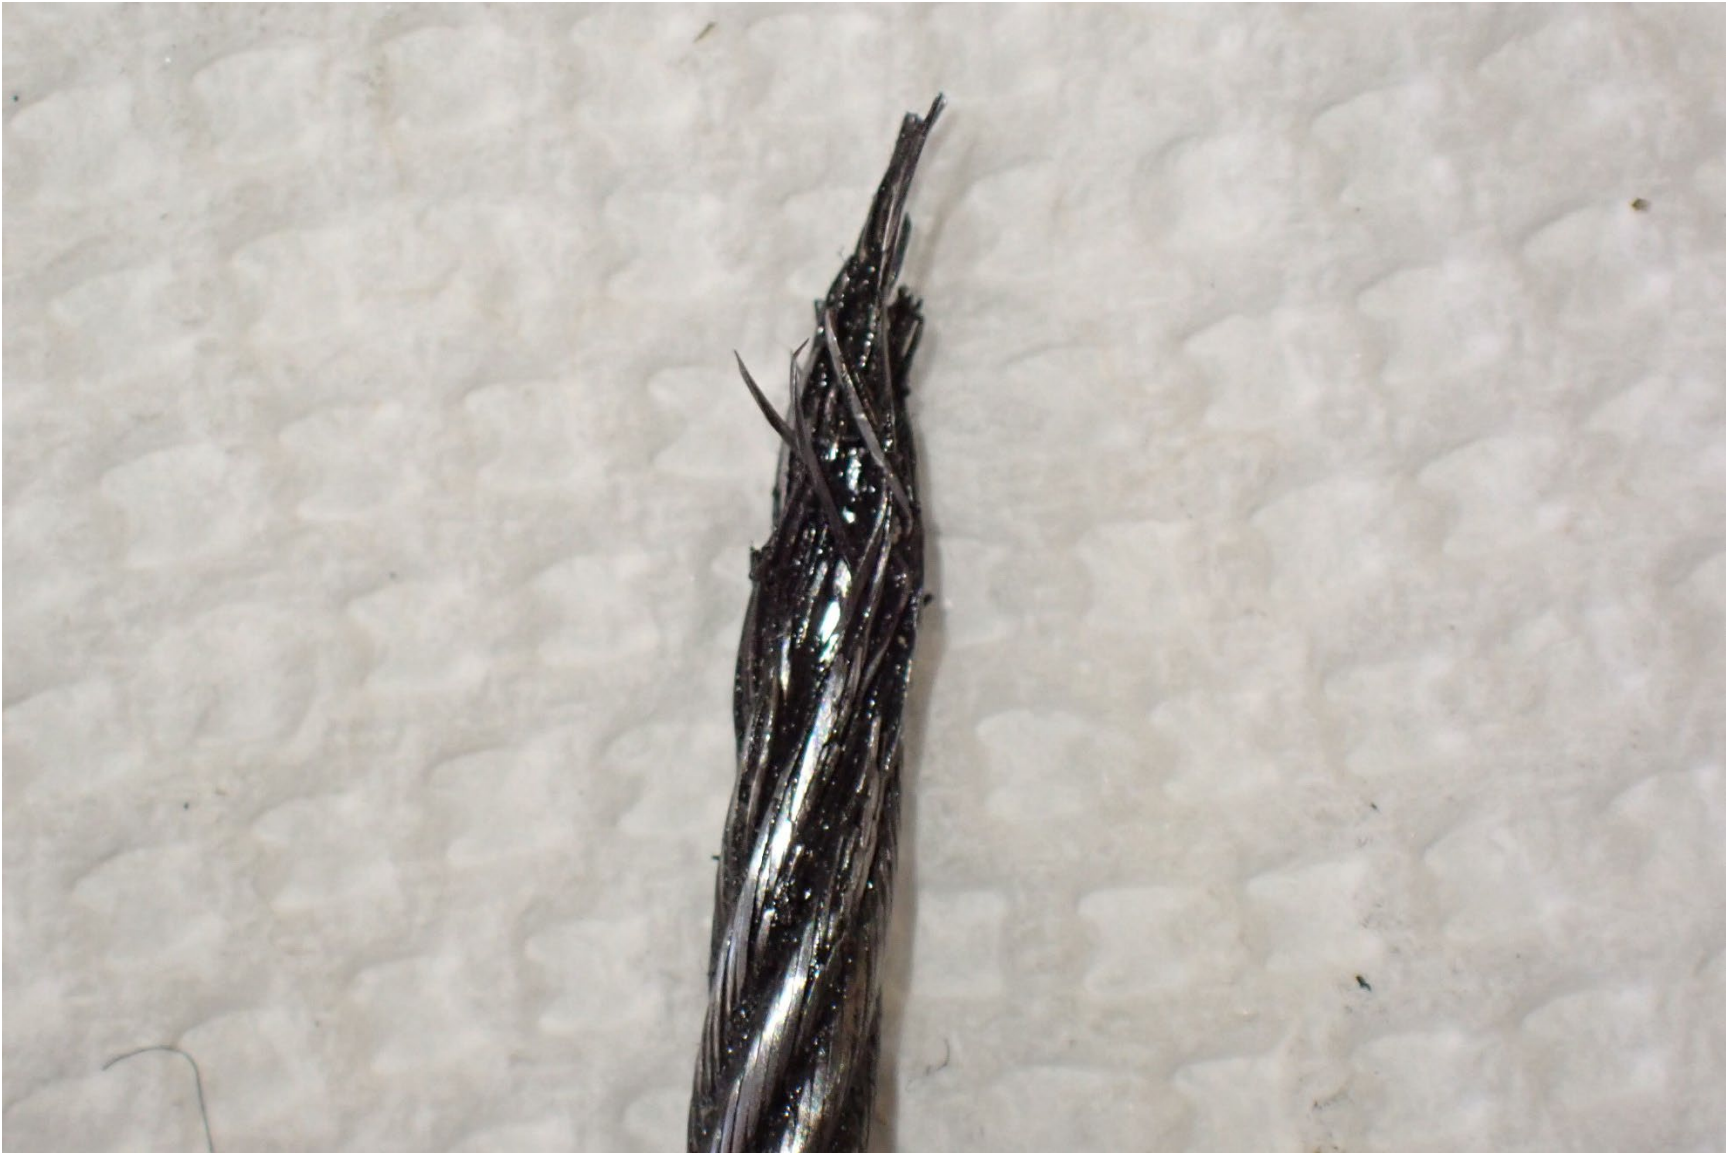
**Photograph 8 - Close up view of broken aileron cable (fuselage side)**

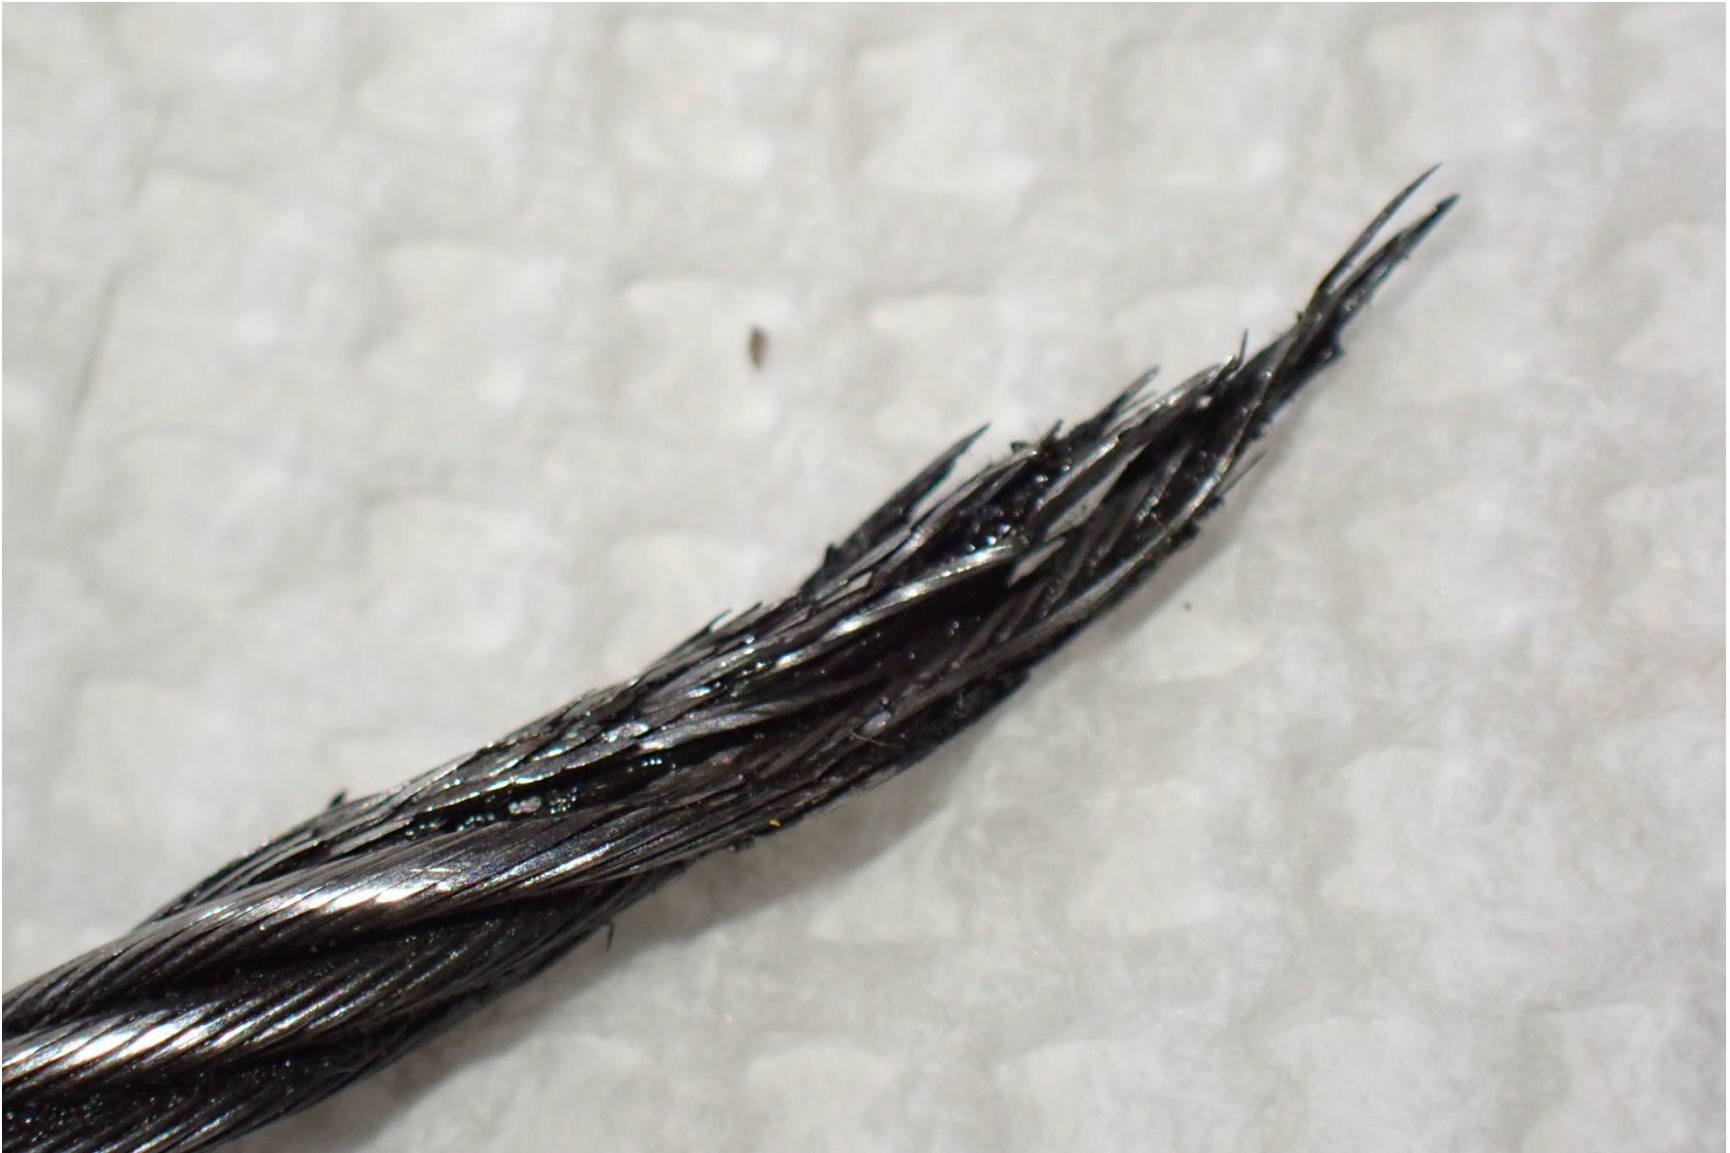
**Photograph 9 - Close up view of broken aileron cable (aileron side)**

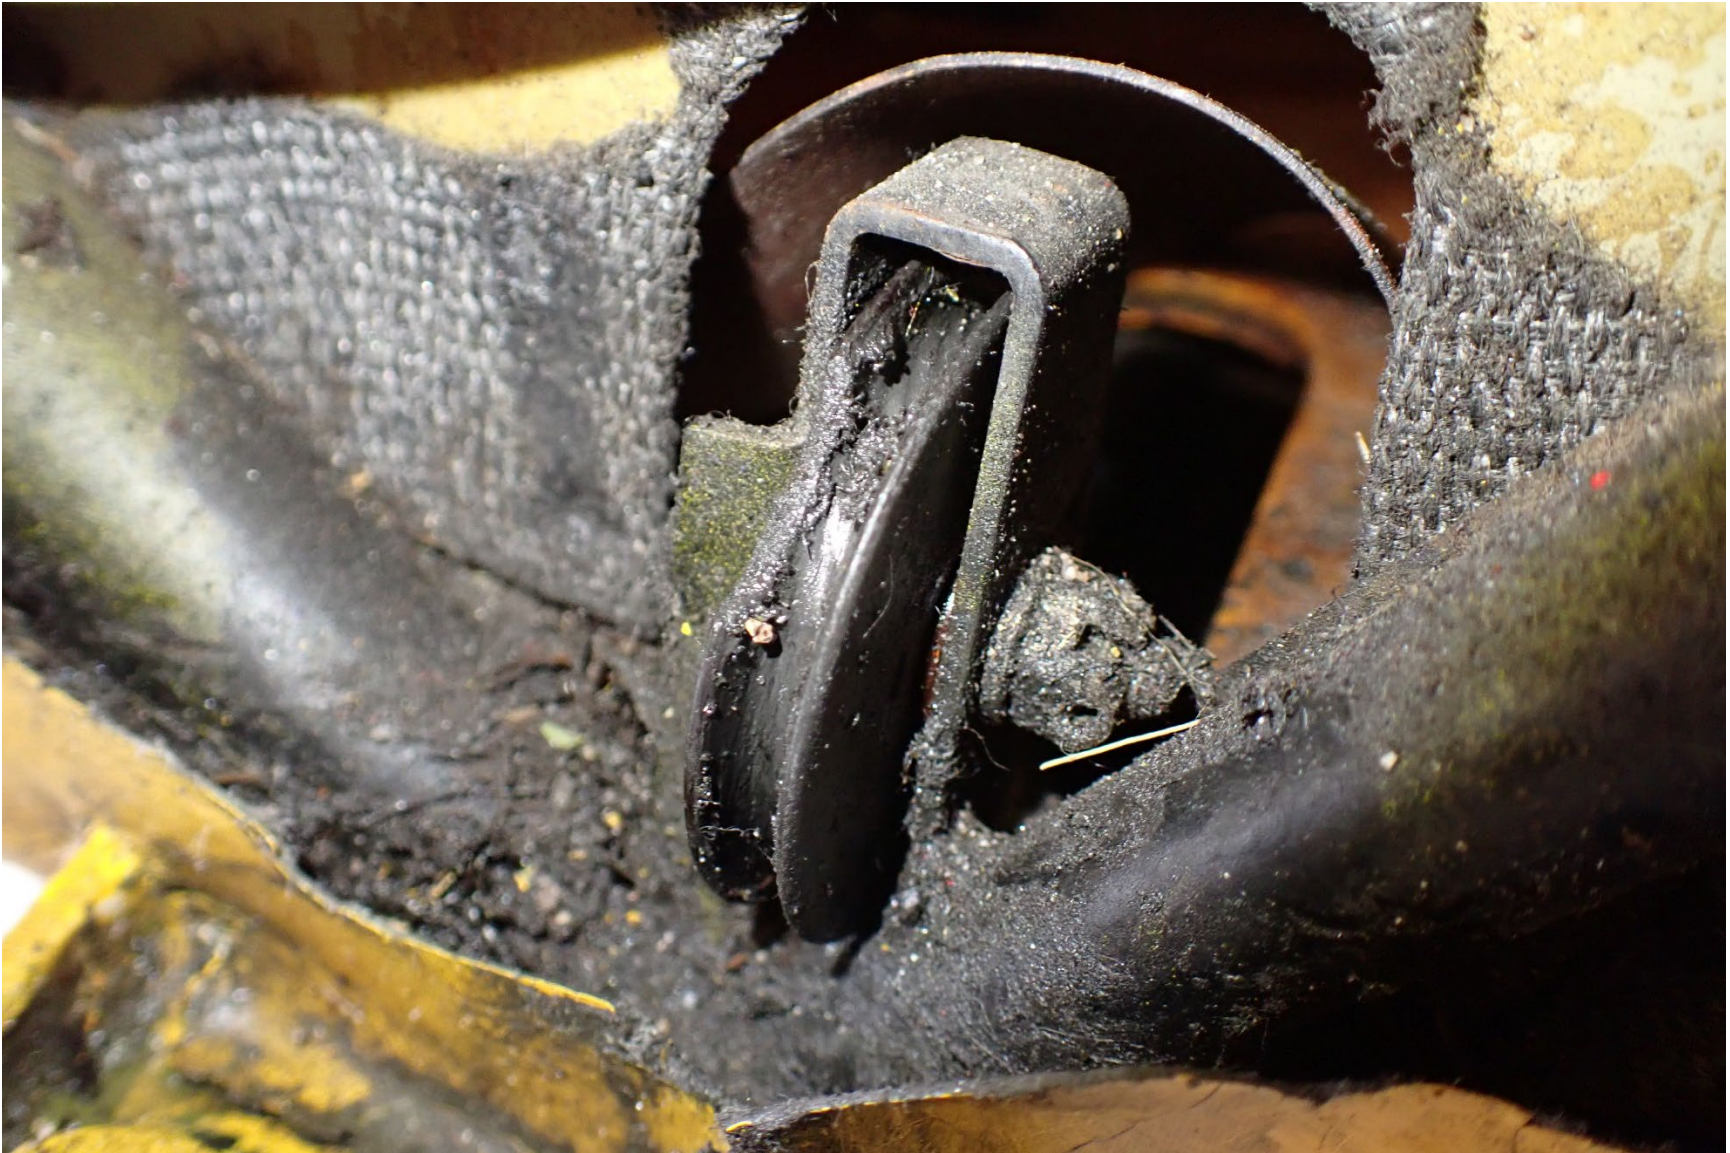
**Photograph 10 - Left aileron direct cable pulley (lower left fuselage)**

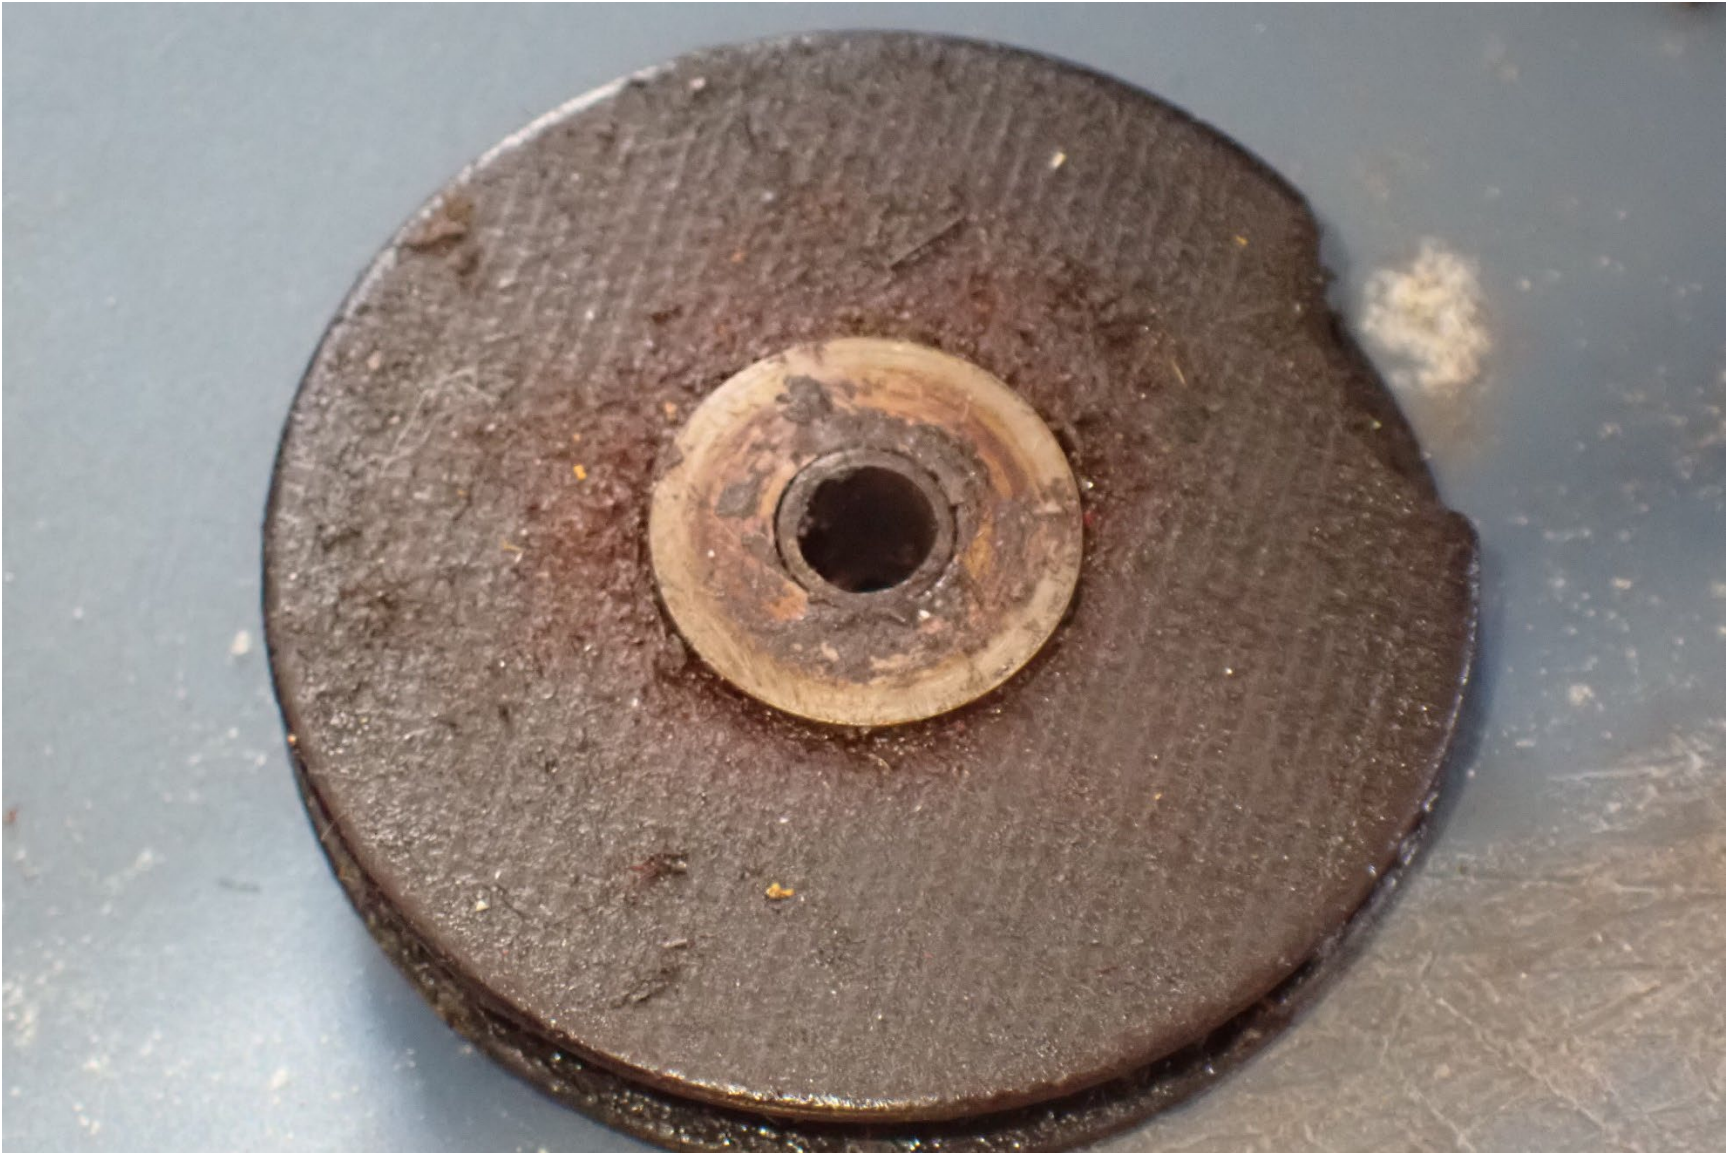
**Photograph 11 - Left aileron direct cable pulley (lower left fuselage)**

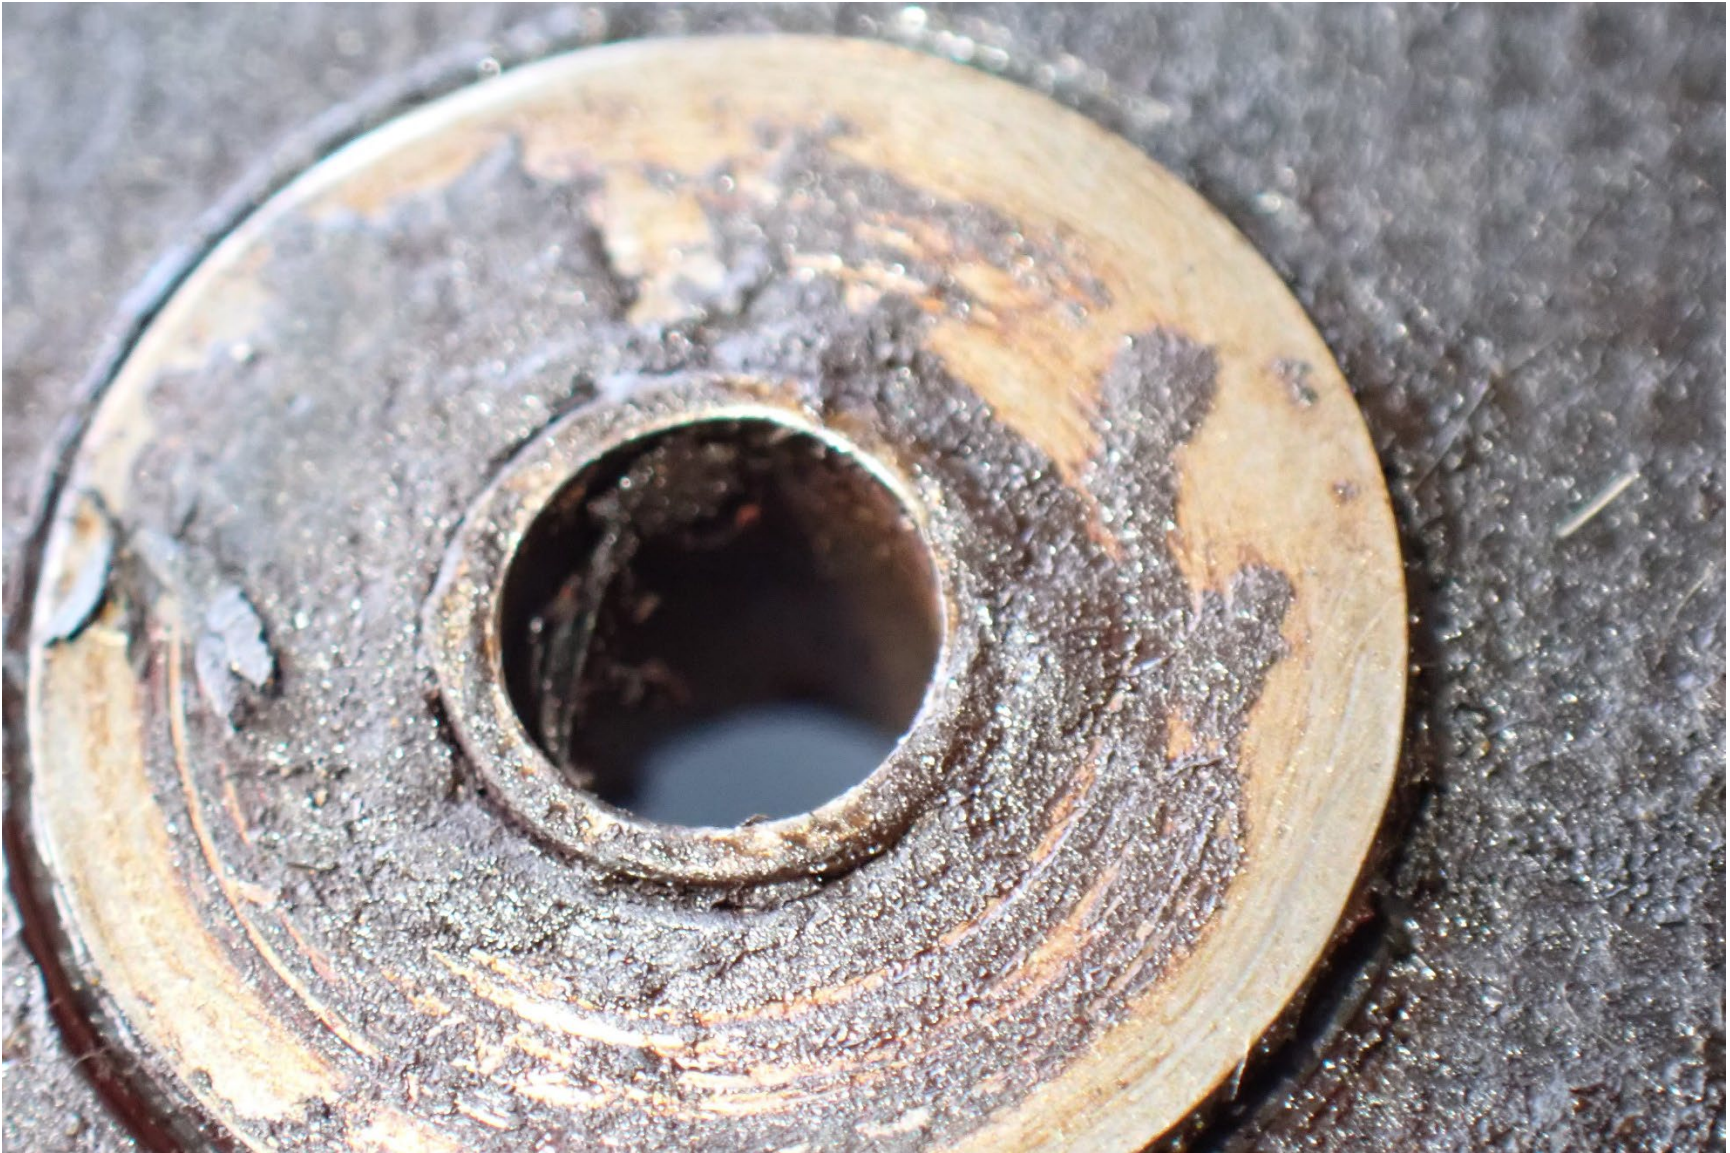
**Photograph 12 - Close up view of the lower left fuselage aileron pulley**
