ERA24LA128

## INVESTIGATION PHOTOGRAPHS

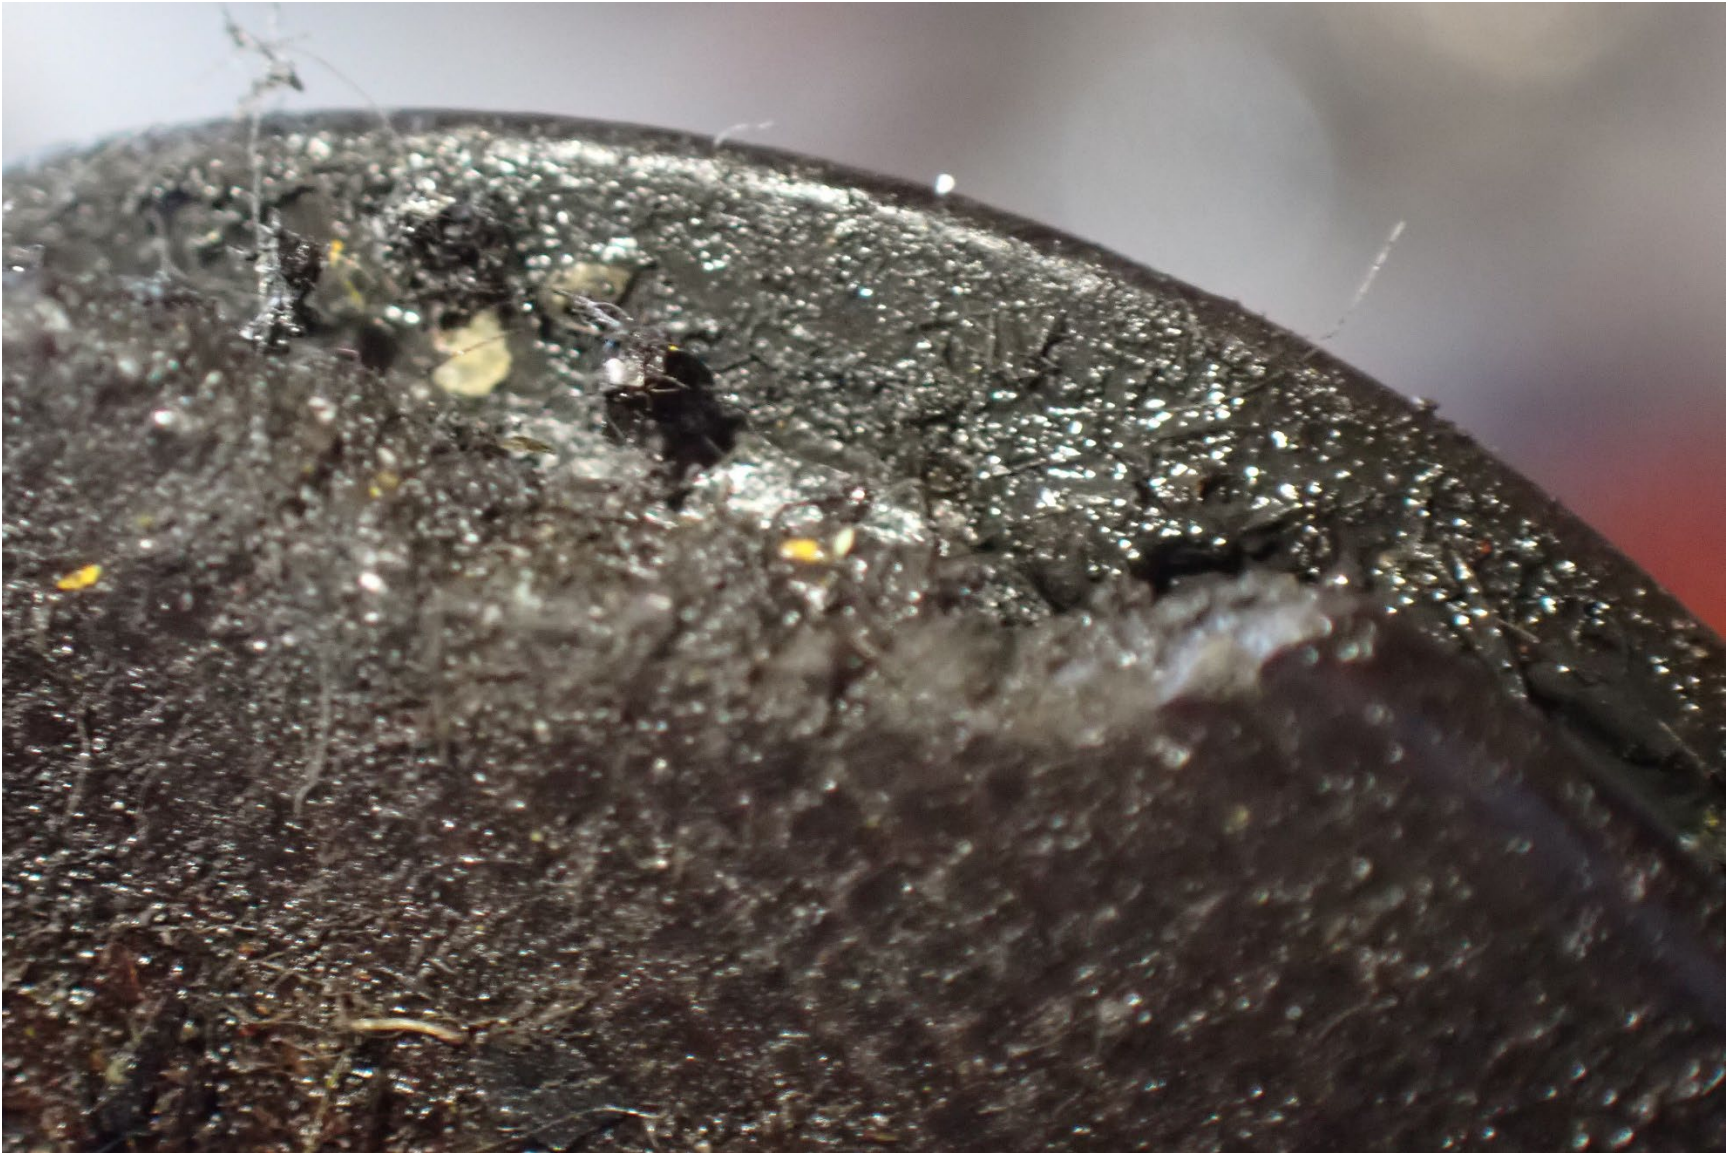
**Photograph 13 - Close up view of the lower left fuselage aileron pulley**

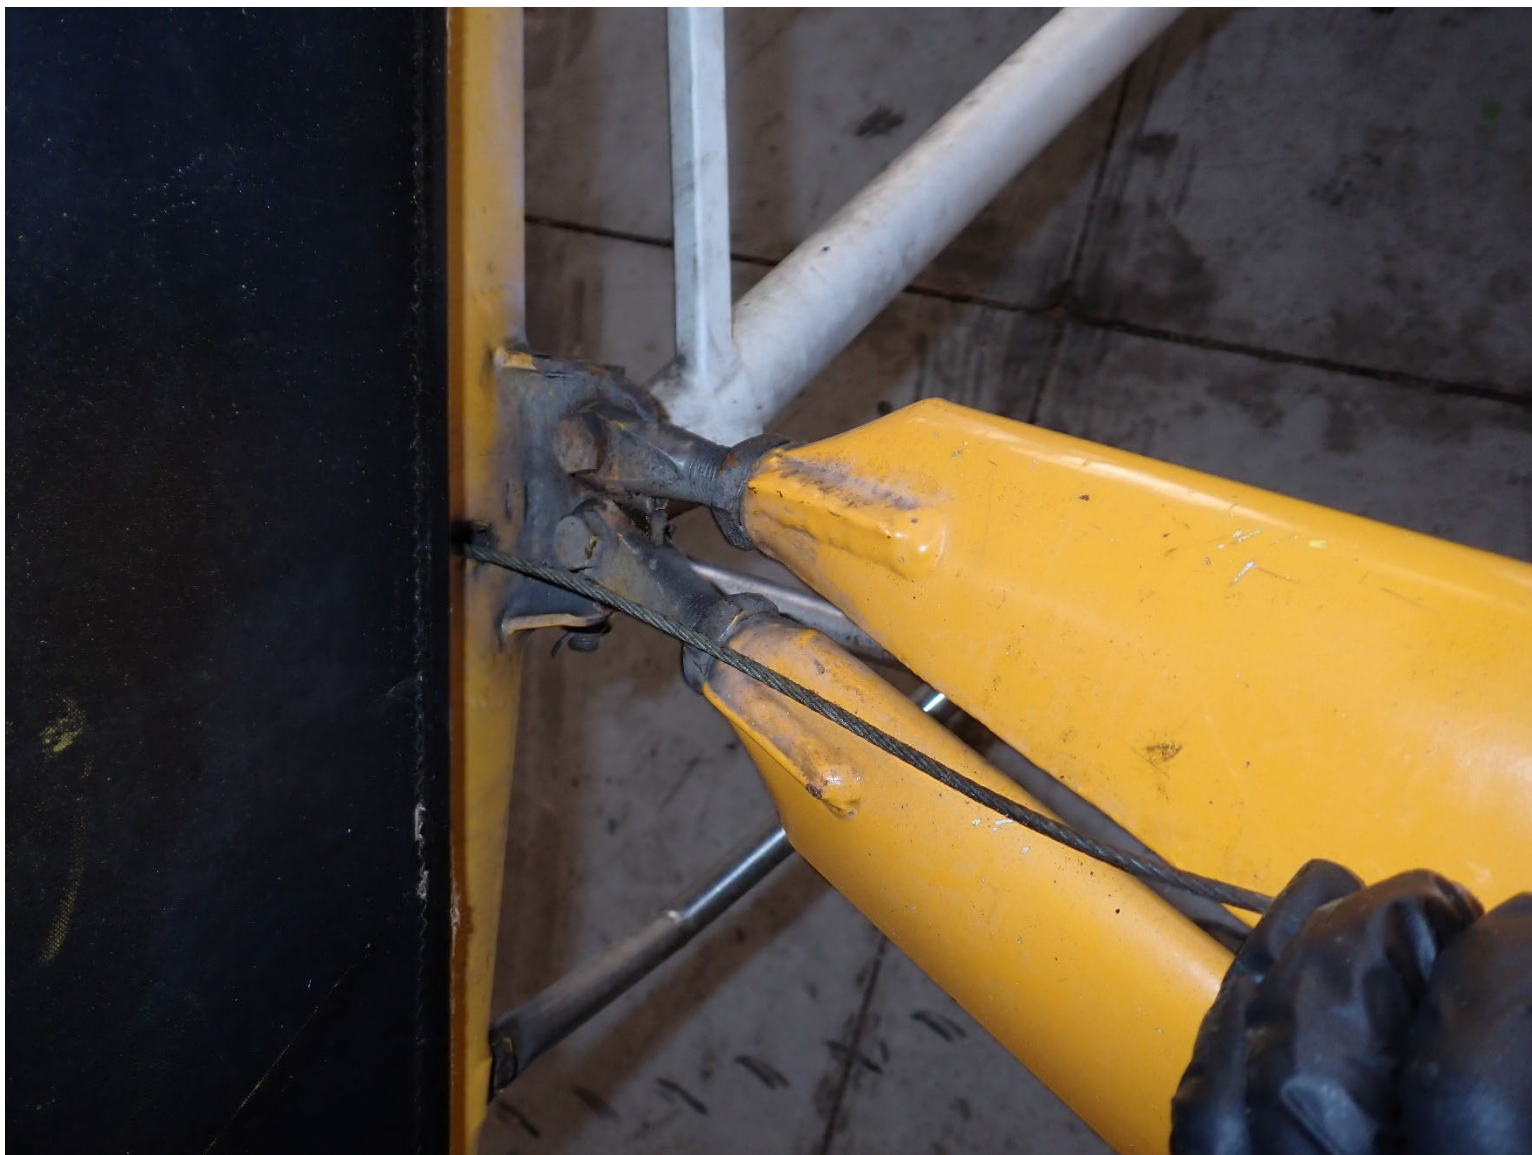
**Photograph 14 - Right direct aileron cable at the lower right fuselage pulley**

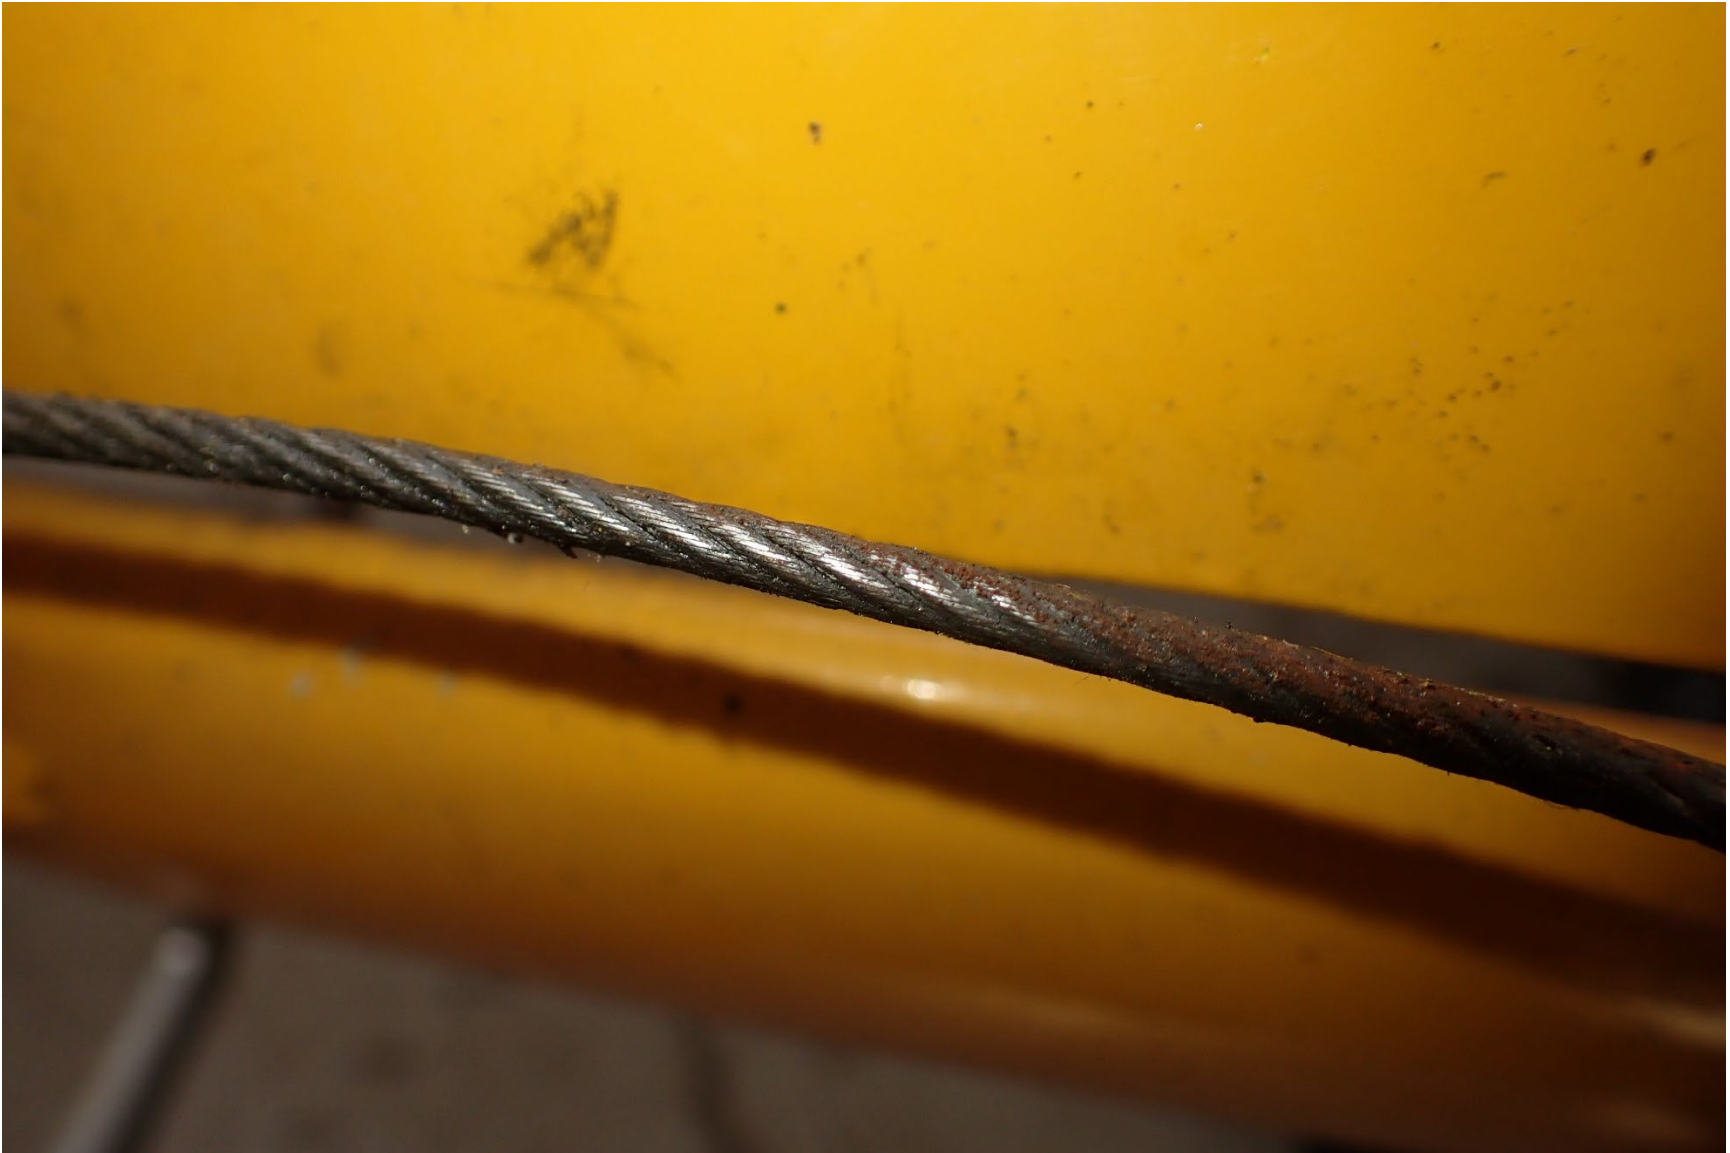
**Photograph 15 - Corrosion and wear on the right direct aileron cable**

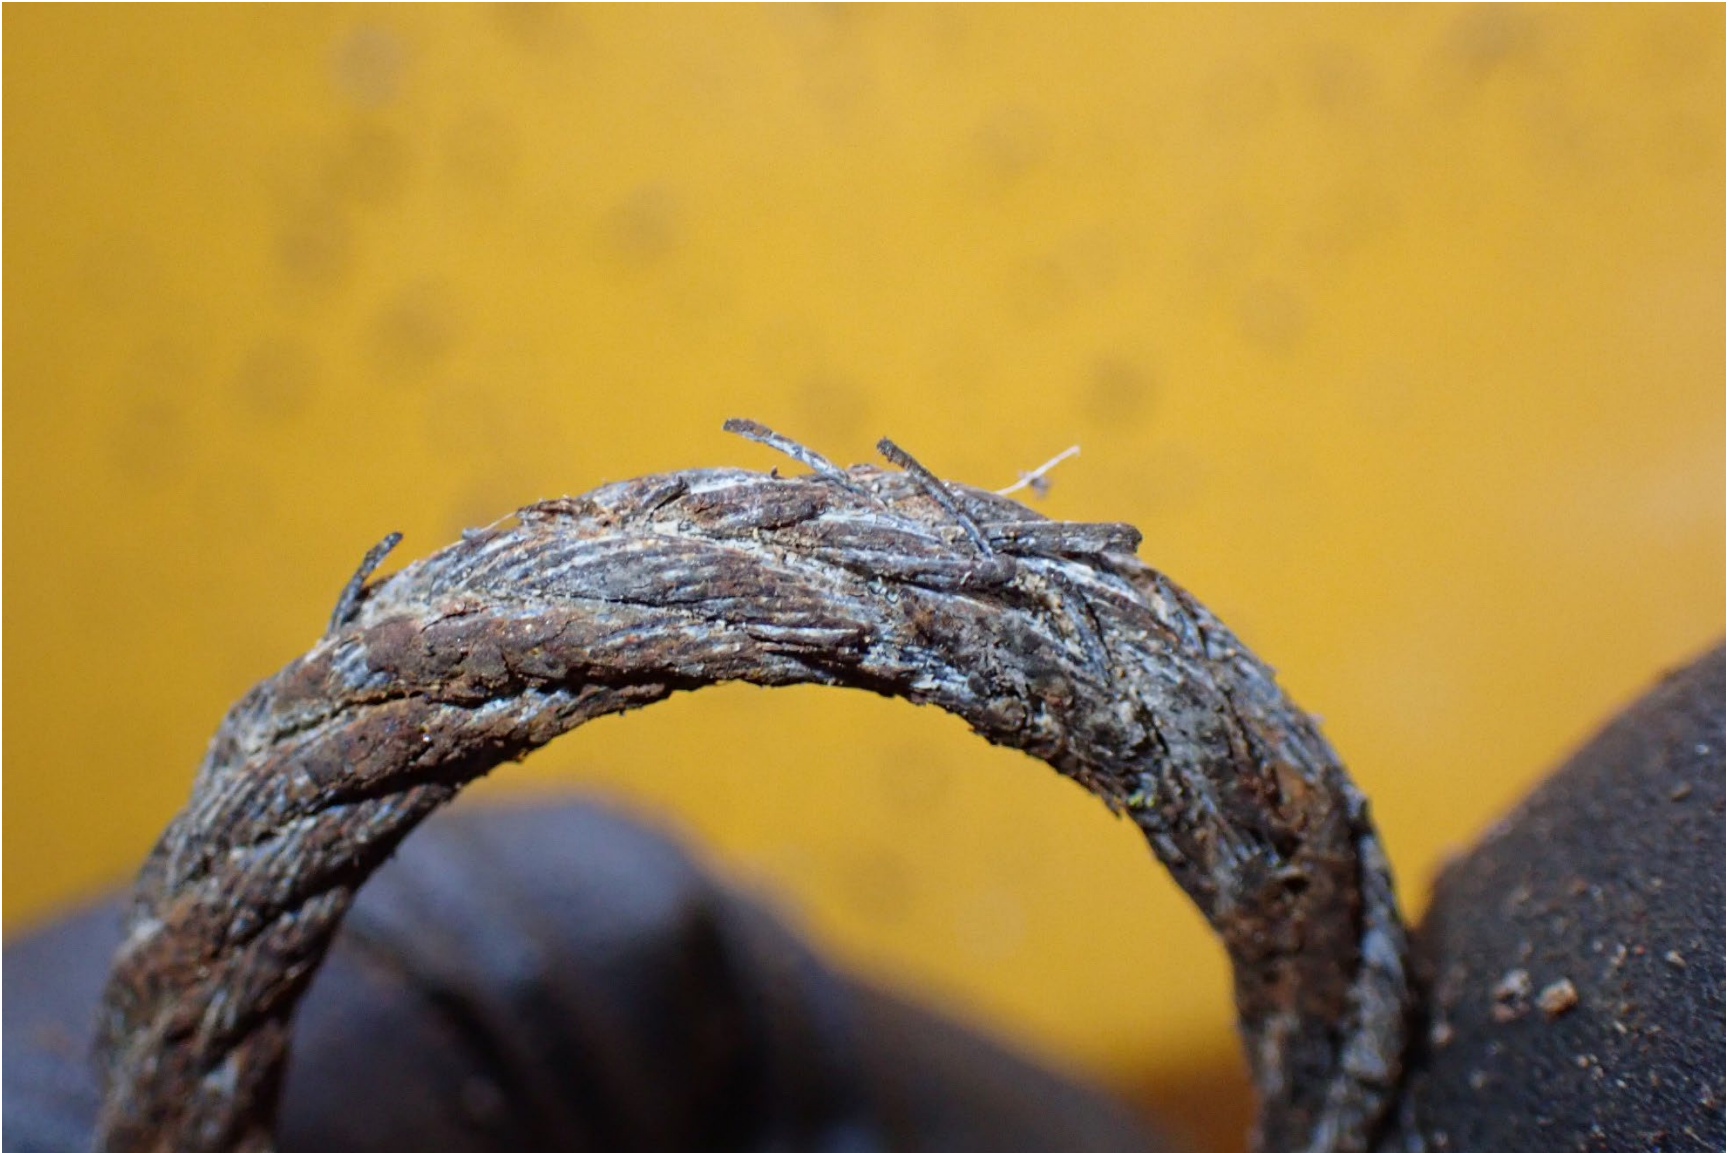
**Photograph 16 - Corrosion and broken strands on the right direct aileron cable**

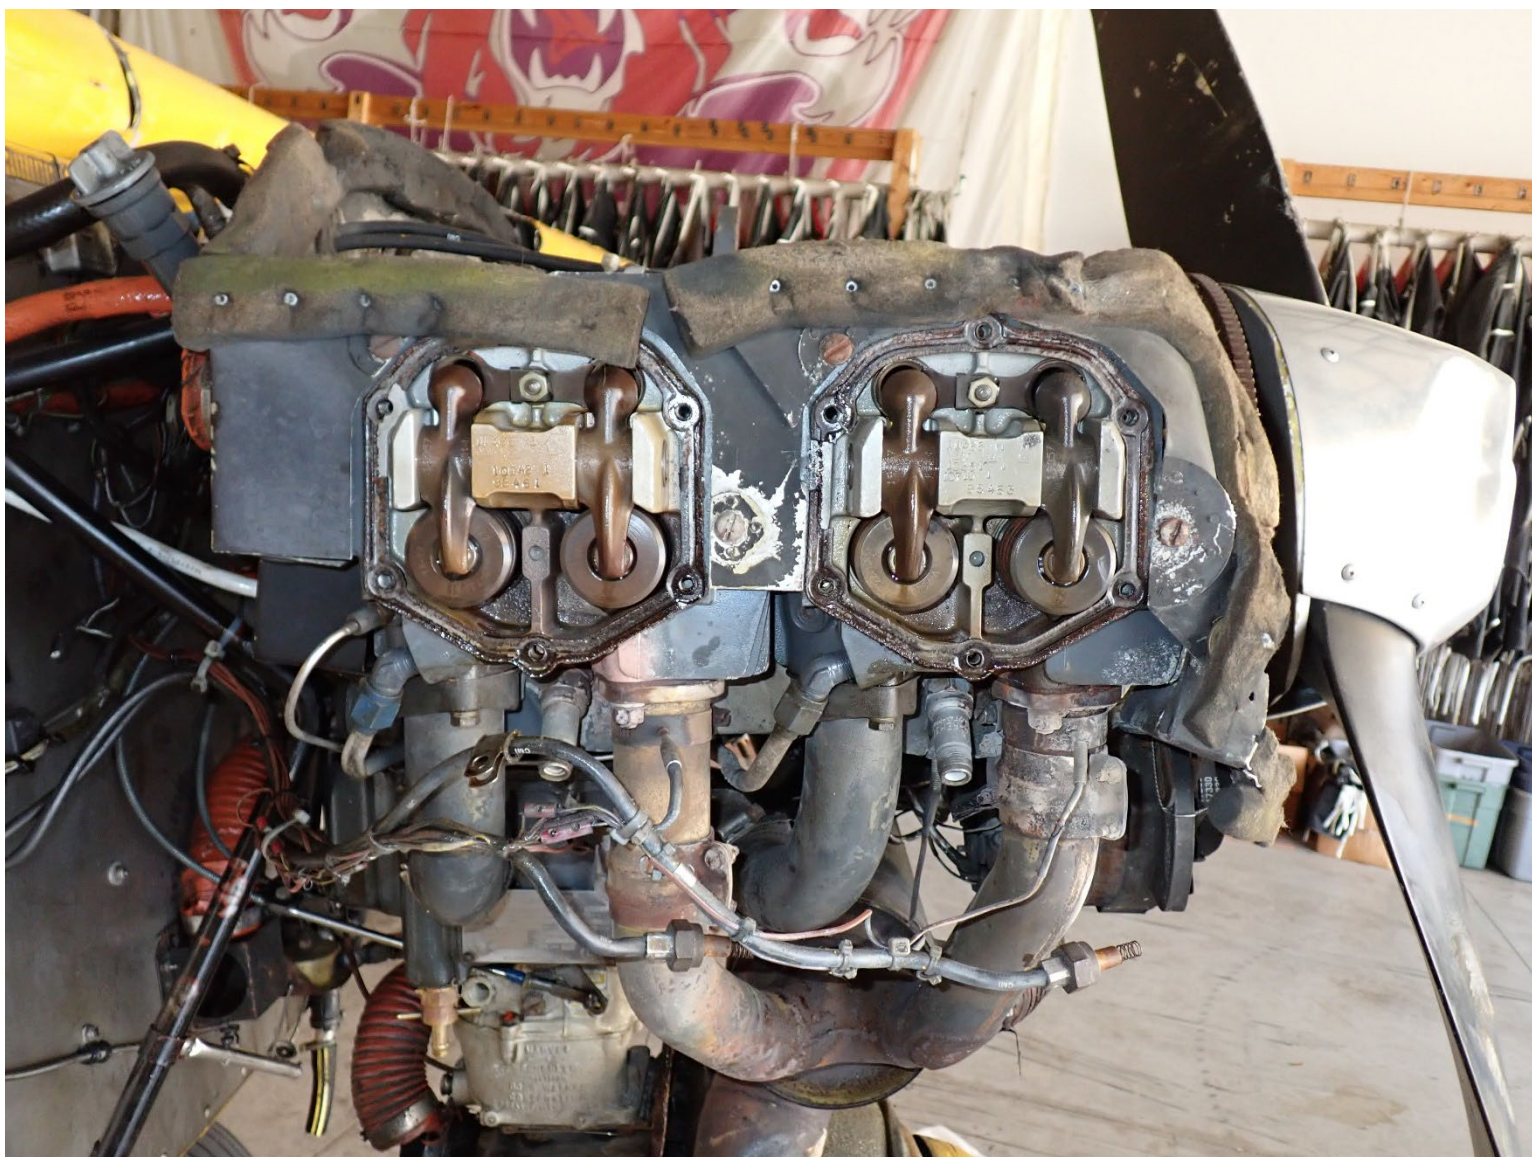
**Photograph 17 - Engine overview, right side**

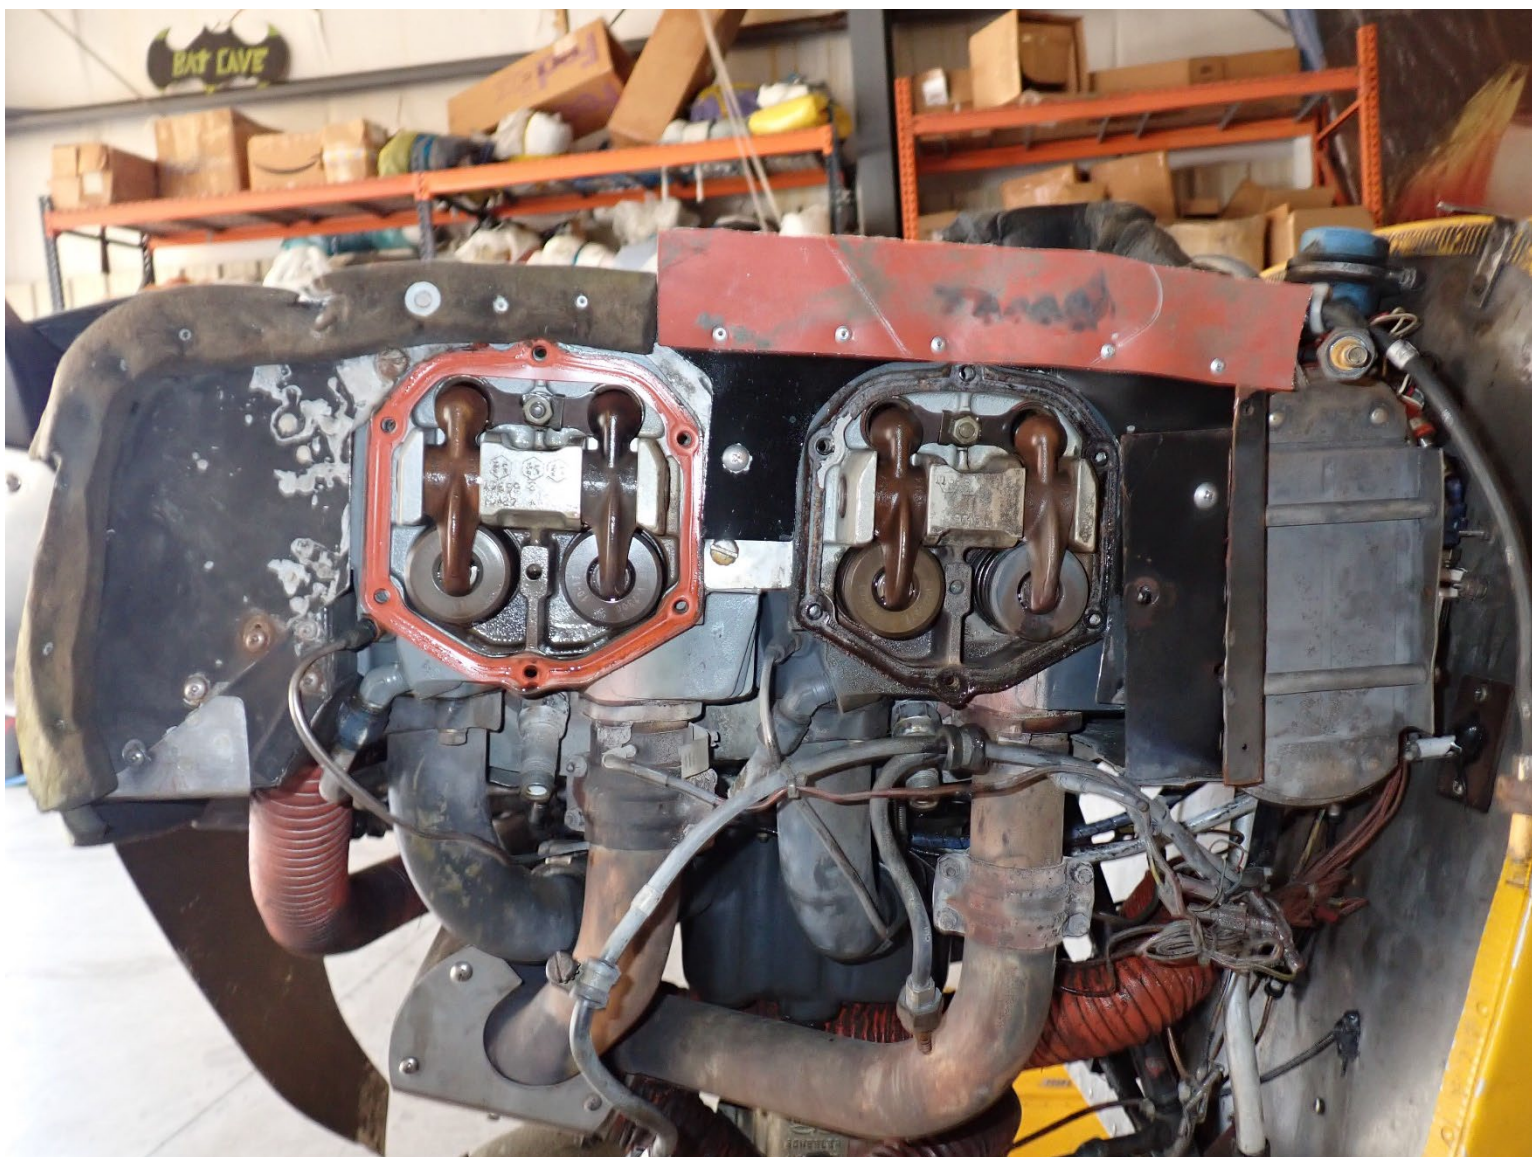
**Photograph 18 - Engine overview, left side**
