ERA24LA129

## INVESTIGATION PHOTOGRAPHS

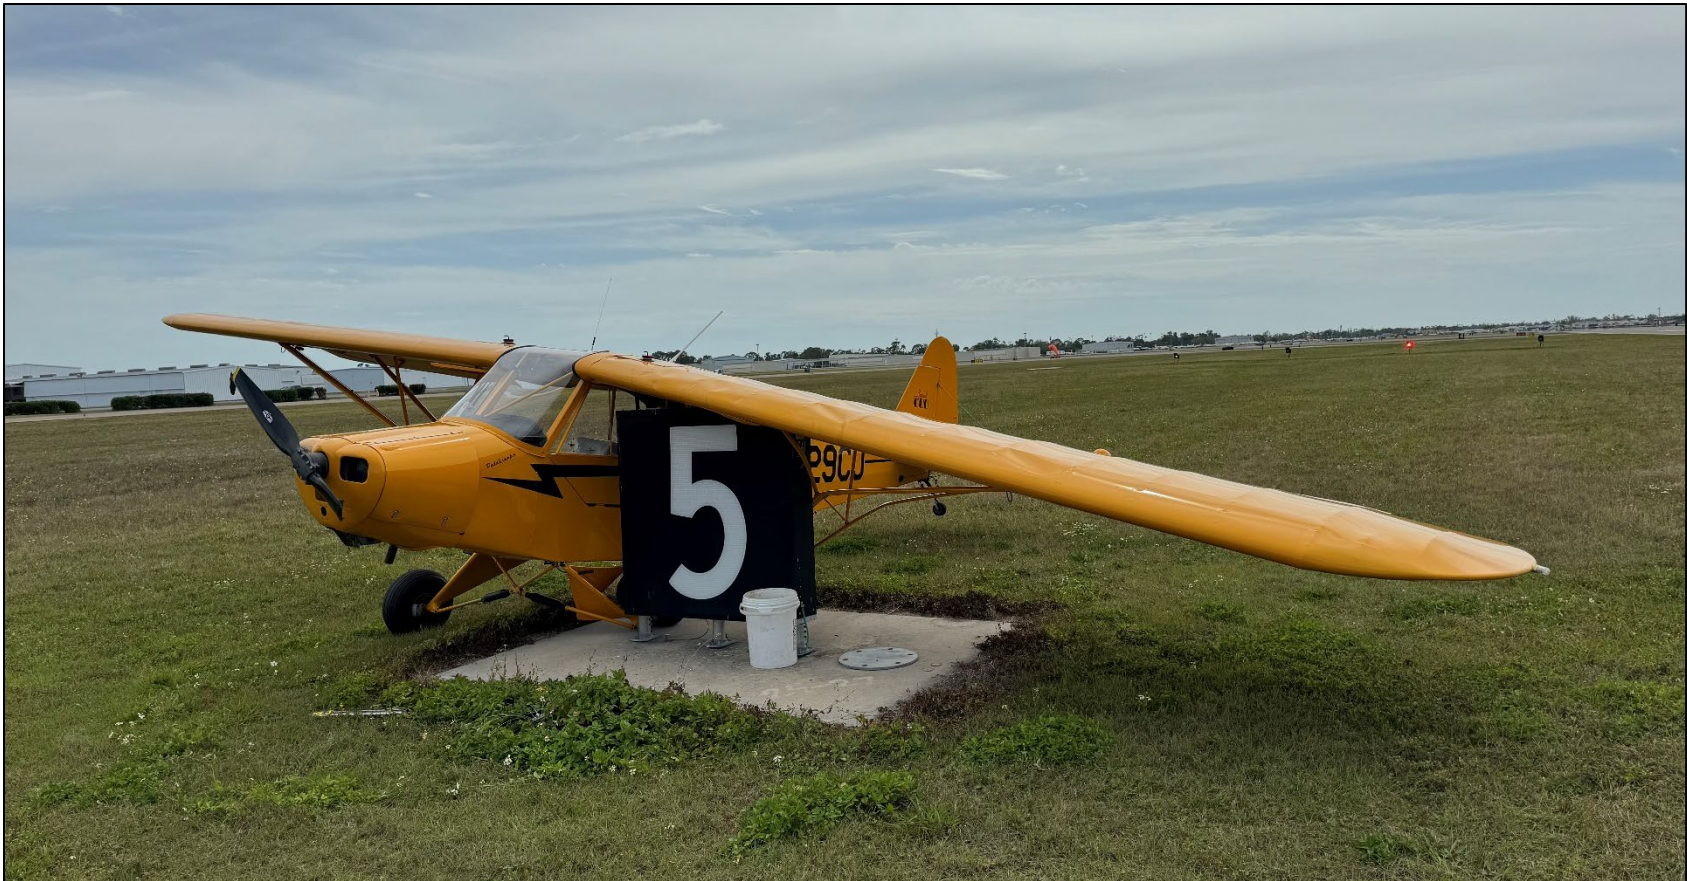
**Photo 1: View of the airplane postaccident (Photo Courtesy of FAA)**

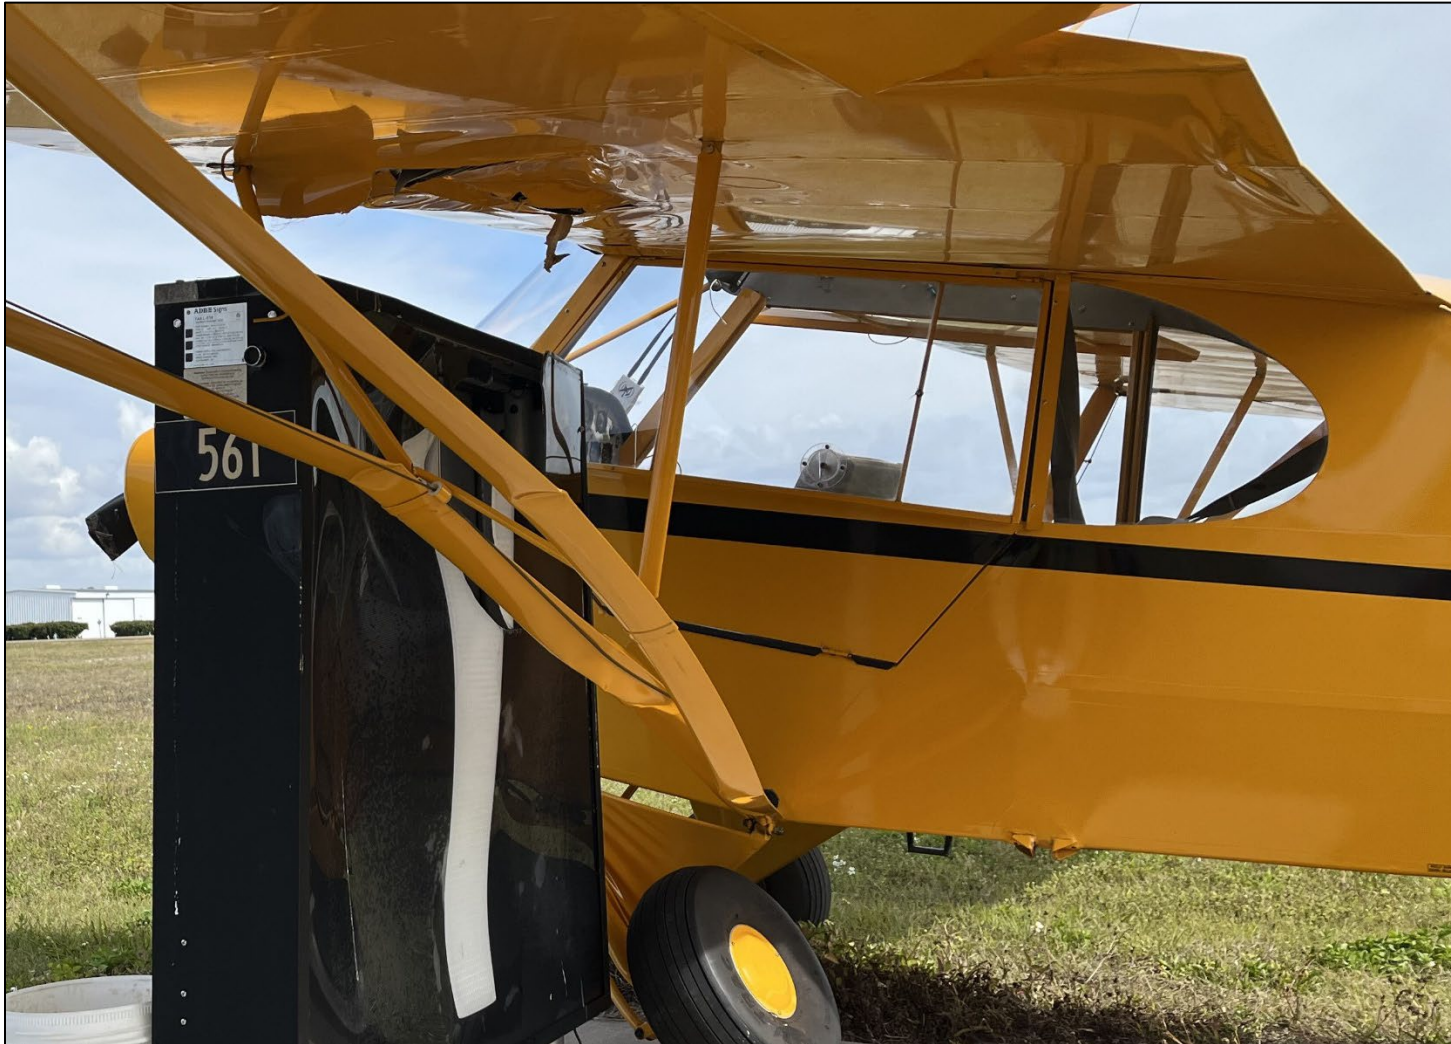
**Photo 2: View of wing strut and wing root damage (Photo Courtesy of FAA)**
