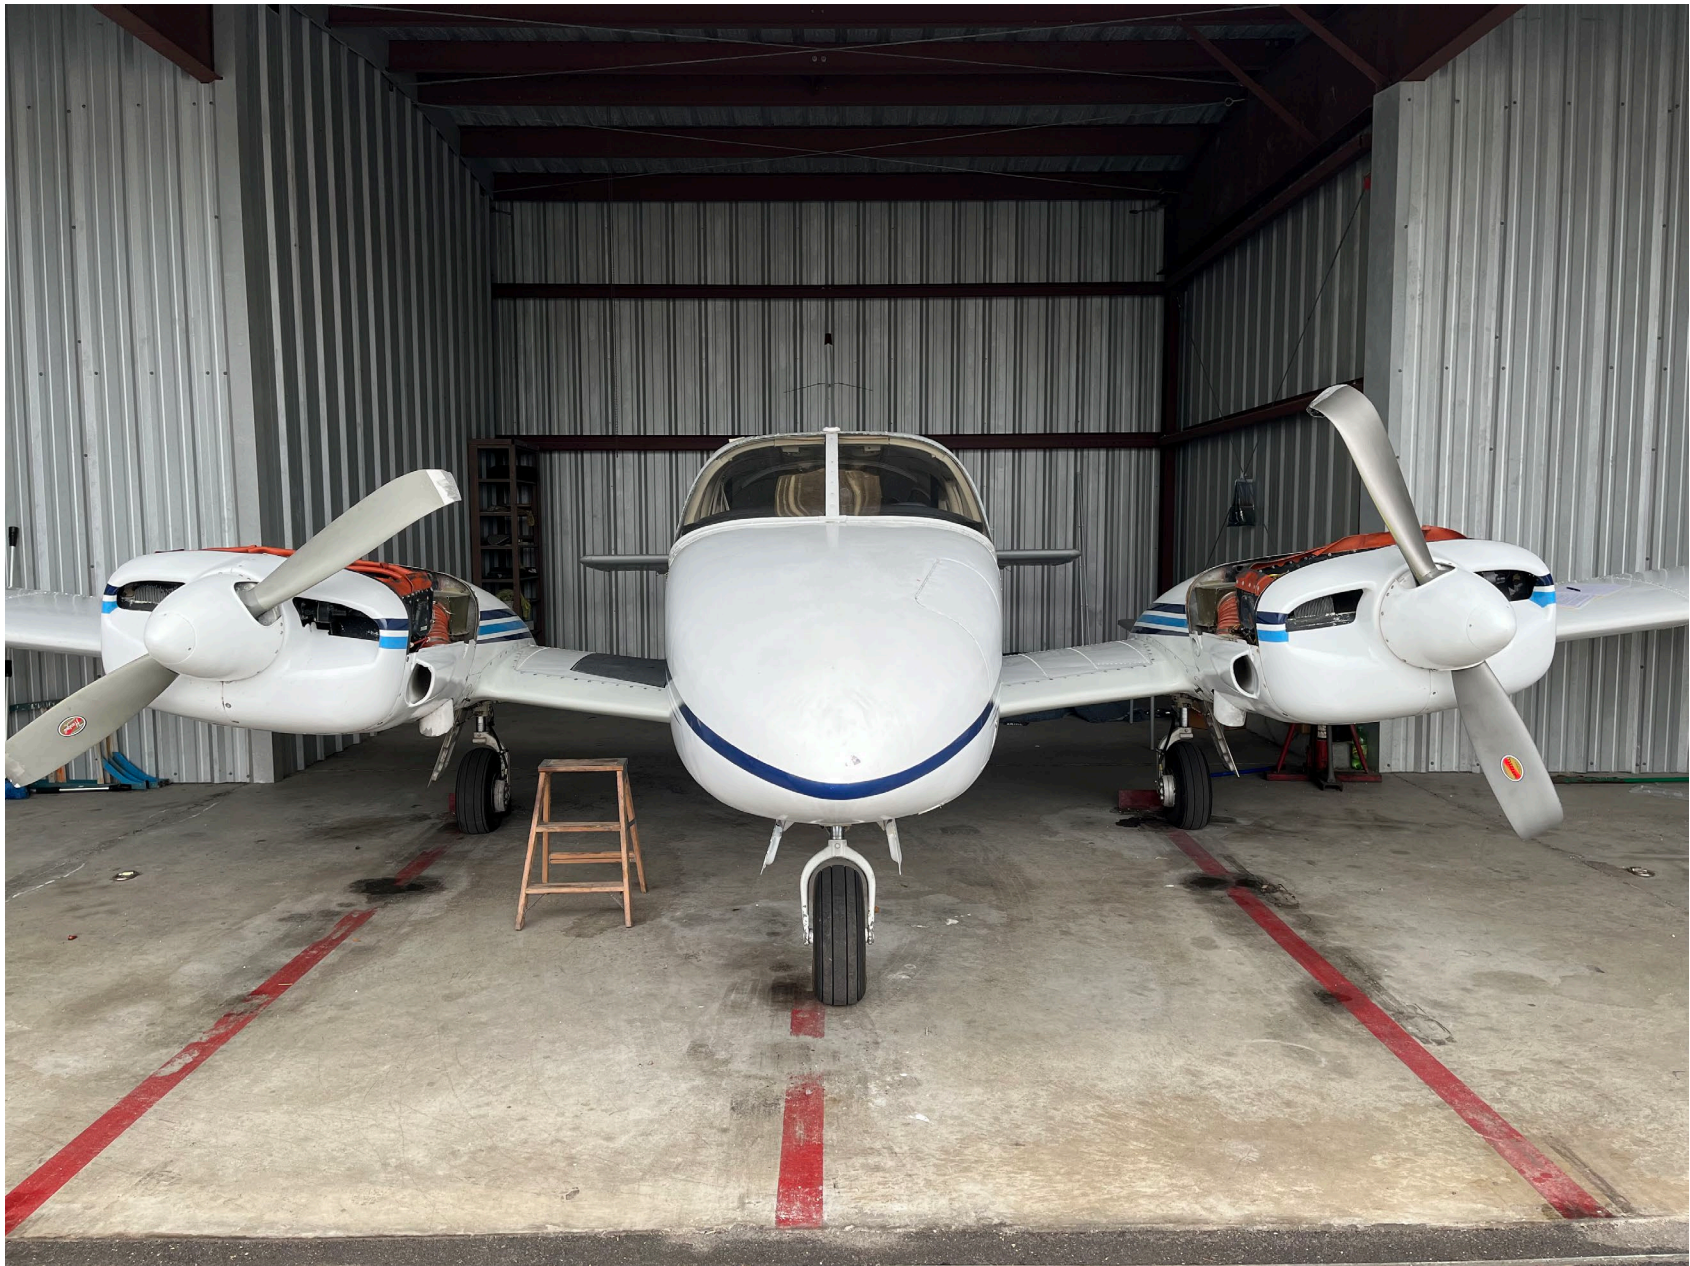
**Photo 1 – View of Airplane After Recovery (FAA)**

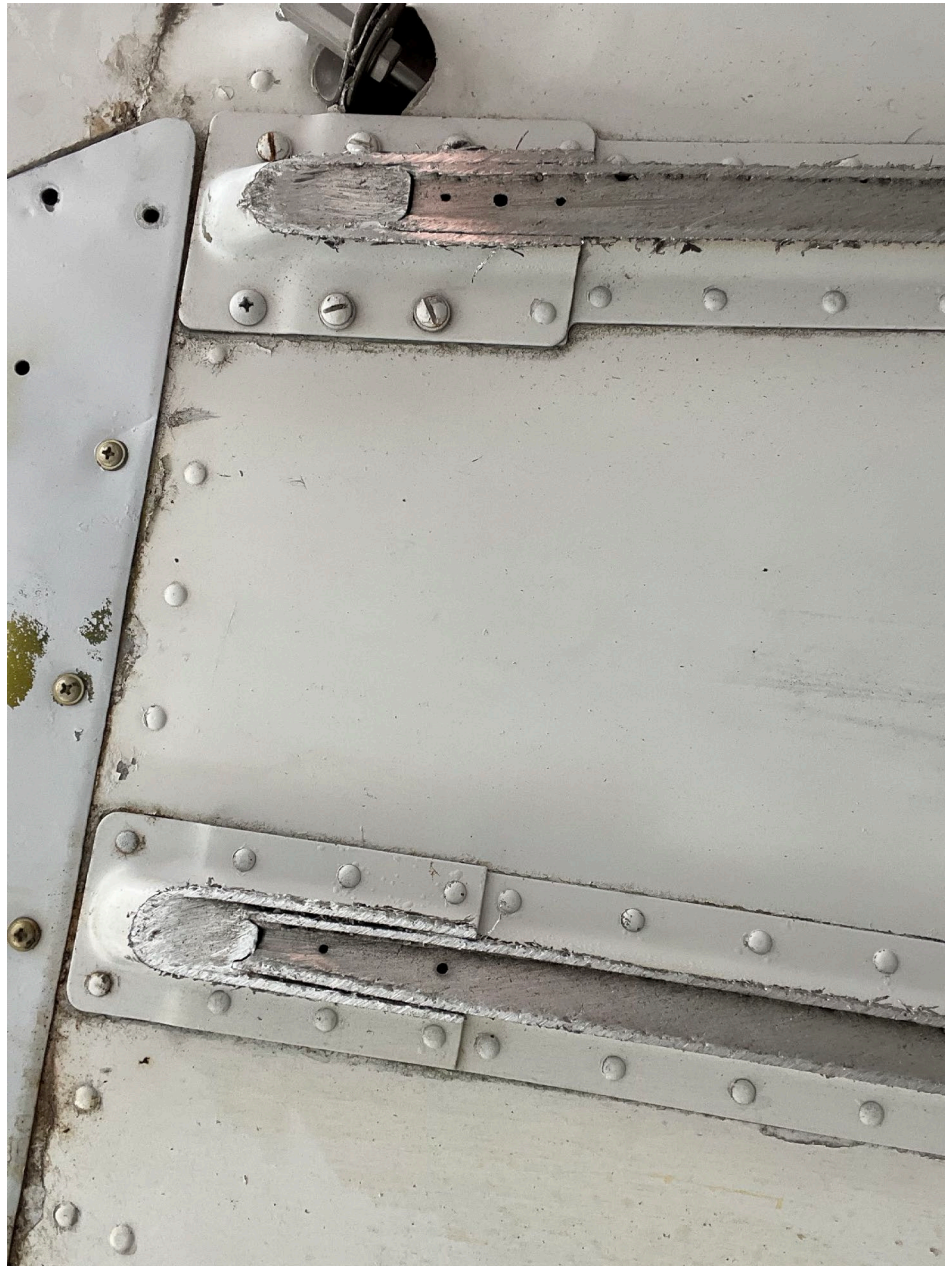
**Photo 2 – View of Damage to External Longerons (FAA)**
