ERA24LA133

## INVESTIGATIVE PHOTOS

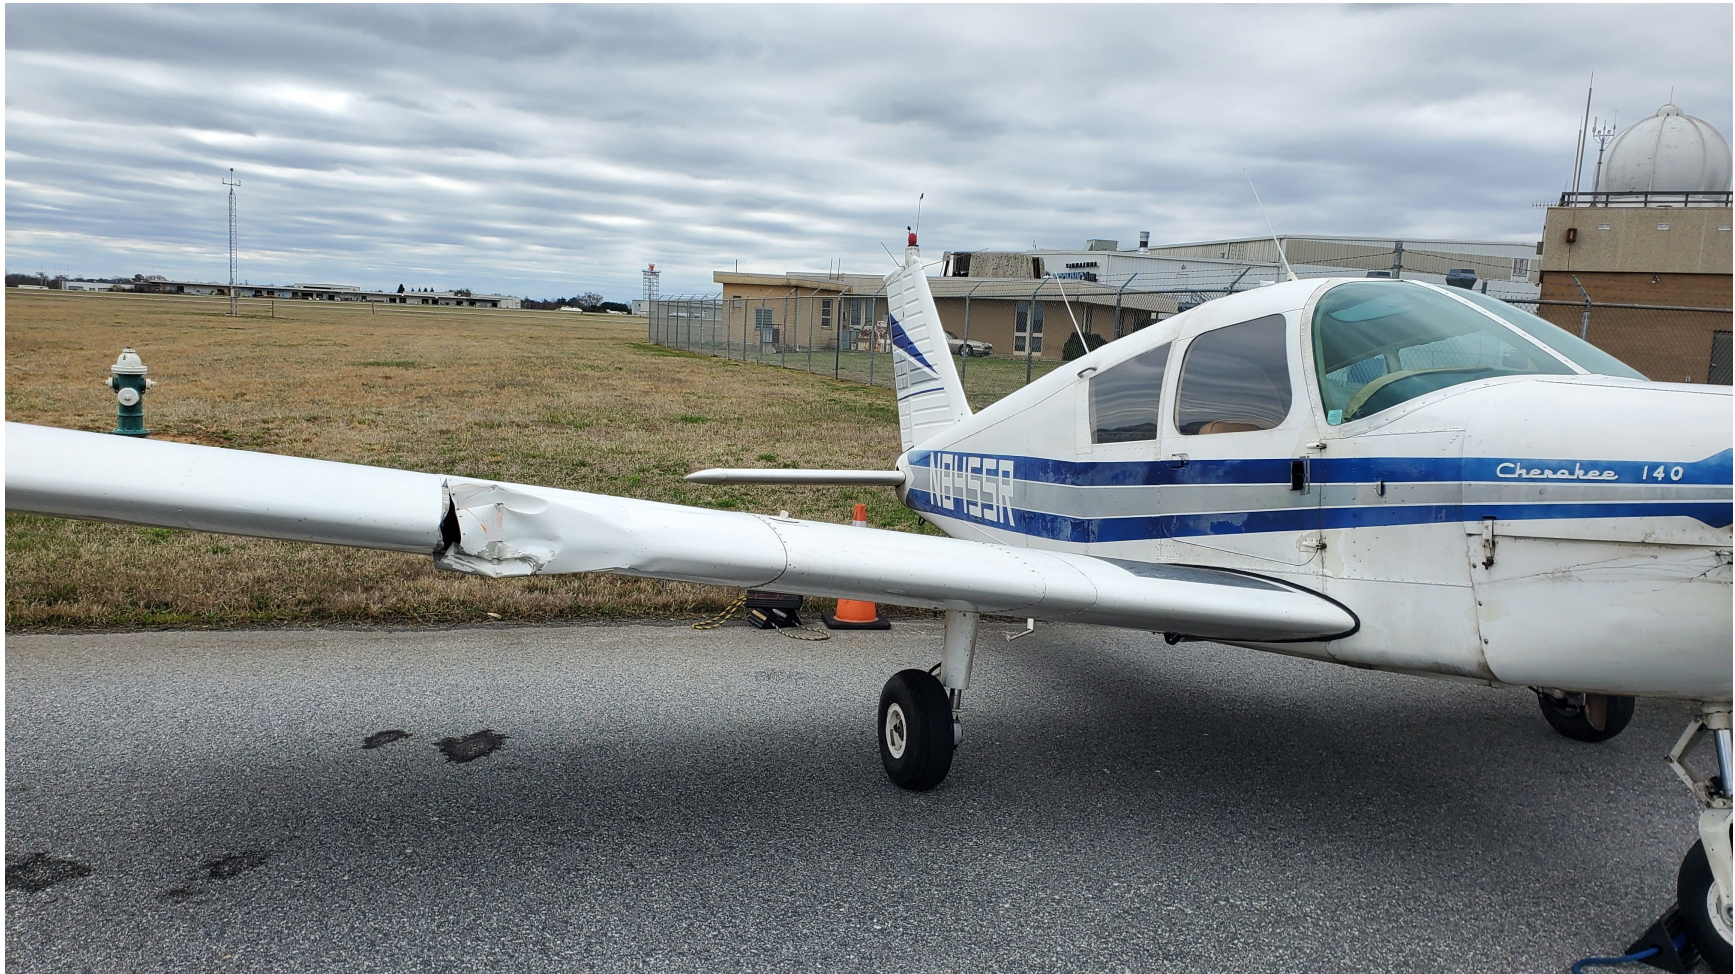
**Photograph 1 - Damaged right wing. (courtesy of FAA)**

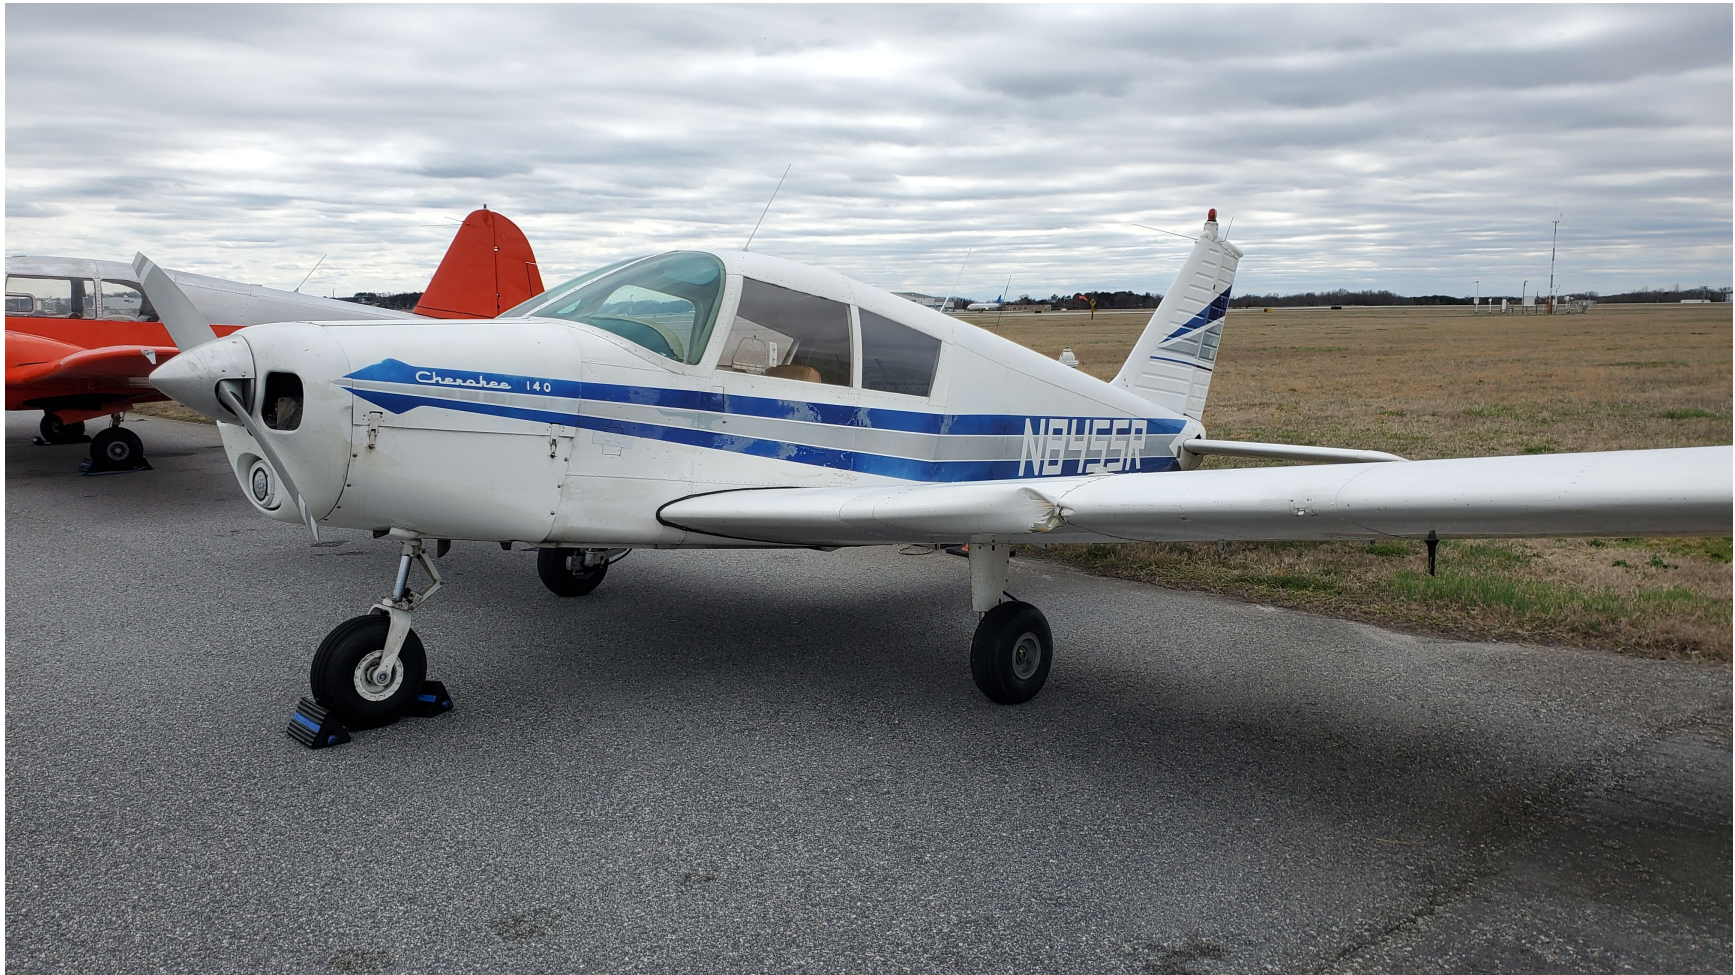
**Photograph 2 - Damaged left wing. (courtesy of FAA)**

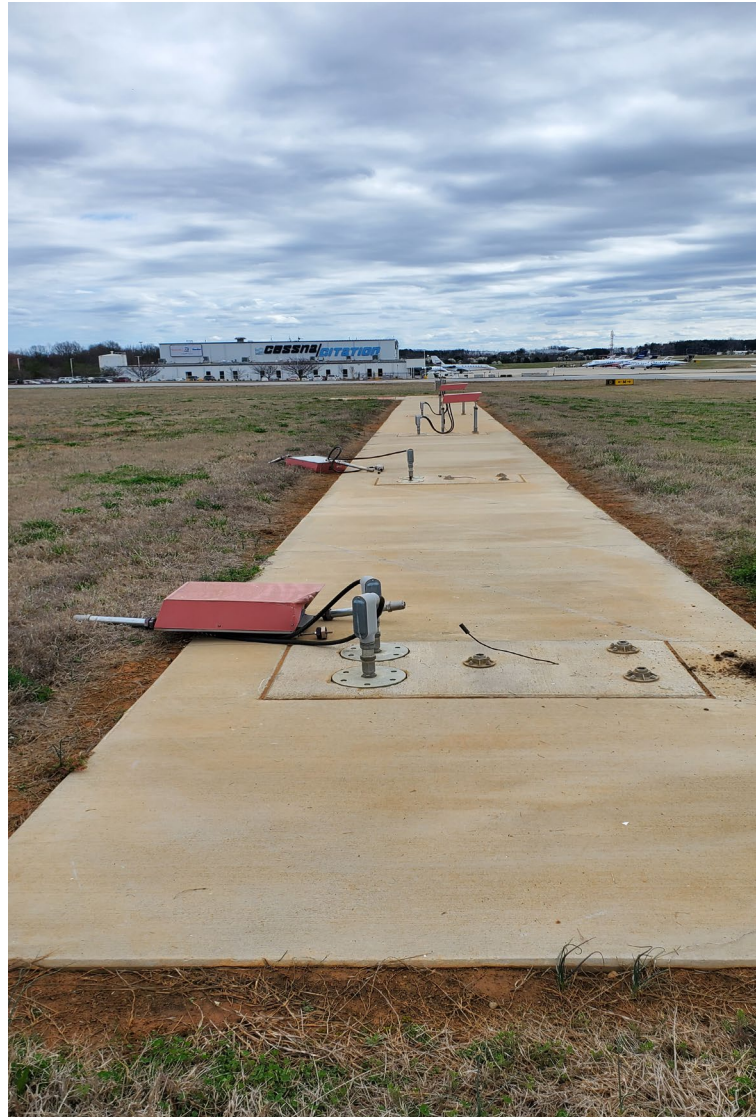
**Photograph 3 -Damage to visual glide slope lights. (courtesy of FAA)**
