# National Transportation Safety Board

ERA24LA139

## **WRECKAGE EXAMINATION**

Location: Front Royal, VA  
Date: March 12, 2024  
Time: 1902 Eastern  
Airplane: N59MK, Beech K35

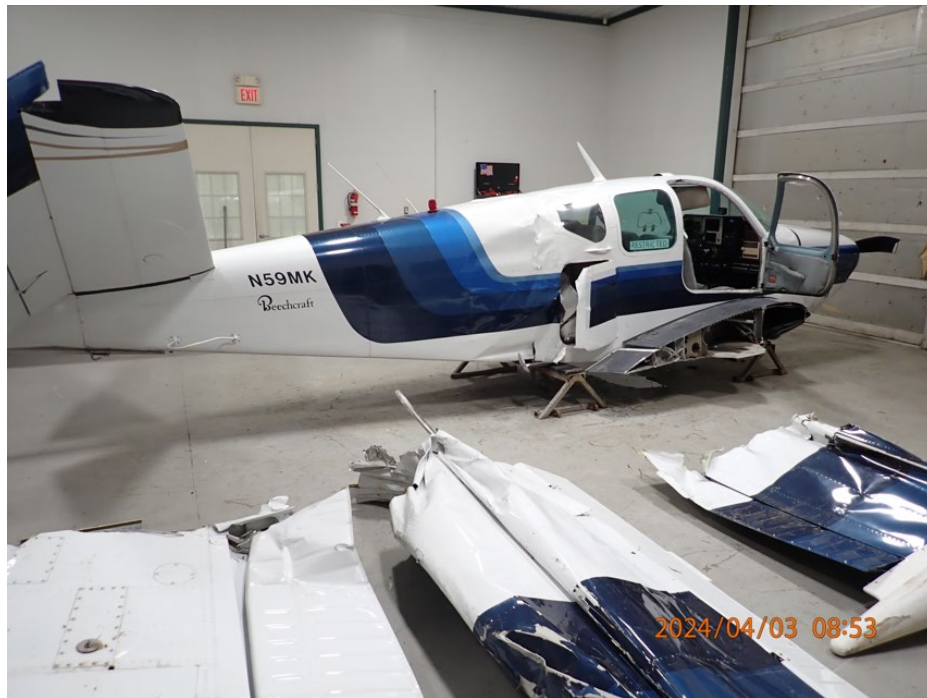
As first viewed, the airplane was positioned on stands with both wings removed about 1 foot from the root. The wings were placed on the floor with the landing gear folded. The engine and propeller remained attached to the fuselage. The propeller blades displayed minimal rotational signatures and both blades were partially bent aft.

**Wreckage Layout Overview**

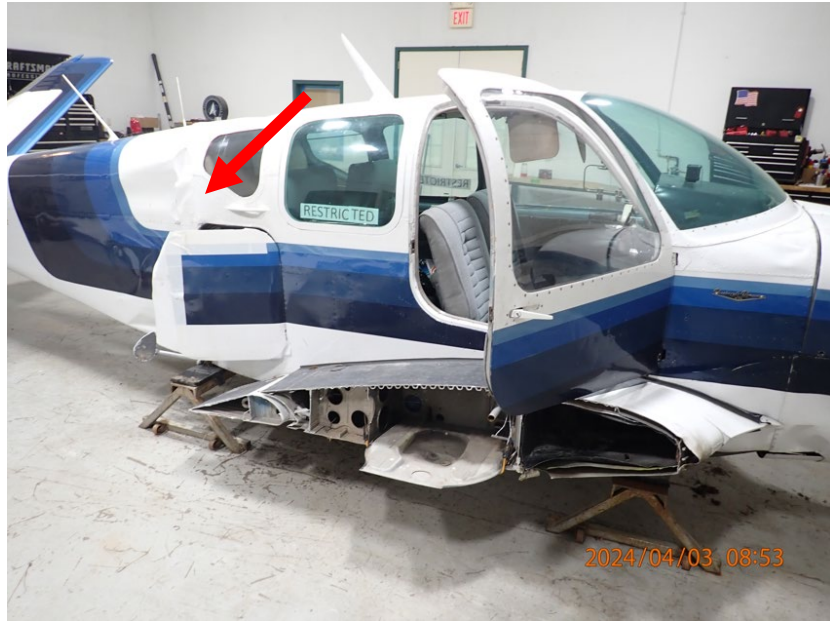
The airplane fuselage sustained substantial damage and wrinkling aft of the rear windows on the left and right sides, and on the belly. The lower cowling was dented and sustained abrasions.

**Wrinkling to the Fuselage**

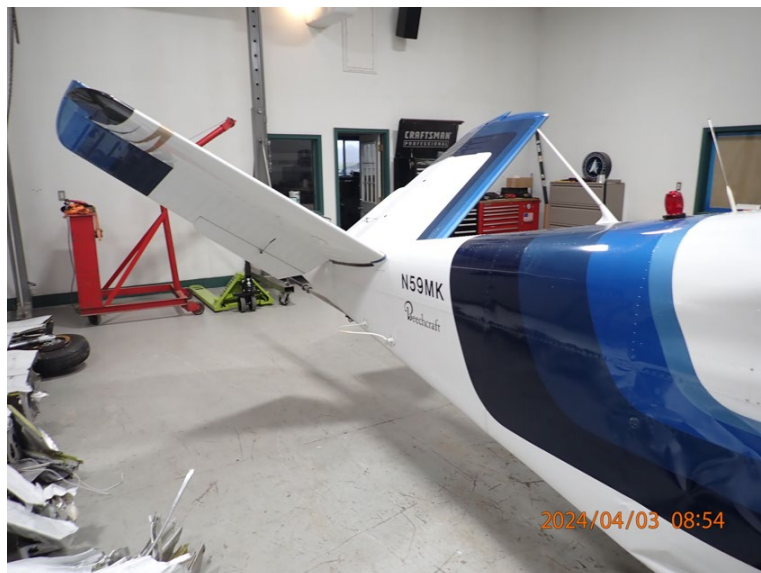
The empennage remained undamaged. Continuity from the rudder and elevator controls was established with no binding noted. The elevator trim did not actuate, and further examination revealed that the control cable was cut and bound. The pilot reported that the elevator trim was working as expected during the accident flight.

**View of the Empennage**

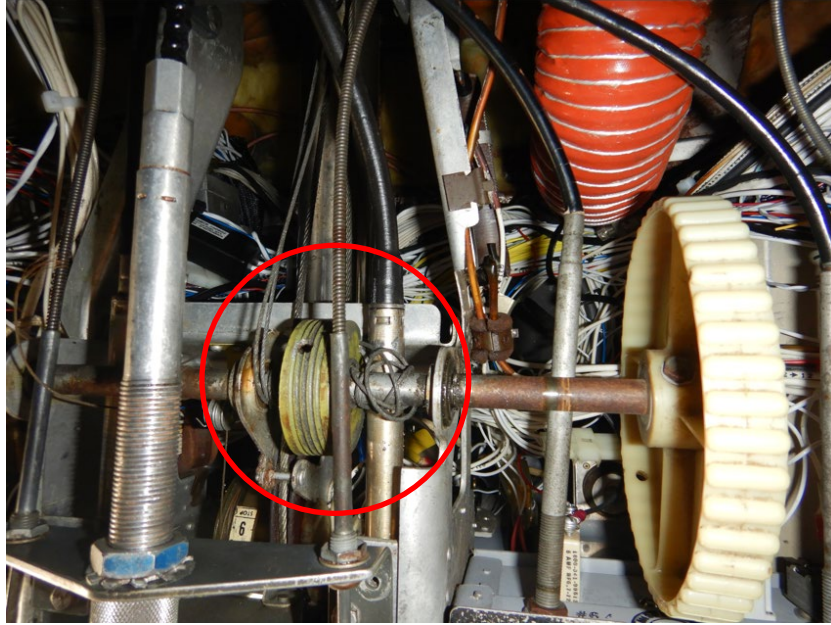
**Broken and Bound Elevator Control Cable (Courtesy of Textron Aviation)**

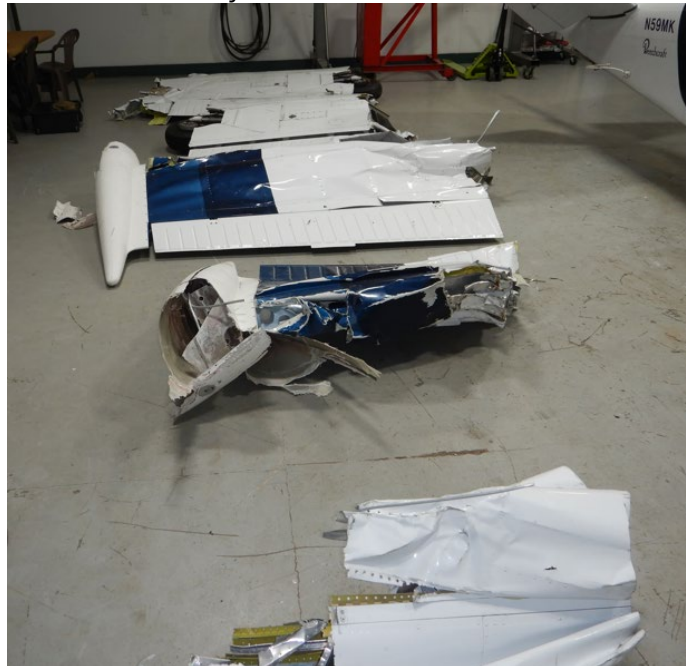
Both wings were fracture separated near the flap-aileron intersection. Each fracture was common to a tree impact signature on the wing leading edge. The wings were cut off by recovery personnel approximately one foot outboard of the wing root. Flight control continuity was established from the cockpit to the ailerons. The flaps were observed in the fully retracted.

**Damage to the Wings (Courtesy of Textron Aviation)**

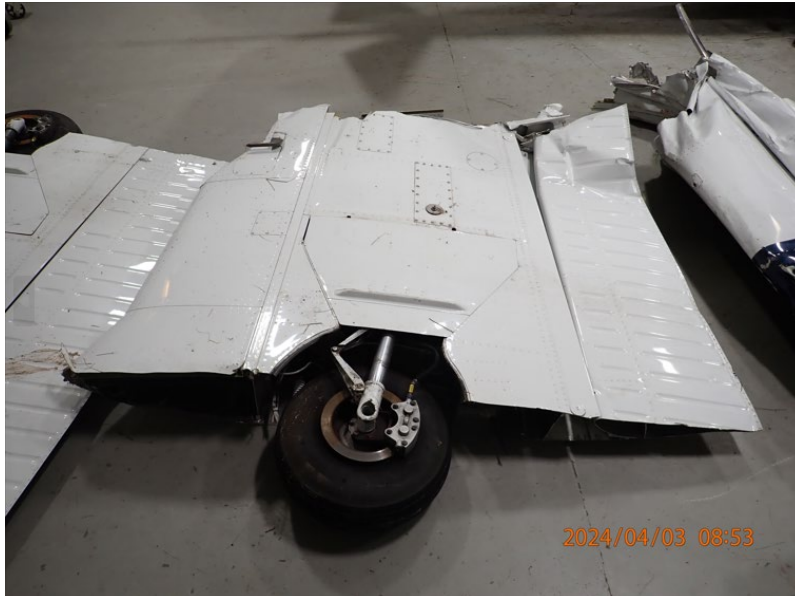
The tricycle style retractable landing gear were found in the up position. The gear selector was in the extended position with the landing gear circuit breaker pulled. The gear selector and the gear breaker were moved by the recovery company.

**Stowed Main Landing Gear**

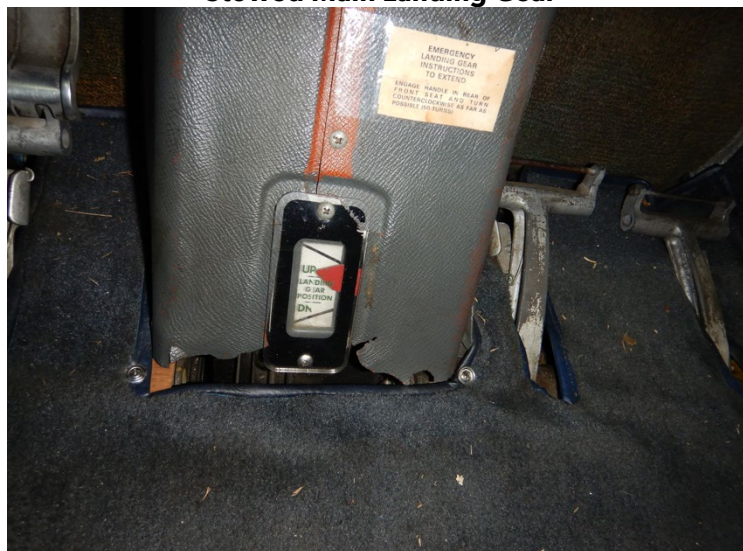
**Gear Position Indicator (Courtesy of Textron Aviation)**

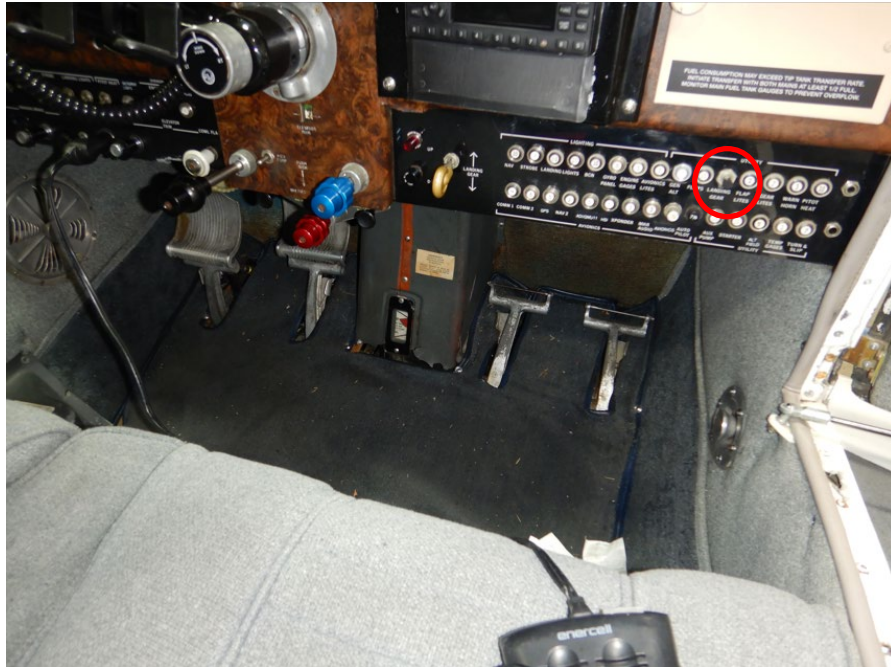
**Pulled Landing Gear Breaker (Courtesy of Textron Aviation)**

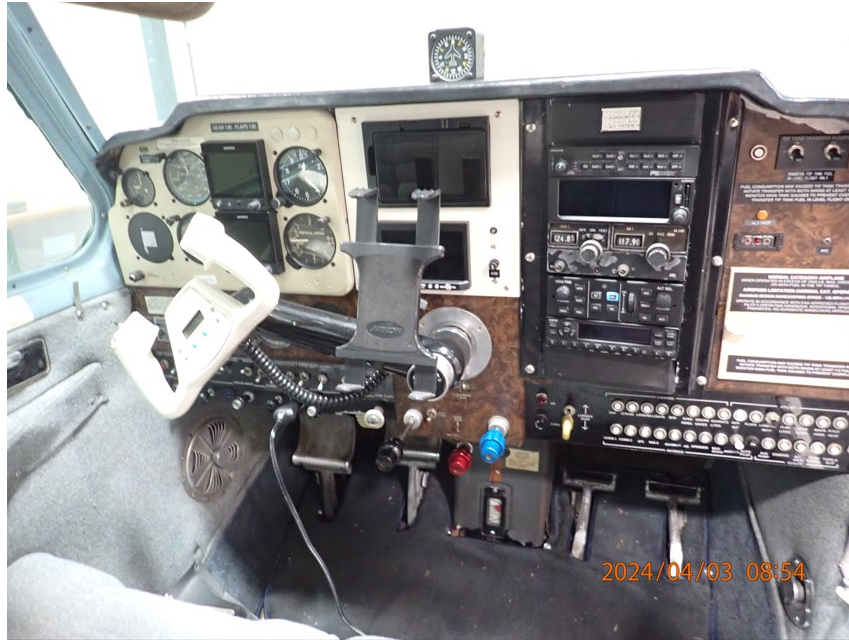
**Cockpit**

The cockpit was equipped with a combination of electronic navigational and engine instrumentation and traditional steam gauges. The instrumentation remained installed and undamaged. A single control yoke was installed with the right-side rudder pedals stowed. As first viewed, the master, alternator, and light switches were in the "off" position. The keys were removed. The throttle control was in the idle position and the mixture and propeller controls were full forward. The auxiliary fuel pump switch was in the off position. The landing gear knob was in the "down" position. All the circuit breaks in the cockpit were pushed in, with the exception of the landing gear breaker which was pulled. The fuel selector was in the off position. The tip tank transfer pump switches were in the off position.

Control continuity of the propeller, throttle, and mixture cables was established with no binding noted. All electronic instrumentation illuminated and appeared functional when the master switch was turned on. The engine data monitor (EDM) was retained.

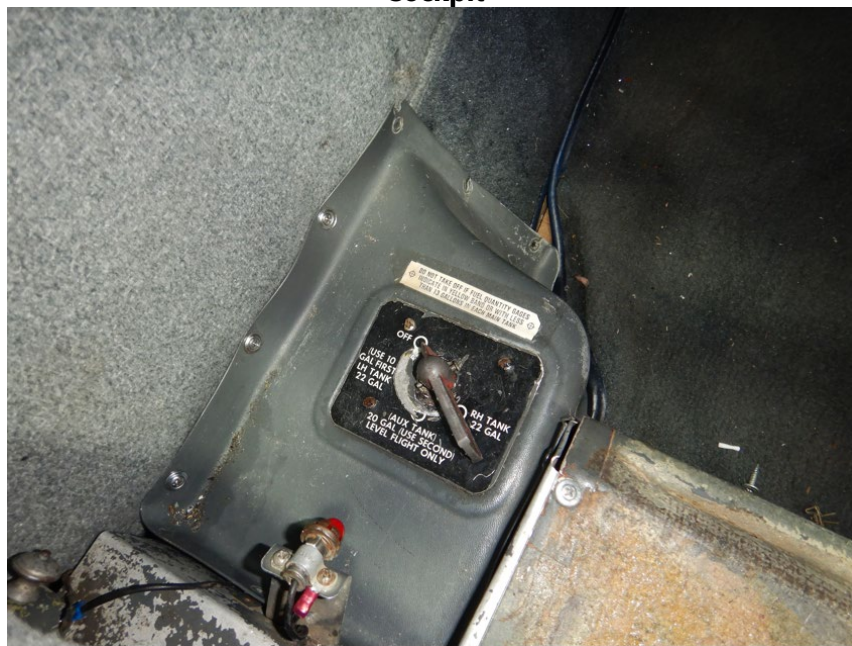
**Fuel Selector (Courtesy of Textron Aviation)**

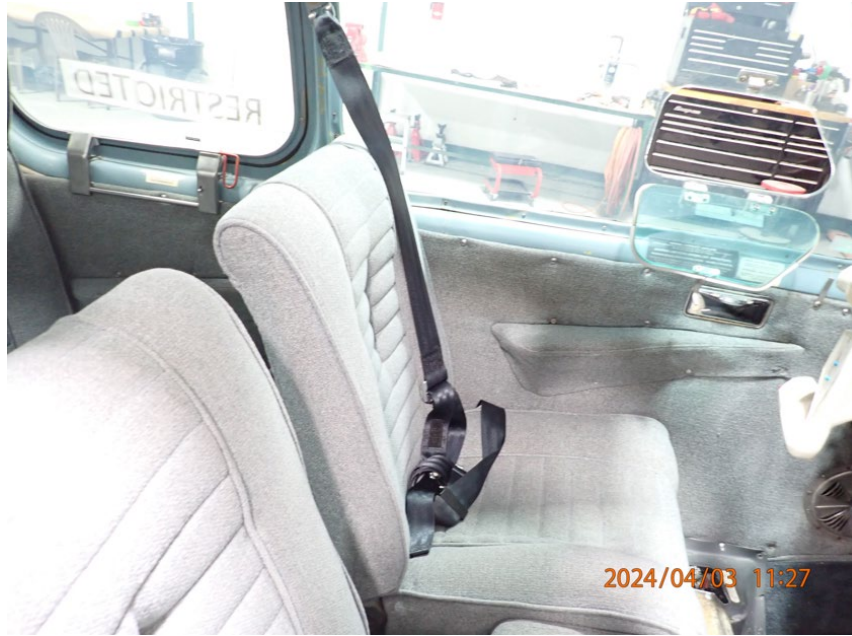
**Pilots Seat**

The pilot did not receive any injuries during the accident. The pilot's seat was equipped with a 3-point safety belt that the pilot was utilizing. The airplane was equipped with an ACK, E-04 ELT that did activate during the accident.

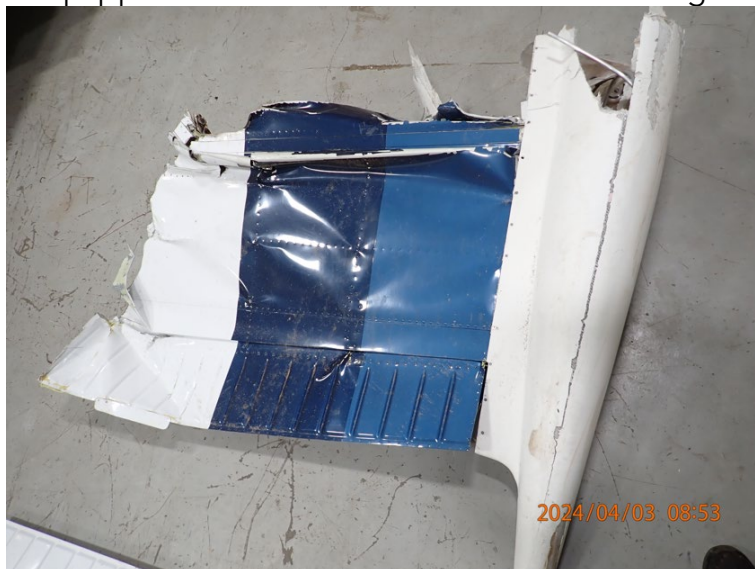
**Left Tip Tank**

The main and auxiliary fuel tanks did not appear to be breached upon impact. The STC installed tip tanks remained attached to the wings but were both ruptured. The wing main tanks were cut adjacent to wing skin cuts made by wreckage recovery personnel to facilitate transportation. Portions of the wing fuel vent plumbing was also cut into sections adjacent to wing recovery cuts. The wing vent plumbing for each main and bladder tank was examined and found to be free from blockage. The right-wing siphon-break plumbing was partly obstructed by dirt near the wing port. The STC installed tip tank vent plumbing was free from obstructions.

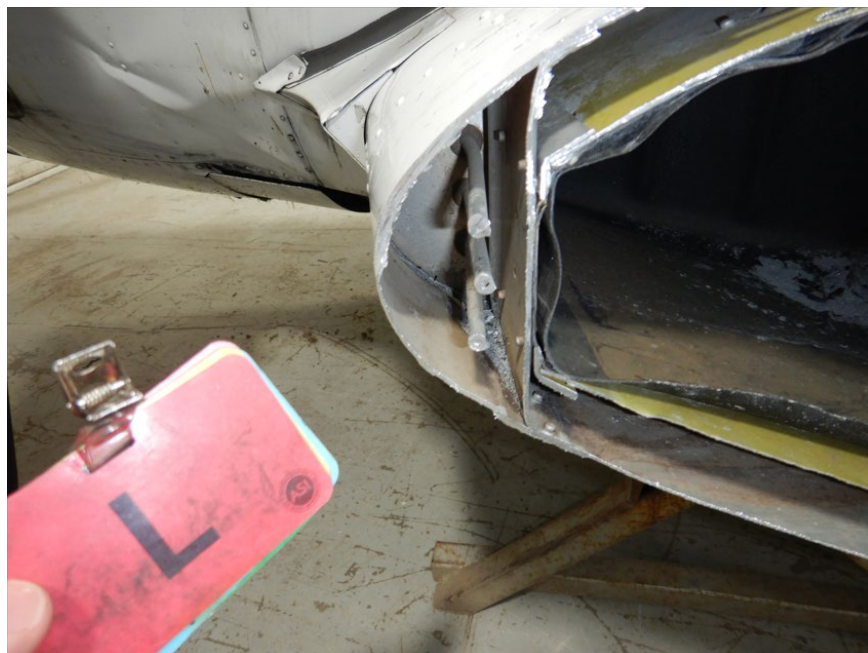
The fuel supply lines from each auxiliary fuel tank to the fuel selector were cut adjacent to wing recovery cuts. The fuel supply plumbing was examined, and found to be free from obstructions, by passing air through both the main wing and auxiliary bladder tank plumbing, the fuel selector, and out the fuel strainer outlet. The STC installed wing tip tank plumbing was examined and found to be free from obstructions. The aircraft battery was connected, and the auxiliary fuel pump was satisfactorily tested. The STC installed fuel transfer pumps and solenoid valves were connected to a 12-volt aircraft battery and satisfactorily tested. The fuel strainer and fuel strainer bowl were clean.

**Fuel Lines and Vents on Left Side (Courtesy of Textron Aviation)**

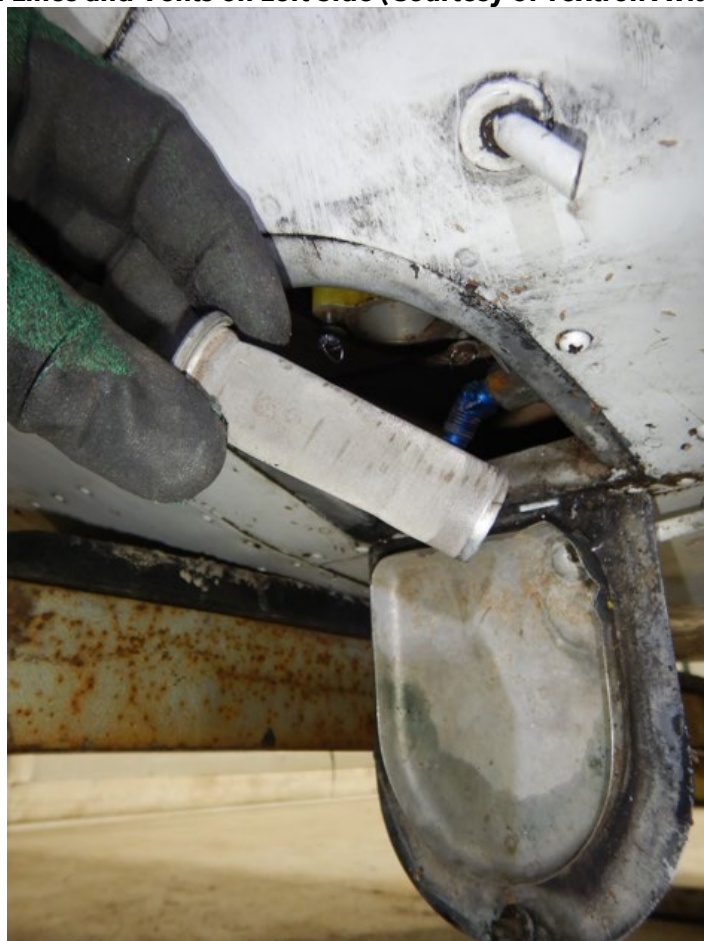
**Unobstructed Airframe Fuel Filter (Courtesy of Textron Aviation)**

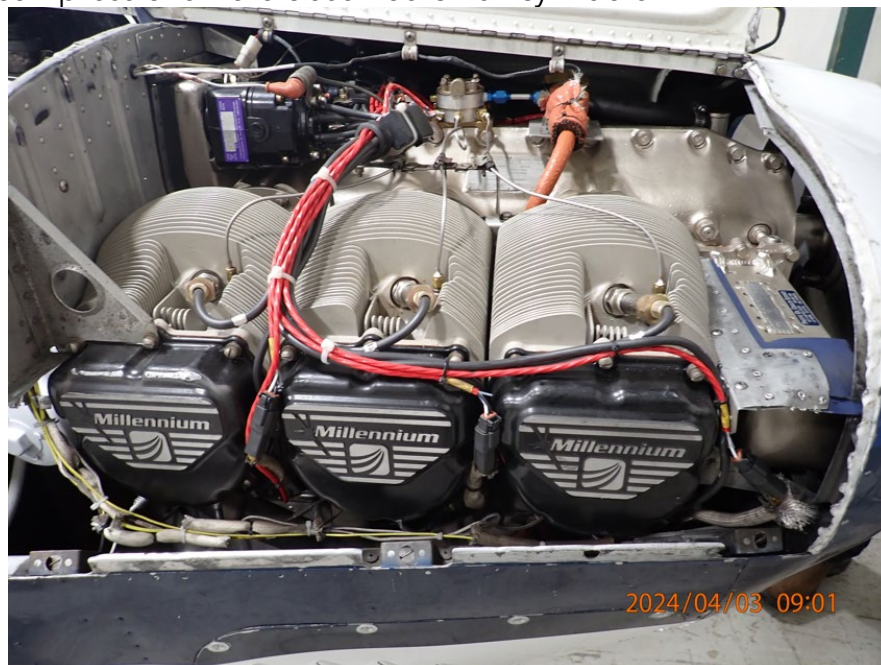
The engine is a Continental IO-470-C, serial number 87559-1-C-R, rated for 250HP at 2600RPM according to the data plate. According to maintenance records, the engine was recently field overhauled. The engine appeared to be undamaged, and a engine test run was attempted. The top spark plugs were removed, and the coloration was consistent with normal engine operation. The oil filter was cut open with no debris noted. The oil sump held about 9 quarts of clean engine oil when the oil level gauge was checked. The cylinders were examined with a lighted borescope and no discrepancies were observed. The engine rotated 720° when force was applied to the propeller. Continuity of the crankshaft to the camshaft was established and thumb compressions were observed on all cylinders.

**View of the Right Side of the Engine**

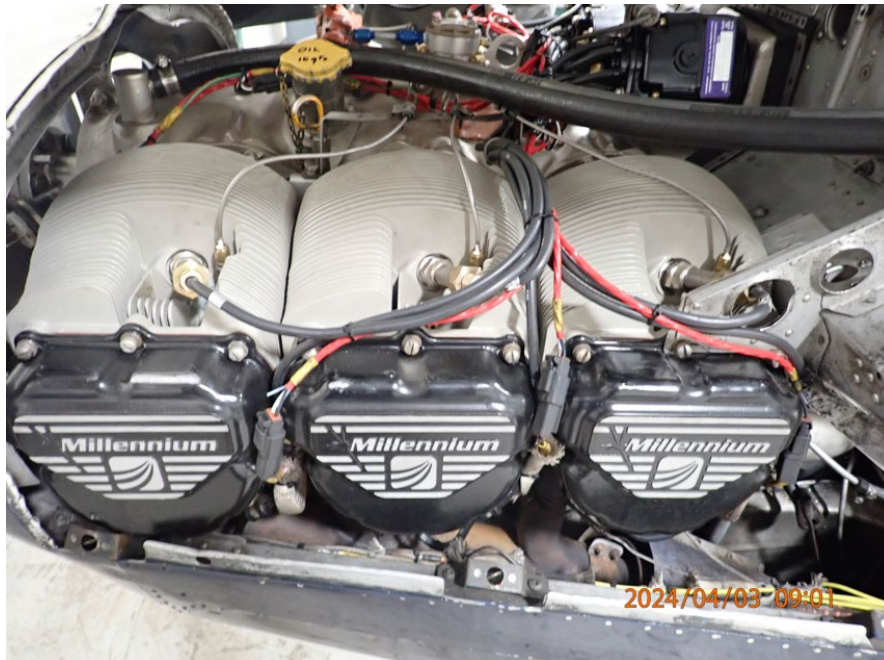
**View of the Left Side of the Engine**

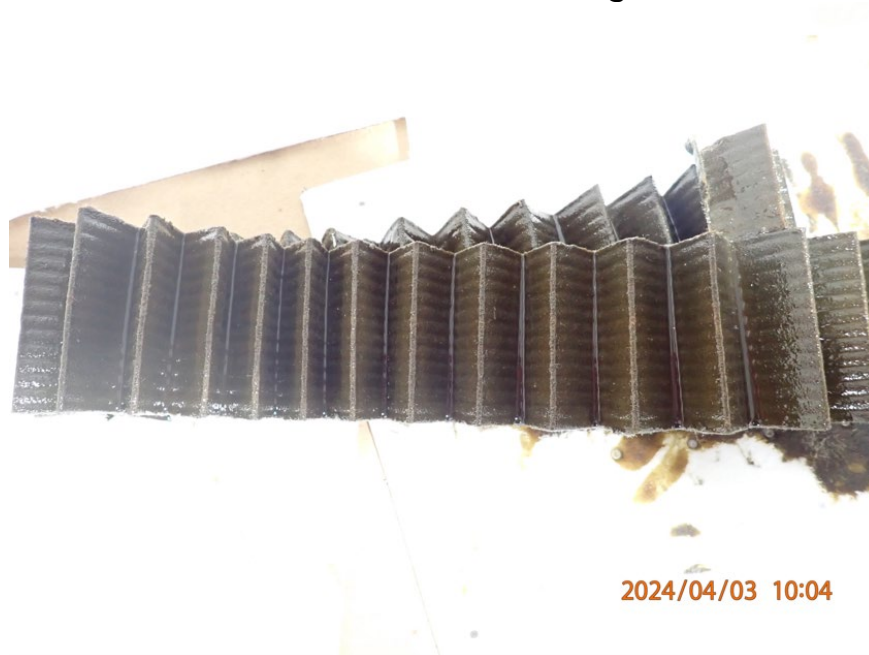
**Clean Oil Filter Element**

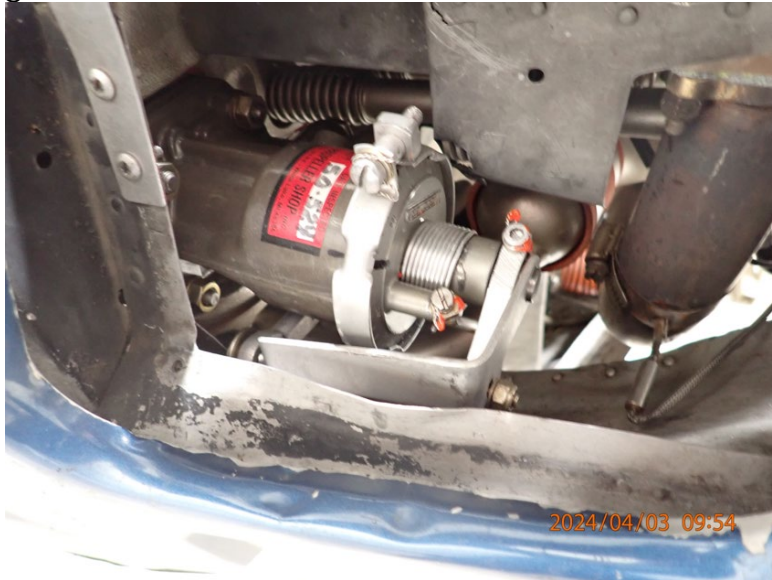
The Woodward propeller governor, A210680, serial number 1451224, remained attached to the front of the engine and was undamaged. Control continuity from the governor to the cockpit was established. The propeller governor was removed prior to the engine test run and the gasket screen was unobstructed. The propeller governor pumped oil when the drive was rotated by hand. The governor was reinstalled to facilitate the engine test run. The propeller governor was retained for further testing.

**Propeller Governor as Installed**

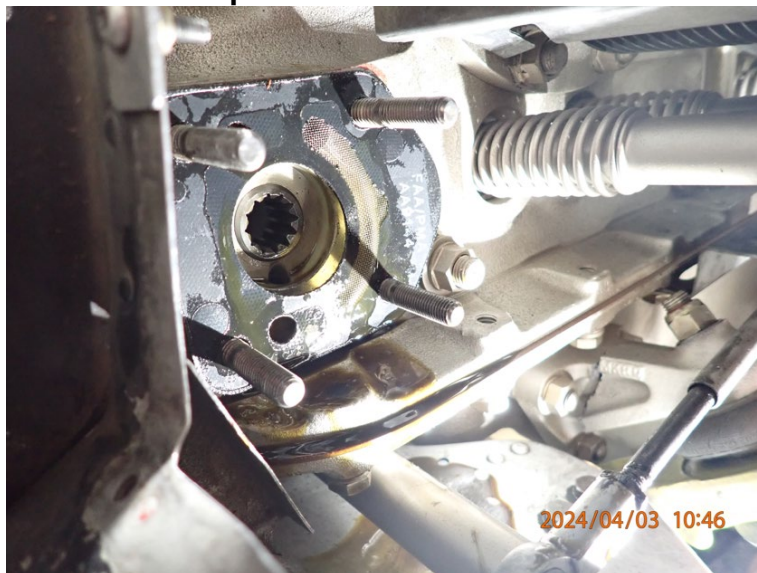
**Unobstructed Propeller Governor Gasket**

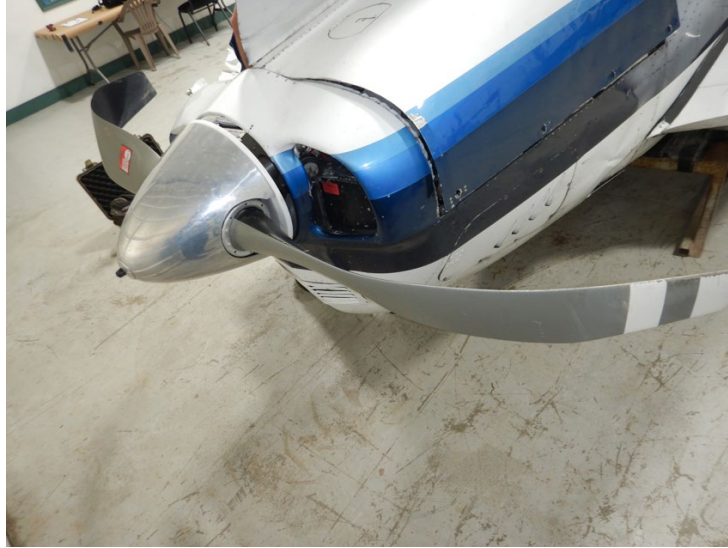
The two-bladed aluminum Beech propeller remained installed on the crankshaft and displayed minimal rotational signatures. Both blades were bent aft at their respective midpoints. A servicing sticker on the blades showed the last inspection date on July 6, 2023. The propeller blades were cut during the examination with a bandsaw and straightened to facilitate the engine test run.

**Damage to Propeller (Courtesy of Textron Aviation)**
