# National Transportation Safety Board

ERA24LA141

## ENGINE EXAMINATION SUMMARY

Airplane: Cirrus SR22; N469GB

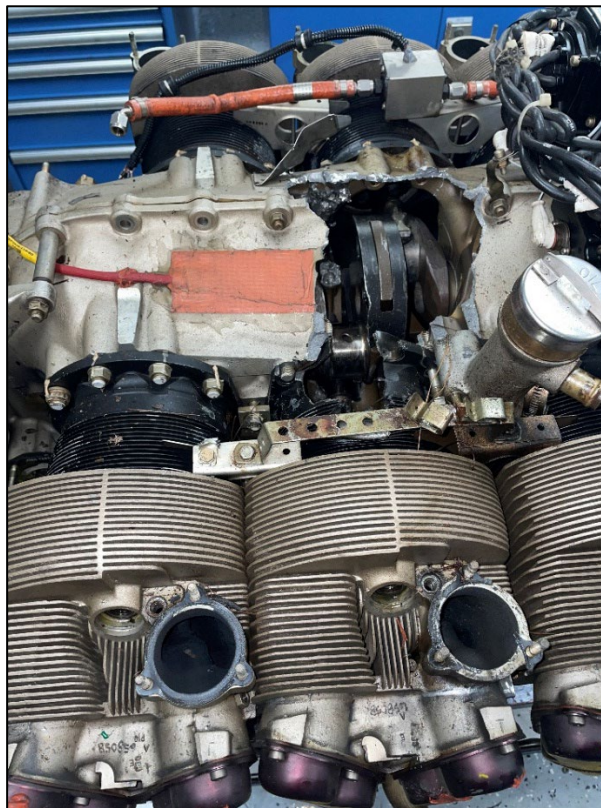
Continental Engines, Mobile, Alabama. The engine exhibited a 9 by 6-inch hole on the top of the crankcase between cylinders Nos 3 and four. The engine was placed on the disassembly stand for a complete teardown examination.

*Figure 2: Top of engine showing hole damage at the #3 and 4 cylinders.*

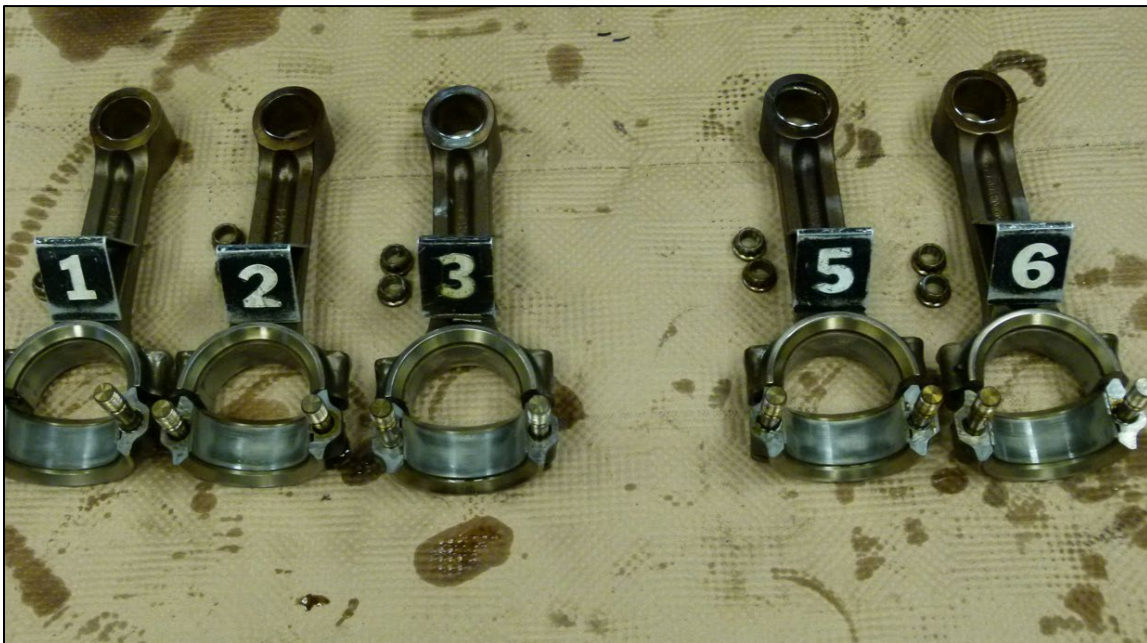
*Figure 3 Connecting rod assemblies minus the number 4 that was destroyed.*

- Connecting rod No. 1: Bushing migrated and chipped.
- Connecting rod No. 2: Serial number AE15CA744, Bushing migrated and chipped.
- Connecting rod No. 3: Serial number AE15CA522, Bushing migrated and chipped.
- Connecting rod No. 4: Serial number AE15CA524, Bushing missing. connecting rod fragmented and discovered in the oil sump.
- Connecting rod No. 5: Serial number AE15CA552, Bushing migrated and chipped.
- Connecting rod No. 6: Serial number AE15CA551, Bushing migrated and chipped.

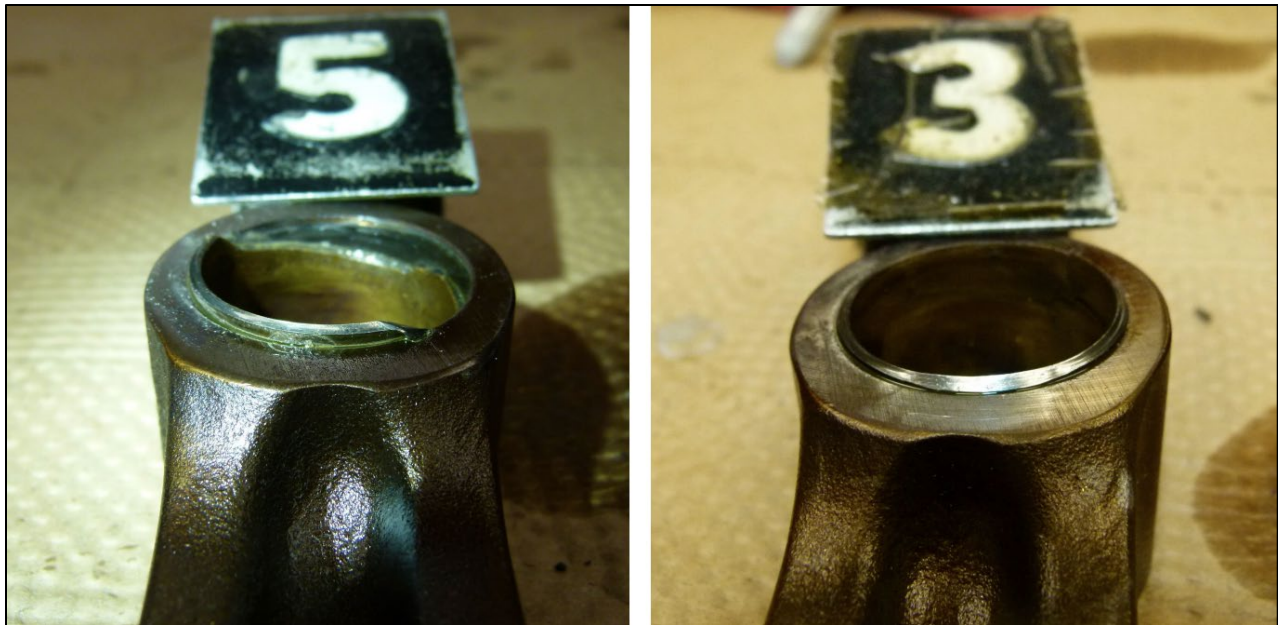
Figure 4 Close up of connecting rod bushings migration and damage. This is indicative of all remaining rods and their respective bushings.

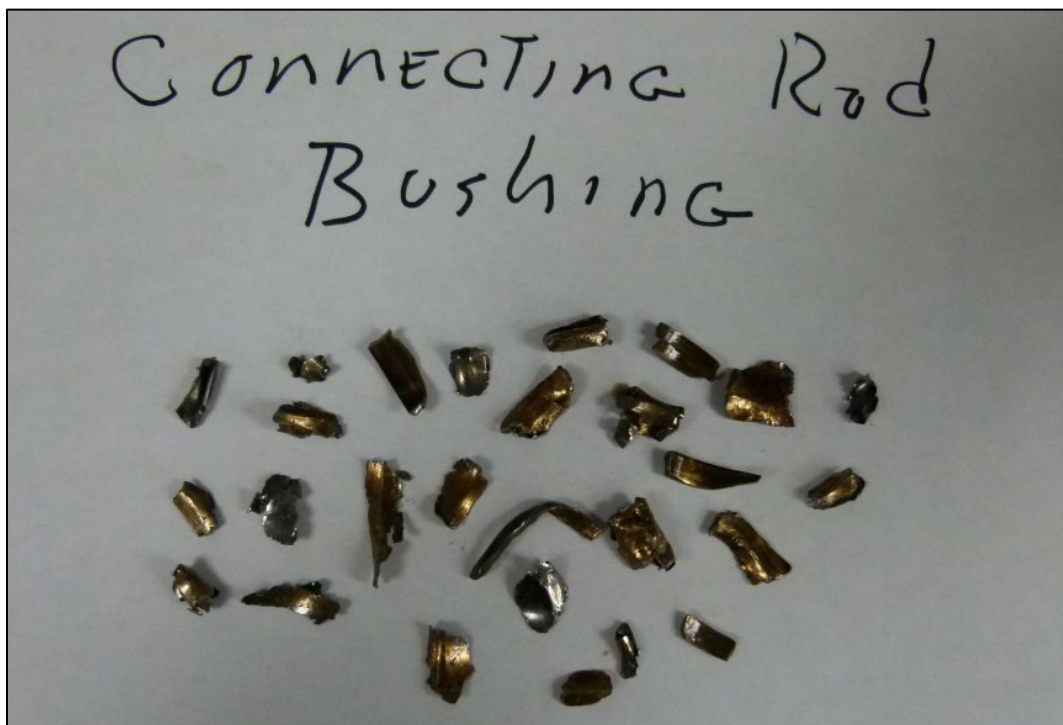
Connecting rod bushing fragments (brass color) discovered in oil sump and throughout engine crankcase.

Figure 5 The number 4 connecting rod bushing discovered in sump and crankcase.
