ERA24LA141

## INVESTIGATION PHOTOGRAPHS

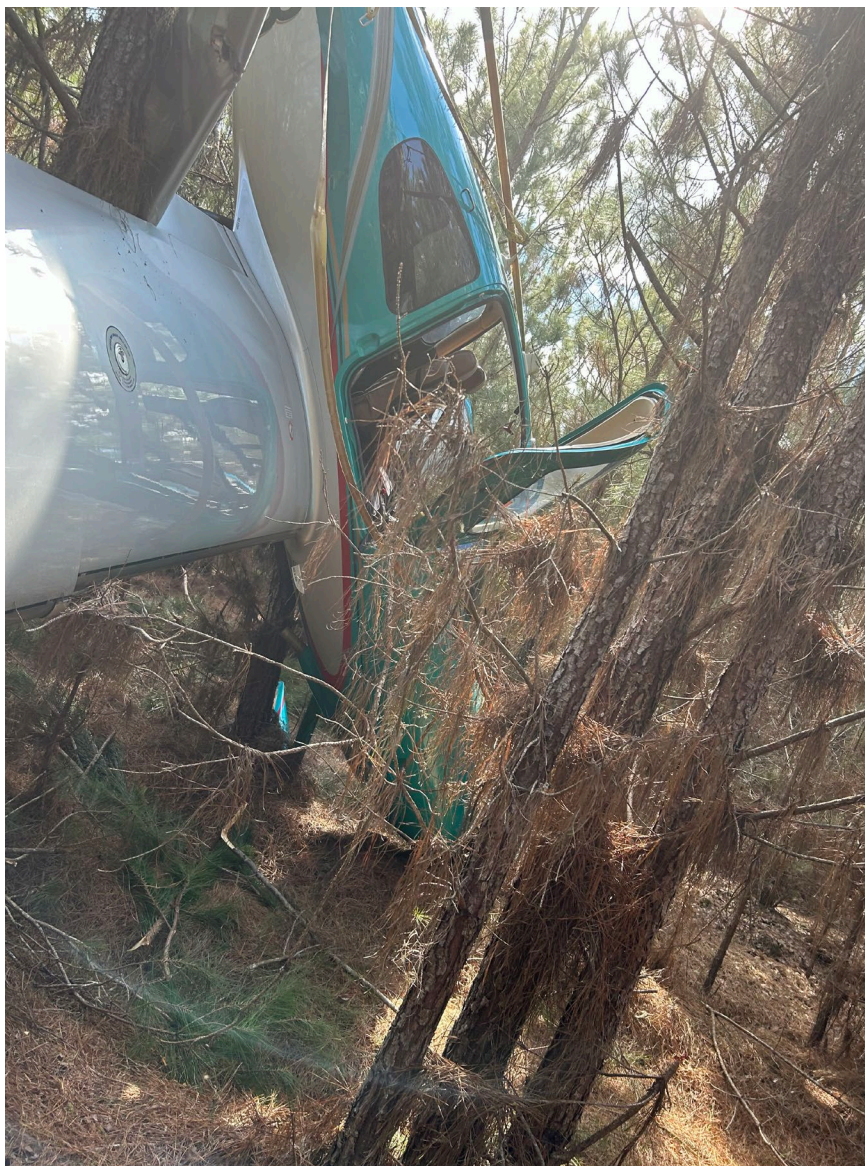
**Photograph 1 - Airplane suspended in the trees at the accident site. (Courtesy of FAA)**

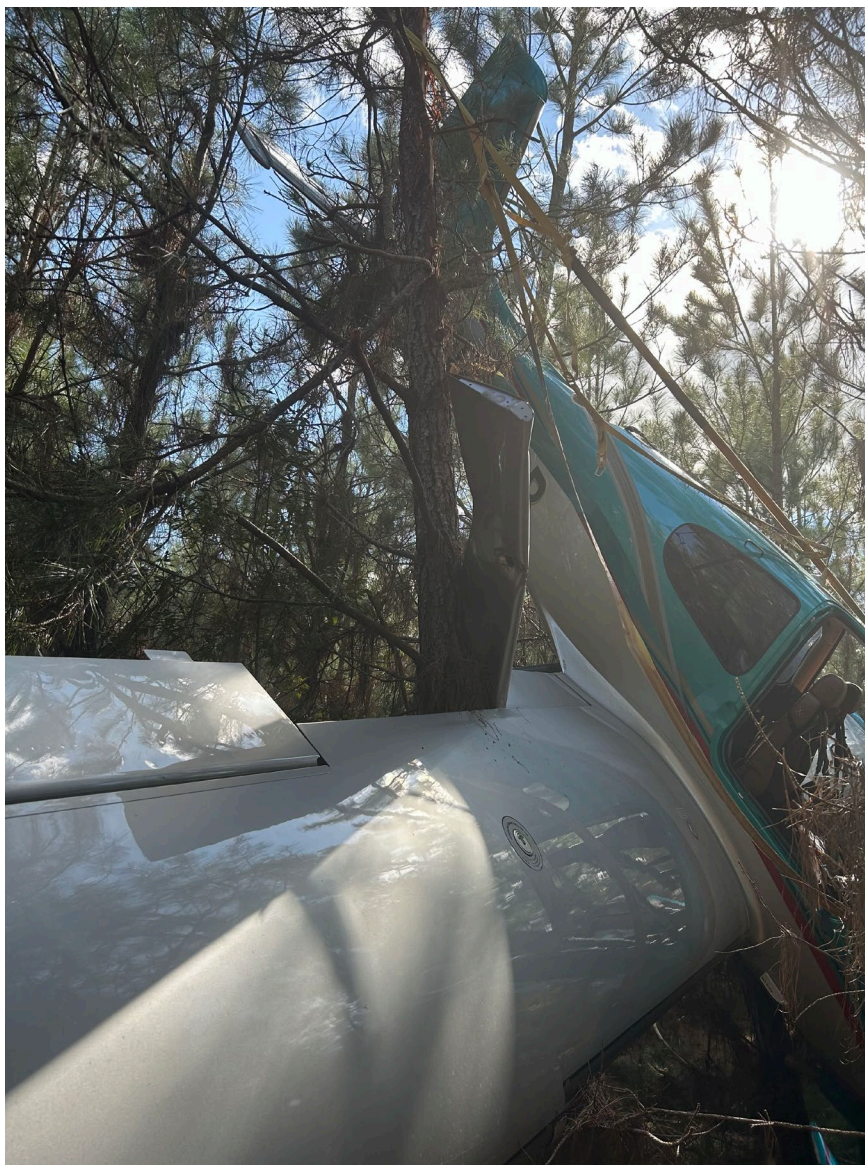
**Photograph 2 - Airplane at the accident site suspended in trees. (Courtesy of FAA)**

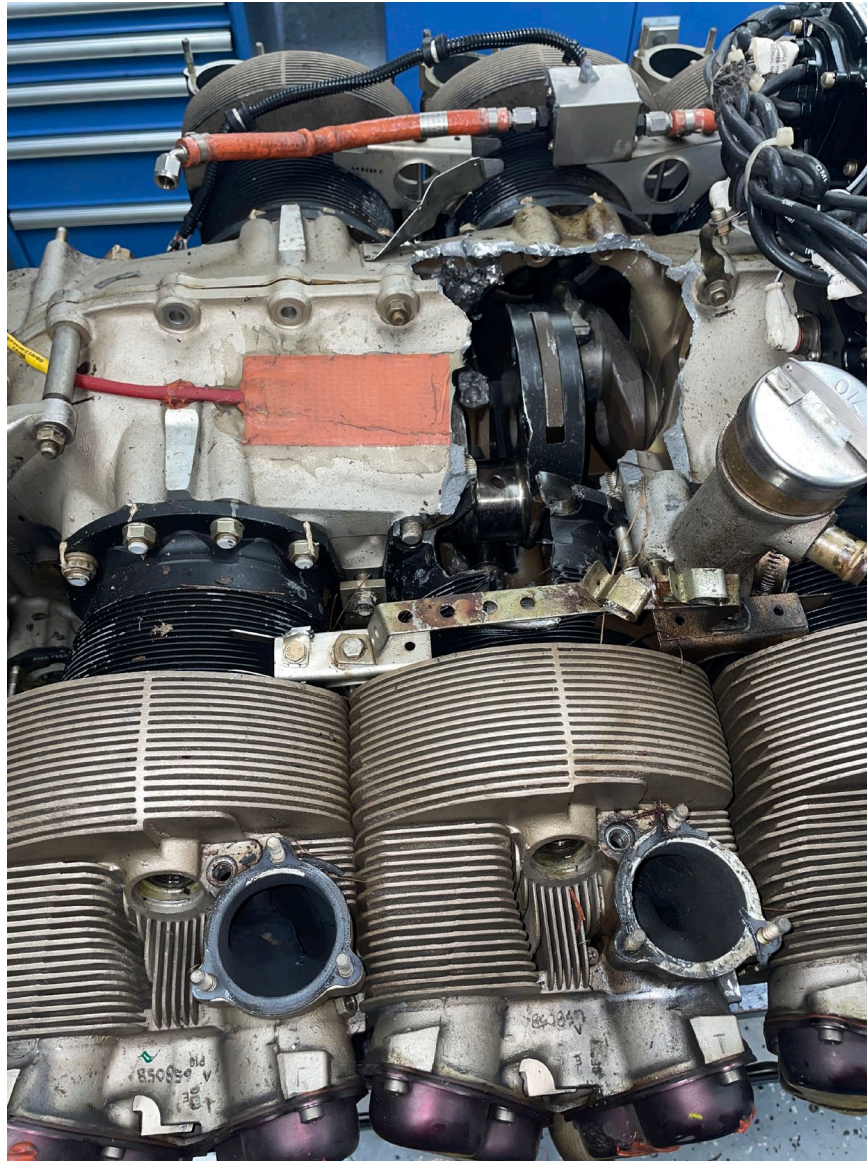
**Photograph 3 - Hole in top of engine. (NTSB)**

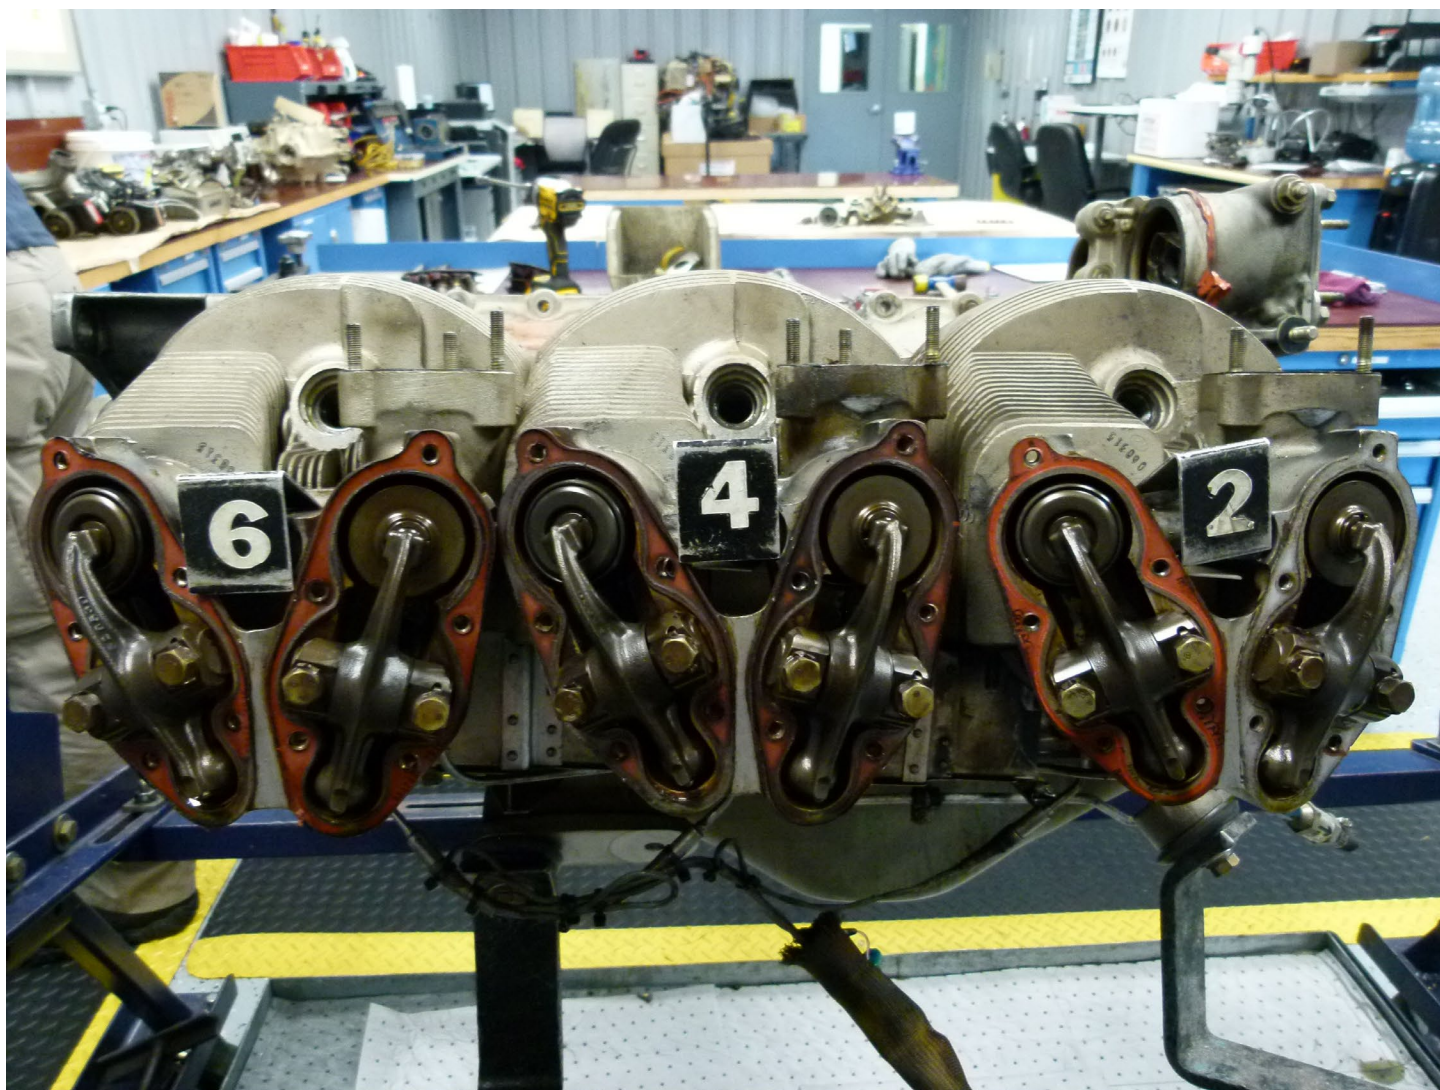
**Photograph 4 - Engine, number 6,4,2 side. (NTSB)**

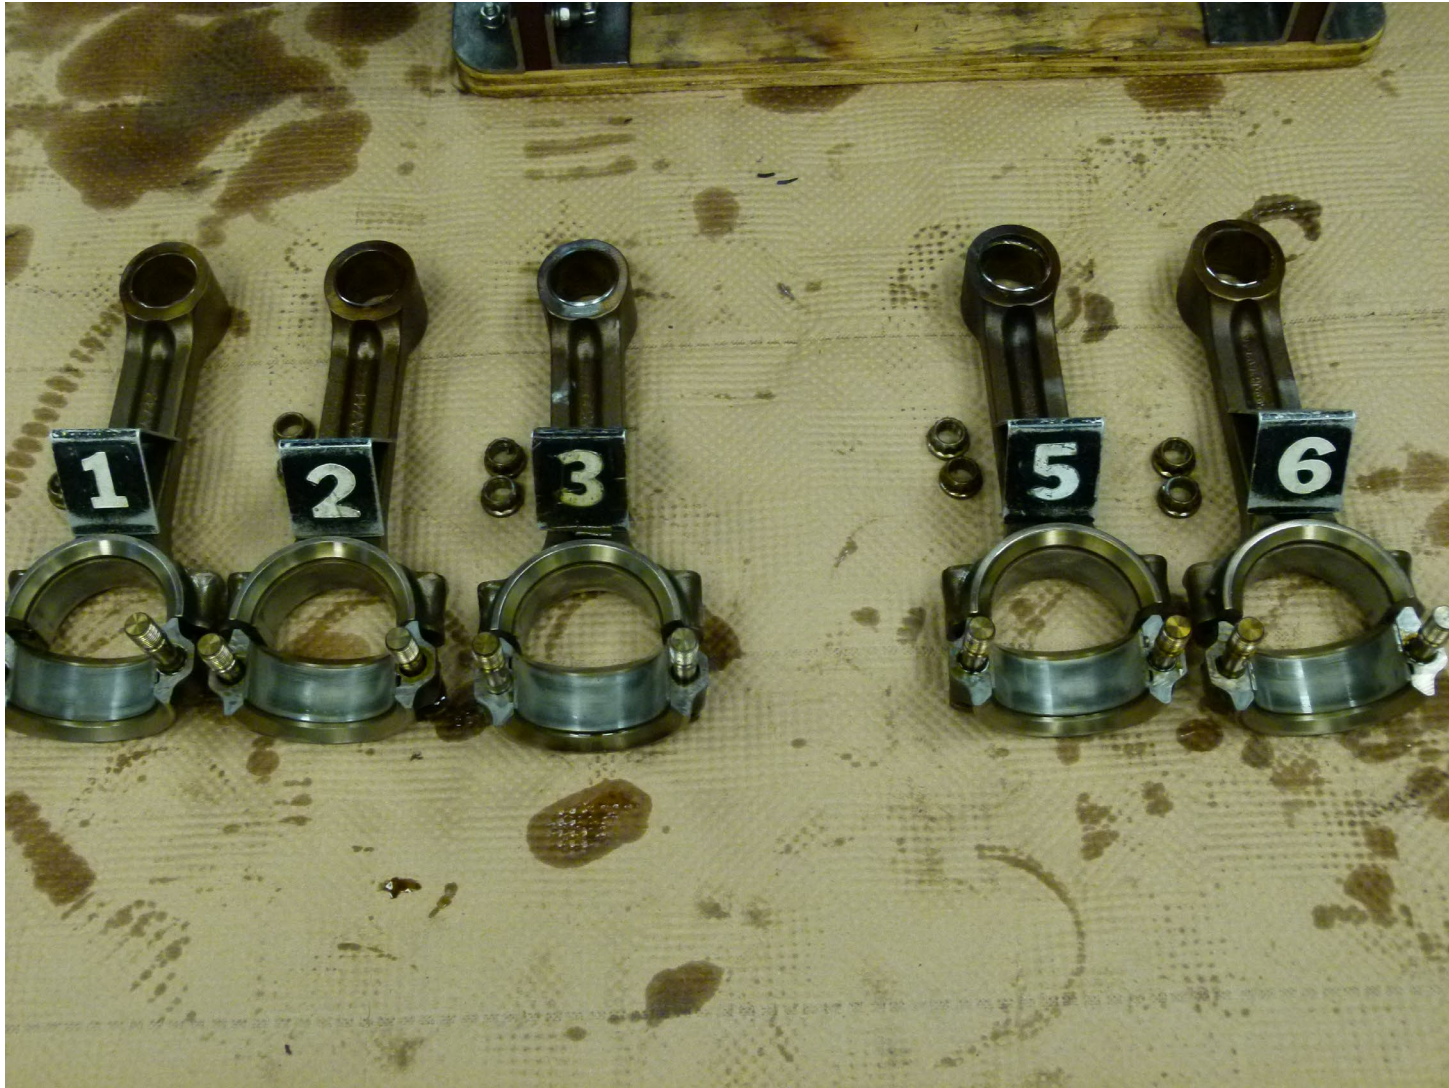
**Photograph 5 - Remaining piston rods and bushings. (NTSB)**

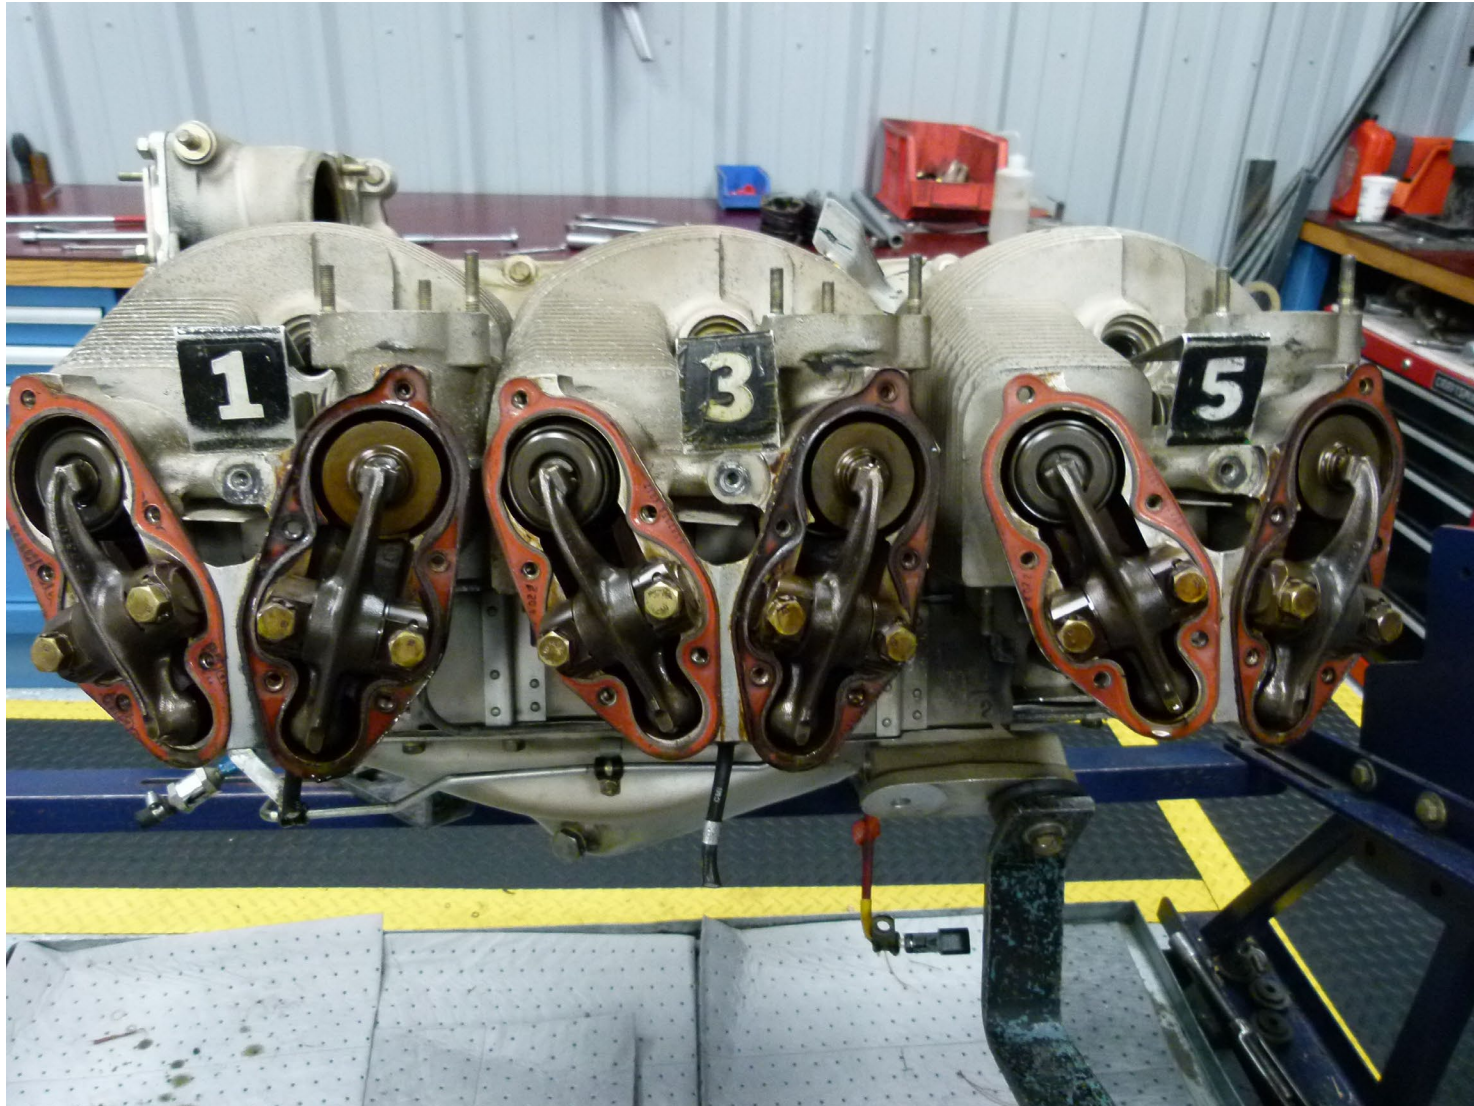
**Photograph 6 - Engine, number 1,3,5 side. (NTSB)**

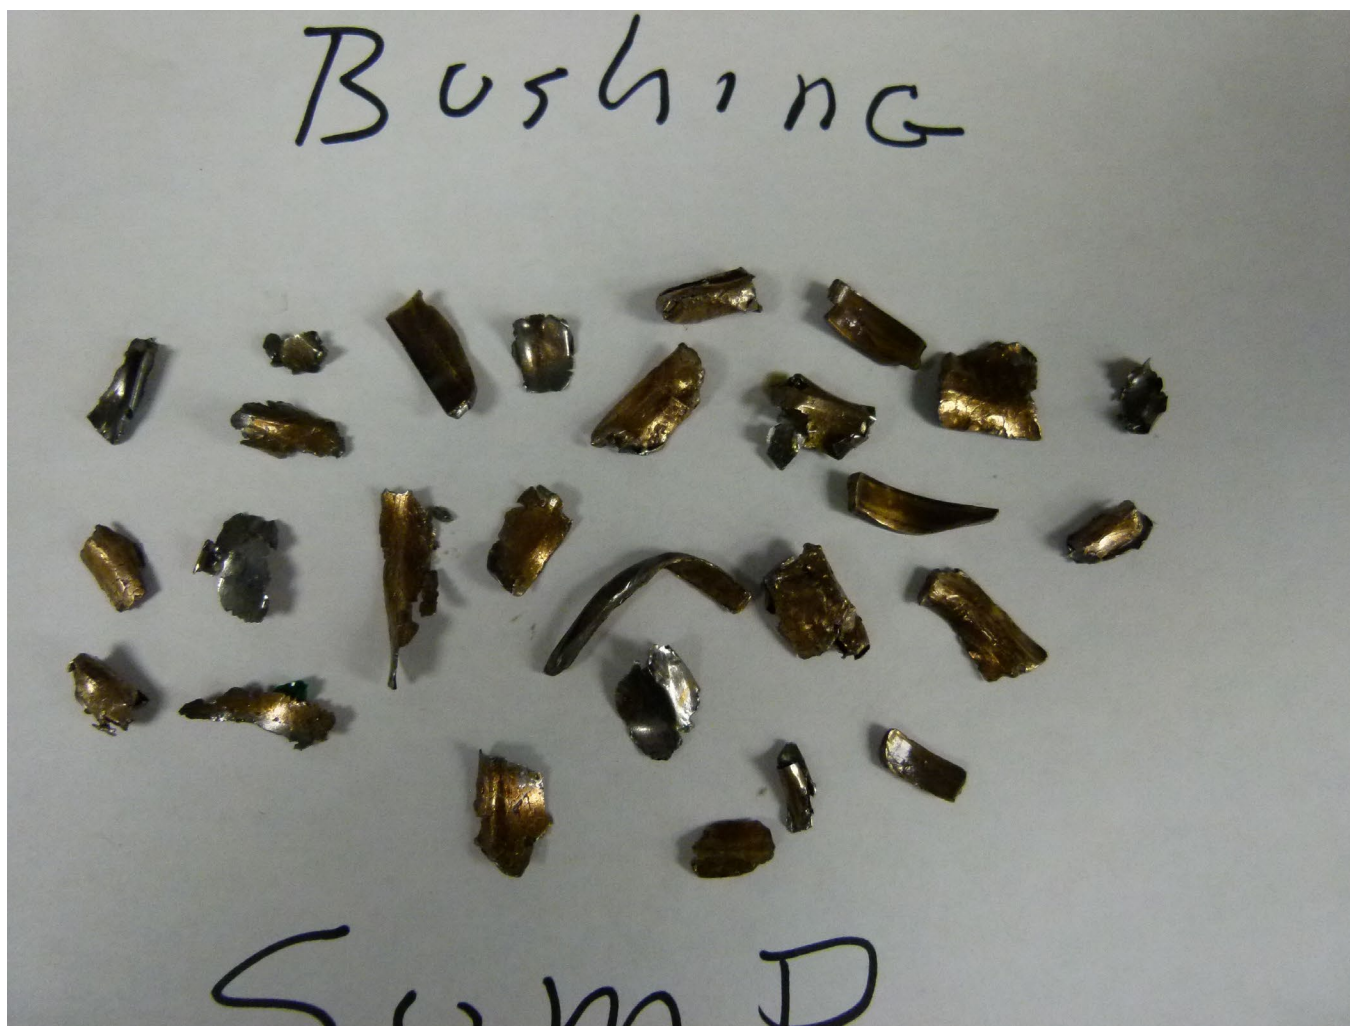
**Photograph 7 - Bushing pieces discovered in sump. (Courtesy of Continental Engines)**
