# National Transportation Safety Board

ERA24LA143

## **ENGINE EXAMINATION**

Location:     Blackshear, GA  
Date:         March 17, 2024  
Time:         0825 EDT  
               1225 UTC  
Airplane:     N729CW

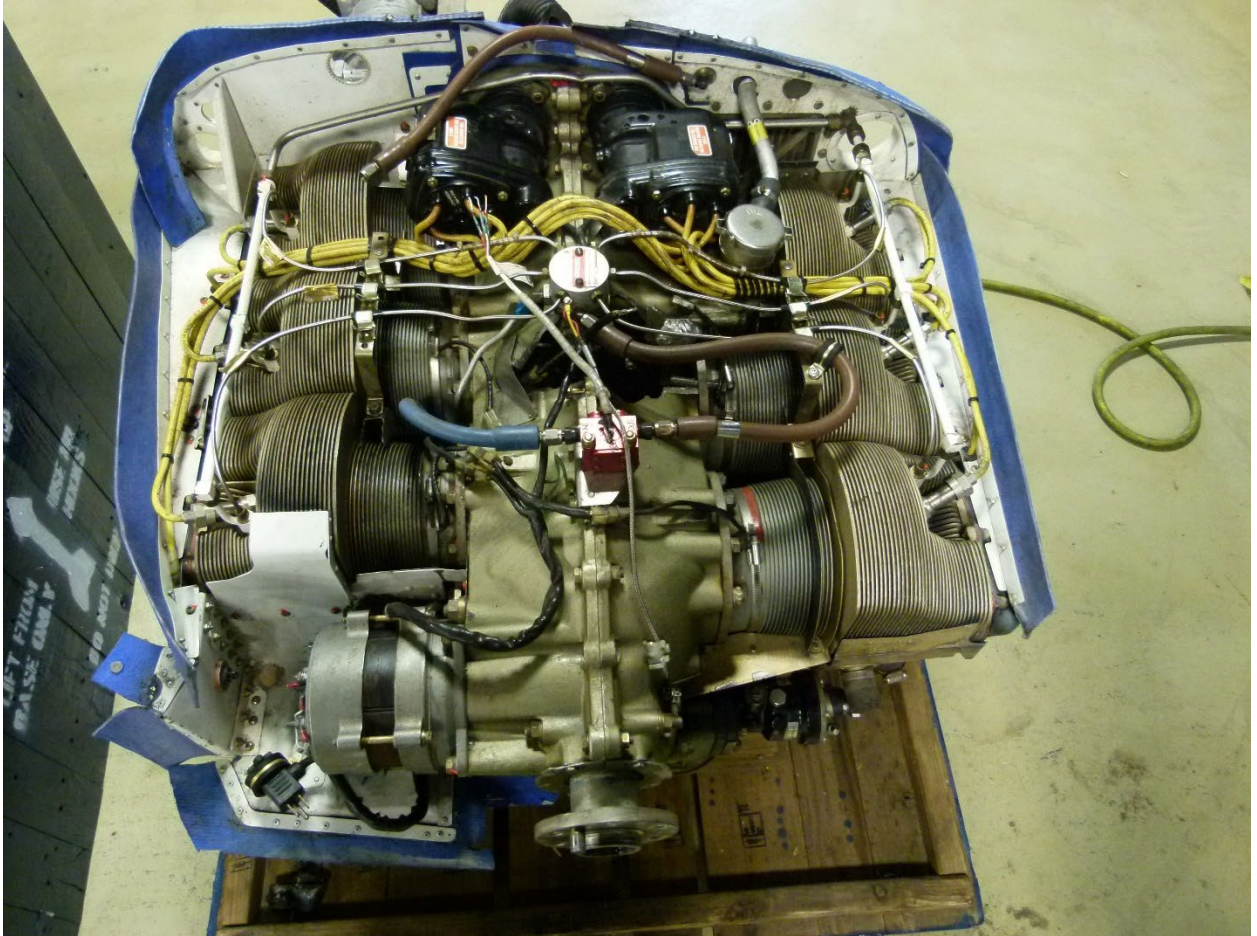
The engine was examined at Continental Motors, Mobile, Alabama, on July 9-10, 2024. A hole in the case was observed between the No. 3 and No. 4 cylinder. A distorted section of a connecting rod cap, which had separated from the engine, was found loose and sitting on the bottom of the shipping crate.

**Photo of the engine as it was being removed from the crate. (Photo courtesy Continental Aerospace Technologies.)**

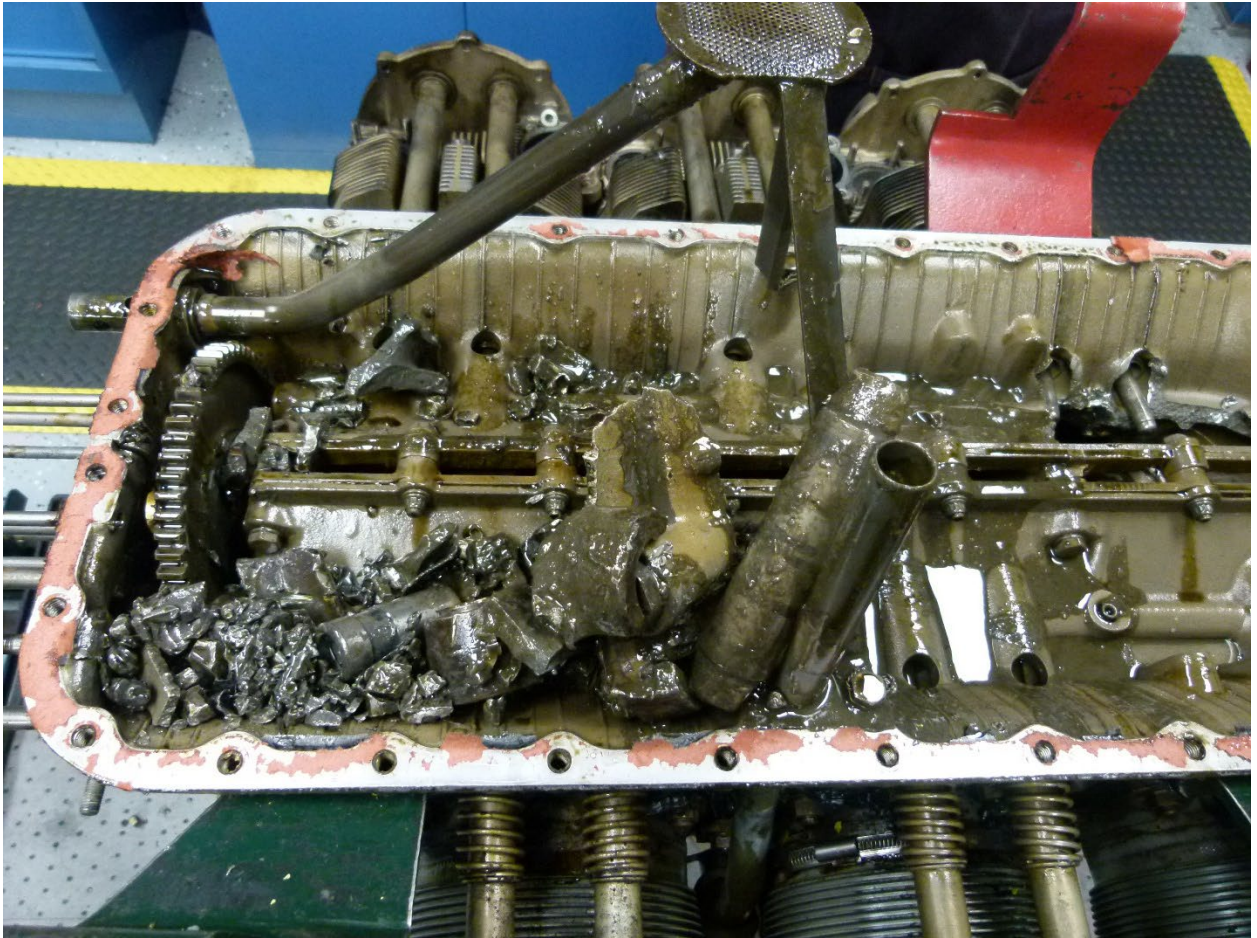
The oil filler cap was secure and there was only a drop of oil on the dip stick. When the oil sump was drained, it was full of water and a small amount of oil. The sump was removed and a large amount of metallic debris including a connecting rod and lifters were in the sump. The pick-up tube was clear of debris.

**Photo of debris found in the oil sump (Photo courtesy of Continental Aerospace Technologies.)**

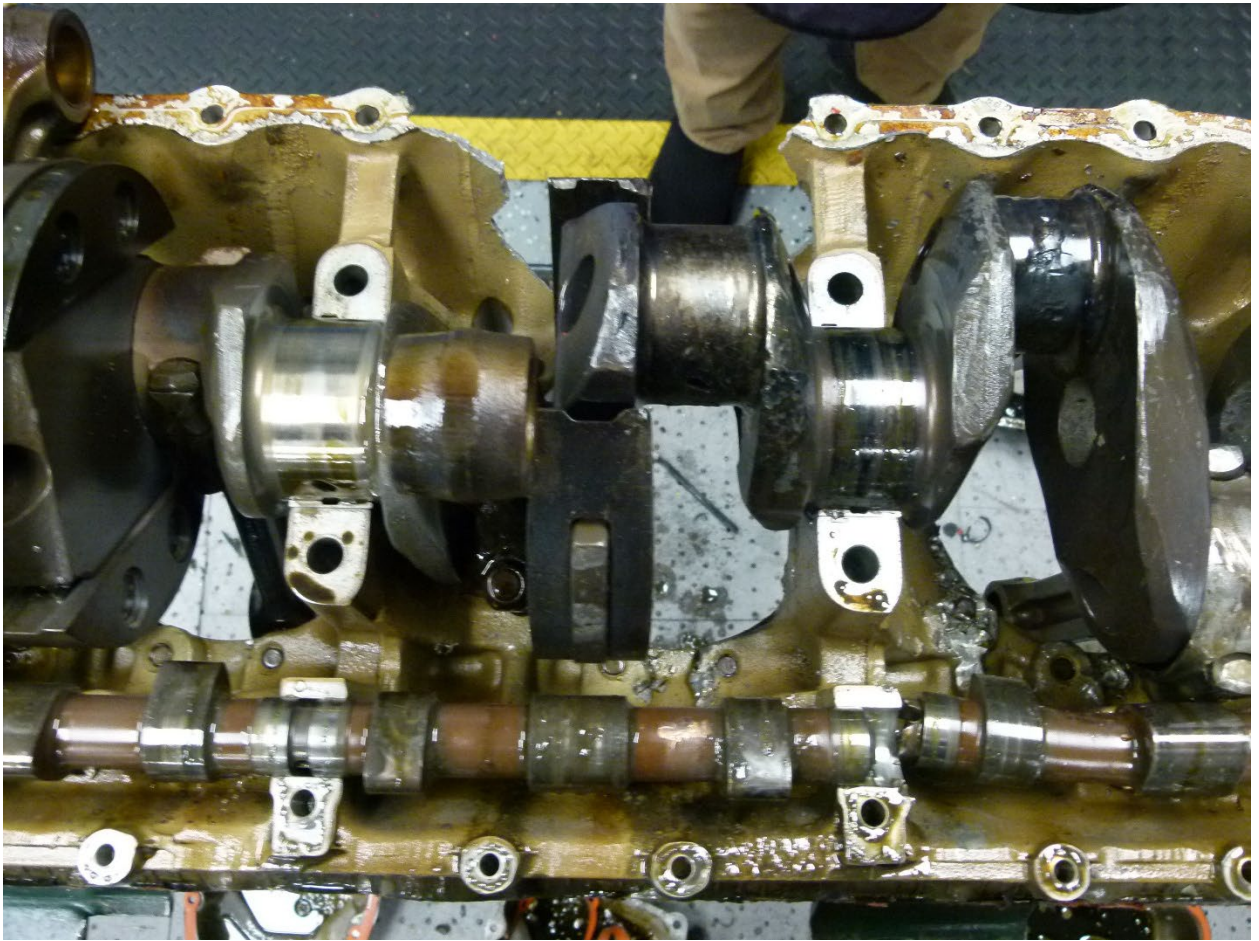
The engine would not rotate due to internal damage of the engine; thus, compression and engine timing could not be established. The camshaft was broken, and the No. 4 push rods were bent.

The engine was disassembled and signs of overheating due to oil starvation were observed on the Nos. 2 thru 5 connecting rods. The No. 4 and No. 5 connecting rods exhibited the most damage and both released from the crankshaft.

**Photo of internal heat damage and broken camshaft. (Photo courtesy of Continental Aerospace Technologies.)**

All of the oil ports were clear except for the No. 5 connecting rod journal, which was welded over from heat during the failure sequence.
