# National Transportation Safety Board

ERA24LA148

Specialist's Field Notes

Location: Belleville, West Virginia  
Date: March 18, 2024  
Time: 1720 eastern daylight time  
Helicopter: MD Helicopters 369D

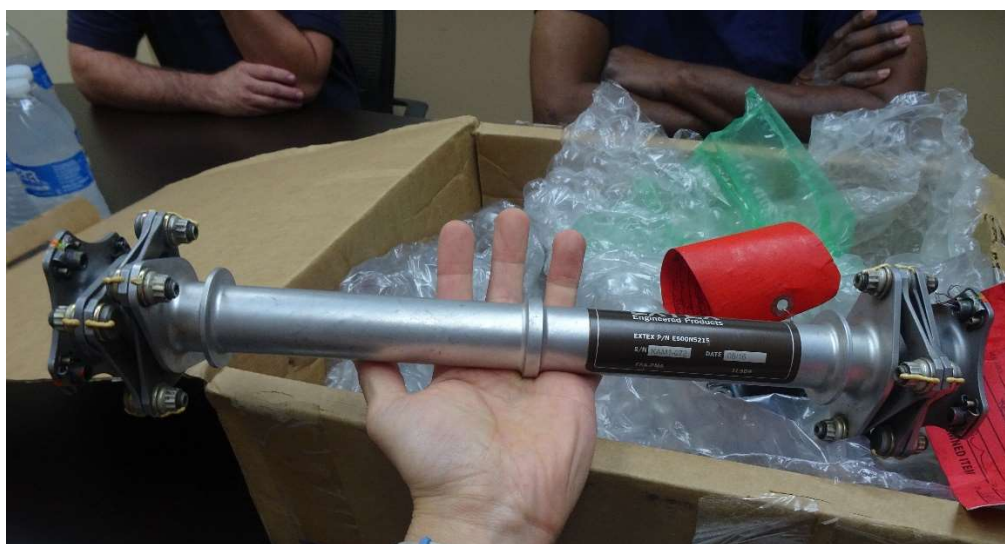
Figure 1. The Kaflex driveshaft.

The Kaflex driveshaft was P/N E500N5215 and S/N KAM1-072. The driveshaft was intact with no evidence of cracks or fractures. All torque striping between the shaft and Kaflex couplings on both ends were present except for one nut where remnant torque stripe was observed but the majority of the stripe had separated from the hardware. The main transmission input coupling, P/N AM369H5660 and S/N 2145, had no evidence of anomalous damage. The splined connection showed no evidence of wear or missing teeth. Remnant grease was present on the splines.

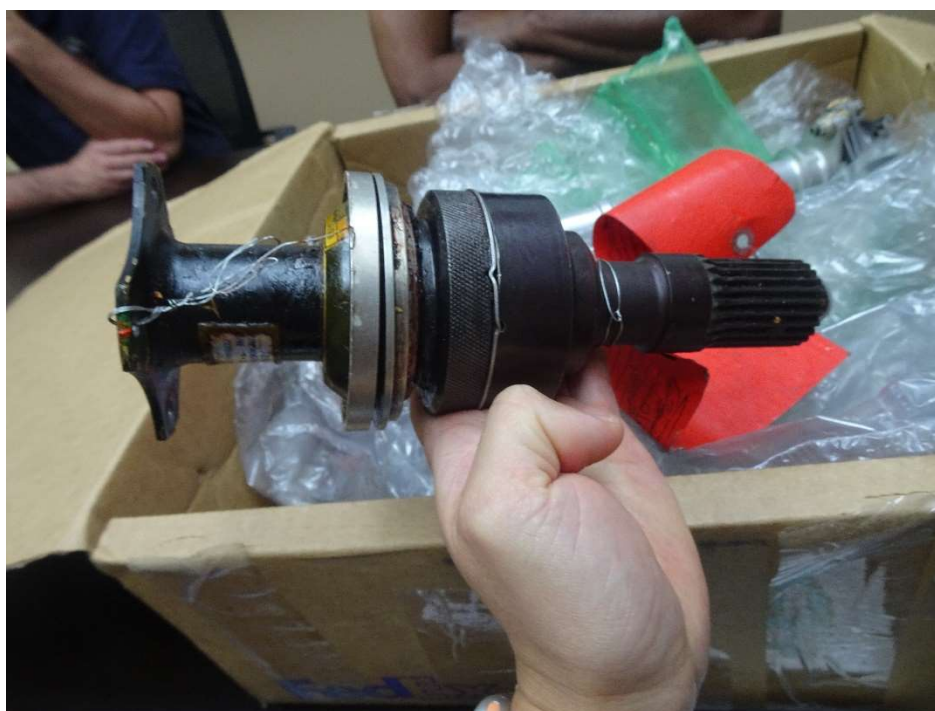
Figure 3. The overrunning clutch subassembly.

The clutch subassembly was P/N 369A5350-41 and S/N 7615. The clutch functionality was confirmed via rotating the clutch inner race in the drive and freewheeling directions while holding the clutch outer race static. The input-side splines, which mates to the engine gearbox, showed no evidence of anomalous wear or fractured teeth. Remnant grease was present on the splines. On the output side of the clutch subassembly, the coupling was S/N 2141. The outer race of the clutch subassembly was S/N 1690. The output bearing remained installed within the bearing carrier and had grease present within the bearing. The grease had a dark coloration. When the output bearing, spacers, and bearing carrier were removed using an arbor press, the output bearing shield came out of the bearing. Oil within the clutch was drained into a cup and the quantity was about 27mL. The fluid had a dark coloration but did not smell acrid. Metallic particles were not seen within the drained fluid. (Note: the minimum allowable quantity is 13 cc and the servicing capacity is 30 cc.) The output splines did not have any anomalous wear or evidence of cracks. The sprags did not have anomalous damage that would preclude its operation. The two bearings, on each side of the sprag assembly, rotated smoothly and did not exhibit seizure.
