**MEMORANDUM FOR RECORD**

**Subject:** ERA24LA149, Video Summary

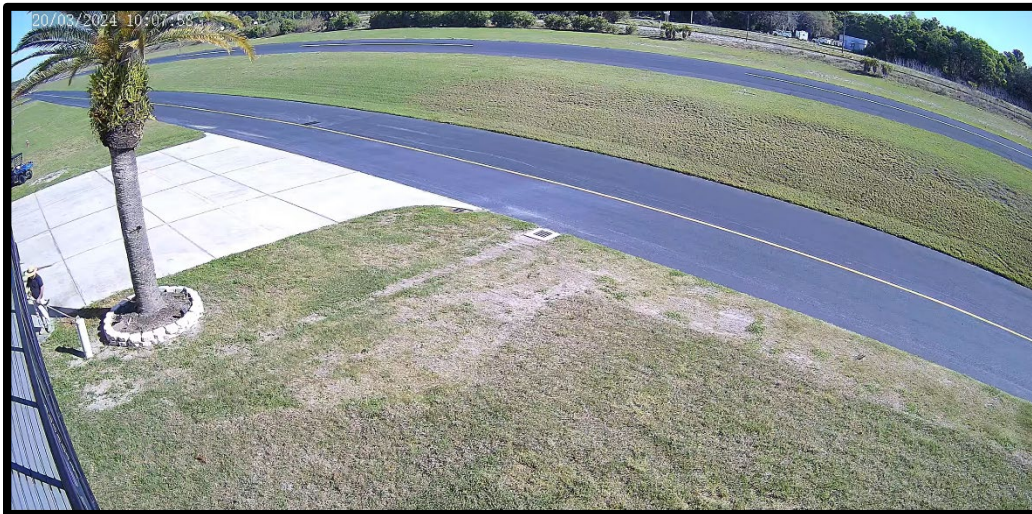
The provided video depicted the airplane when it was on the taxiway about 832 ft northwest from the impact location. At that time, which was about 41 seconds before the impact, the impacted individual was adjacent to the building with his back to the airplane (Figure 1).

**Figure 1: Screenshot from provided video at Start of Video. Note the Location of the Worker.**

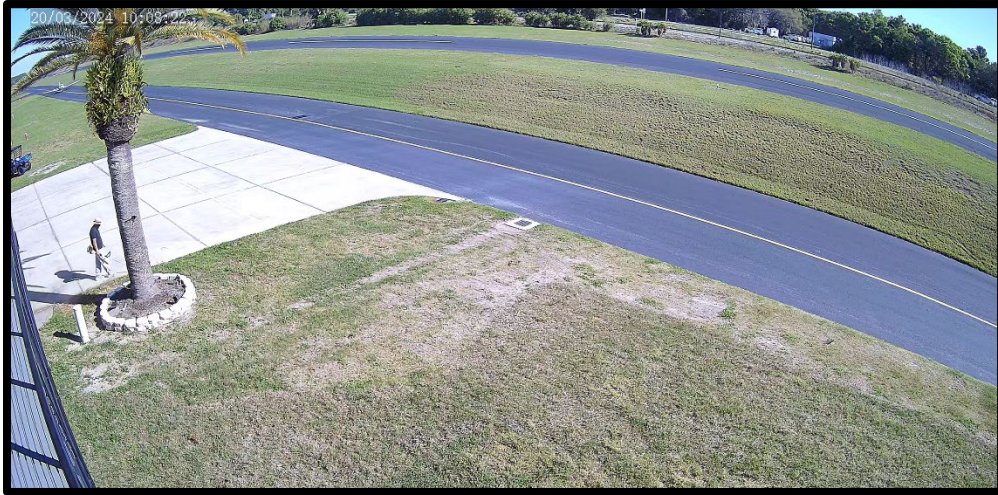
As the video continued the airplane continued along the taxiway while the worker was working while walking towards the taxiway with his head down (Figure 2).

**Figure 2: Screenshot from provided video depicting the location of the airplane and worker**

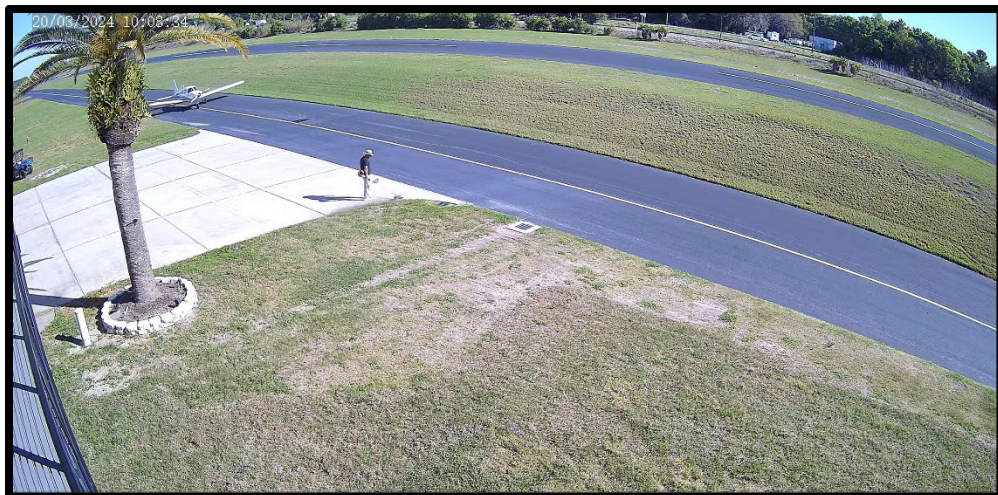
The airplane continued on the taxiway while the worker continued towards the taxiway with his head down (Figure 3). When near the edge of the taxiway the airplane was still about 91 ft northwest of where the collision occurred.

**Figure 3: Screenshot from provided video depicting the locations of the worker adjacent to the edge of the taxiway and the airplane, respectively**

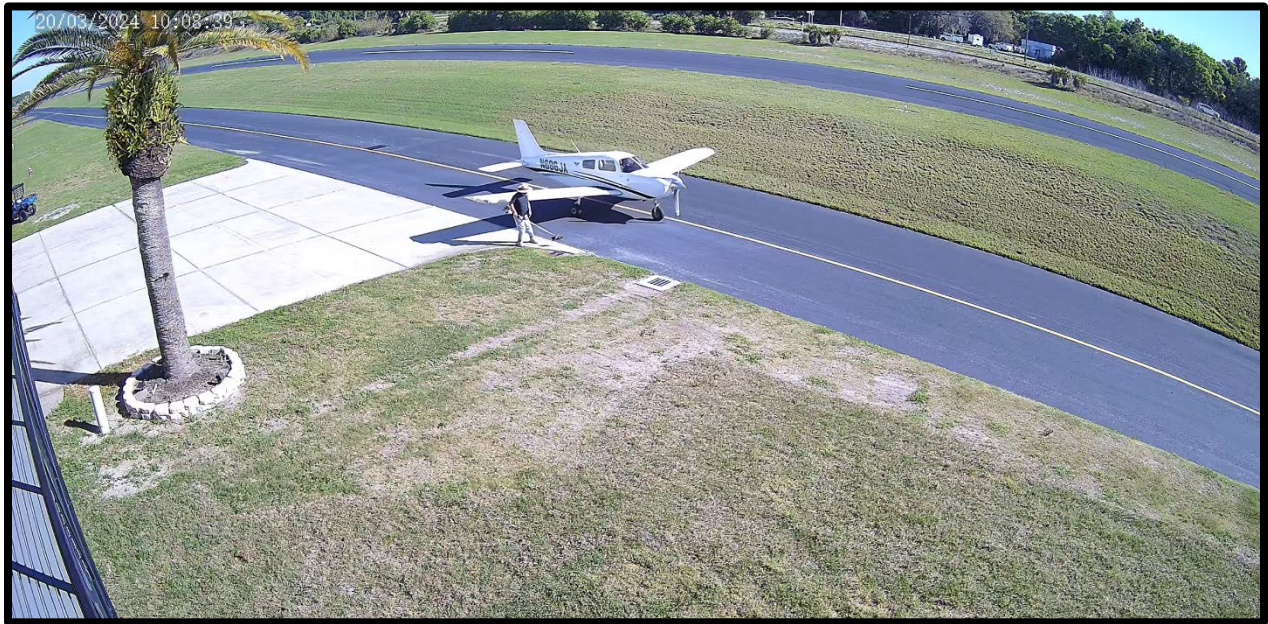
The airplane continued along the taxiway on centerline while the worker turned to the right with his back to the airplane. The airplane continued impacting the worker near the tip of the right wing (Figure 4). The worker was knocked forward and tumbled and the airplane veered slightly to the right then stopped about 6 seconds after the collision with only the aft empennage visible in the video.

**Figure 4: Screenshot from provided video immediately before impact. Note the airplane near taxiway centerline**
