ERA24LA151

## INVESTIGATION PHOTOGRAPHS

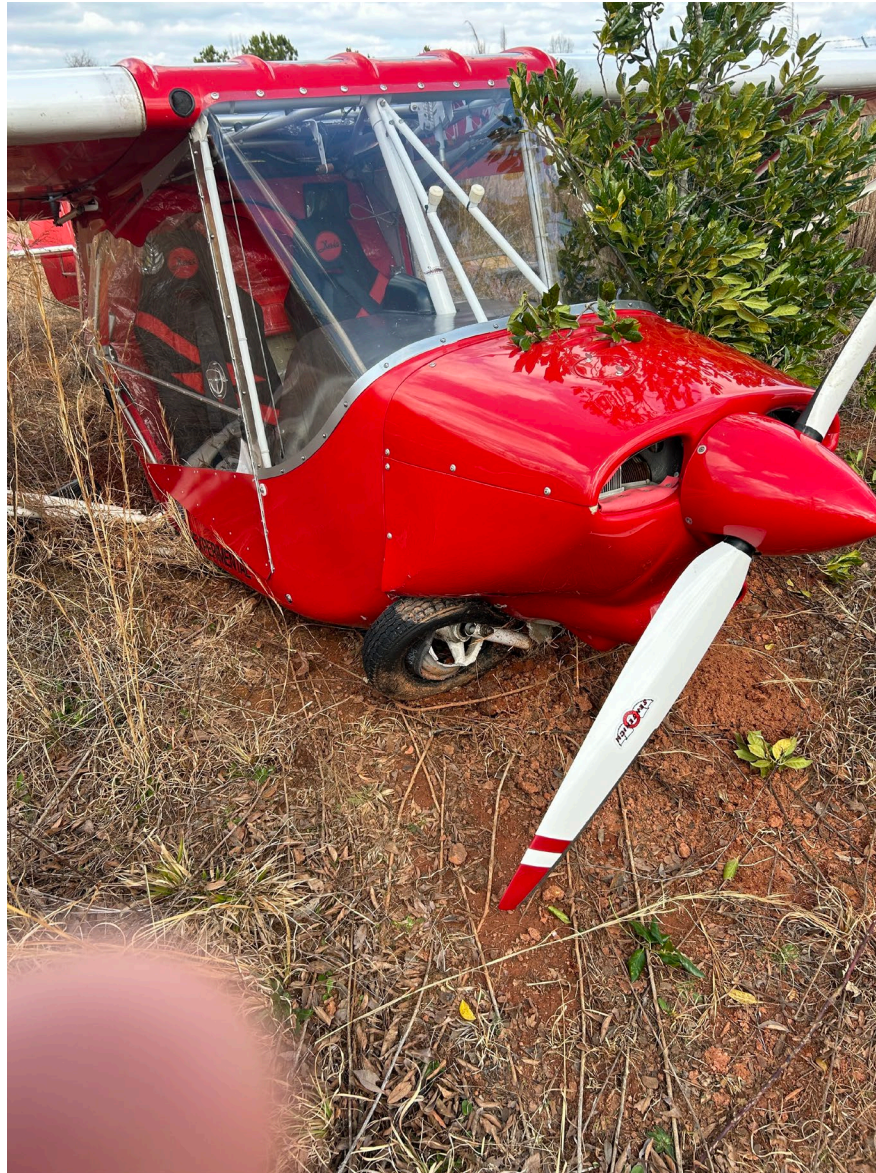
**Photograph 1 - Airplane on Scene (Courtesy of Owner)**

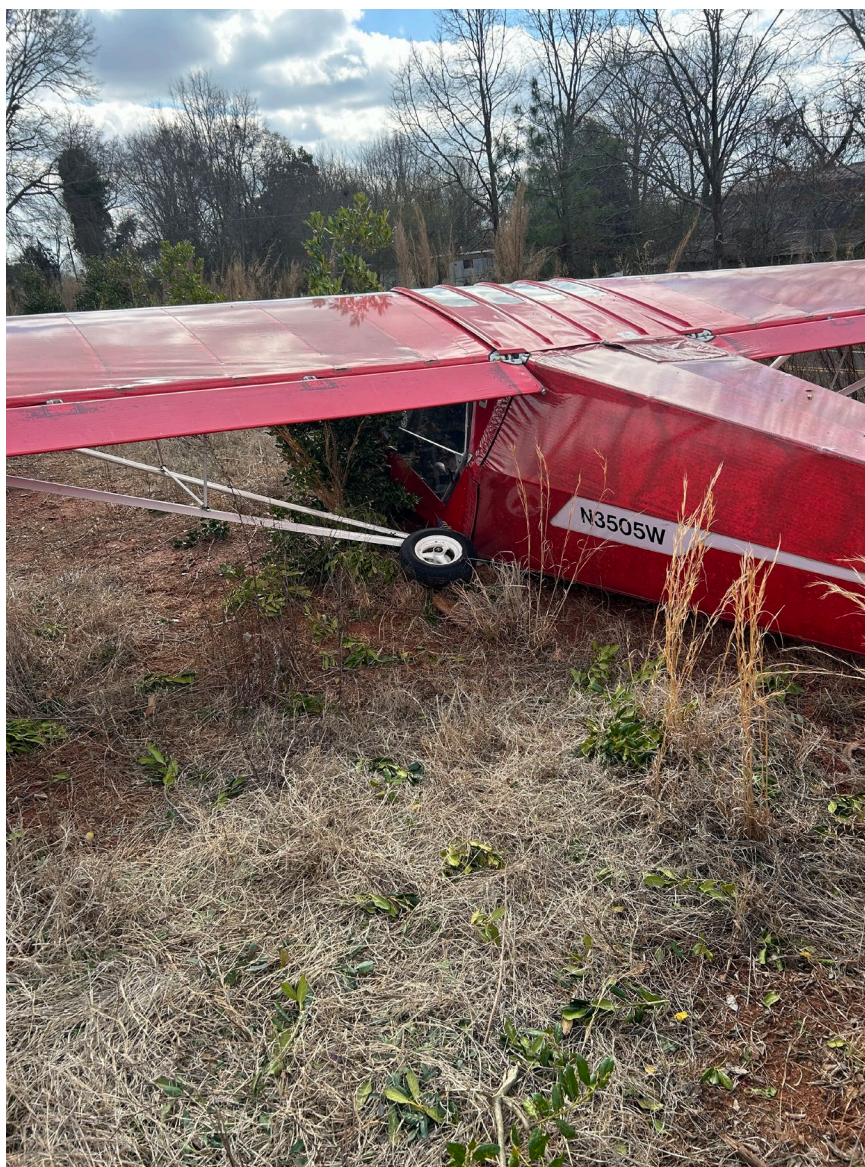
**Photograph 2 -Collapsed Gear and Fuselage Damage (Courtesy of Owner)**

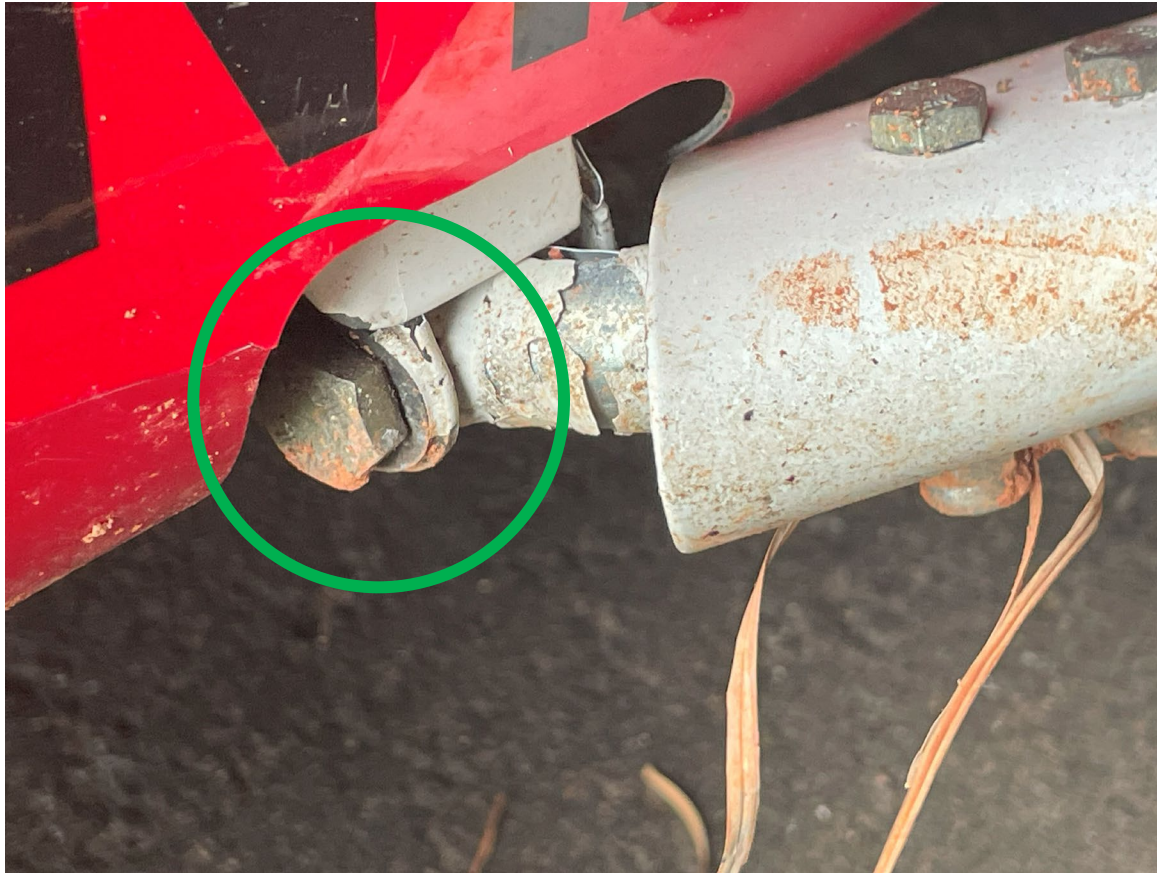
**Photograph 3 - Bent Structure at Main Landing Gear (Courtesy of Owner)**
