ERA24LA153

## INVESTIGATION PHOTOGRAPHS

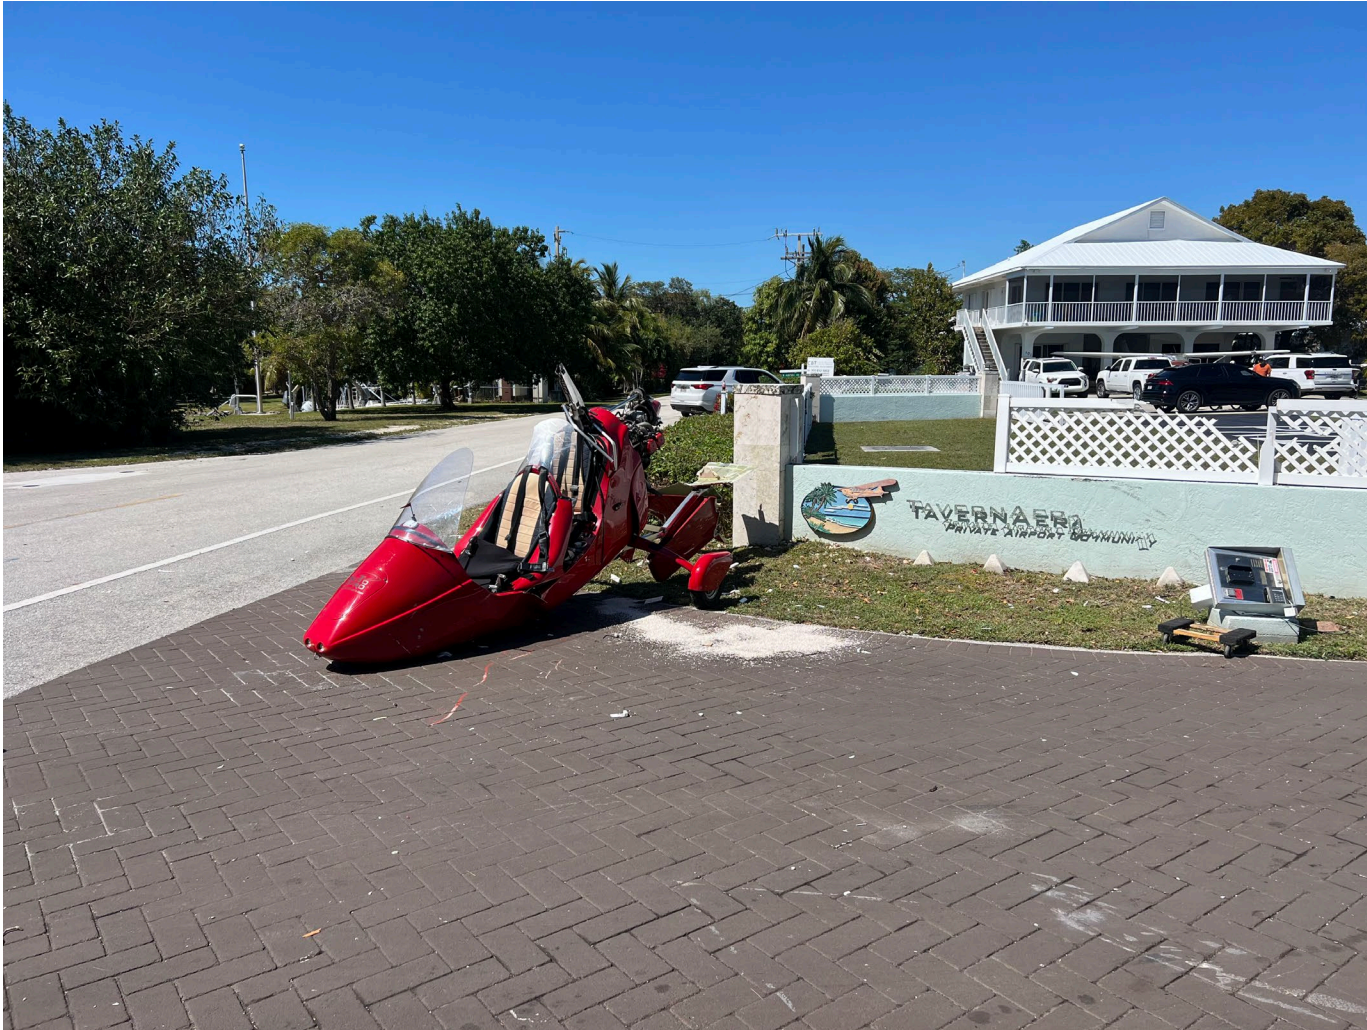
**Photograph 1 - View of gyroplane from front. (Courtesy of FAA)**

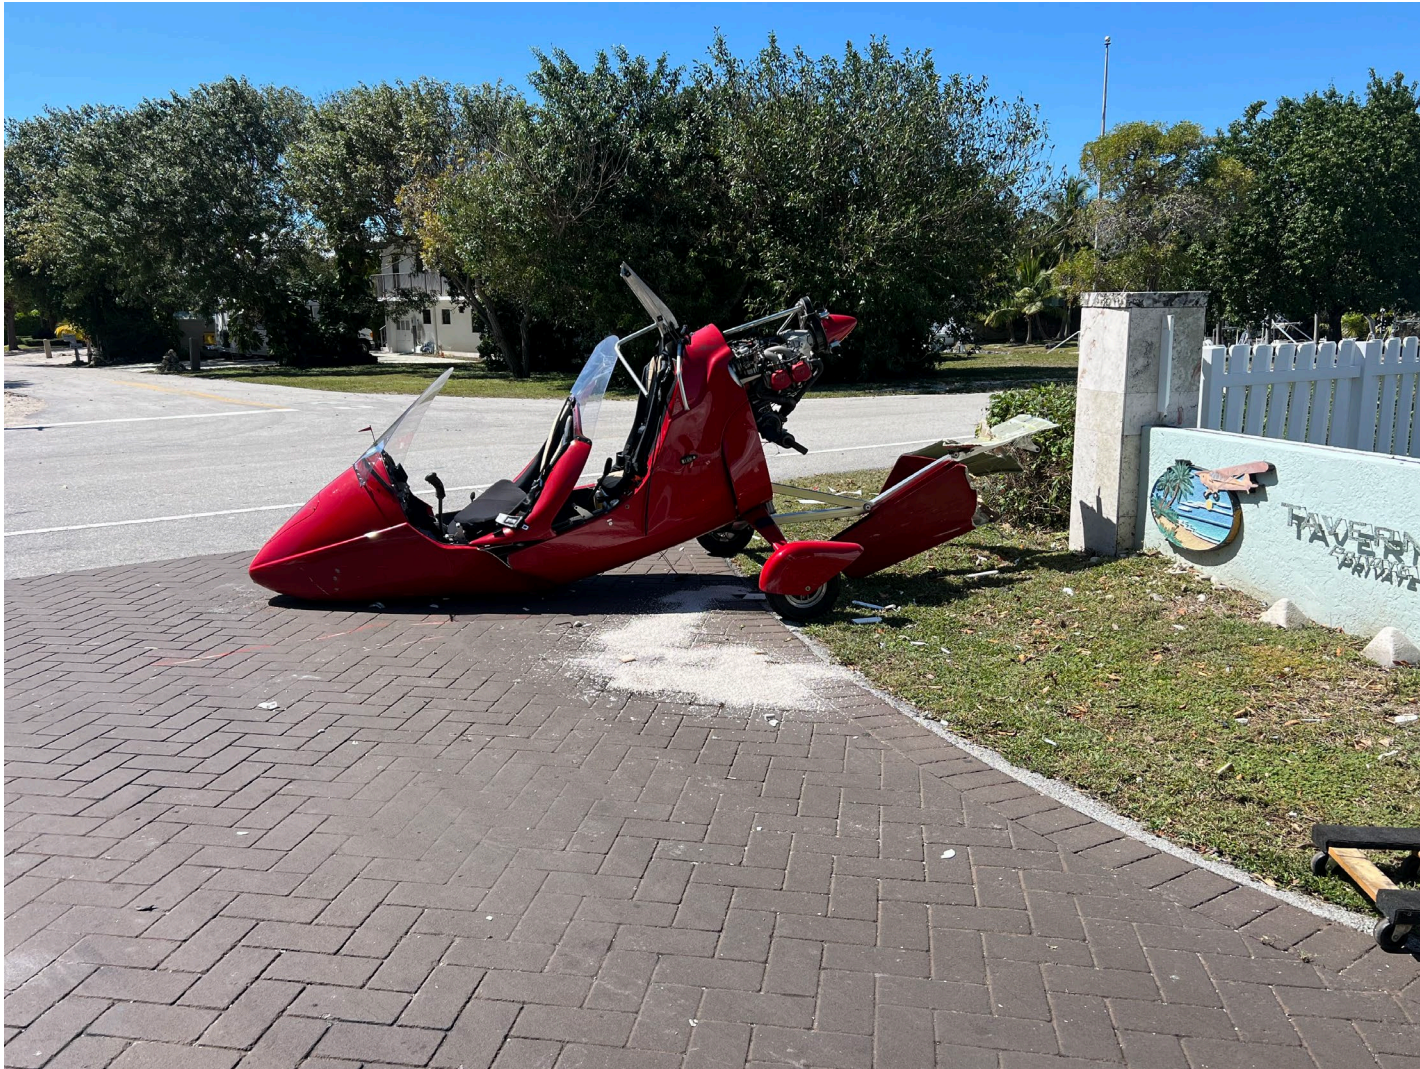
**Photograph 2 - View of gyroplane from left. (Courtesy of FAA)**

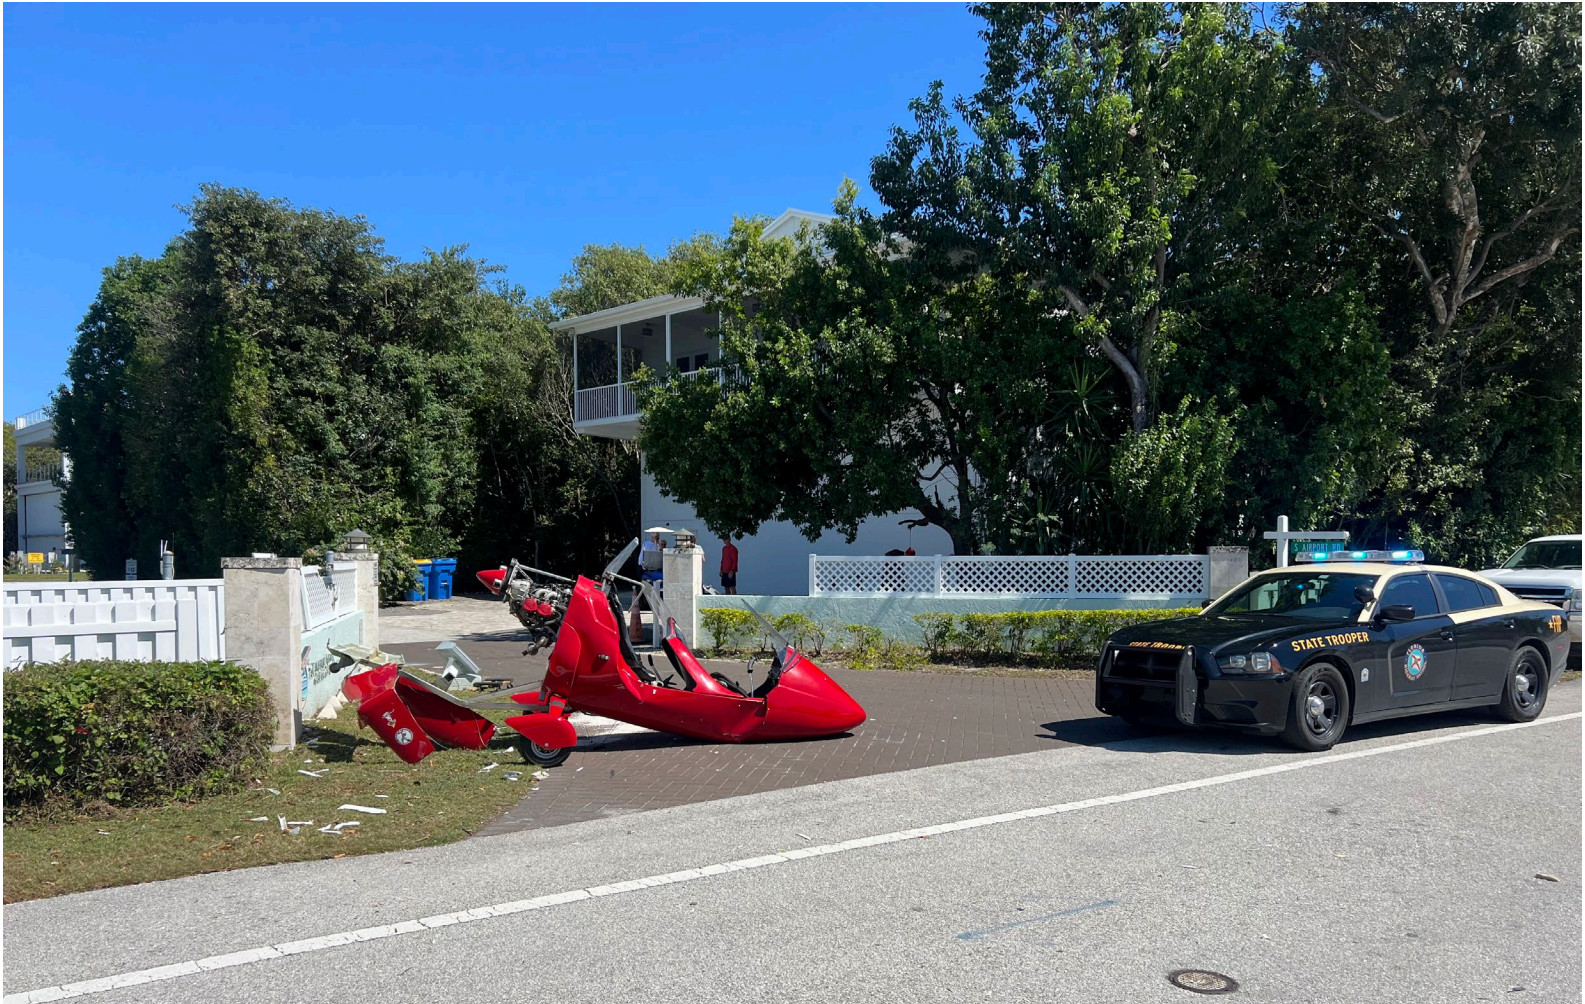
**Photograph 3 - View of gyroplane from right. (Courtesy of FAA)**

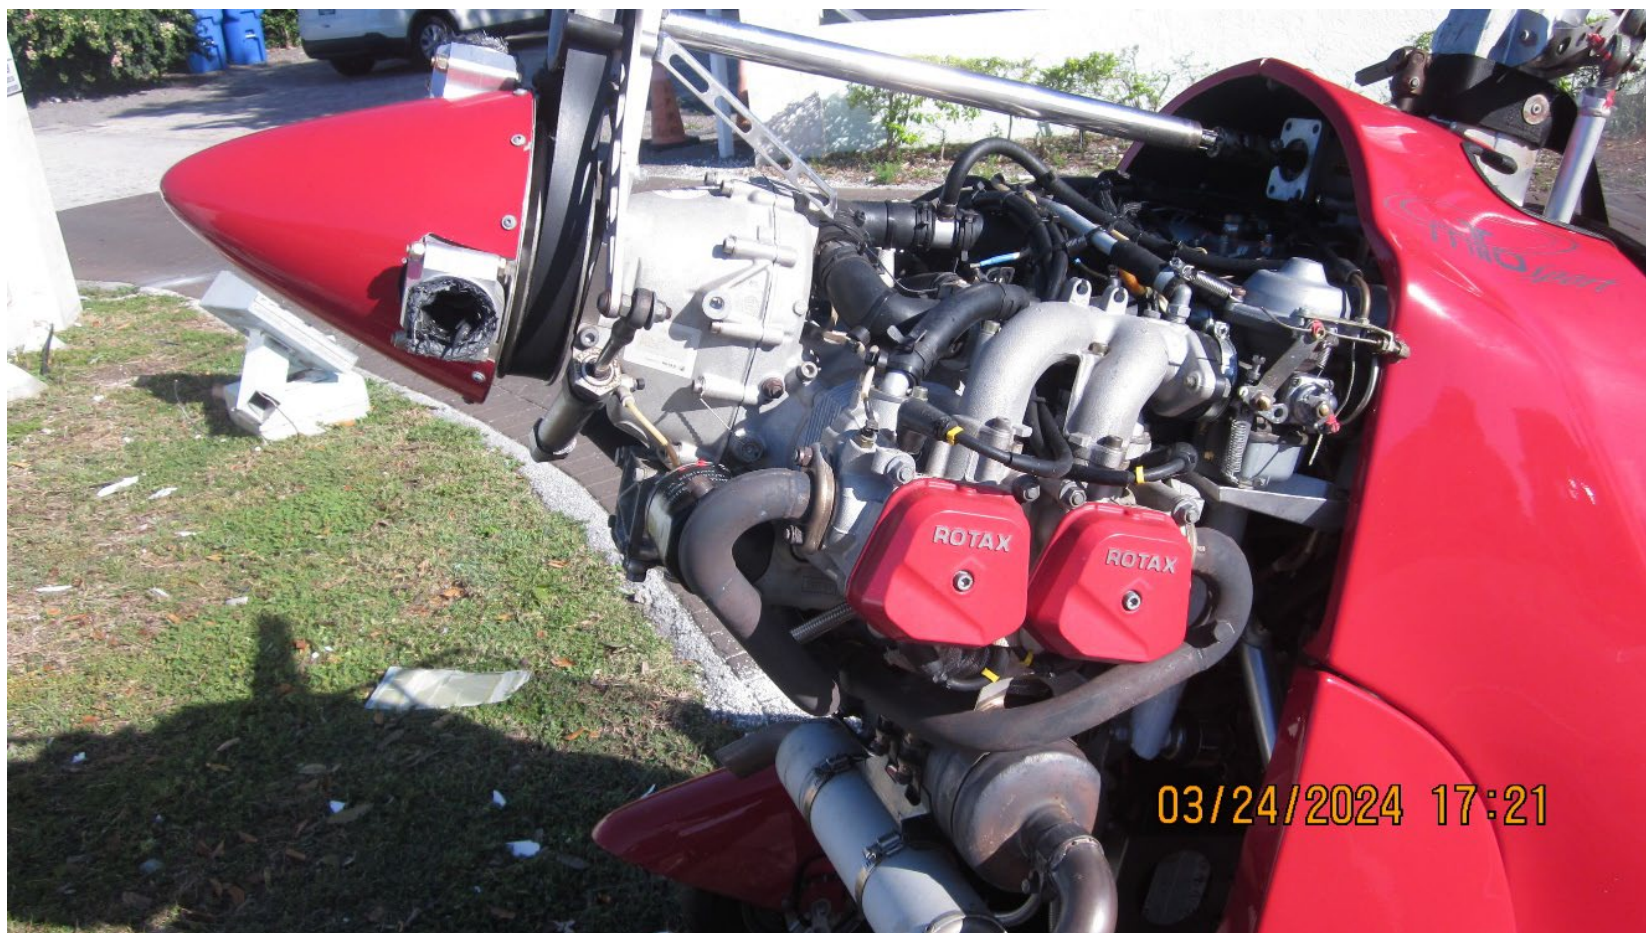
**Photograph 4 - Close-up view of engine. (Courtesy of FAA)**

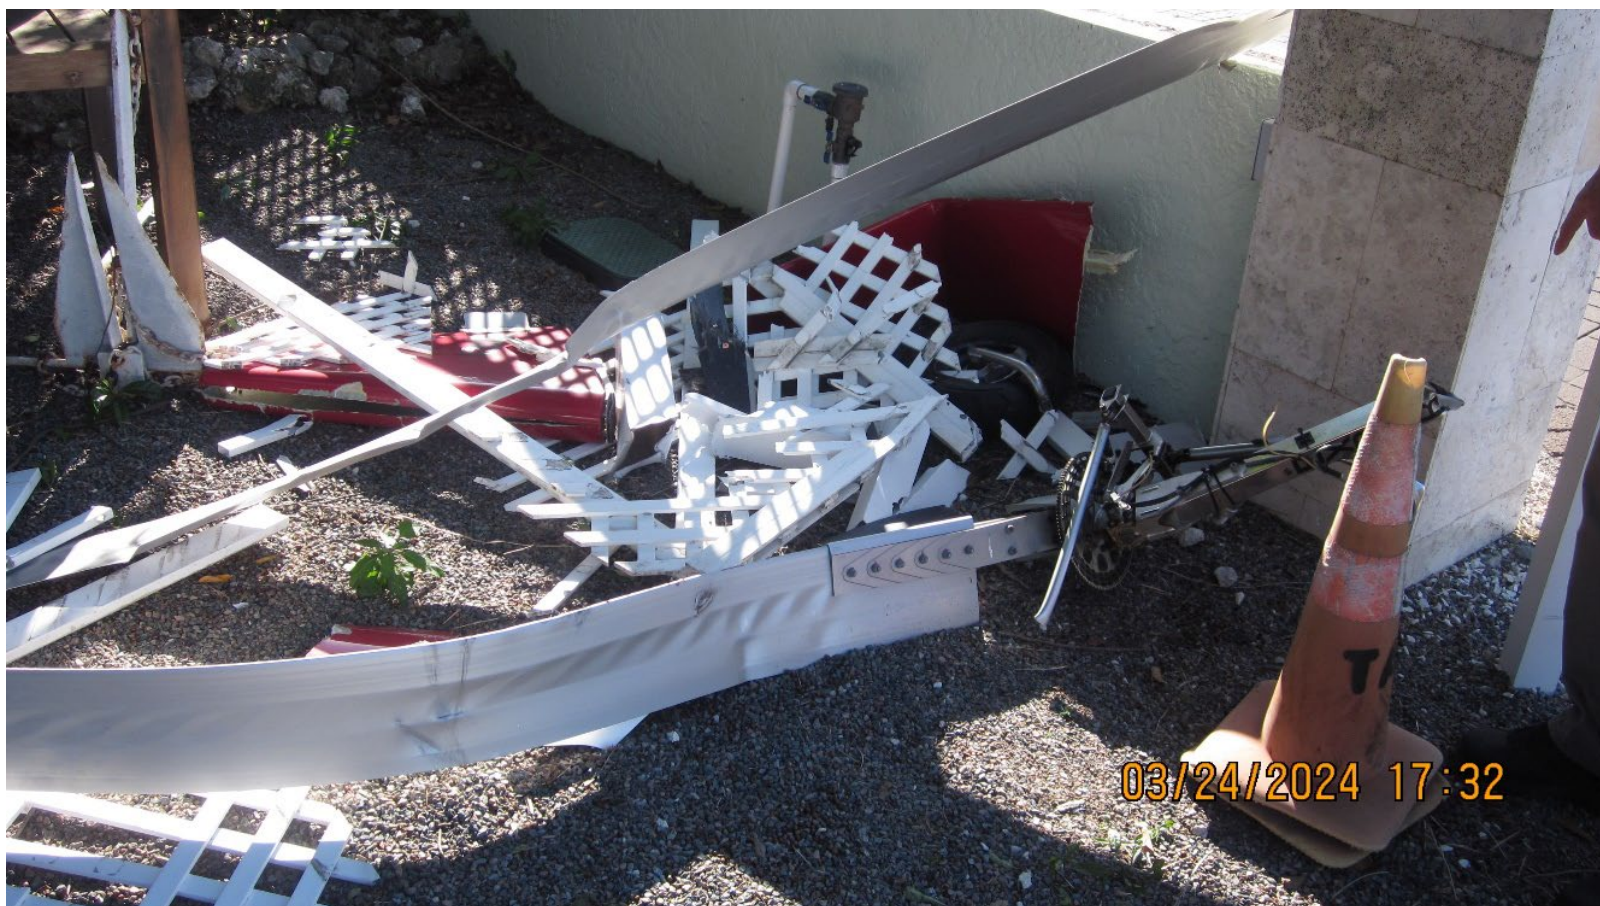
**Photograph 5 - View of fence damage and gyroplane debris (Courtesy of FAA)**
