# National Transportation Safety Board

ERA24LA153

## **WRECKAGE EXAMINATION REPORT**

Gyroplane: Autogyro MTO Sport

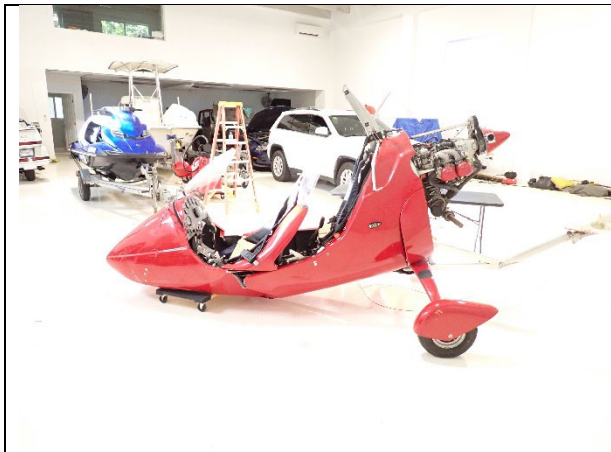
The fuselage near the front seat had buckled on both the left and right side of the fuselage and the fuselage had buckled on the right side near the rear seat. The rotor head assembly had impact separated from the rest of the airframe and one of the rotor blades had impact separated from the rotor head assembly. The other rotor blade had been removed from the rotor head assembly before the examination by the NTSB. The empennage sustained substantial damage; the horizontal stabilizer, vertical stabilizers, and the rudder had impact separated from the gyroplane and were not observed during the examination. The nose landing gear had impact separated from the aircraft, the main landing gear assemblies remained attached to

Figure 1: Left side of the gyroplane

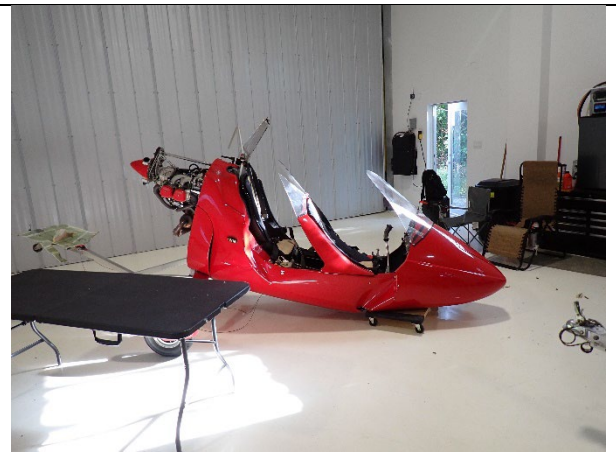
Figure 2: Right side of the gyroplane

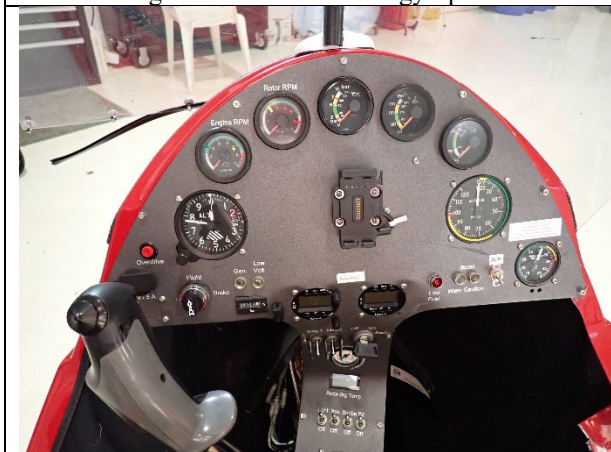
Figure 3: Instrument panel

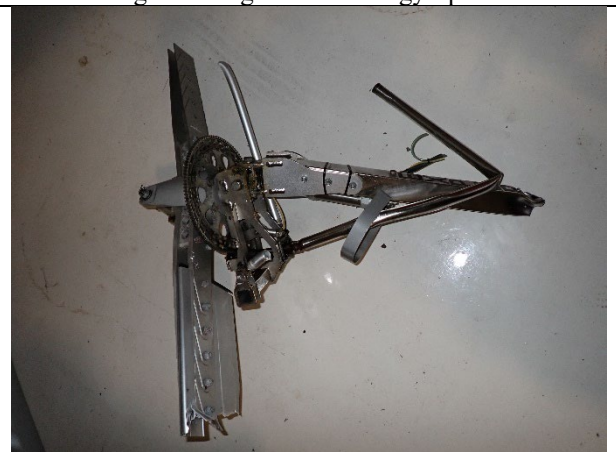
Figure 4: Rotor head assembly

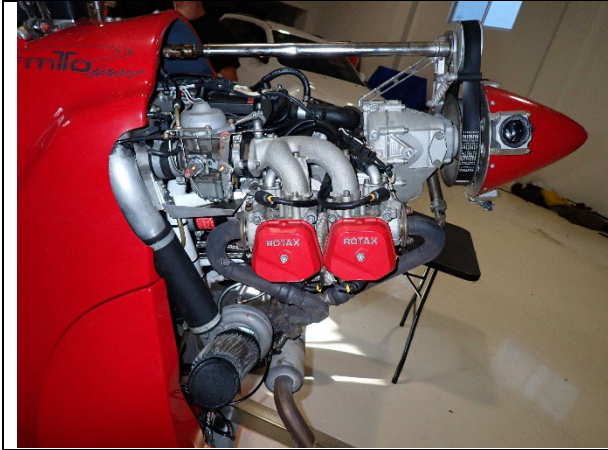
The gyroplane was equipped with a Rotax 914 UL engine, which is a carbureted, 4-cylinder, turbocharged engine that had a maximum takeoff power of 115 horsepower for 5 minutes. The engine remained attached to the airframe through the engine mounts, hoses, wires, and cables. It was noted that the engine had been pushed towards the front of the gyroplane, consistent with the observed

Figure 5: The engine when viewed on the left side of the gyroplane

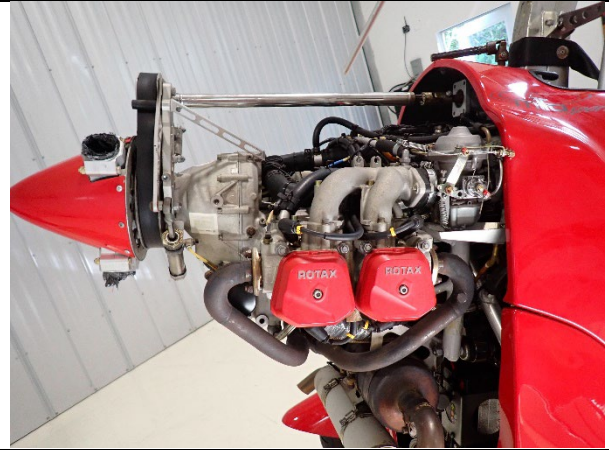
Figure 6: The engine when viewed on the right side of the gyroplane

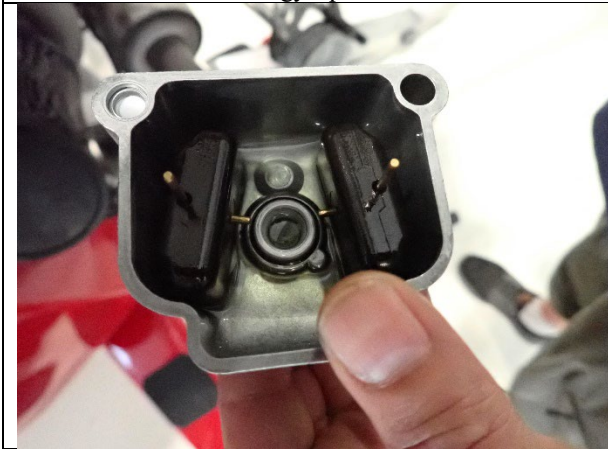
Both carburetors remained attached to the engine and were undamaged; however, the throttle control arm and cable of the carburetor on the right side of the gyrocopter (carburetor B) was impinged against the airframe which was consistent with the observed impact damage. The throttle valve of carburetor A operated normally during actuation. The throttle valve of carburetor B was stuck in the full open position which was consistent with the impact damage observed to the carburetor. There were no signs of fuel or intake leaks around the carburetors. The carburetor bowls were removed from both carburetors and visually examined. Both carburetor bowls contained fuel that was consistent with automotive gasoline. There were no signs of water or debris contamination within the carburetor bowls. The carburetor floats remained intact and displayed normal operating signatures.

Figure 7: Carburetor "A" bowl and floats with fuel

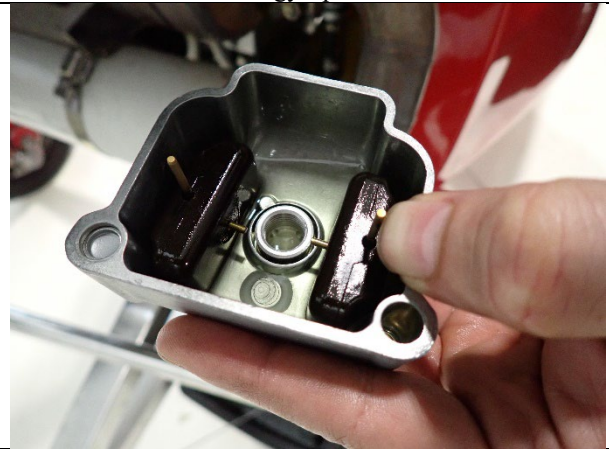
Figure 8: Carburetor "B" bowl and floats with fuel

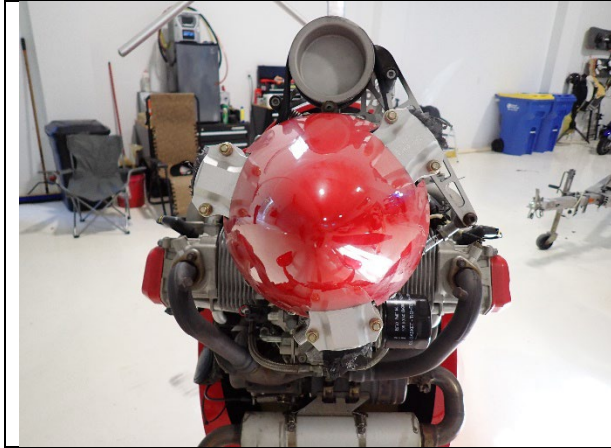
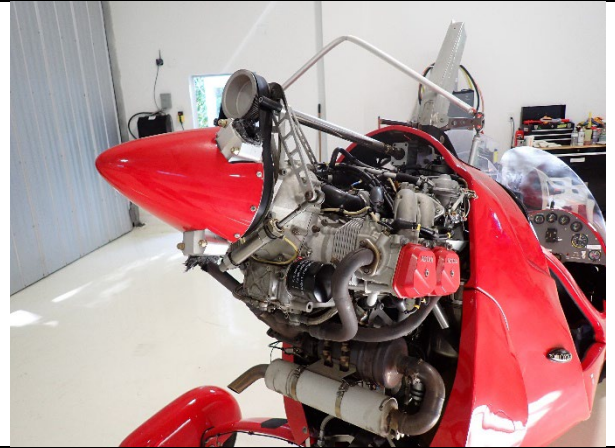
The three-blade, fixed-pitch propeller remained attached to the propeller drive shaft. All three of the propeller blades had sheered near the hub which was consistent with impact damage. The separated portions of the propeller blades were not observed at the time of the examination.

Figure 9: Propeller spinner and hub
