# National Transportation Safety Board

ERA24LA159

## **WRECKAGE EXAMINATION SUMMARY**

Location: Clermont, FL  
Date: March 30, 2024  
Time: 0854 EST  
1254 UTC  
Airplane: DTA Voyageur

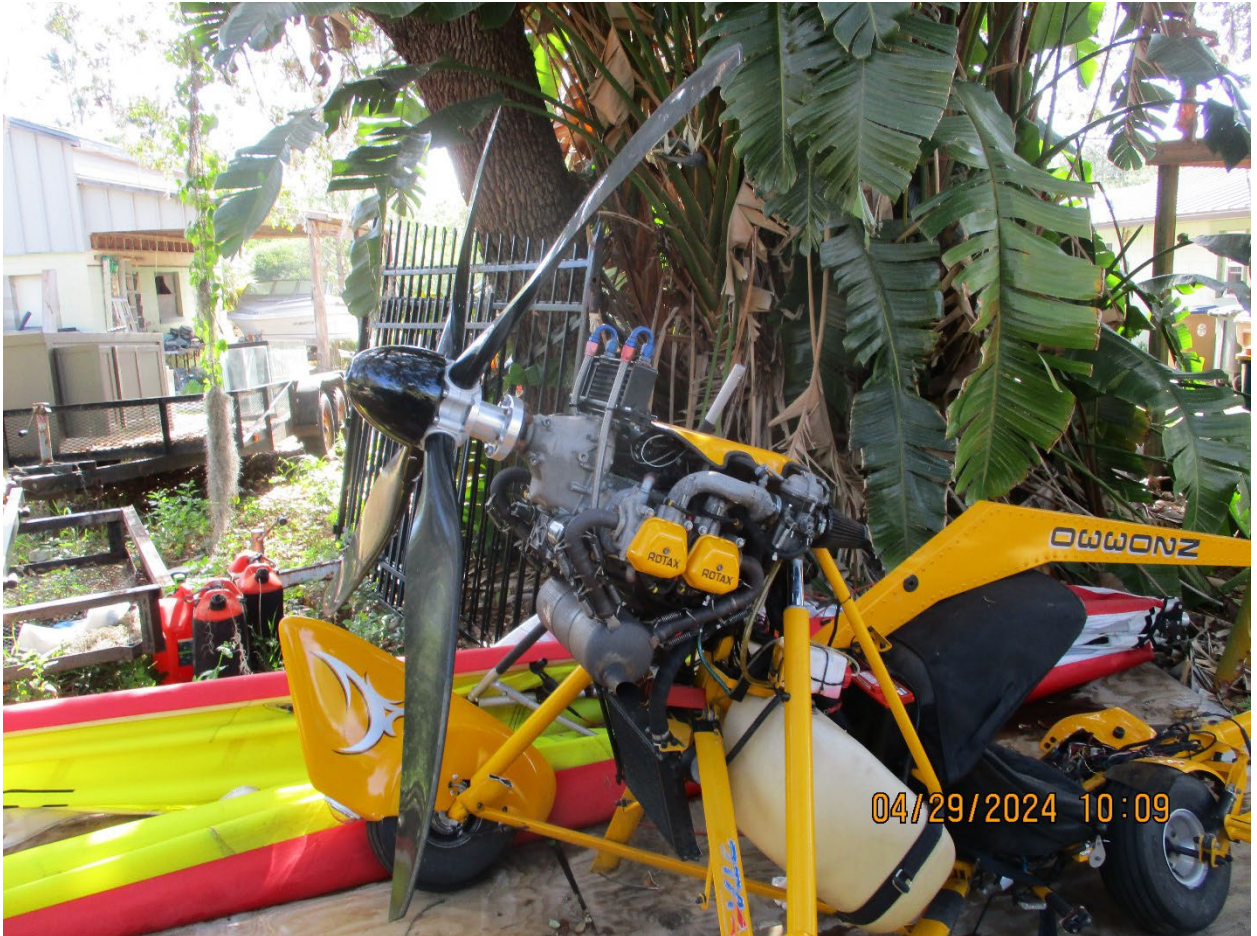
The airplane was first observed at the pilot's residence. The upper wing was removed and laying beside the aircraft. The left main landing gear strut was fractured from impact forces. The nose landing gear was separated and laying beside the aircraft. The engine and propeller were still attached to the airframe. one propeller blade was cracked, otherwise it was clean and normal looking from the outside.

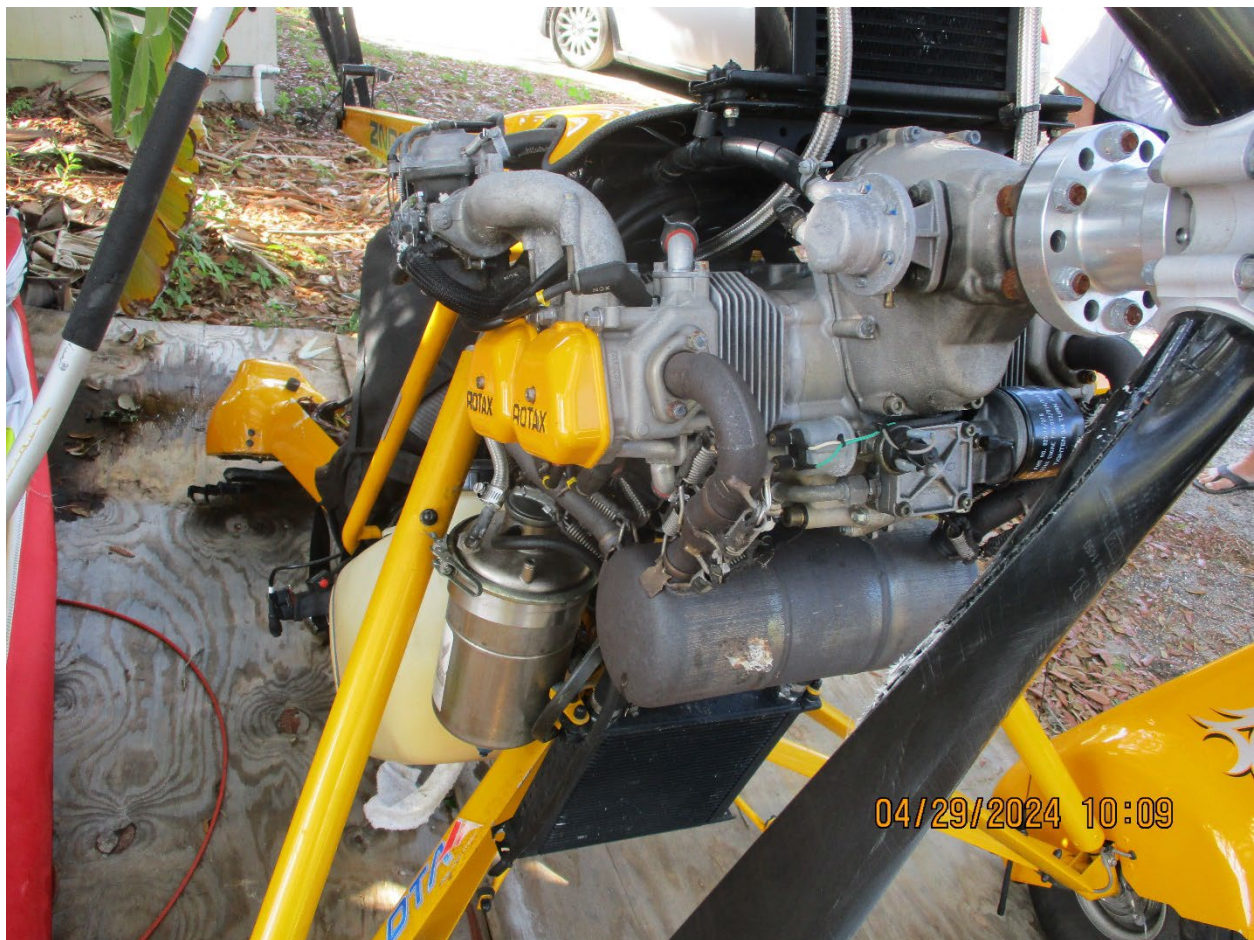
The chip detector was removed, and no metallic particles were observed. The bottom spark plugs were removed, they were clean and clear. The propeller was rotated by hand. The propeller would only rotate about 90° then come to a sudden stop. A lighted boroscope was used on all cylinders. The piston tops, valves and cylinders all appeared normal. When the propeller was rotated. Pistons 1-2-3 moved. Piston No 4 did not move. The rocker covers were removed. No oil was present in any of the rocker covers. The gearbox was removed, no oil was present in the gearbox. The oil pump was removed, it was unremarkable.
