# National Transportation Safety Board

ERA24LA161

## **WRECKAGE EXAMINATION SUMMARY**

Location: Sanford, FL  
Date: March 29, 2024  
Time: 1250 EDT  
1650 UTC  
Airplane: Navion B

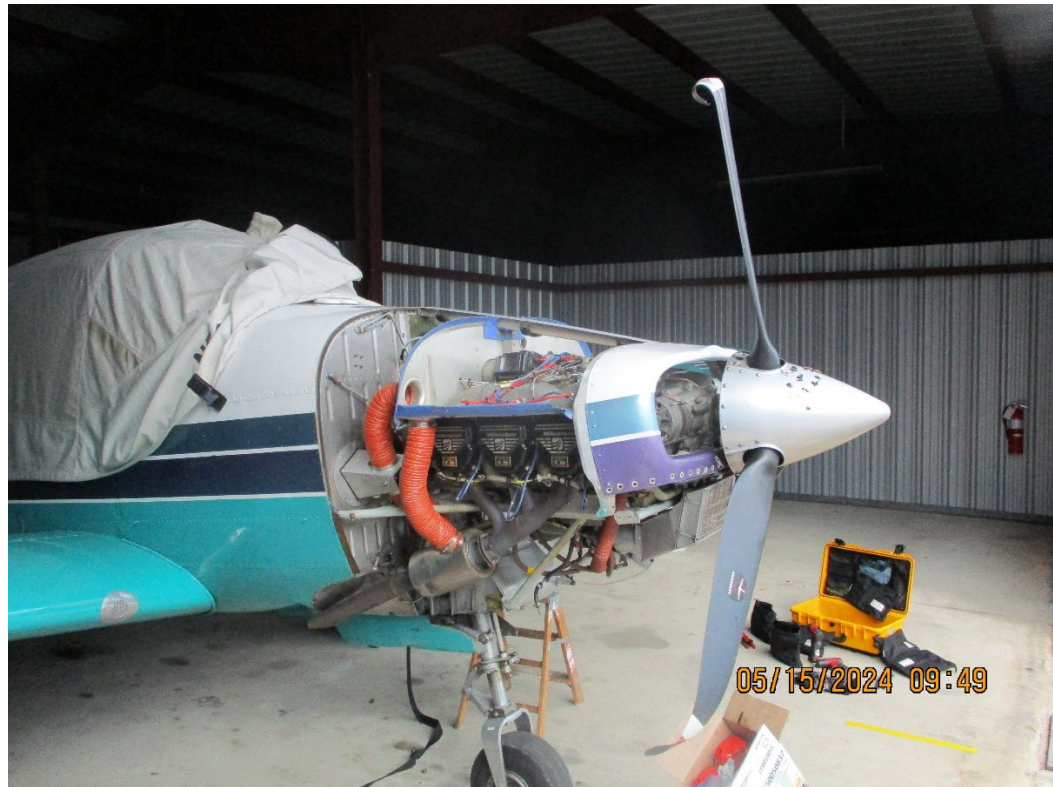
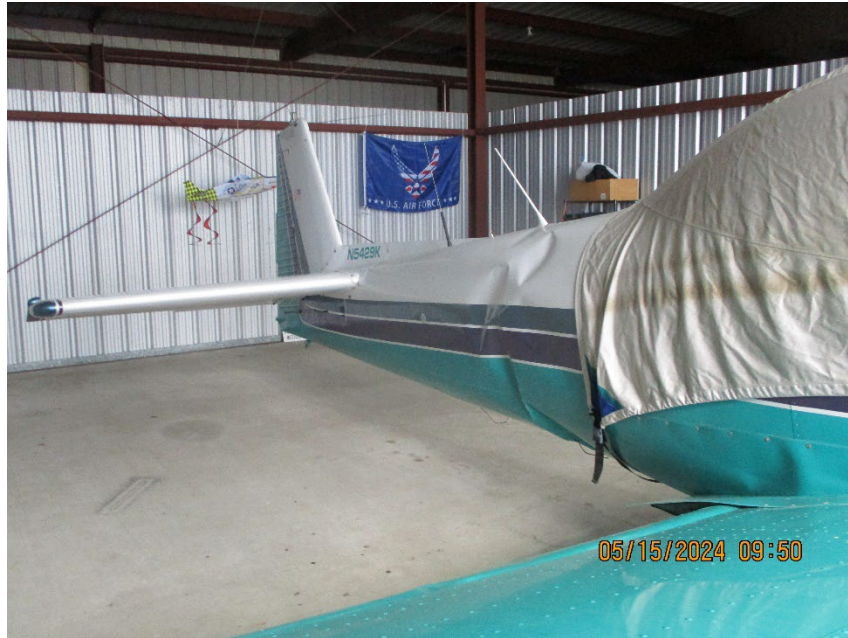
The airplane was first observed at the pilot's hangar at SFB; the airplane was on its landing gear. That empennage was bent from impact forces. The propeller blades were all curled over from contact with the runway. The fuel selector was in the "OFF" position. The electric fuel pump was

in the "OFF" position. The lower cowlings and belly of the airplane were damaged from skidding on the runway. The fuel tanks were stuck with a stick and appear to have about 20 gallons of fuel in the tanks; however, when battery power was applied to the airplane, the fuel gauges were at zero. Also noted was the transfer fuel pump circuit breaker was tripped.

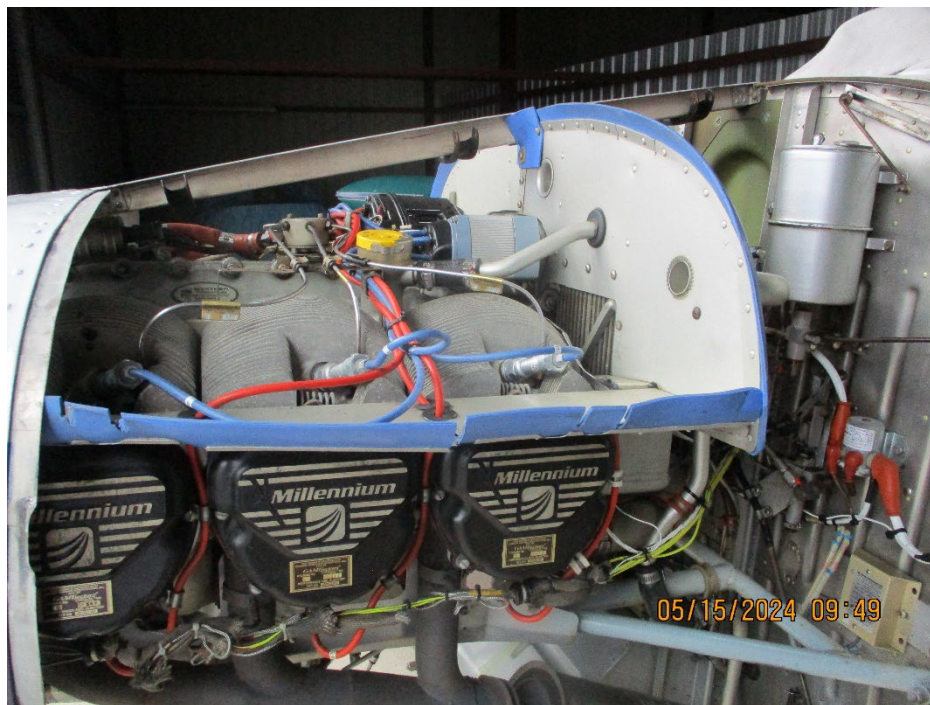
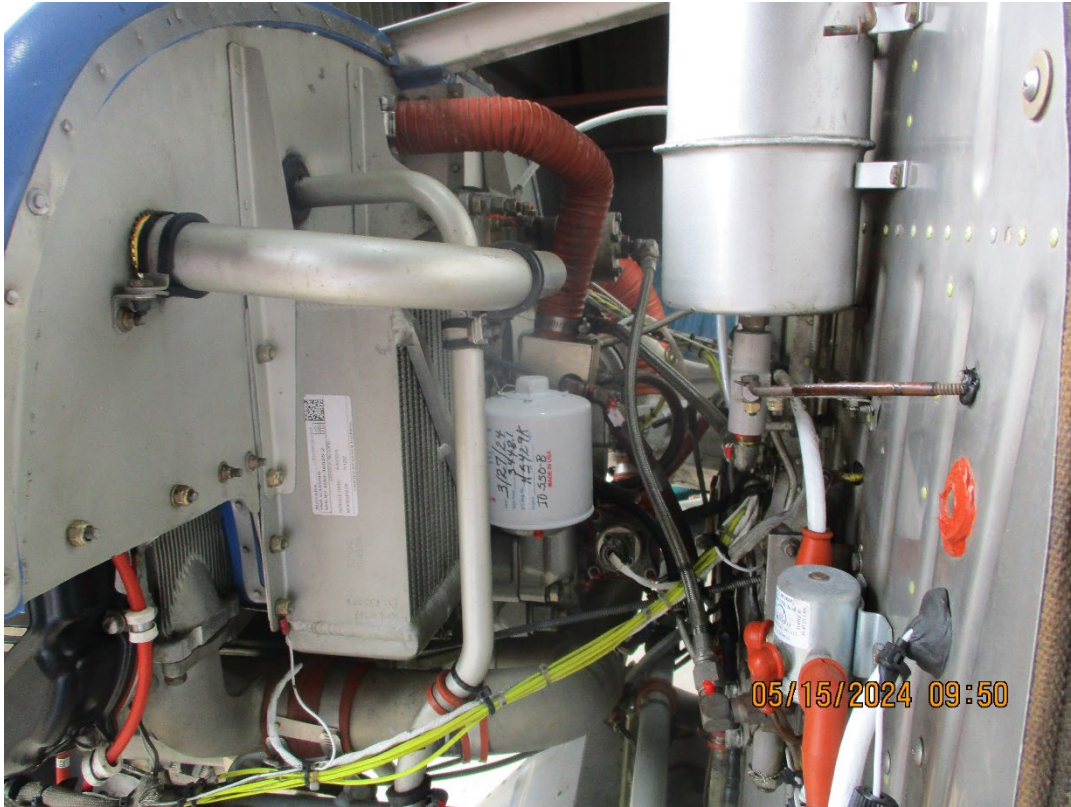
The engine was clean and well kept.

The top spark plugs were removed, and thumb compression was established on all cylinders. A lighted borescope was used on all cylinders and no anomalies noted on the valves, piston top, and cylinder walls. The engine rotated smoothly by the propeller. The fuel line was disconnected at the injector and the electric fuel pump was turned on. Fuel was pumping from the fuel system. The mechanical fuel pump was removed at the spline and verified to be in good condition and not fractured. The right magneto was removed and spun by hand. All leads produced spark. The left magneto was an electronic mag and could not be tested.
