# National Transportation Safety Board

ERA24LA163

## **ON SCENE EXAMINATION REPORT**

Location: Seffner, Florida  
Date: 04/04/2024  
Time: 1537 EDT  
1937 UTC  
Airplane: Evektor Harmony LSA Registration: N469JA

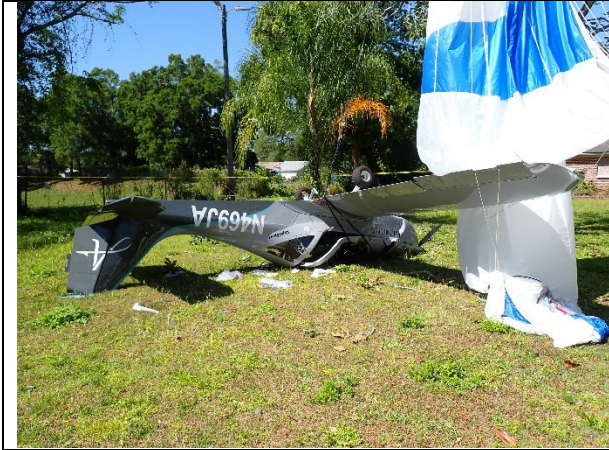
The airplane came to rest inverted next to a large tree in a residential yard. The airplane's whole airplane parachute system had been deployed, and the parachute was caught in the branches of the tree.

Photograph 1: Airplane overview

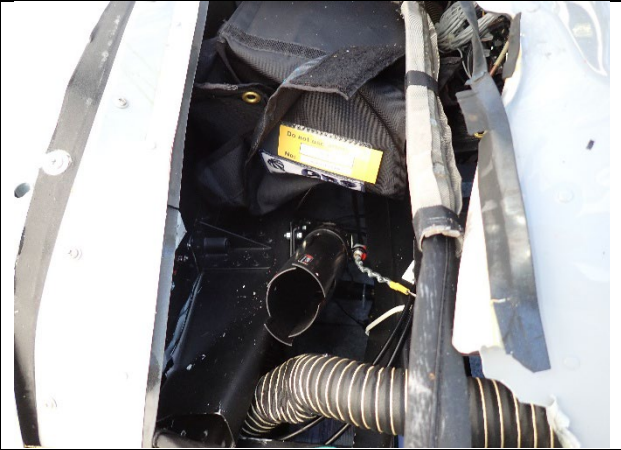
Photograph 2: Whole airplane parachute system rocket launch tube

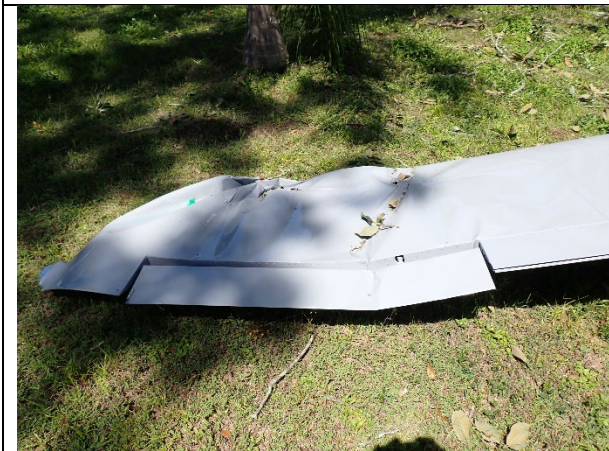
The airframe sustained substantial damage to the fuselage, and to both wings. The whole airframe parachute system (had been deployed and remained secured to the airframe. An examination of the wing attach fittings found that one of the wing attach bolts for the right wing was missing a required securing pin; however, the bolt and nut remained secure to the attach fitting.

Photograph 3: Damage to the right wing

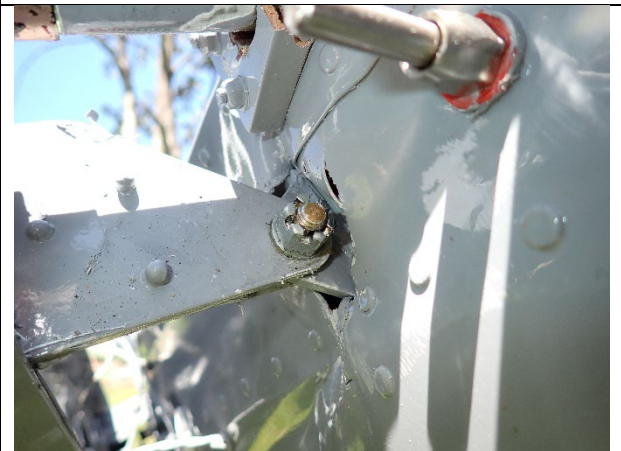
Photograph 4: Right, rear wing attach bolt and nut with missing securing pin

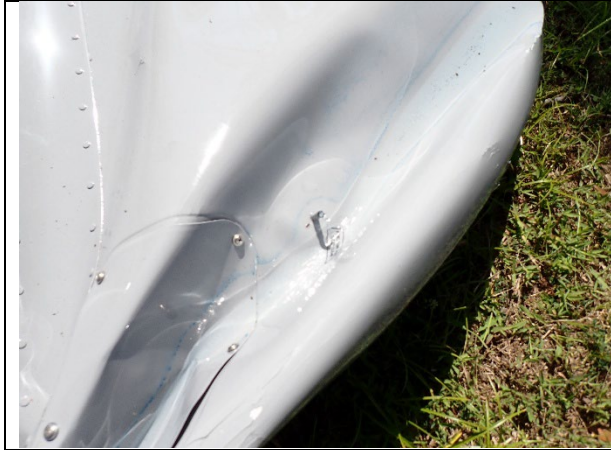
Upon the initial fuel system examination, fluid that had the color and odor consistent of 100LL AvGas was draining out of both of the wing fuel vents. Several gallons of fuel were drained from both wing tanks, and the unmeasured amount of fuel was determined to be sufficient to sustain engine operation. The fuel lines going from the fuel tanks going into the fuselage root were found to be secured and there were no signs of fuel leaks around the fuel tanks or wing root fuel lines.

Photograph 5: Fuel draining from the right fuel vent

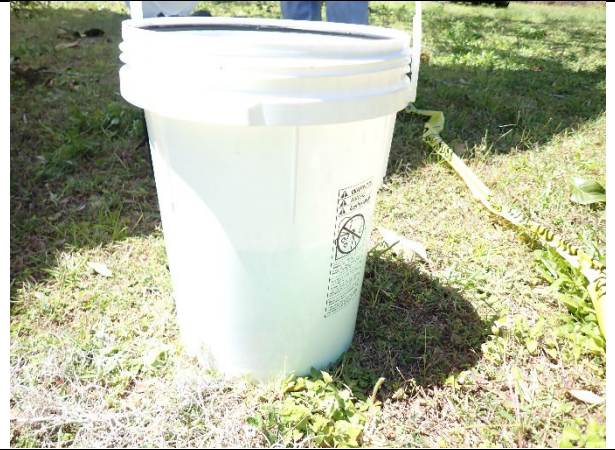
Photograph 6: Fuel drained from airplane

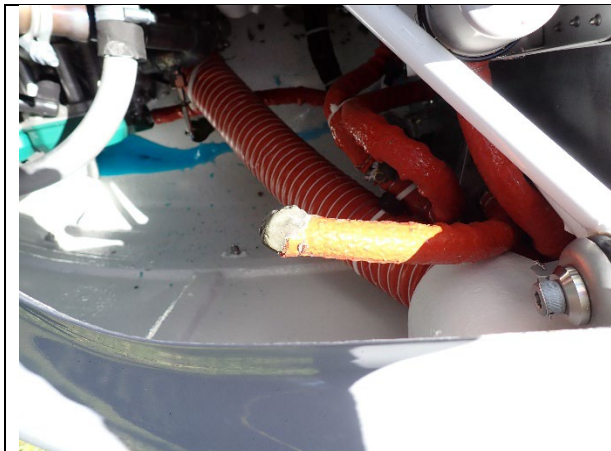
The fuel line going from the fuel pump to the four-way distribution valve was found disconnected and had putty placed on both the disconnected fuel line and on the four-way distribution valve. According to the FAA, the putty was placed by first responders to stop the fuel from leaking out of the fuel line and valve.

Photograph 7: Disconnected fuel line (with putty)

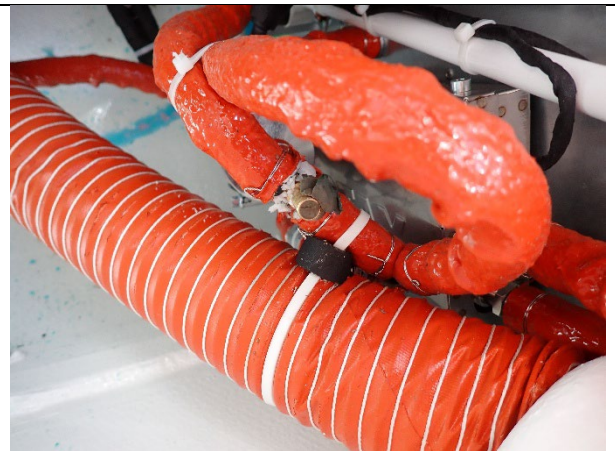
Photograph 8: Four-way distribution valve (with putty at disconnected fitting)

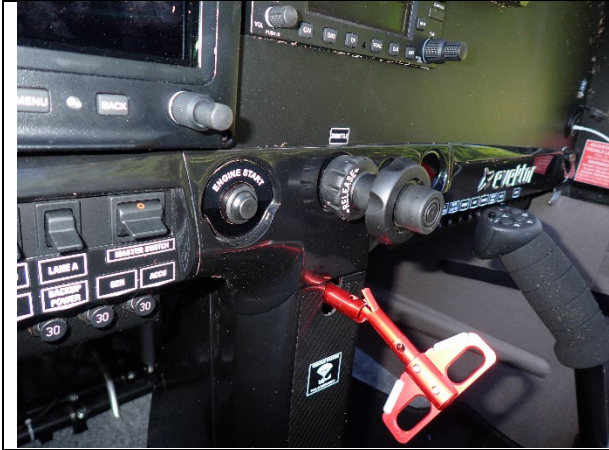
The airplane was flipped over onto its landing gear to facilitate documentation of the cockpit. The flaps were found in the retracted position, the throttle was found in the full forward position, and the emergency whole parachute system handle was in the pulled position. The fuel selector valve was found in the "LEFT" position and was found to be able to move between "LEFT" and "RIGHT" without any signs of binding. All the main electrical switches were found in the "OFF" position except for the guarded "Emergency Switch" which the guard had been put in the open position and the switch was in the "ON" position. None of the circuit breakers were popped. The ELT remained installed and was undamaged; however, both the antenna connector and electrical switch connector were disconnected.

Photograph 9: Whole airplane parachute system handle

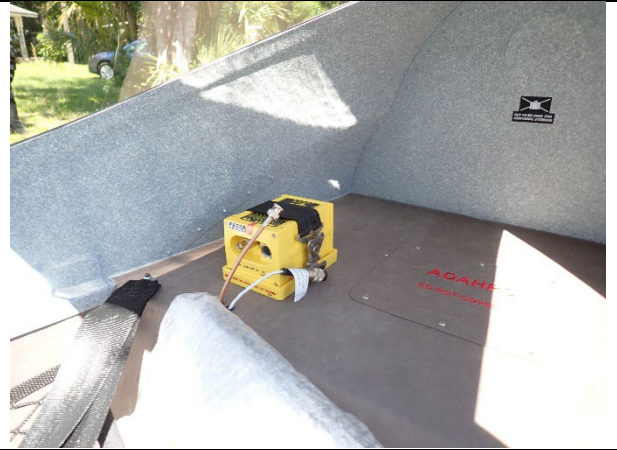
Photograph 10: ELT installed with disconnected wiring
