ERA24LA163

## INVESTIGATION PHOTOGRAPHS

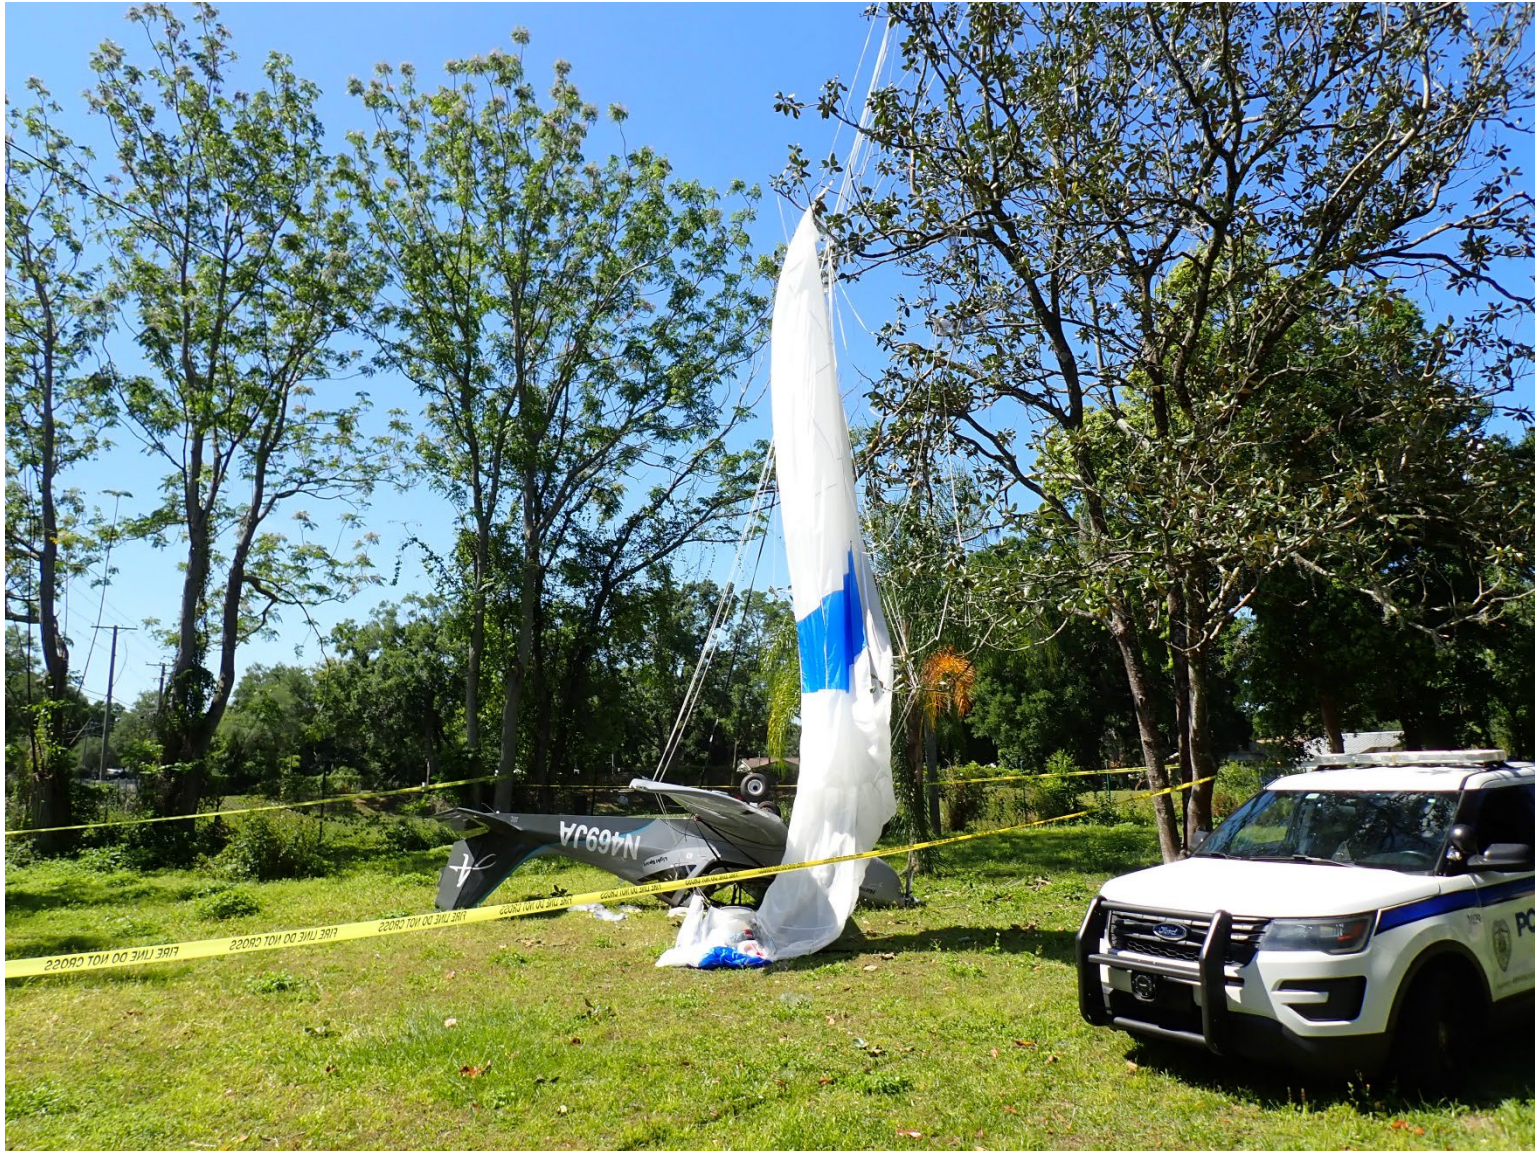
**Photograph 1 – Accident site overview**

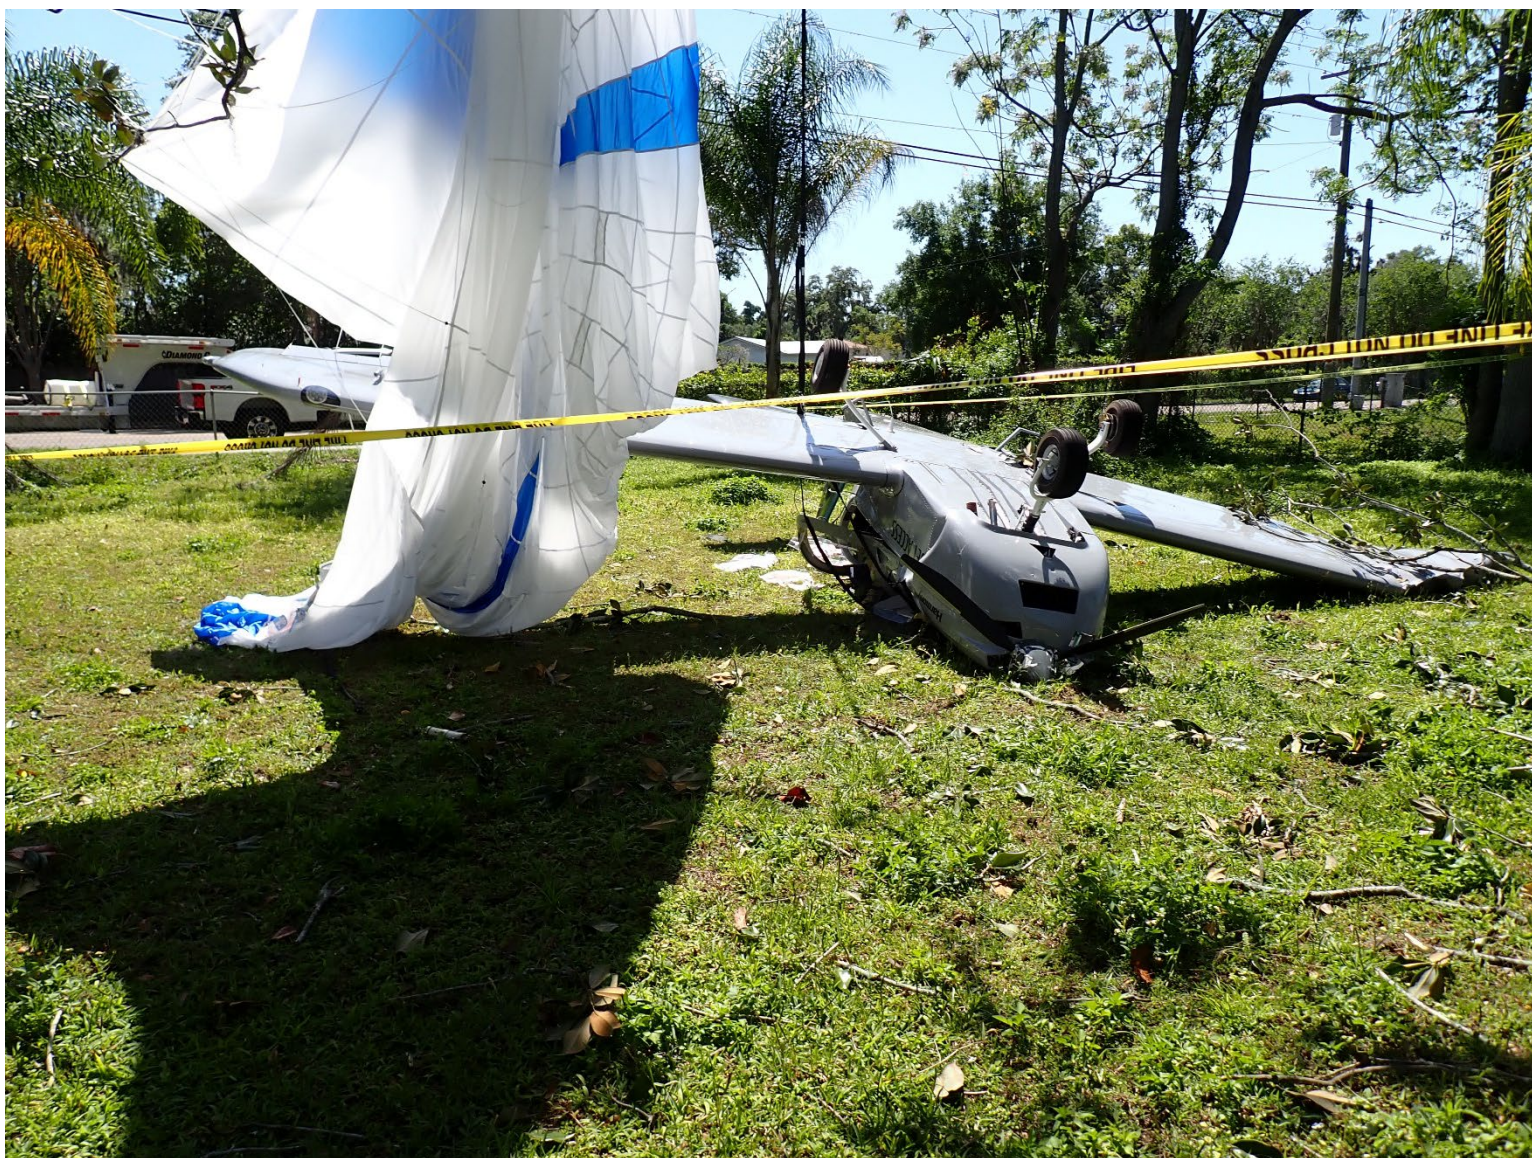
**Photograph 2 – Accident site overview**

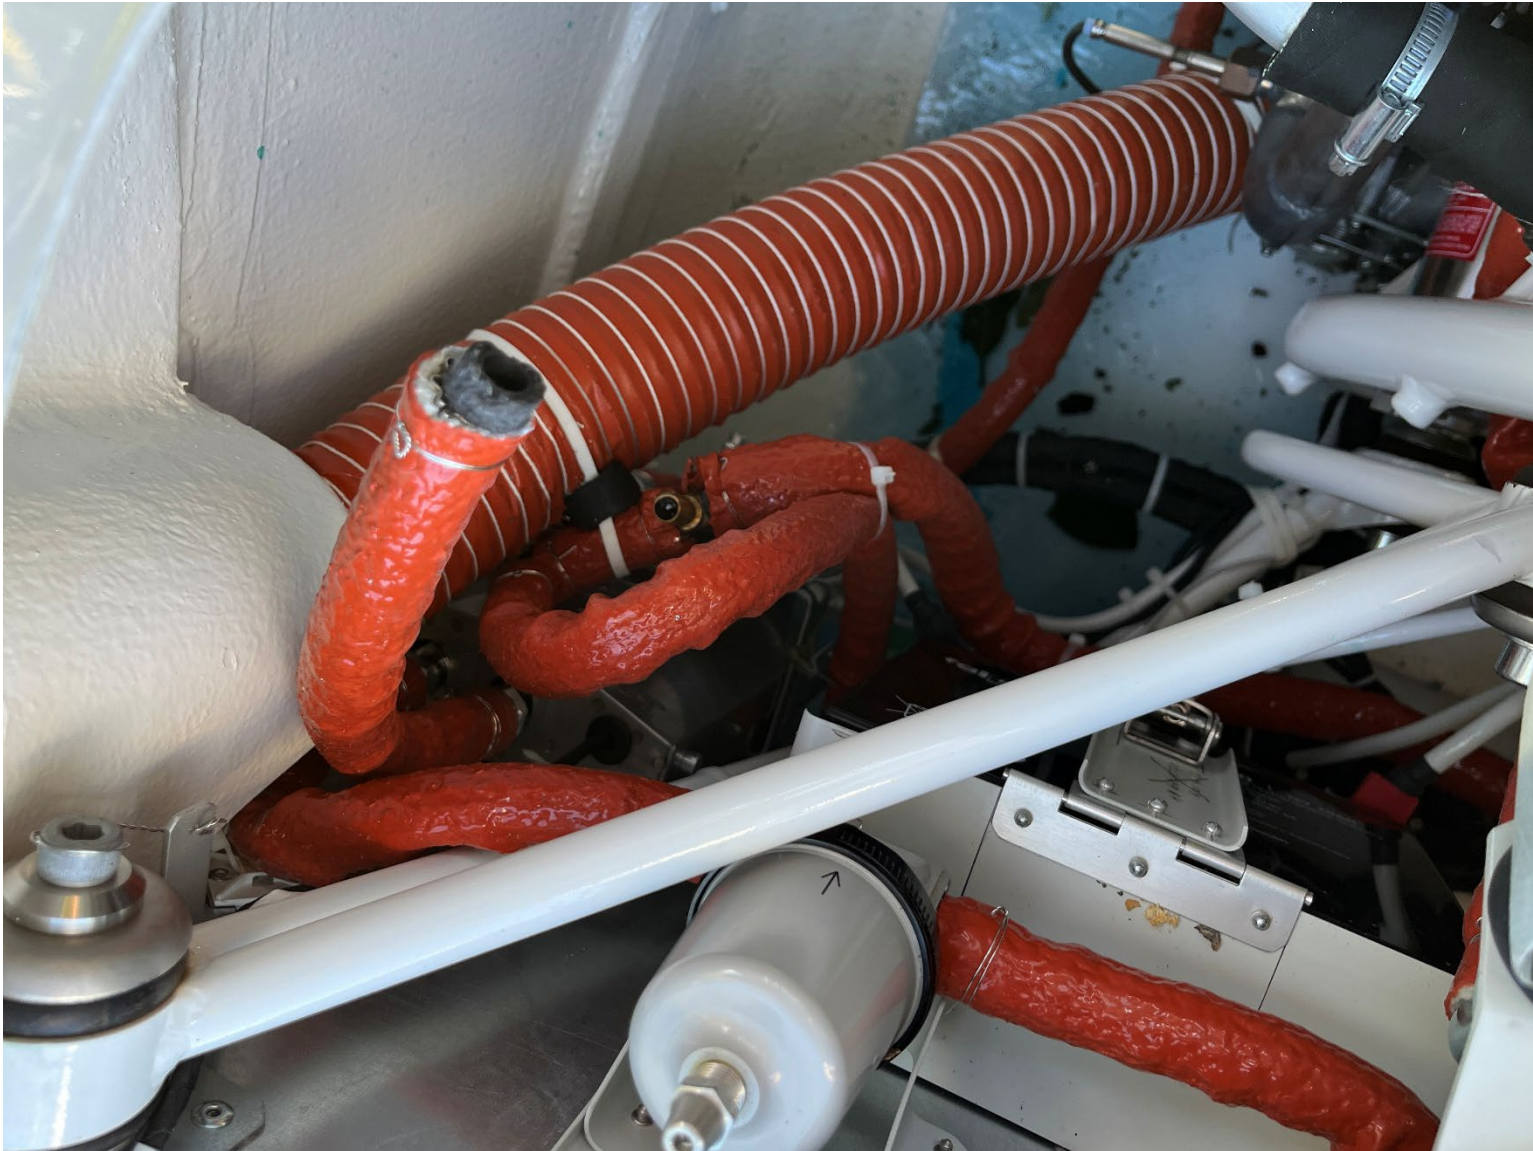
**Photograph 3 – Disconnected fuel line found at the accident site (Courtesy of FAA)**

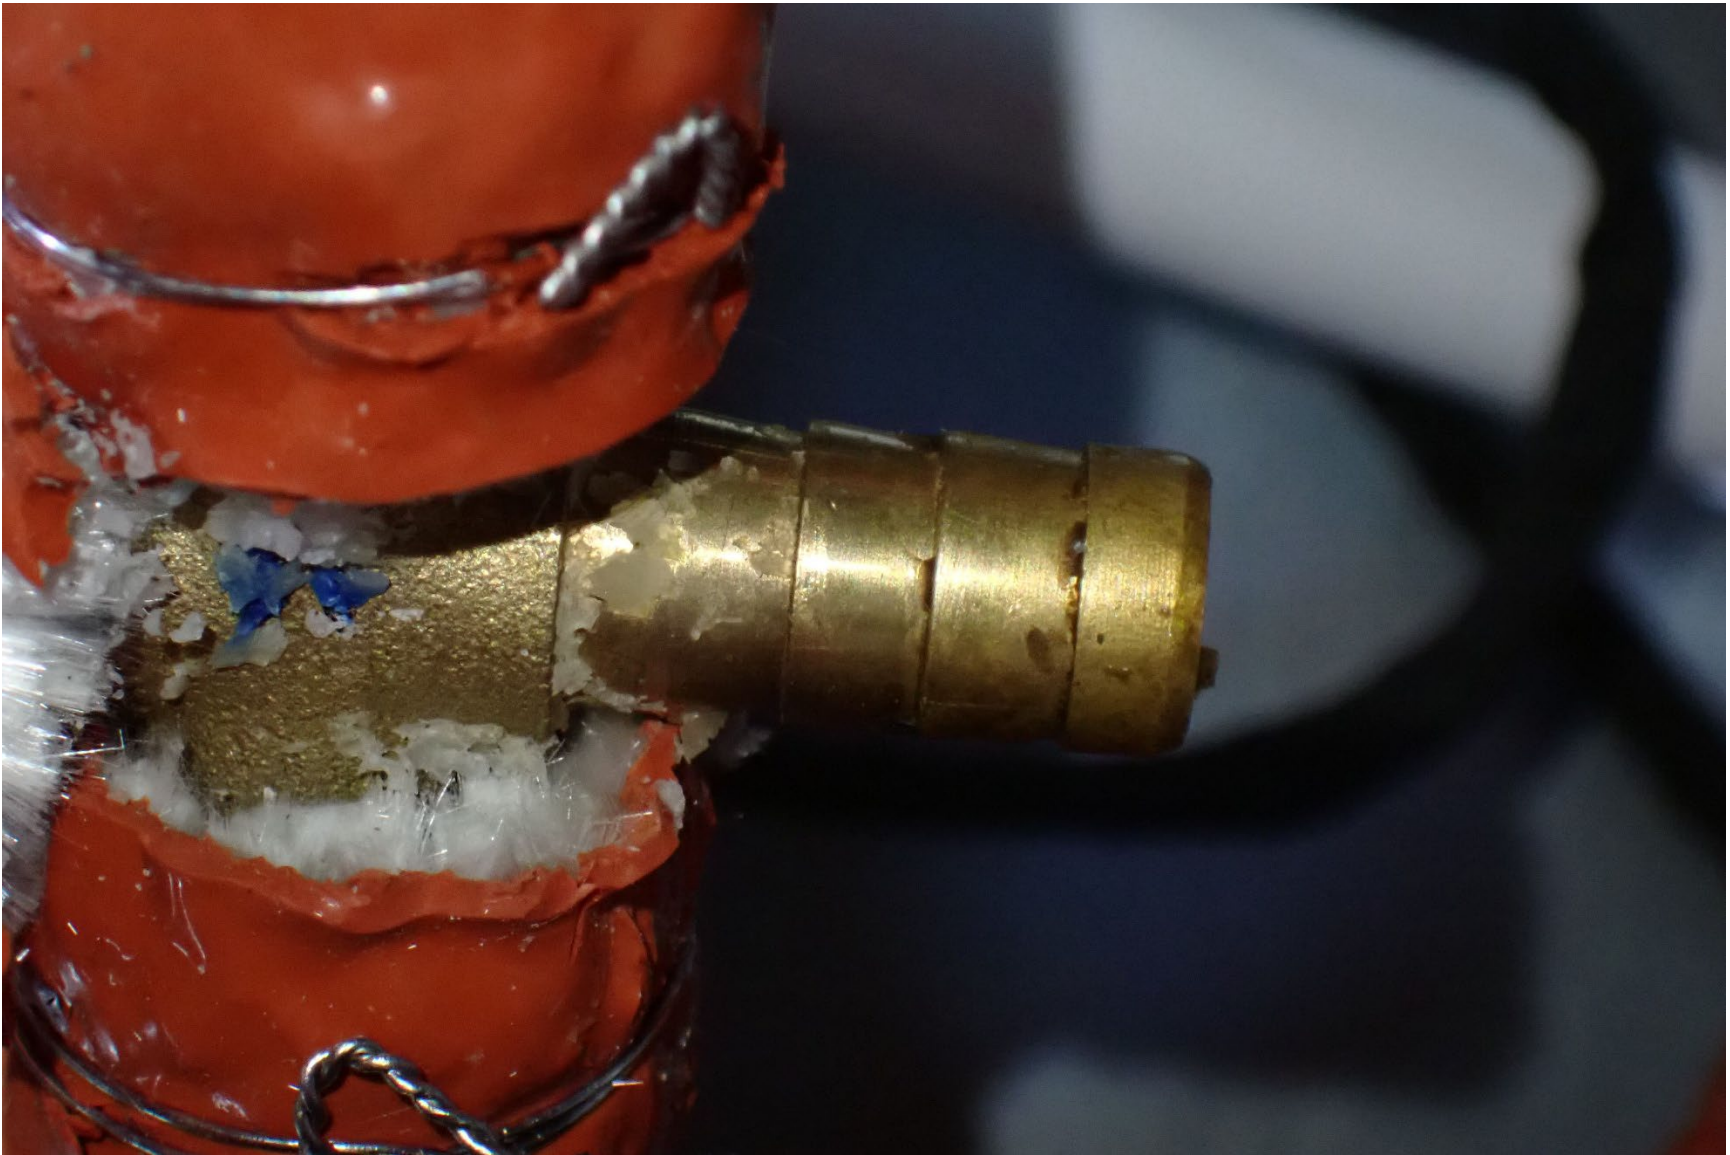
**Photograph 4 – Four-way distributor fitting**

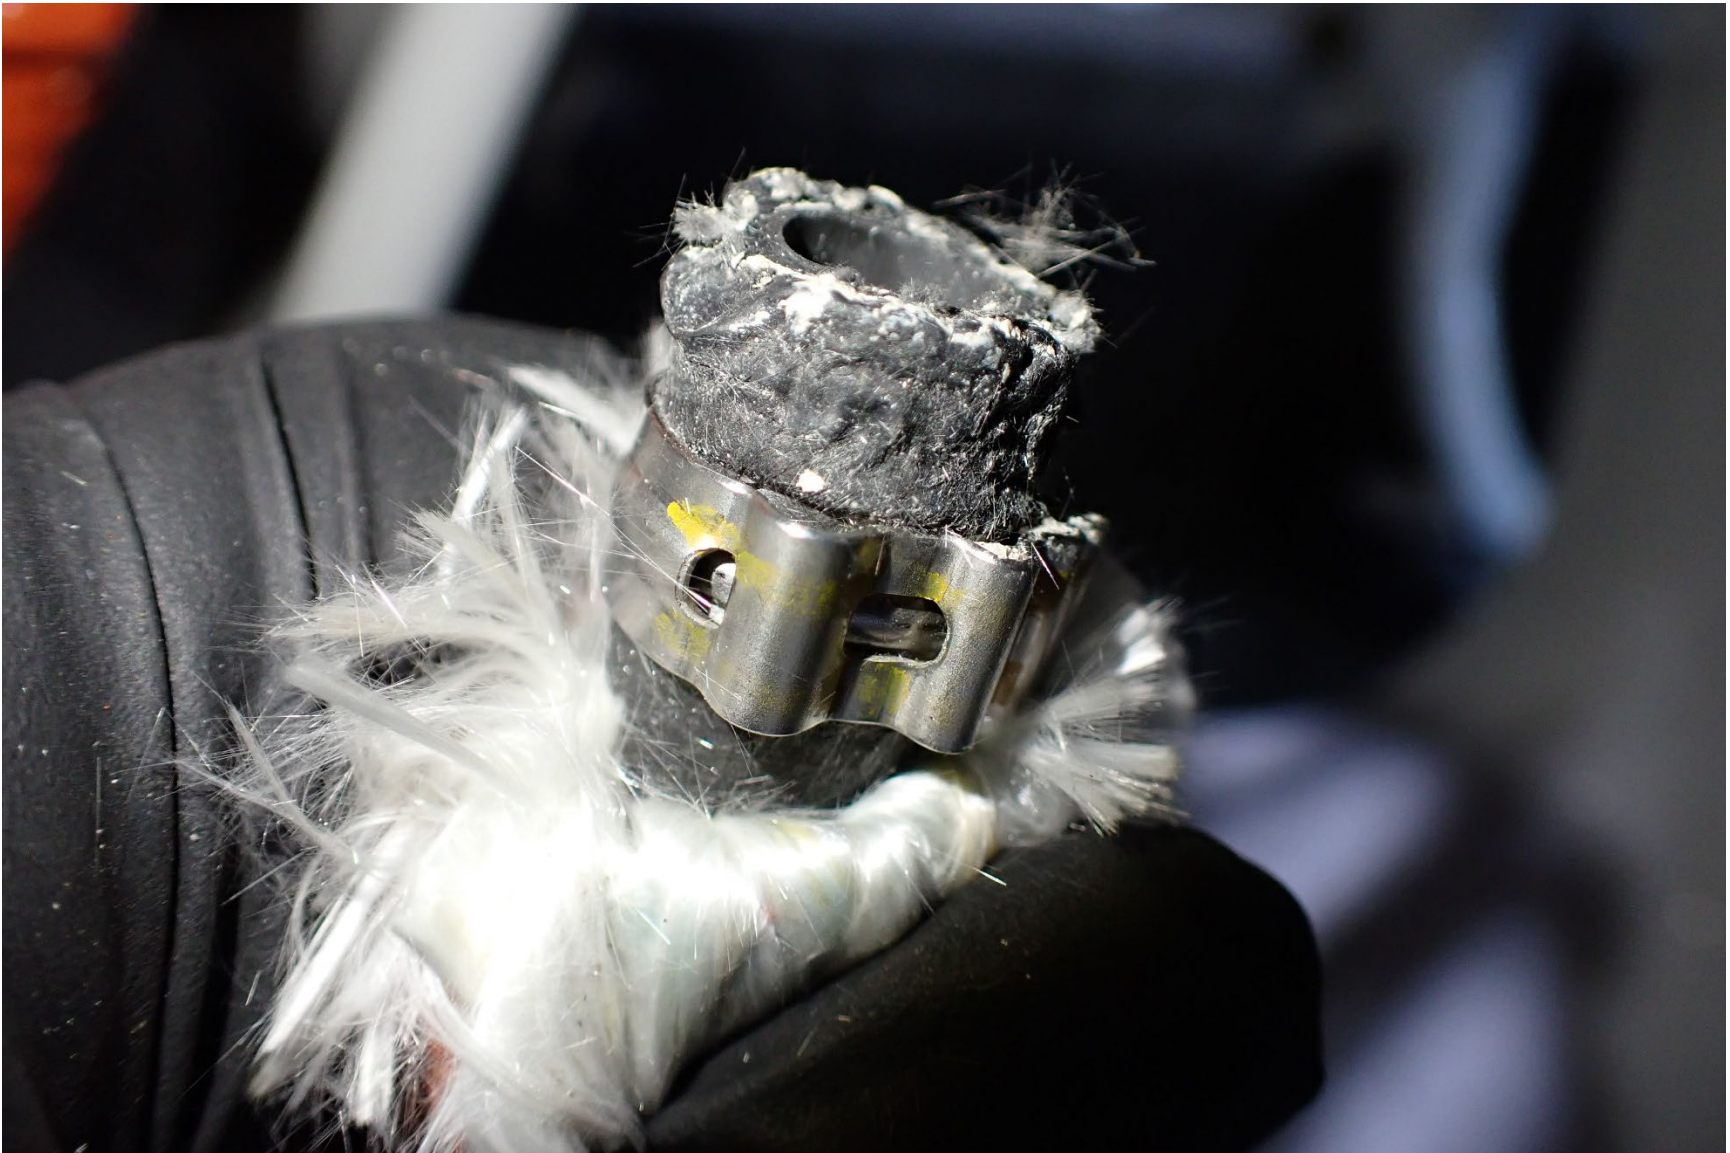
**Photograph 5 – Disconnected fuel line with clamp installed**

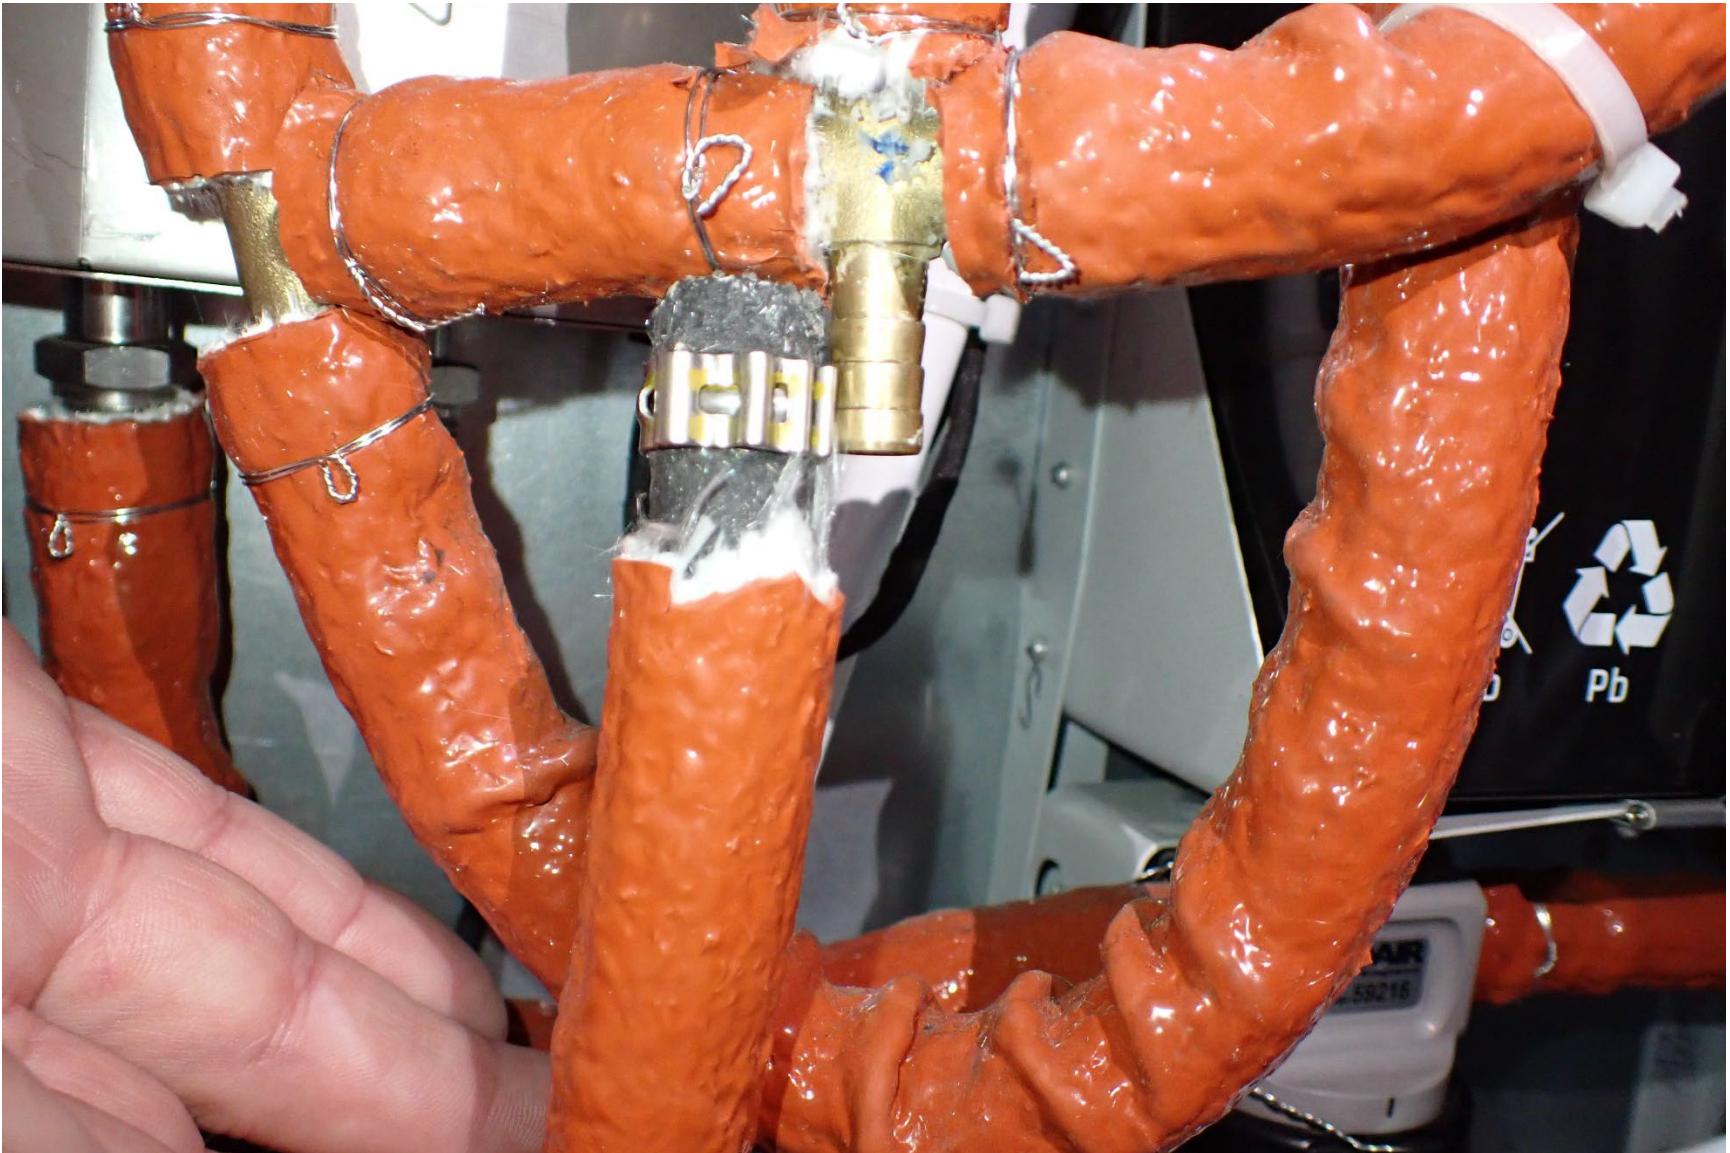
**Photograph 6 – Disconnected fuel line lined up with the four-way distributor**

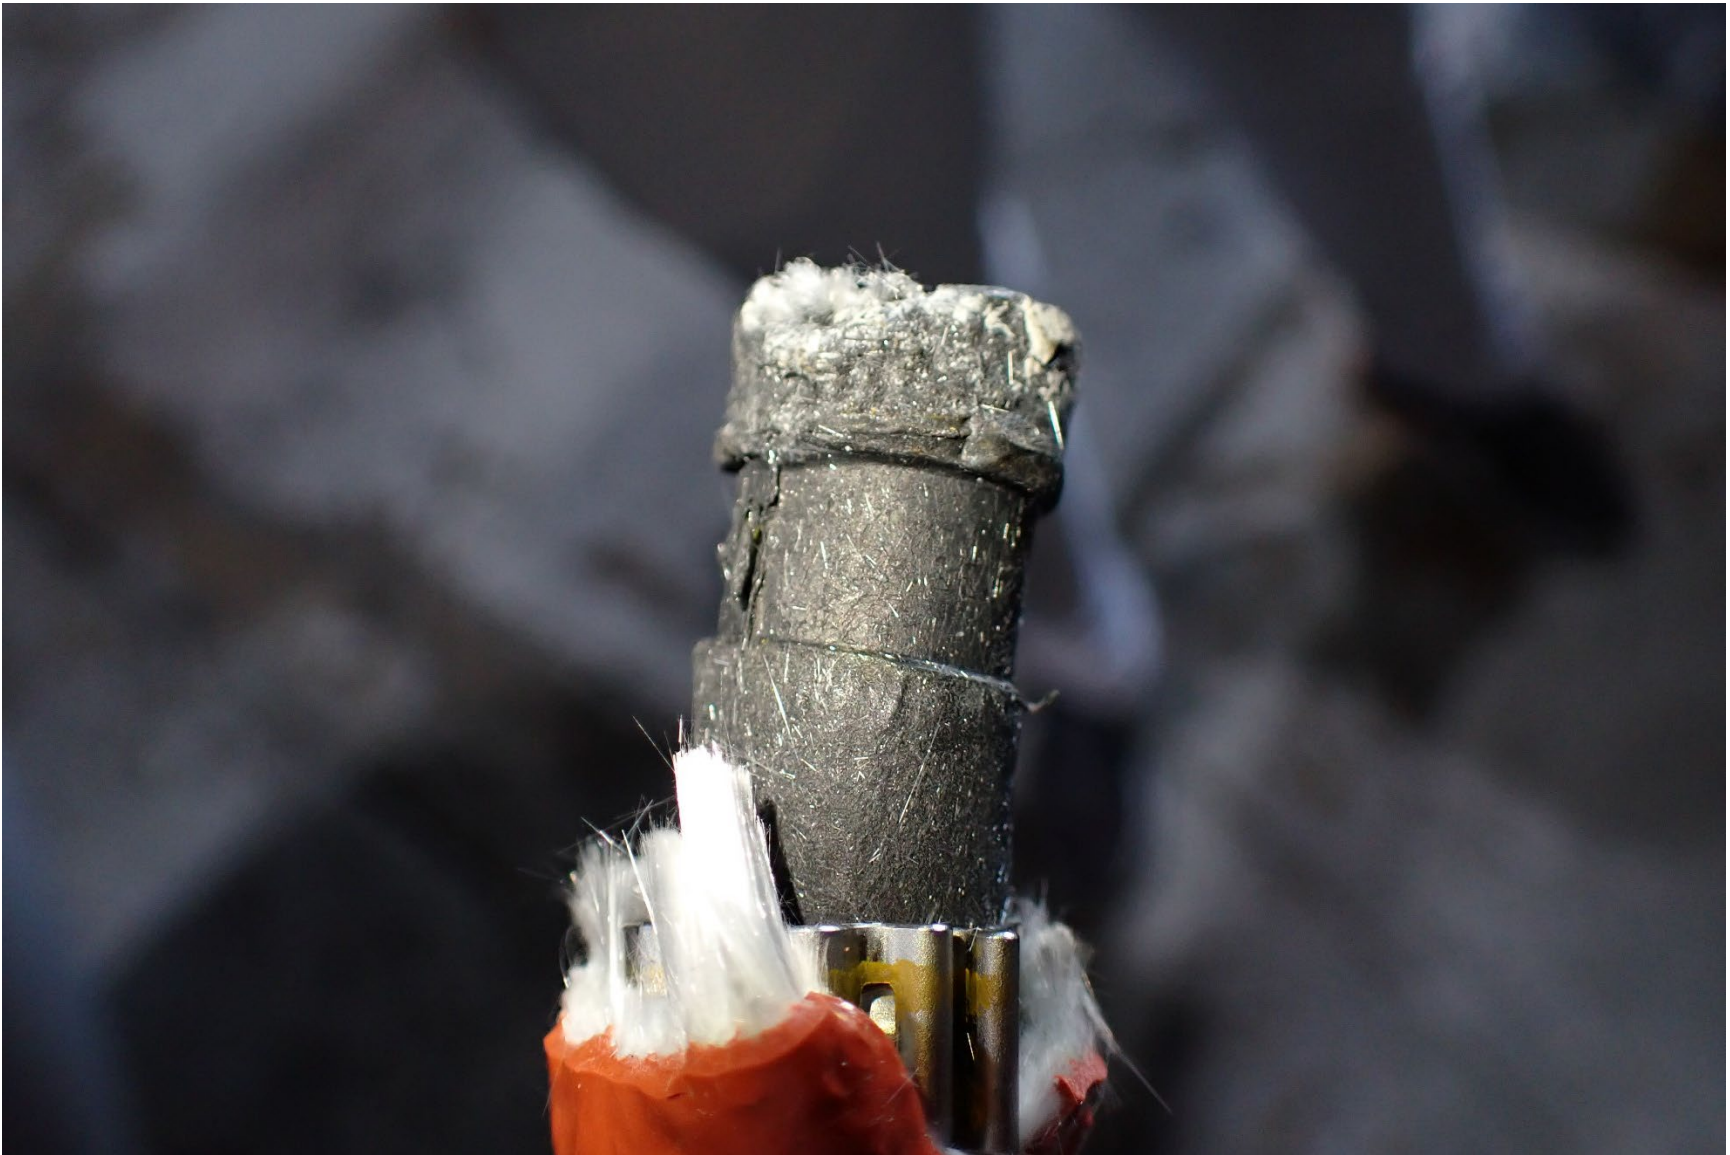
**Photograph 7 – Disconnected fuel line after clamp was moved**

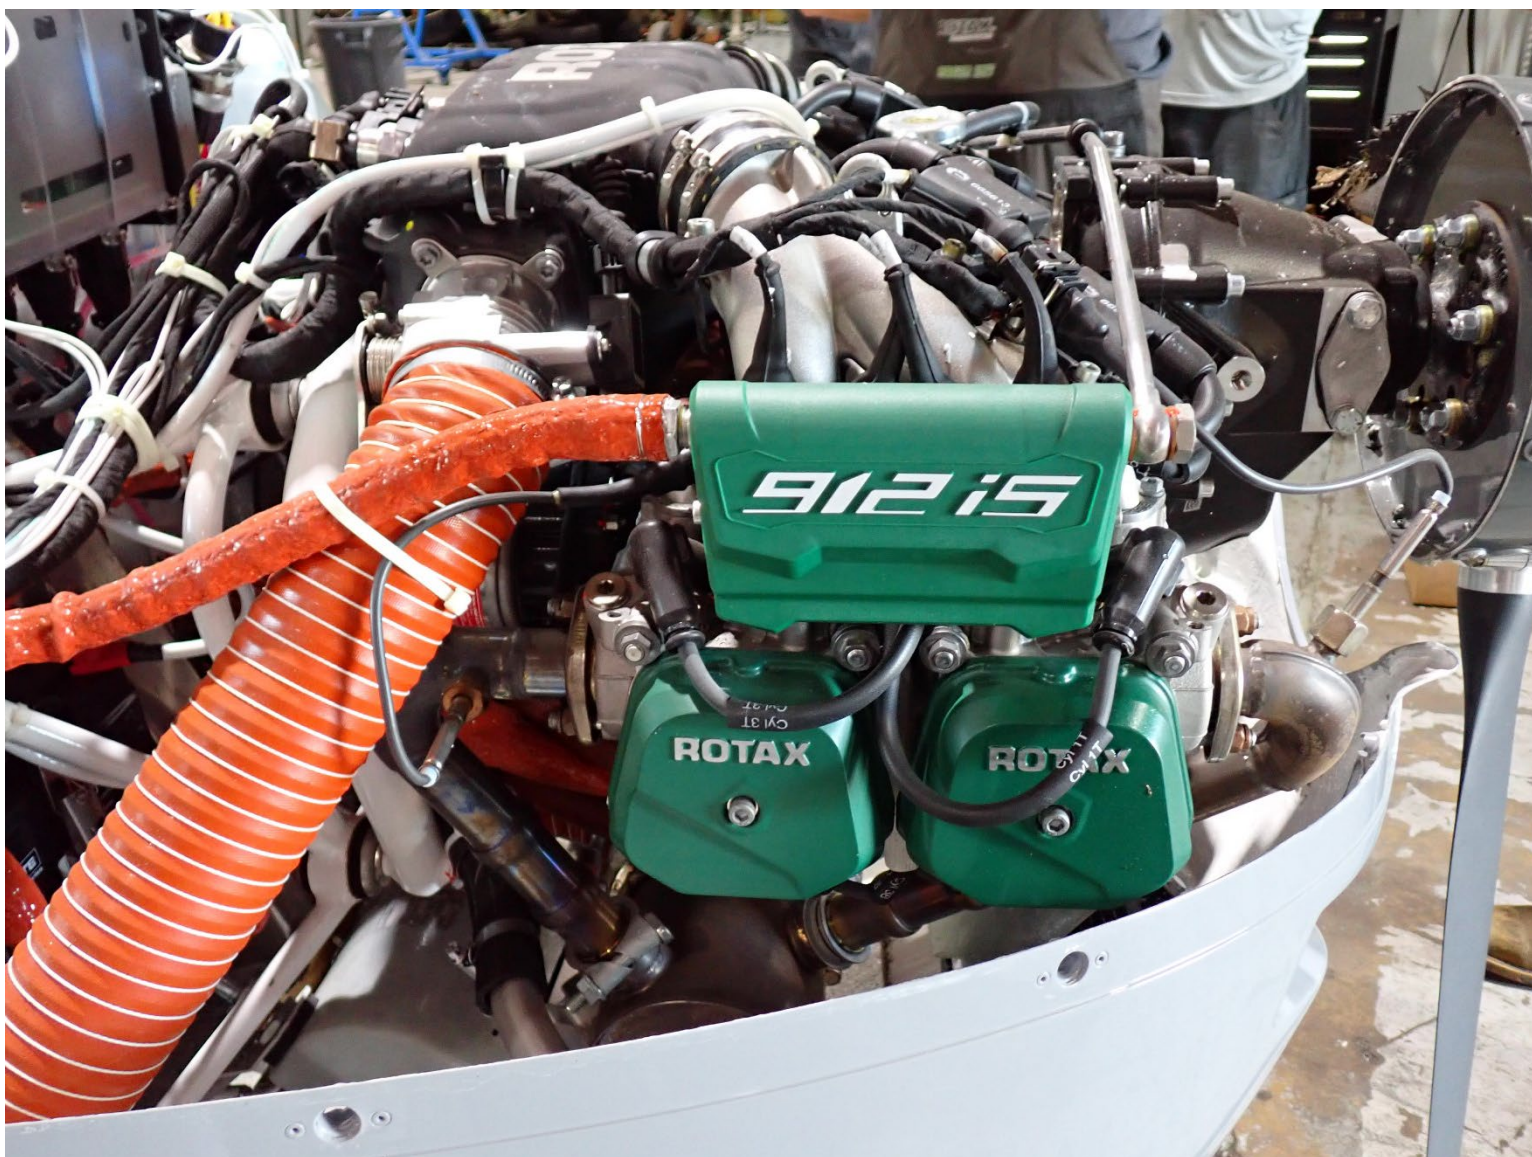
**Photograph 8 – Engine overview**
