# National Transportation Safety Board

ERA24LA163

## WRECKAGE EXAMINATION REPORT

Location: Seffner, Florida  
Date: 04/04/2024  
Time: 1537 EDT  
1937 UTC  
Airplane: Evektor Harmony LSA Registration: N469JA

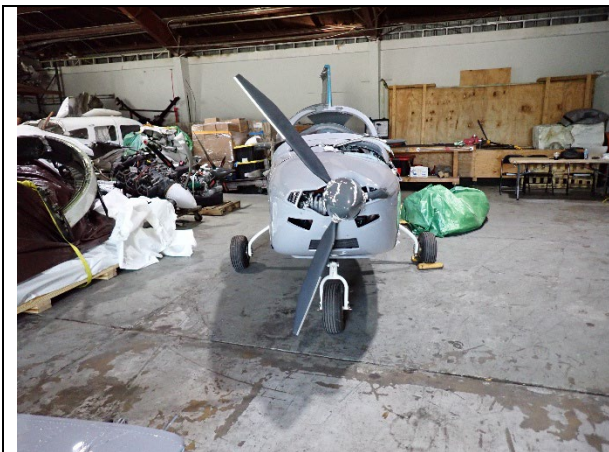
All the major airplane components were observed at the salvage facility. The airframe sustained substantial damage to the rudder, elevator, fuselage, and to both wings.

Photograph 1: Airplane overview

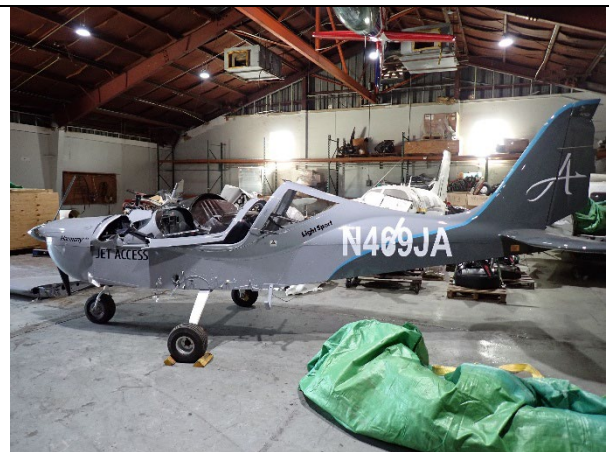
Photograph 2: Airplane overview

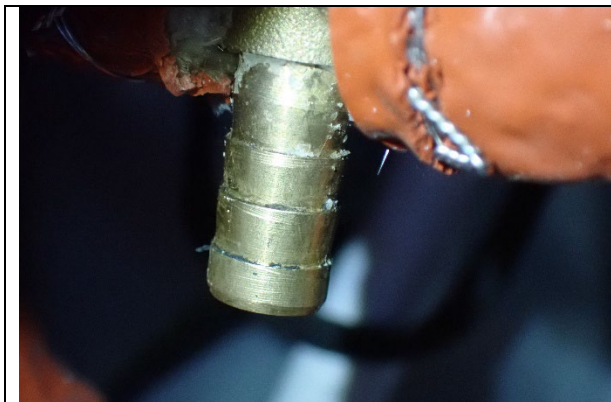
The fuel line at the fuel pump assembly outlet to the four-way fuel distributor was found disconnected at the four-way fuel distributor. The fuel line was reconnected after examination and the engine was test ran at various RPM settings. The disconnected fuel line was the only anomaly observed during the examination that would have precluded normal operation.

Low pressure air was blown into both wing fuel outlet and return lines going to the fuel tank. Both fuel outlet lines and fuel return lines were clear of any blockages. The top engine cowling was removed to facilitate examination of the engine and airframe fuel system. It was observed that the fuel line from the fuel pump assembly outlet going to the four-way fuel distributor was disconnected from the four-way fuel distributor. There were no signs of impact damage to the fuel pump assembly, four-way distributor valve or the fuel line. The fuel line and the four-way fuel distributor had been capped by first responders using putty. The putty was removed from the fuel line and the four-way fuel distributor. The four-way fuel distributor was consistent with the correct part when referencing the Evektor Harmony LSA illustrated parts catalog (IPC) that was current at the time of the examination. The fuel line was visually examined, and the cobra clamp was found to be secured to the fuel hose. The fuel hose was placed adjacent to the four-way fuel distributor end and the clamp appeared to be aligned to the last ridge of the fuel distributor end. The cobra clamp on the disconnected fuel line appeared to have more hose from the clamp to the end of the hose when compared with the other fuel lines that were connected to the four-way fuel distributor. The clamp was removed, and the indentation of the fuel hose was consistent with the clamp being compressed the correct amount. The fuel line was reinstalled and secured with a new clamp.

Photograph 3: Four-way fuel distribution valve

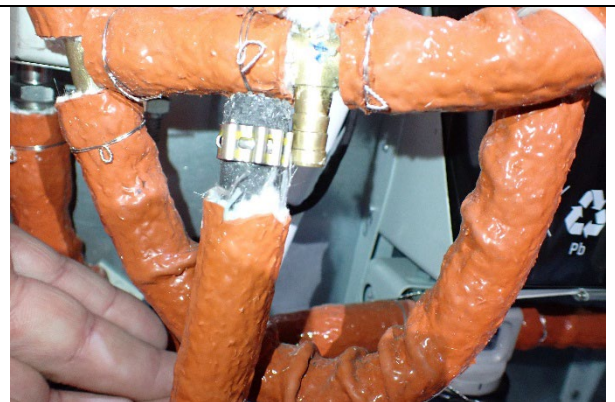
Photograph 4: Disconnected fuel line lined up with the four-way distribution valve

The fuel system was inspected for condition, correct installation, and proper routing. The airframe fuel line that connects the outlet of the electric fuel pumps to the four-way distributor valve was found disconnected. The fuel pumps were function tested and found to be operational. The disconnected fuel line was reinstalled onto the fuel pump, and the entire fuel system was function tested during the test run.

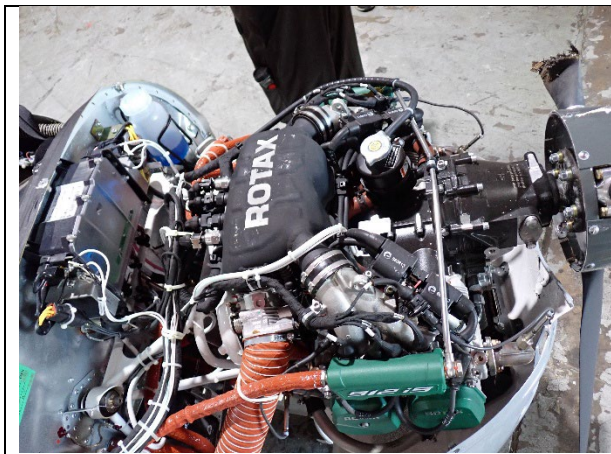
The engine remained attached to the airframe and there were no signs of impact damage to the engine.

Photograph 5: Engine overview

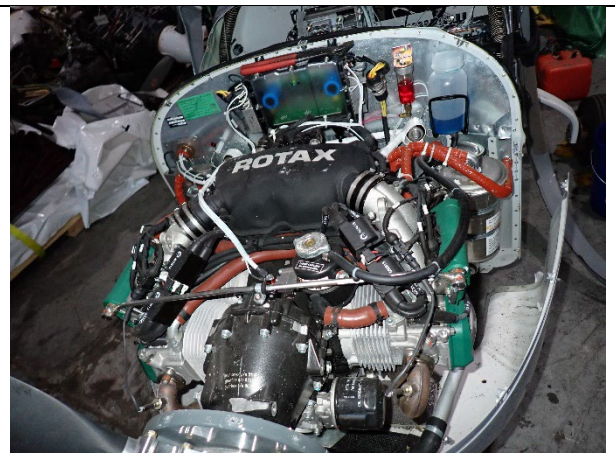
Photograph 6: Engine overview

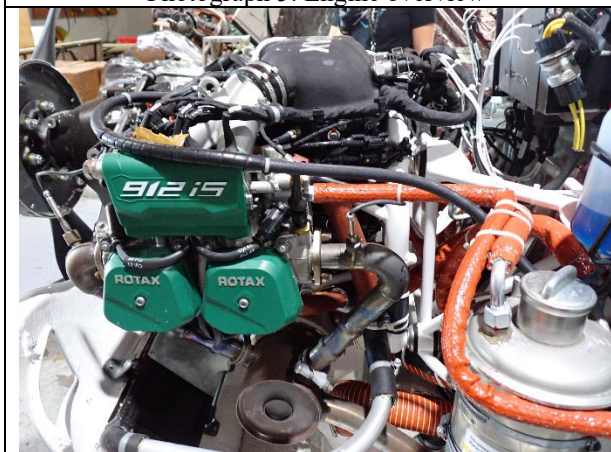
Photograph 7: Engine overview (left side)

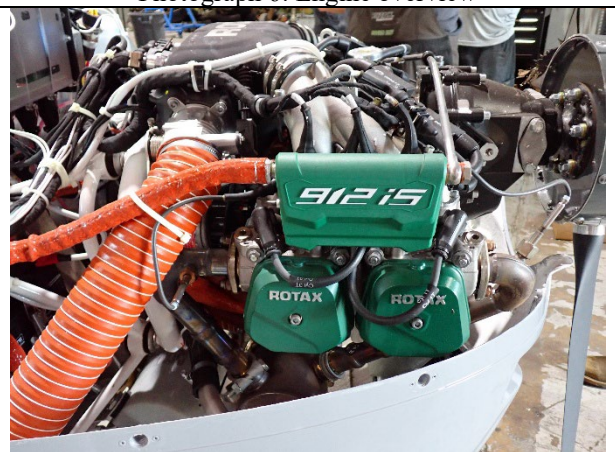
Photograph 8: Engine overview (right side)
