ERA24LA164

## INVESTIGATION PHOTOGRAPHS

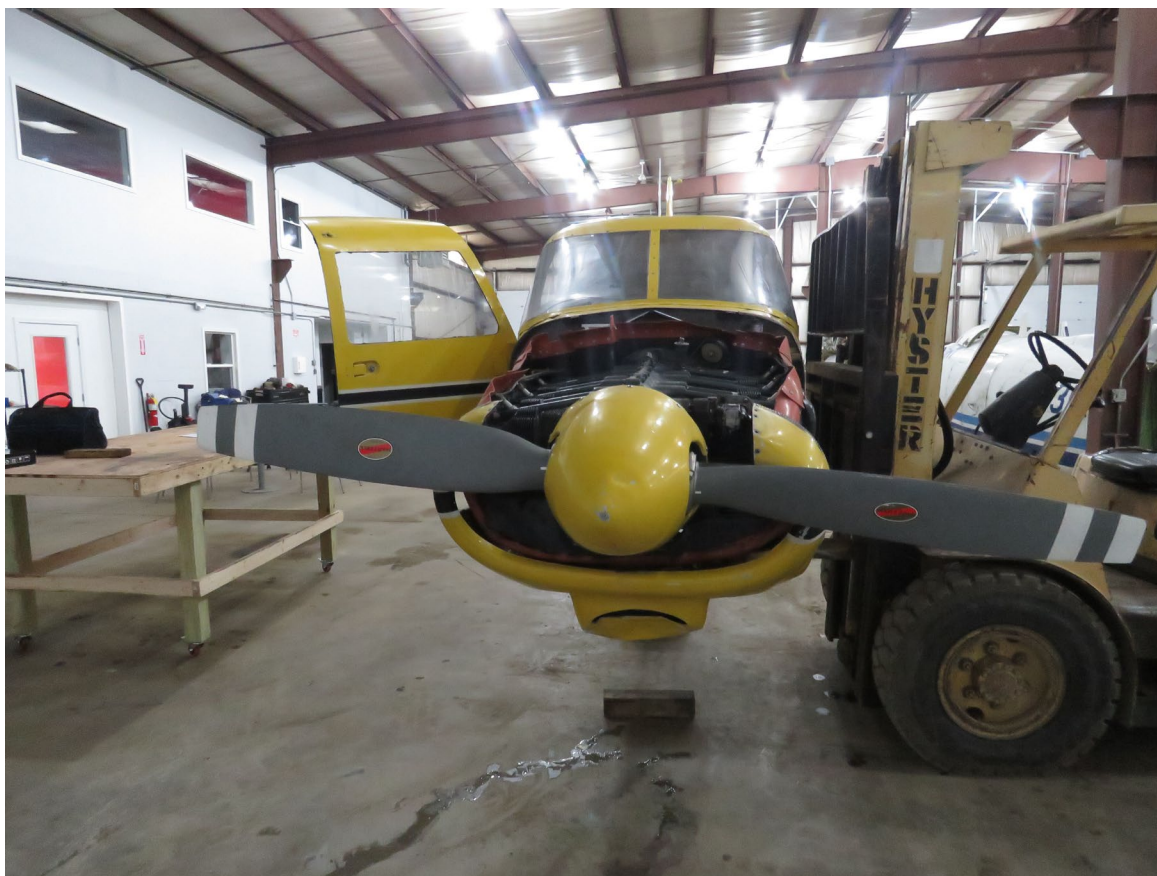
**Photograph 1 - Frontal View of the Fuselage Following Recovery (Courtesy of Lycoming)**

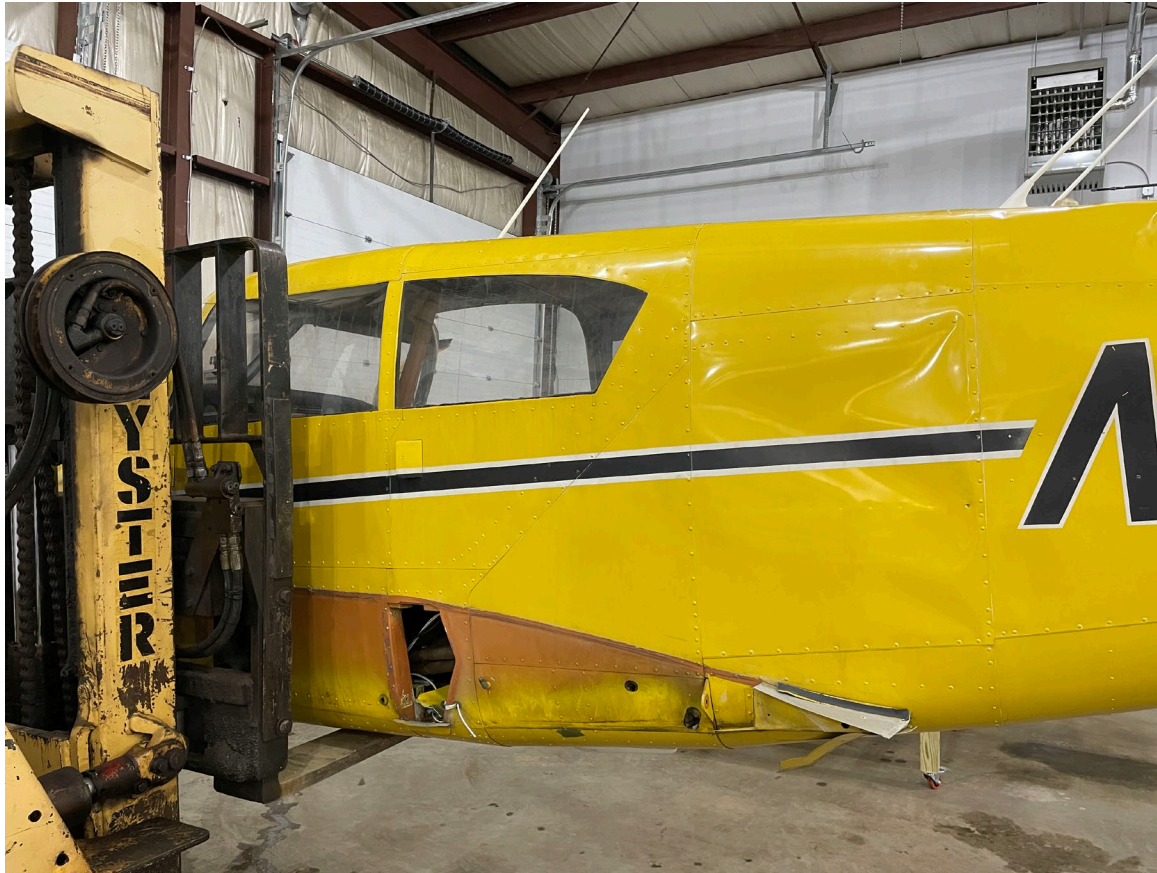
**Photograph 2 - Left Side View of Aft Fuselage. Note large Dent (Courtesy of FAA)**

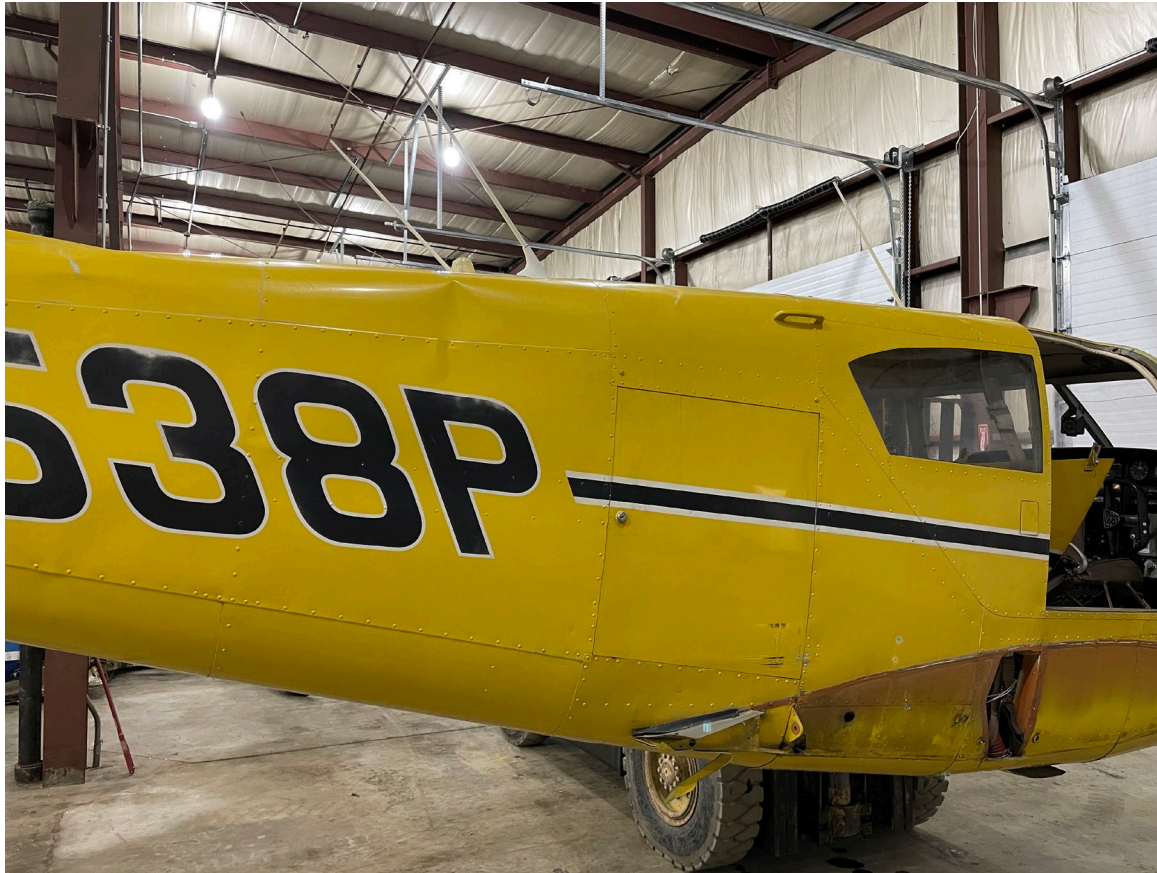
**Photograph 3 - Right Side of Aft Fuselage. Note Compression Wrinkle in Fuselage Skin  
(Courtesy of FAA)**

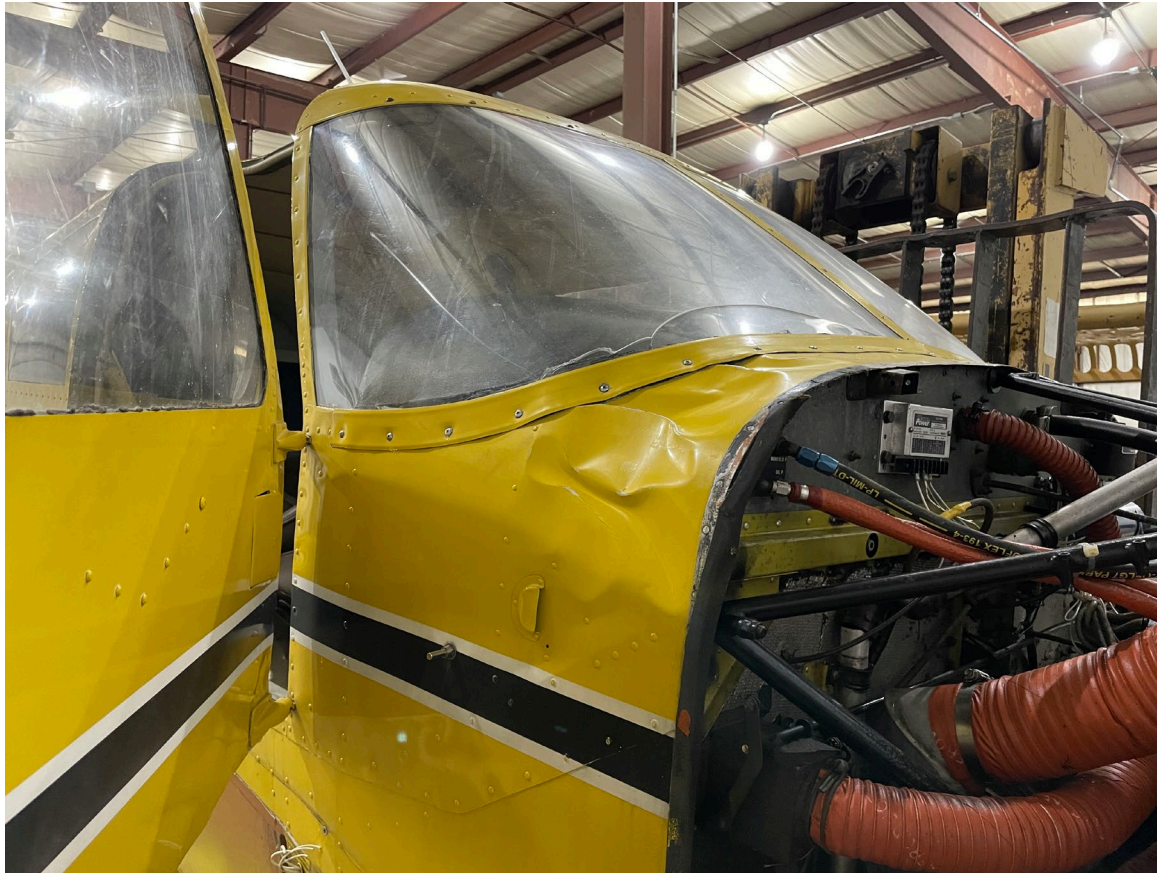
**Photograph 4 - Right Forward Quartering View of the Forward Fuselage. Note the Extensive Skin Damage Aft of the Firewall (Courtesy of FAA)**

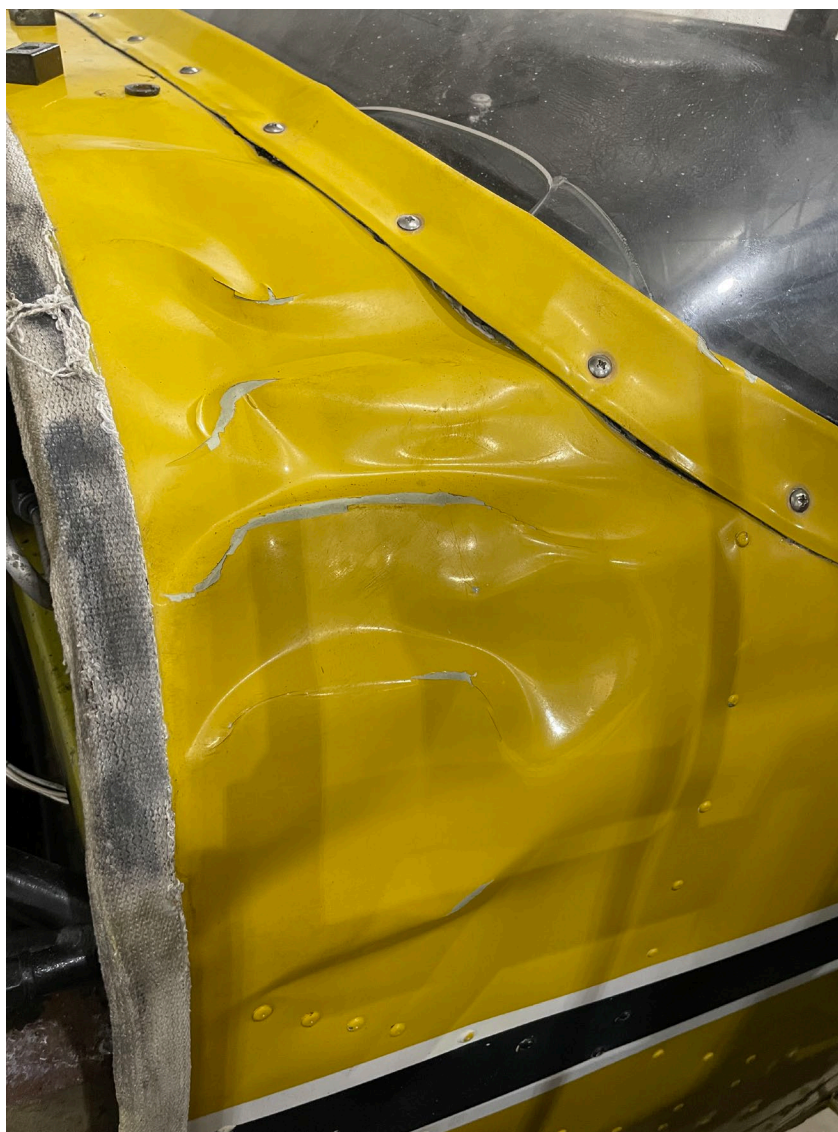
**Photograph 5 - Left Side View of the Forward Fuselage. Noted the Extensive Skin Damage Aft of the Firewall (Courtesy of FAA)**

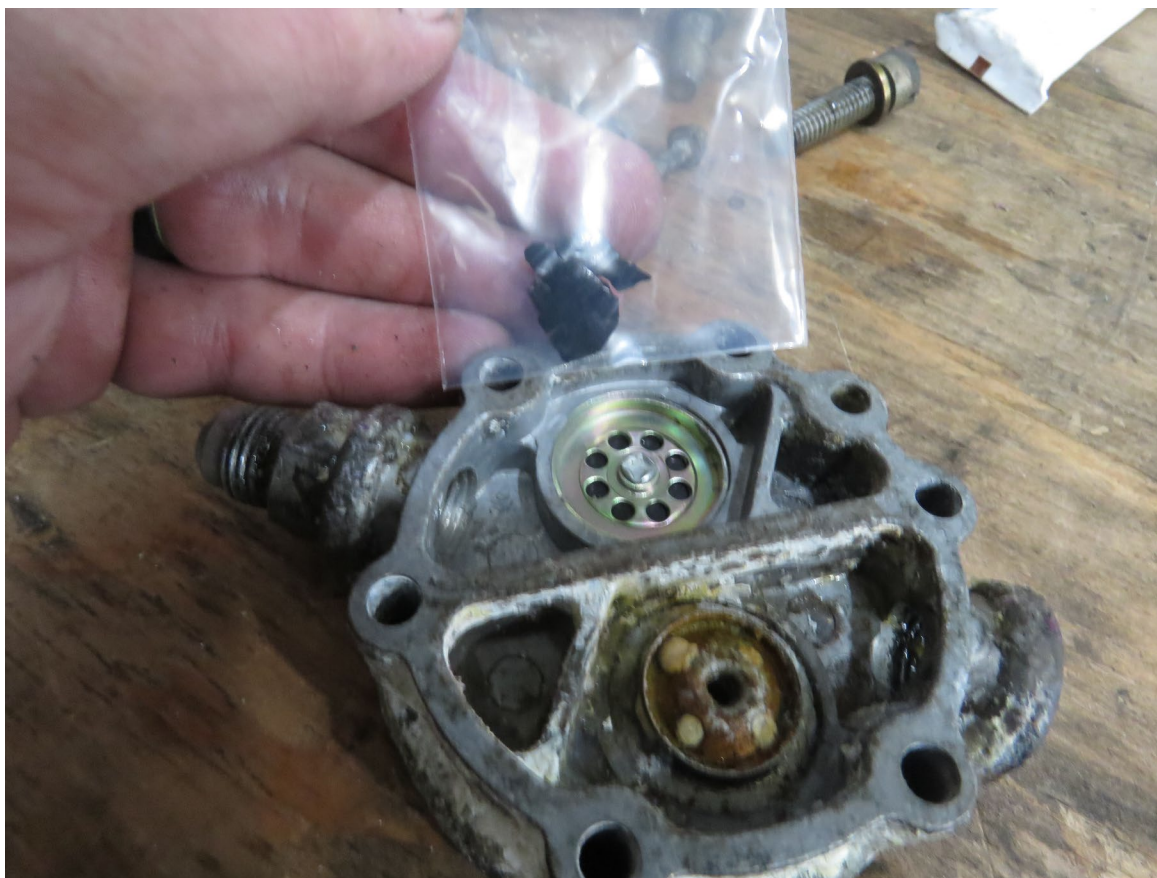
**Photograph 6 - View of the Disassembled Engine-Driven Fuel Pump Showing the Foreign Object Found Inside the Pump (Courtesy of Lycoming)**
