ERA24LA165

## INVESTIGATION PHOTOGRAPHS

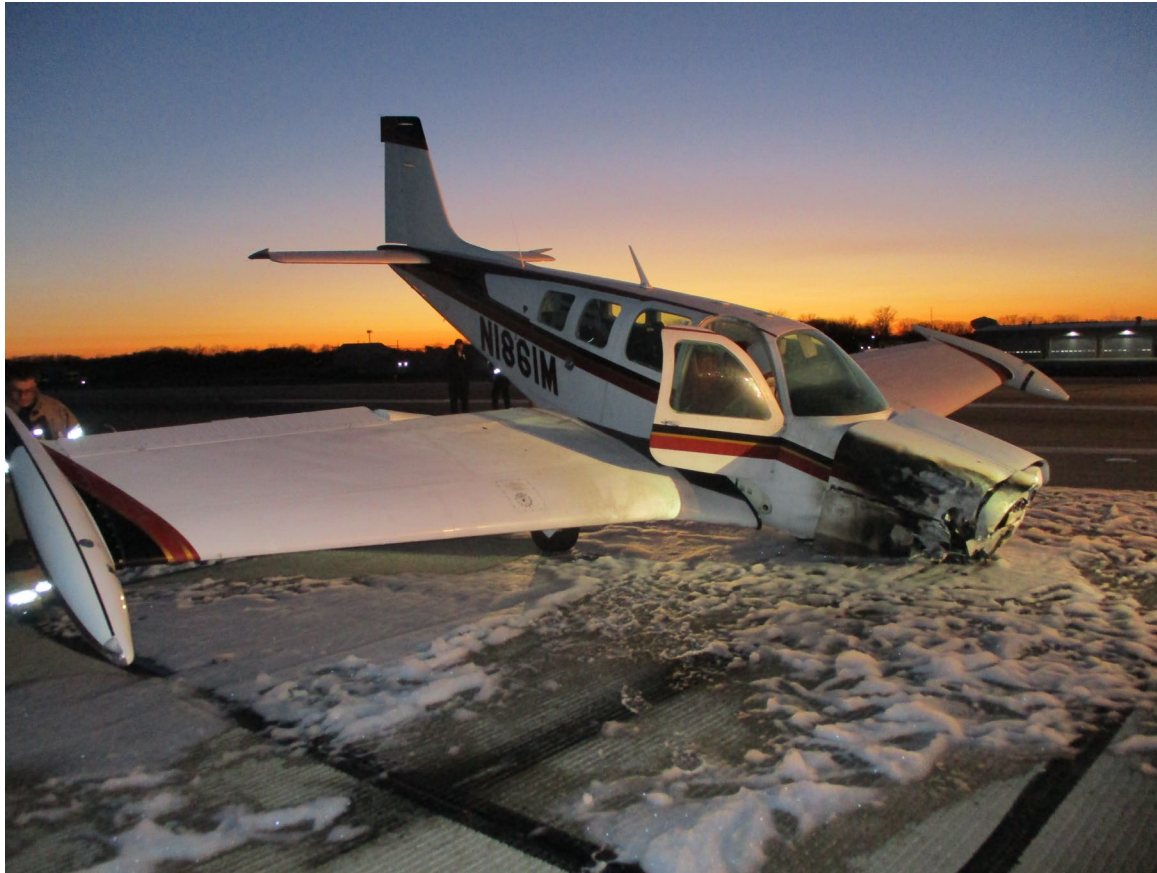
**Photograph 1 - Overview of the Airplane Damage Right Side (Courtesy of FAA)**

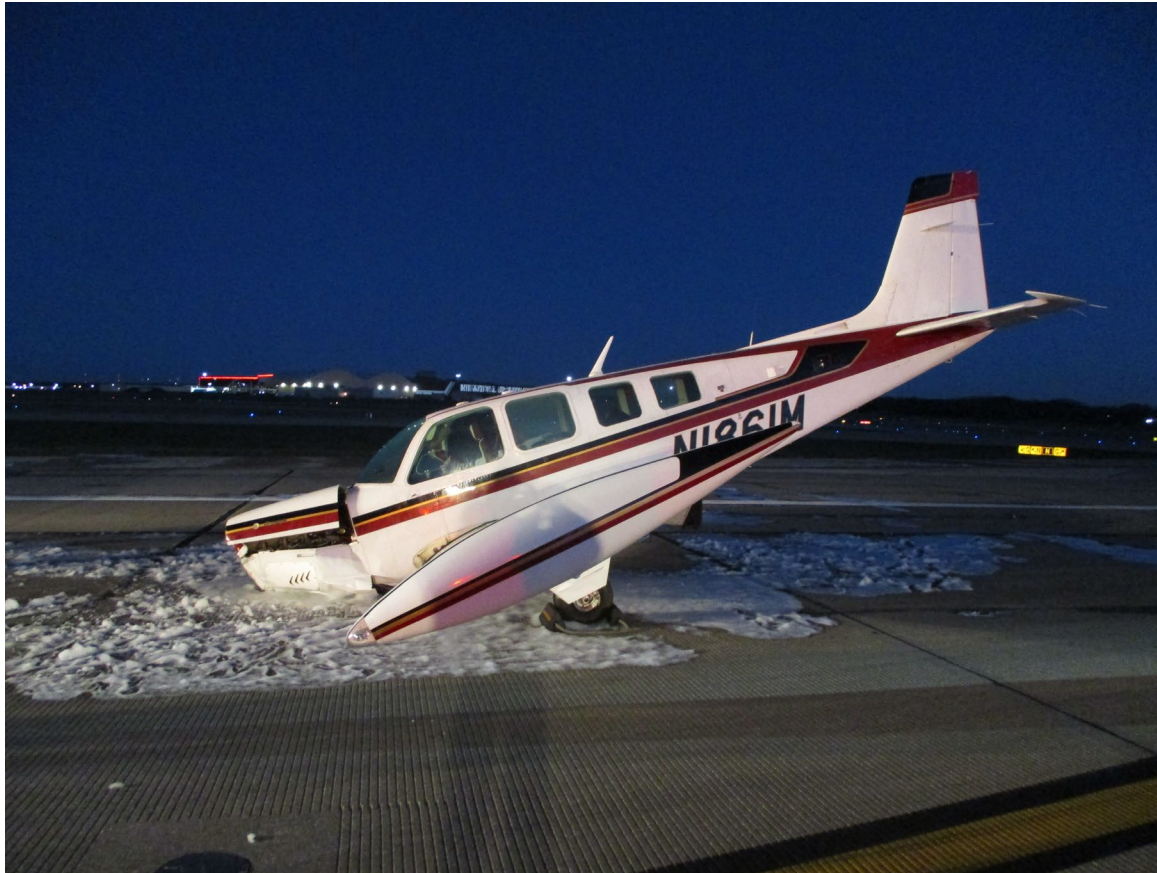
**Photograph 2 - Overview of the Airplane Damage Left Side (Courtesy of FAA)**

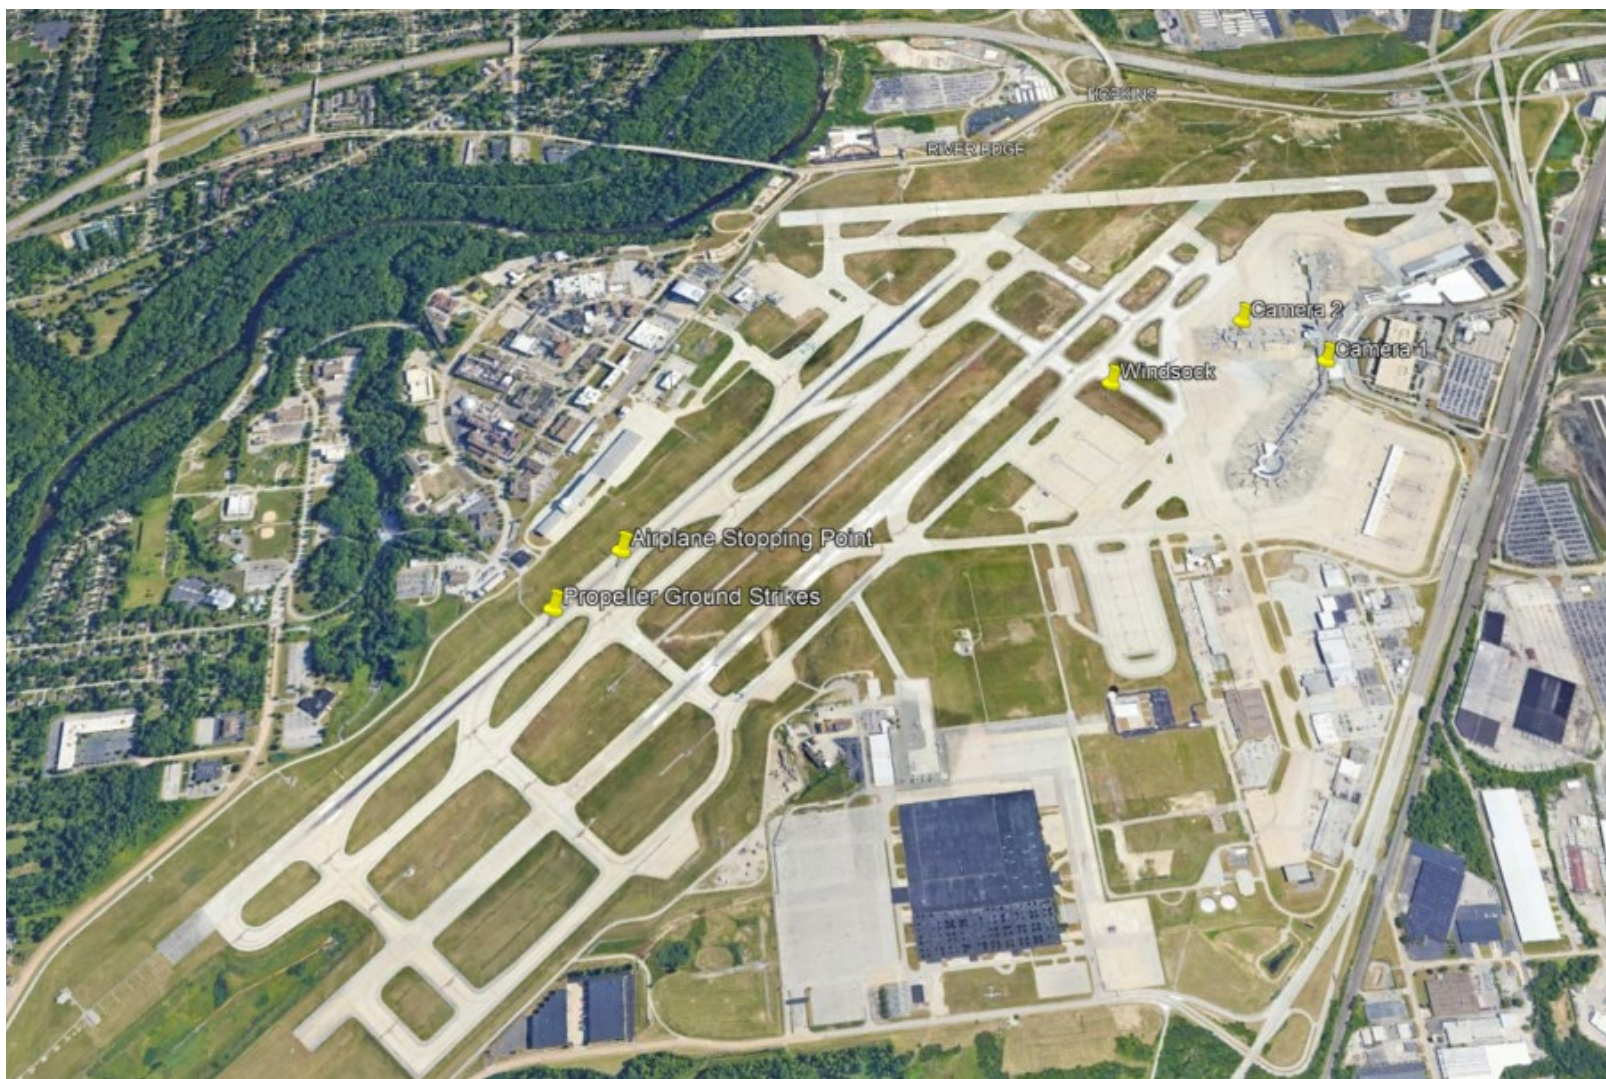
**Photograph 3 - Airport Security Camera and Windsock Location**

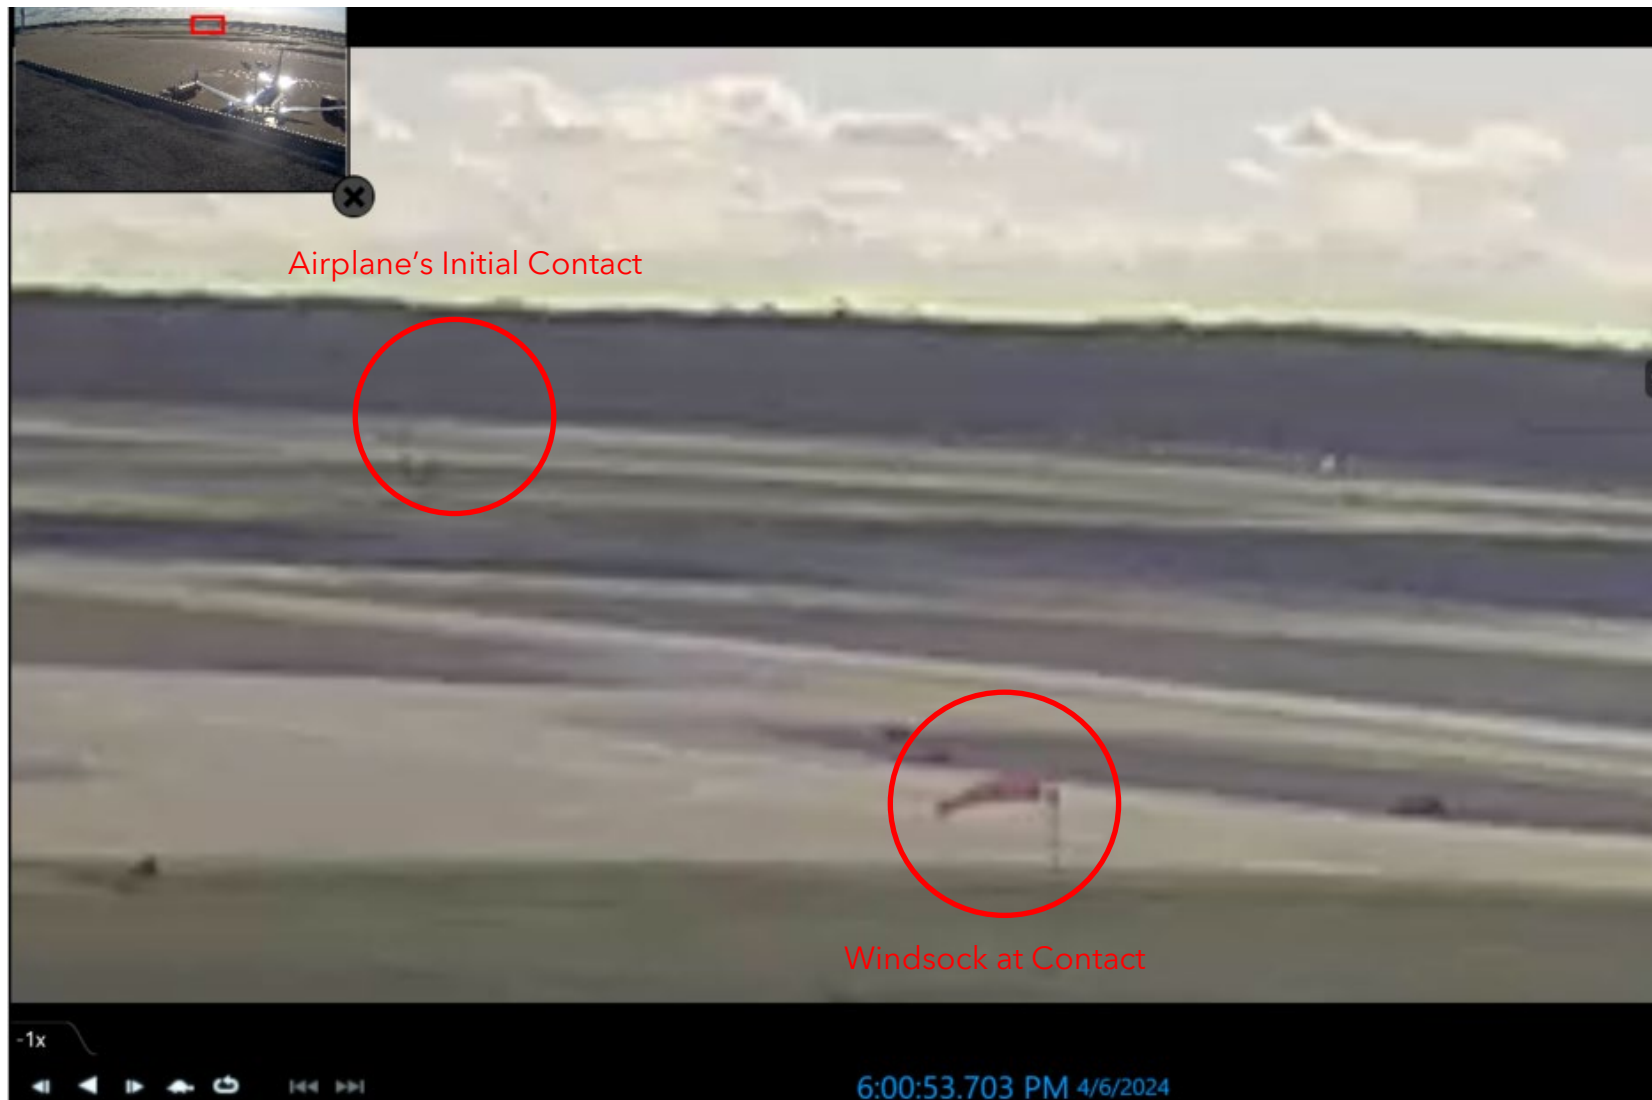
**Photograph 4 - Windsock During Initial Touchdown**

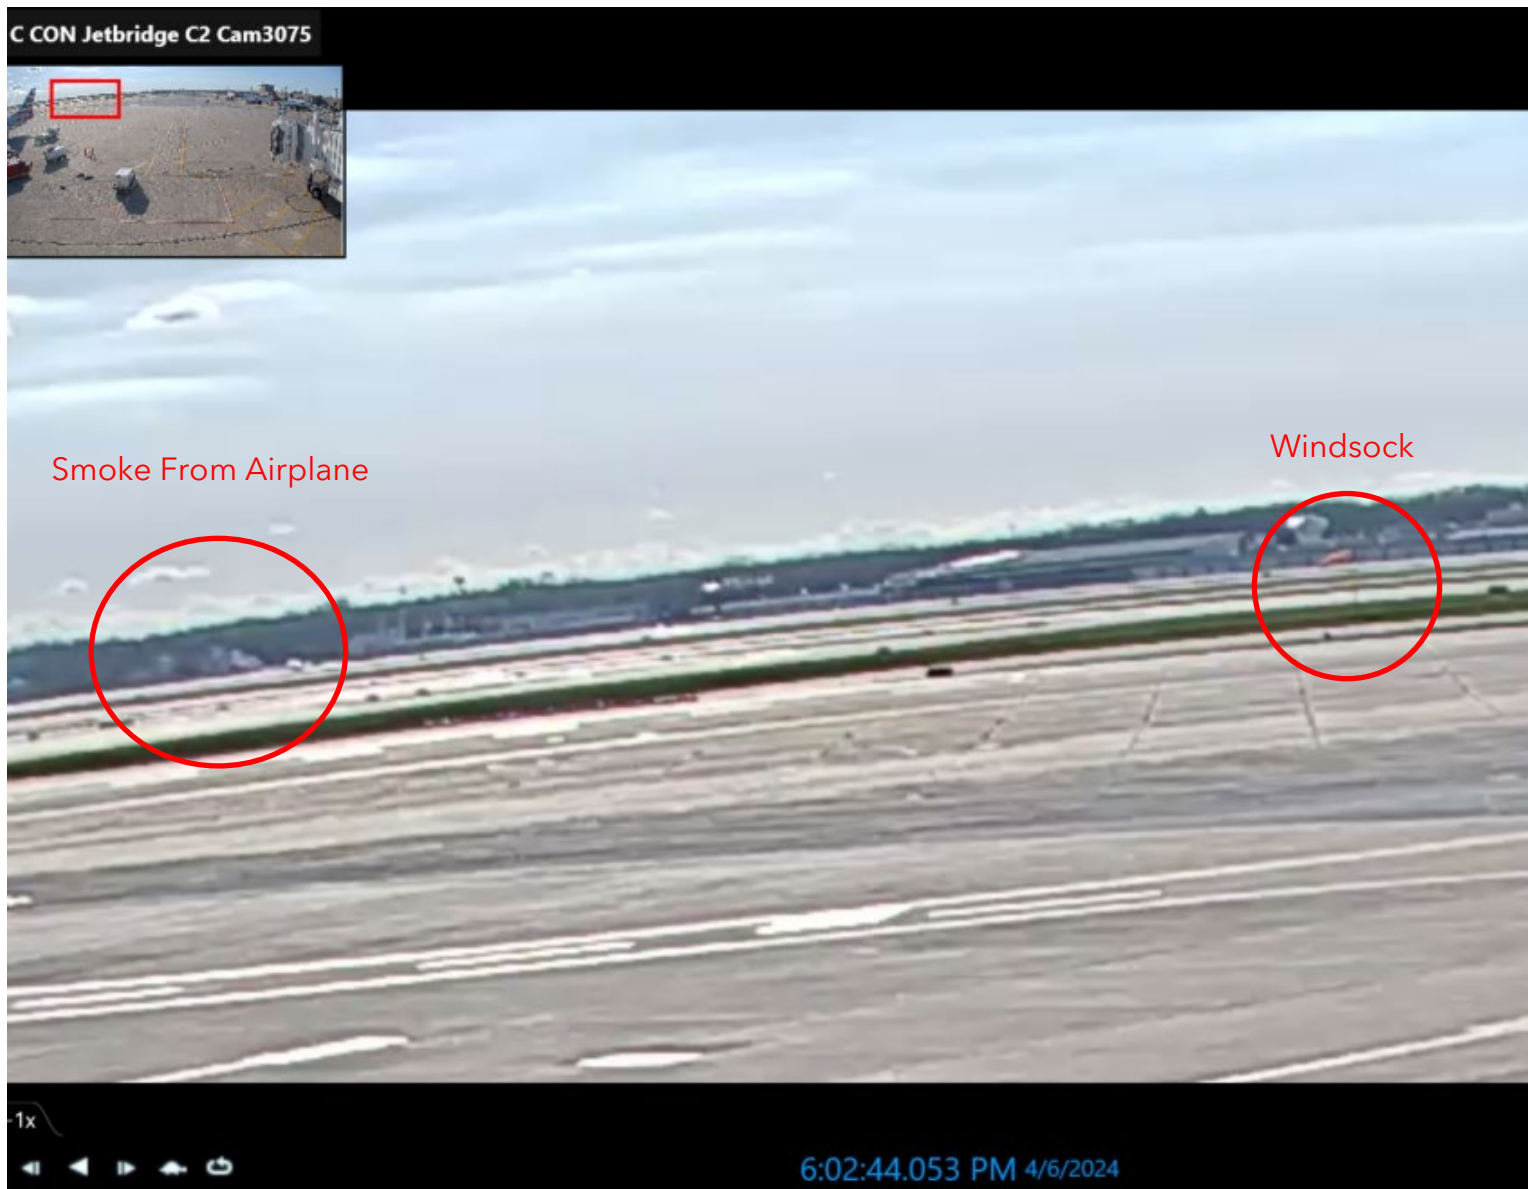
**Photograph 5 - Windsock and Smoke When Airplane Stopped**

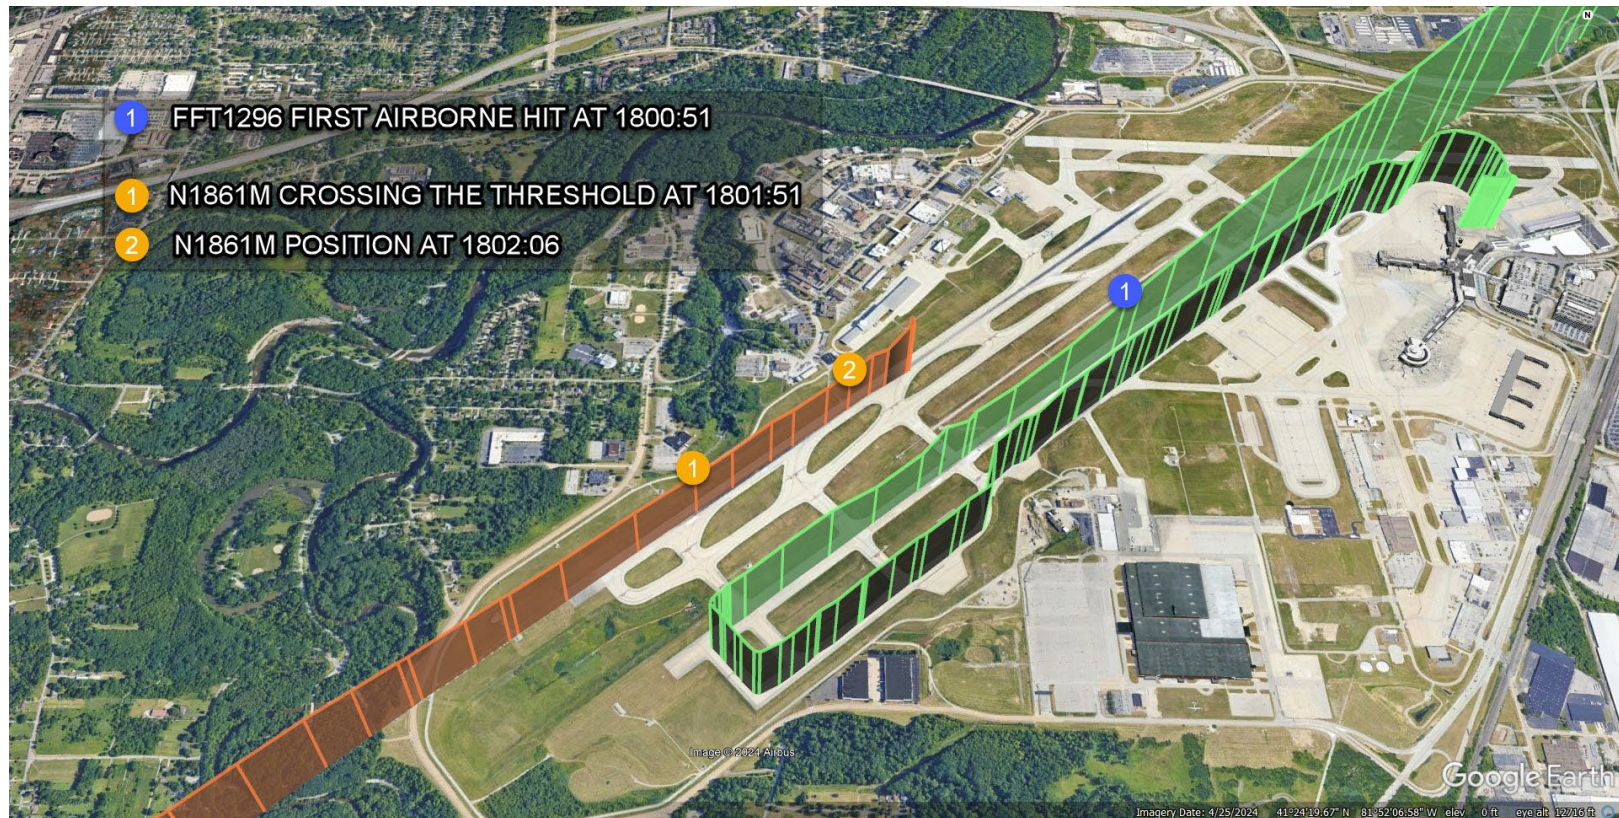
**Photograph 6 - N1861M Approach and Frontier Airlines Departure**
