ERA24LA166

## INVESTIGATION PHOTOGRAPHS

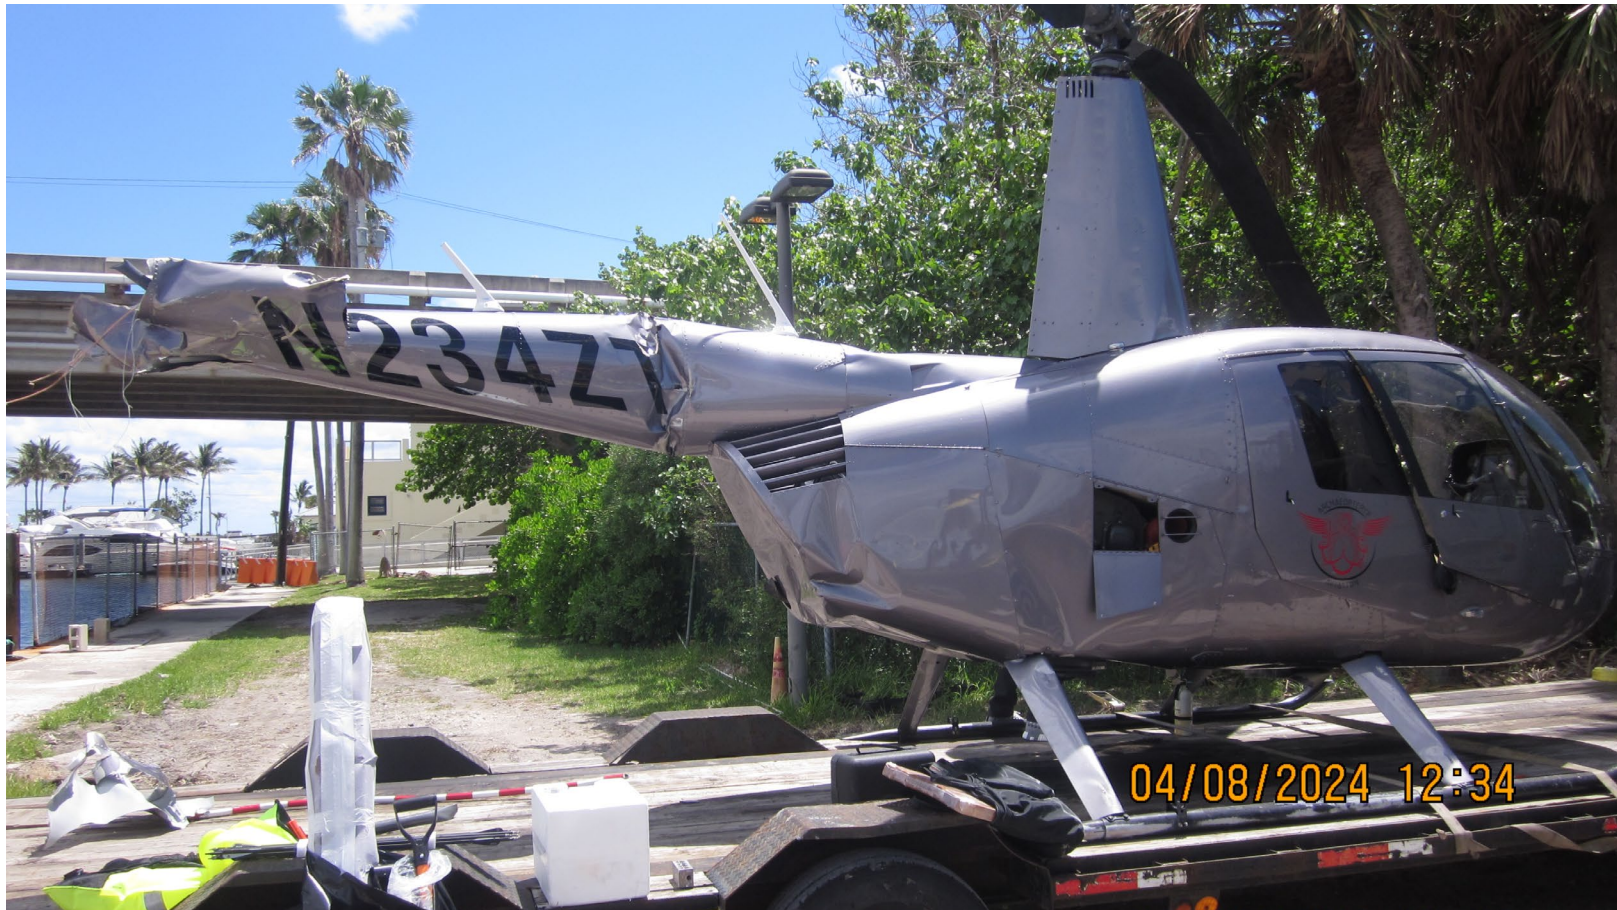
**Photograph 1 - View of helicopter after recovery. (Courtesy of FAA)**

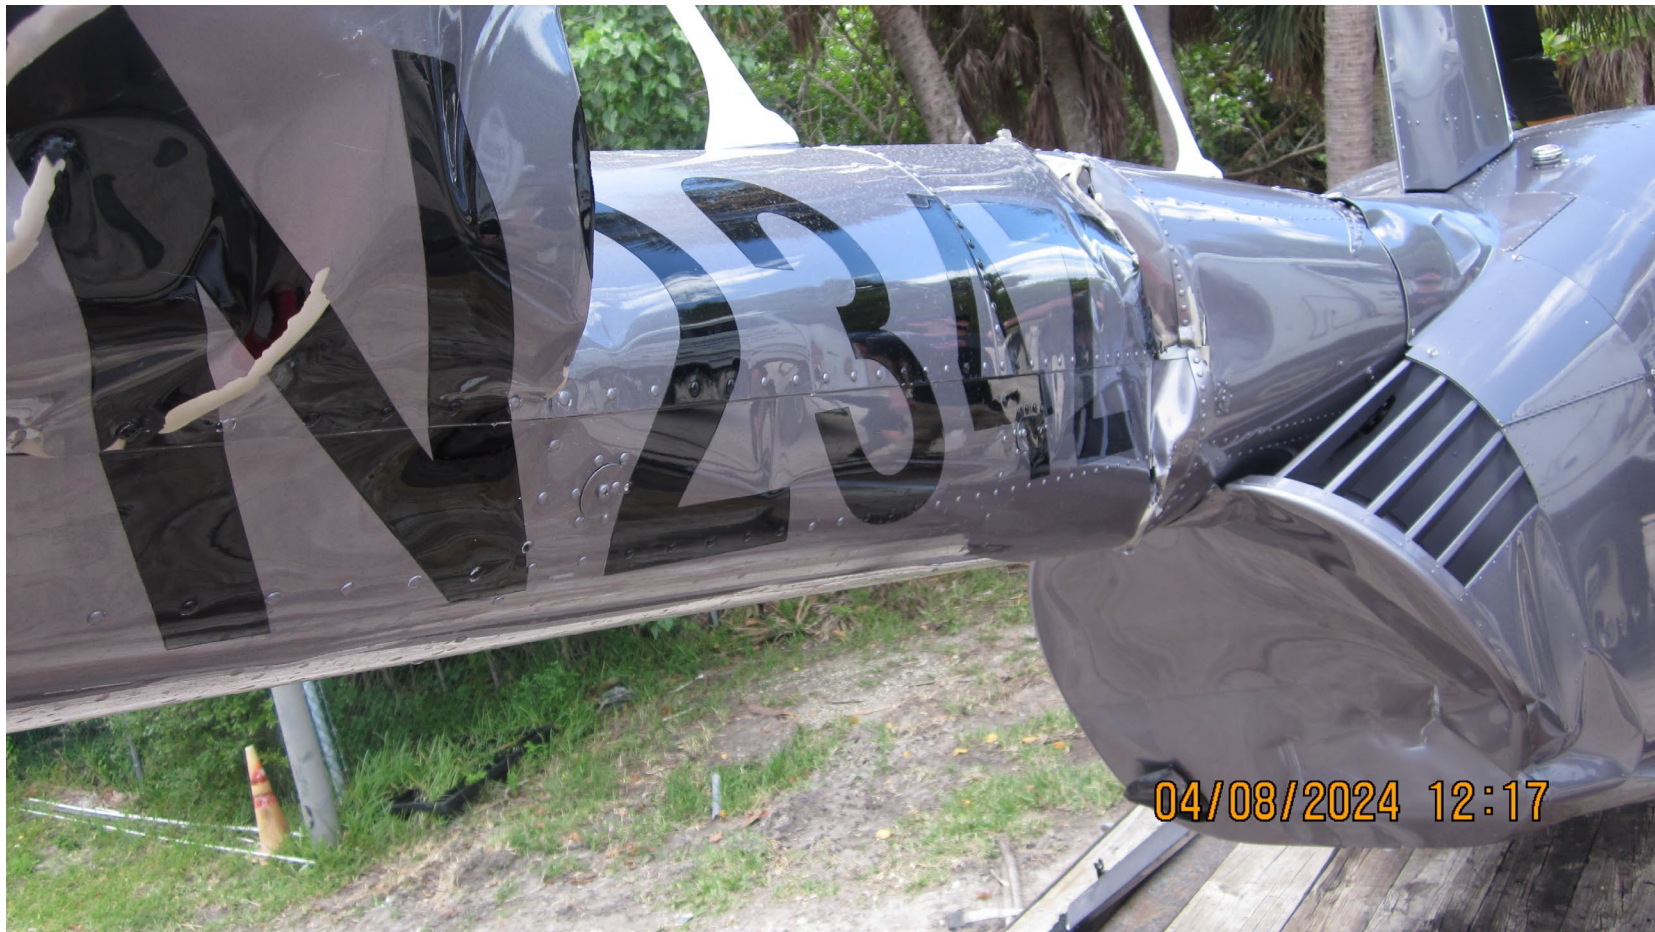
**Photograph 2 - View of tailcone damage. (Courtesy of FAA)**

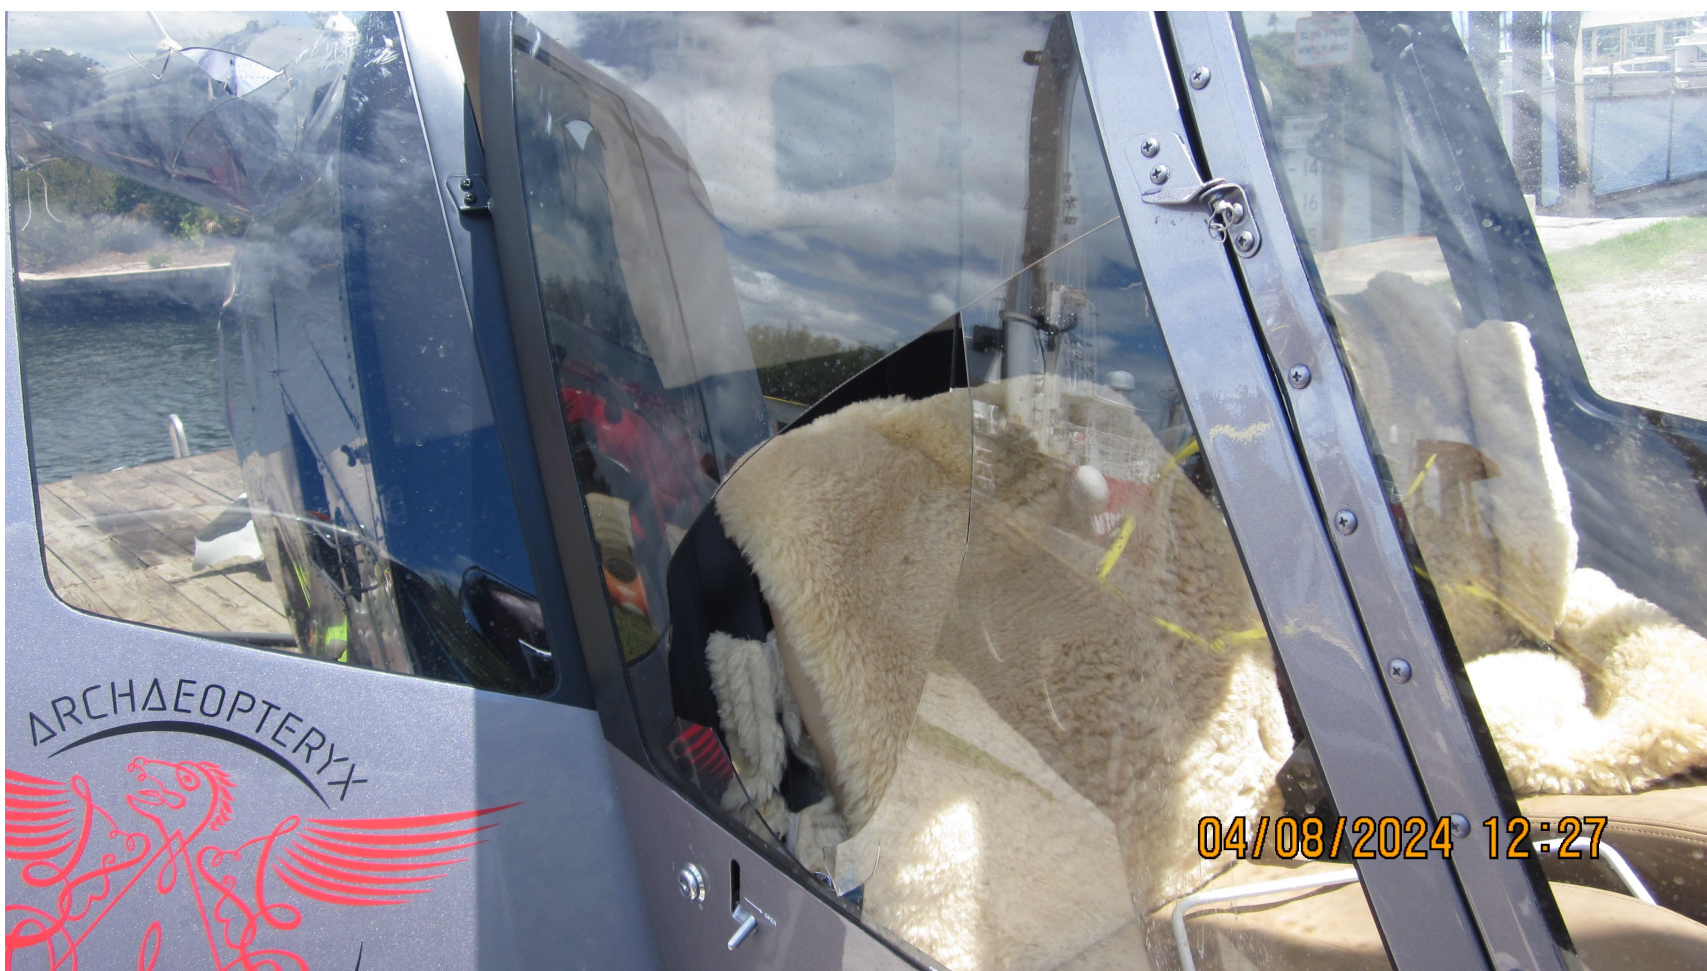
**Photograph 3 - View of hole in cockpit window. (Courtesy of FAA)**

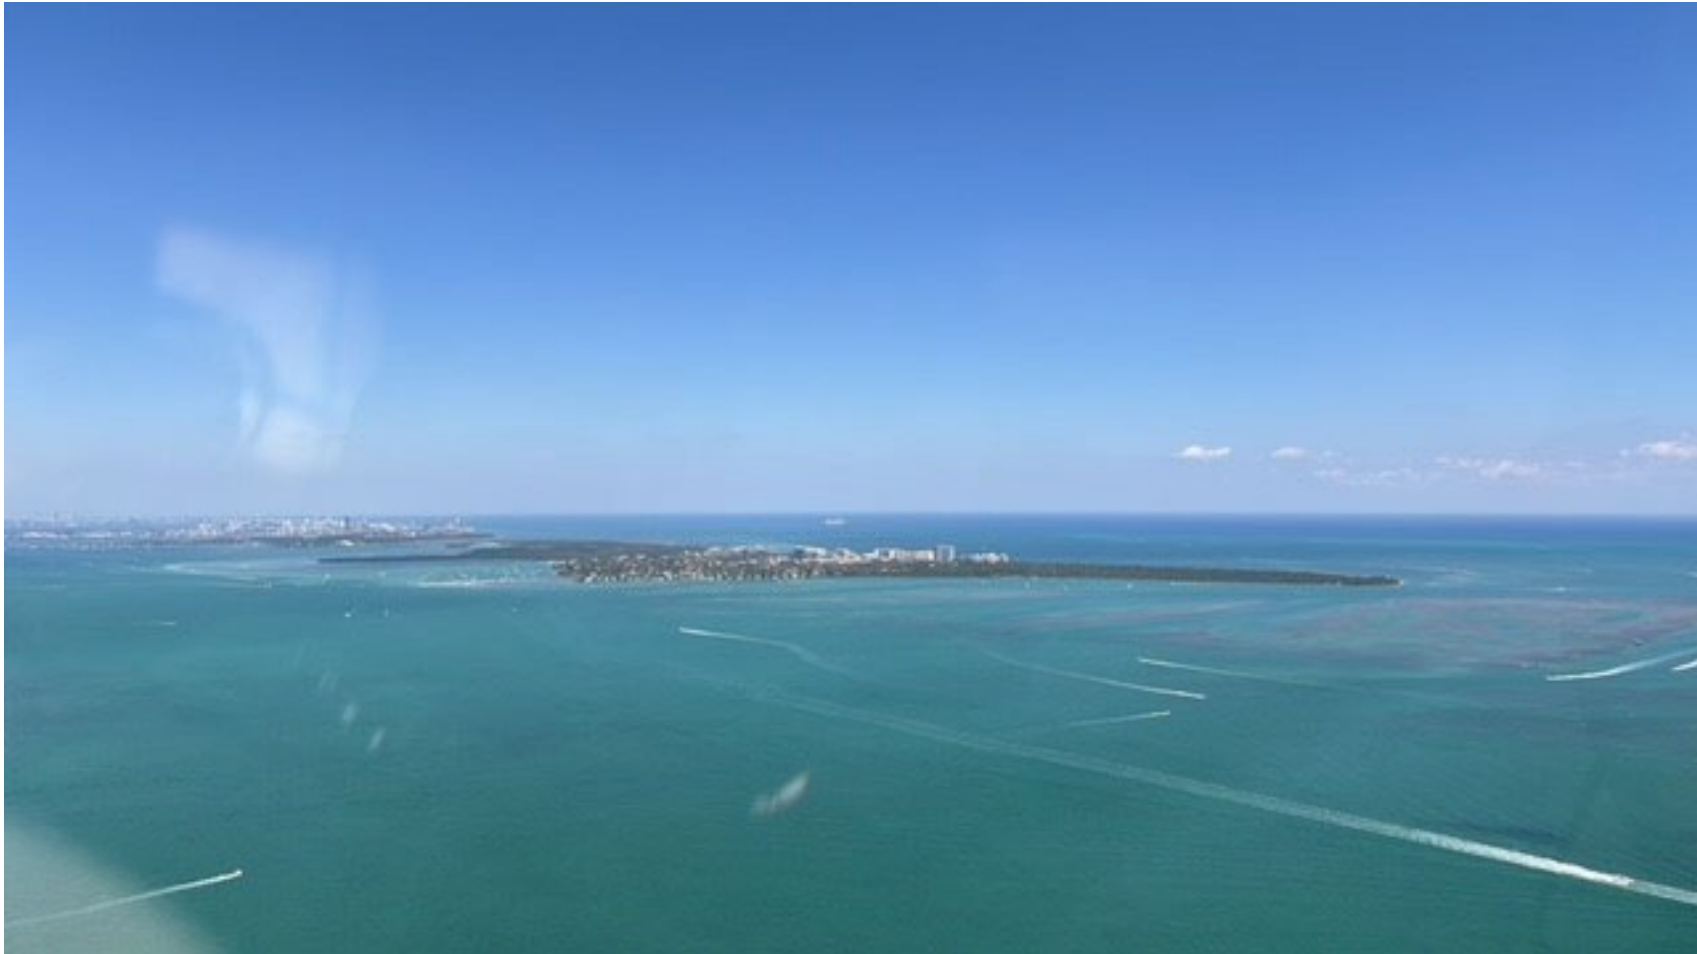
**Photograph 4 - Photo taken during flight of where ditching occurred. (Courtesy of pilot)**

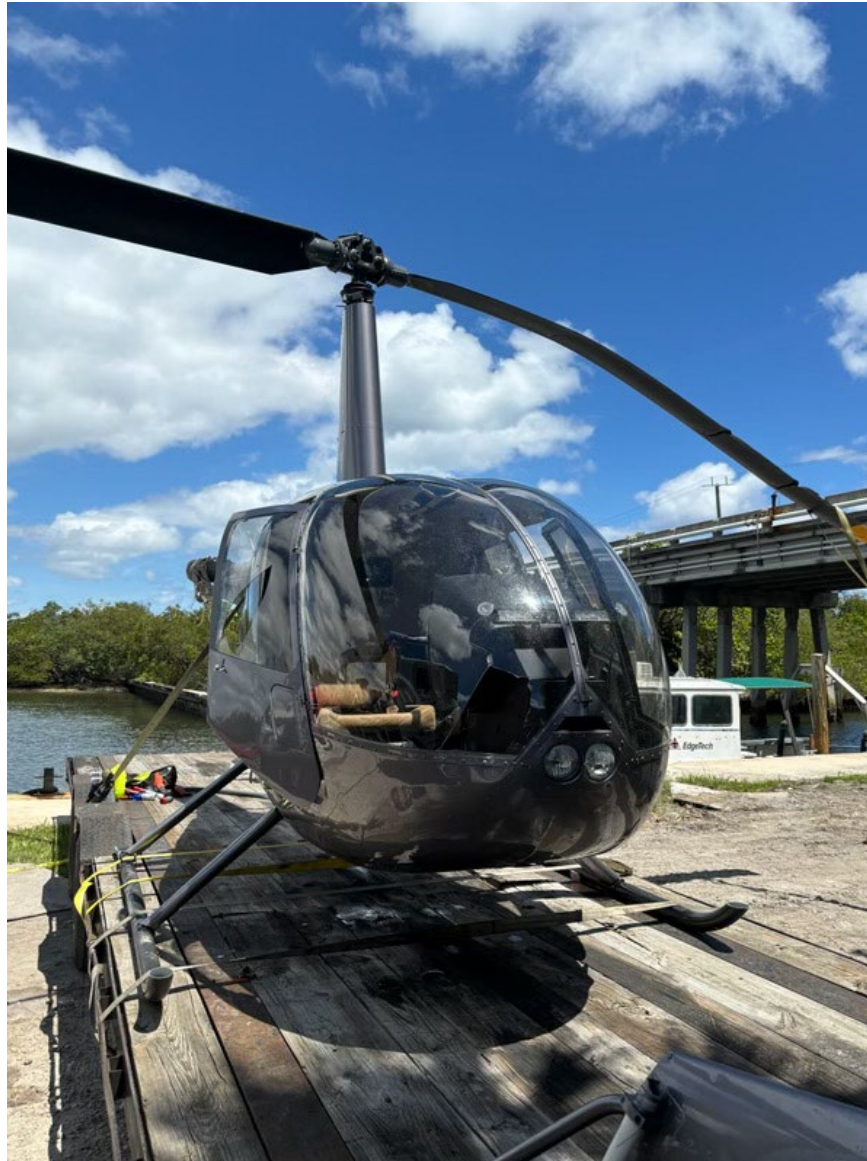
**Photograph 5 - View of helicopter from front after recovery. (Courtesy of Pilot)**

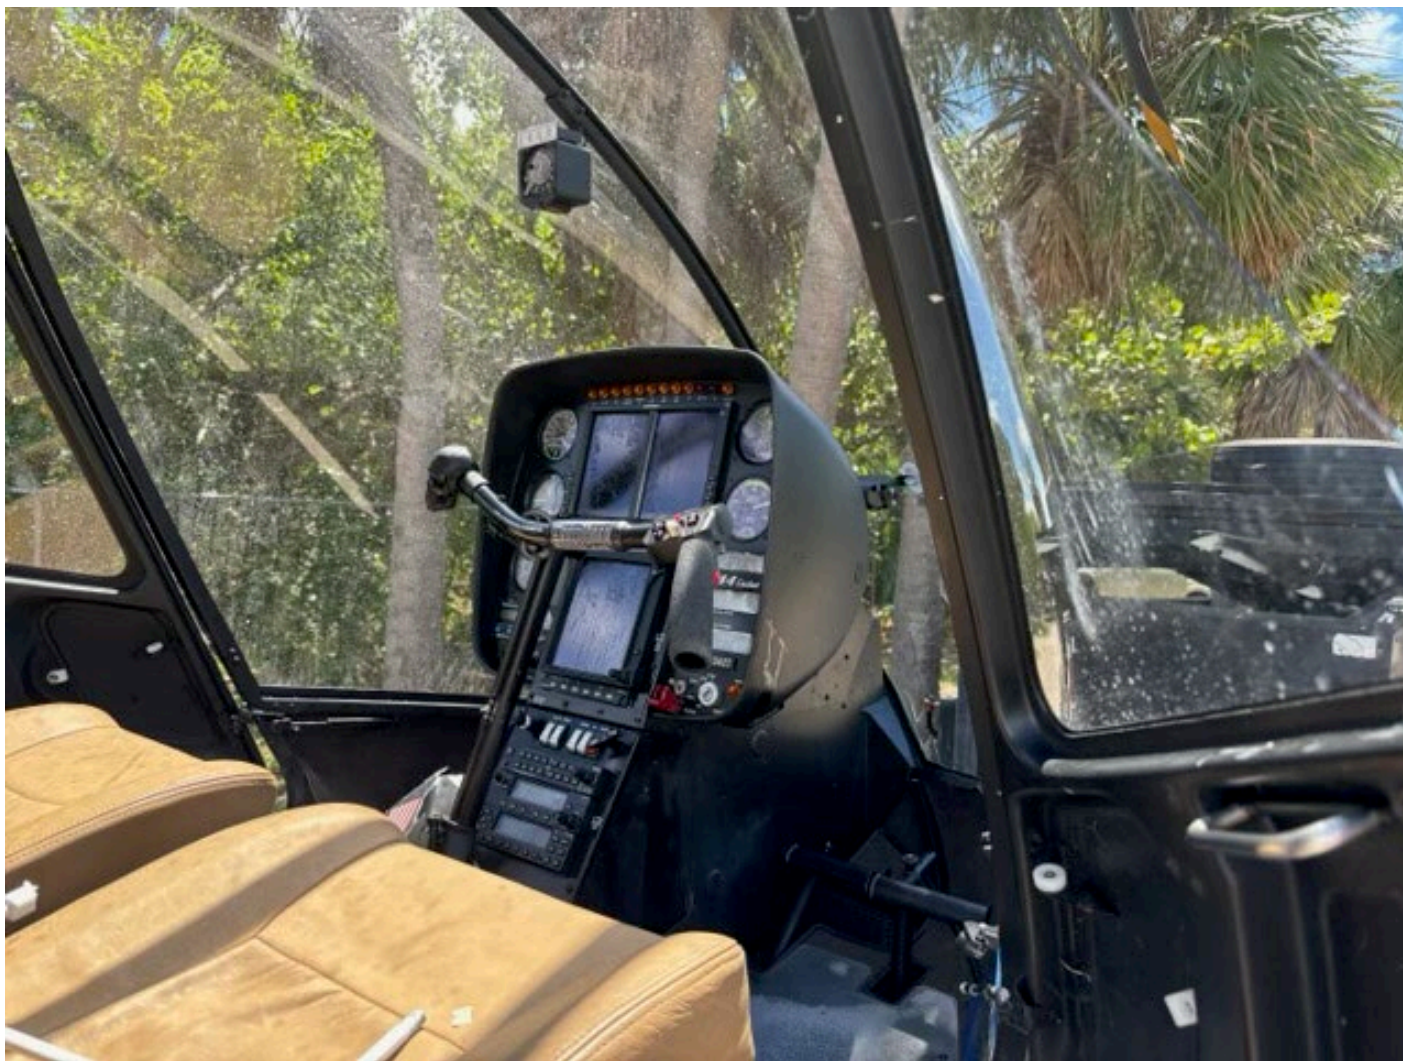
**Photograph 6 - View of cockpit after recovery. (Courtesy of pilot)**

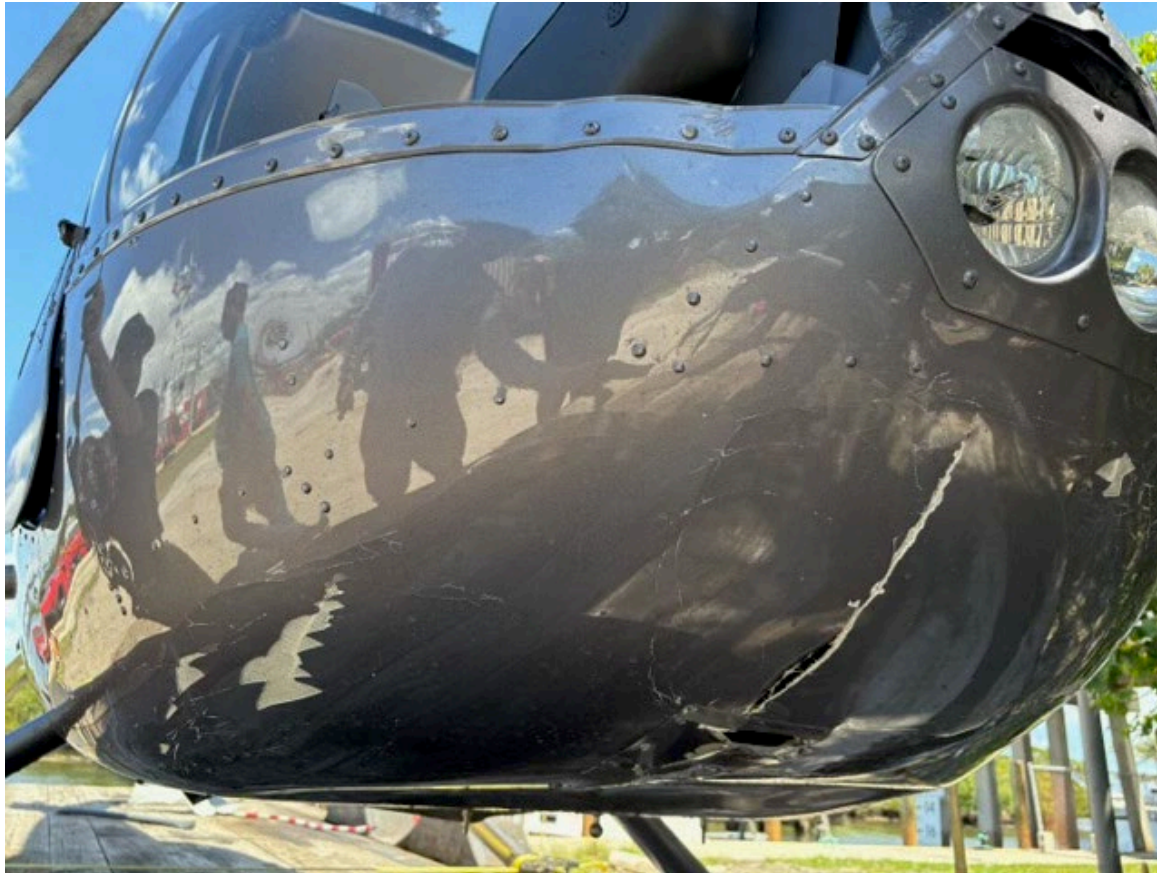
**Photograph 7 - View of lower cockpit area after recovery. (Courtesy of pilot)**
