# National Transportation Safety Board

ERA24LA166

## **AIRFRAME AND ENGINE EXAMINATION**

N234ZT, R44

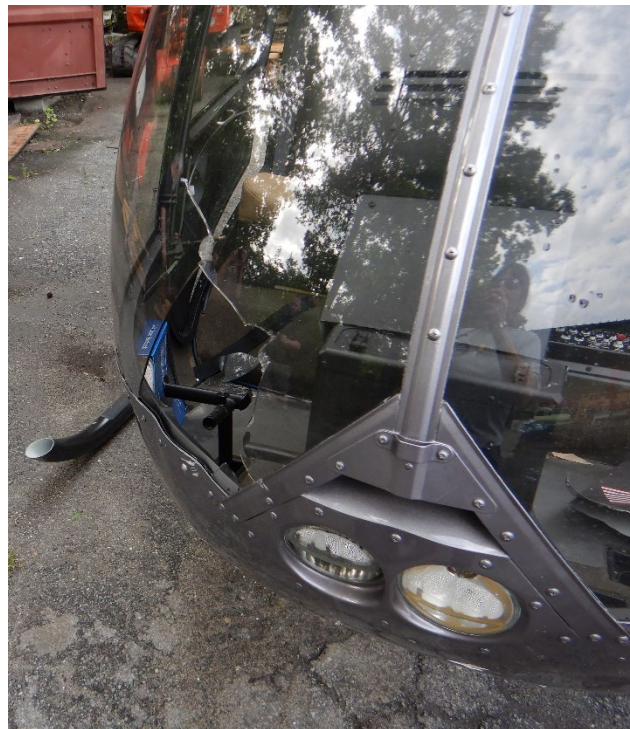
The windshield was intact, except for a small hole on the right windshield near the front, and the pilot's door window. The mast fairing had minor wrinkling/buckling on its lower edges. There was minor wrinkling/buckling on the rear engine cowling. The vertical firewall exhibited minor wrinkling in the lower right corner. The horizontal firewall did not appear to be damaged. At least three of the main rotor gearbox mounts were intact, but the left forward mount was not visible at the level of airframe disassembly that was conducted.

**Photo 5 - View of the broken windscreen on forward right of cockpit.**

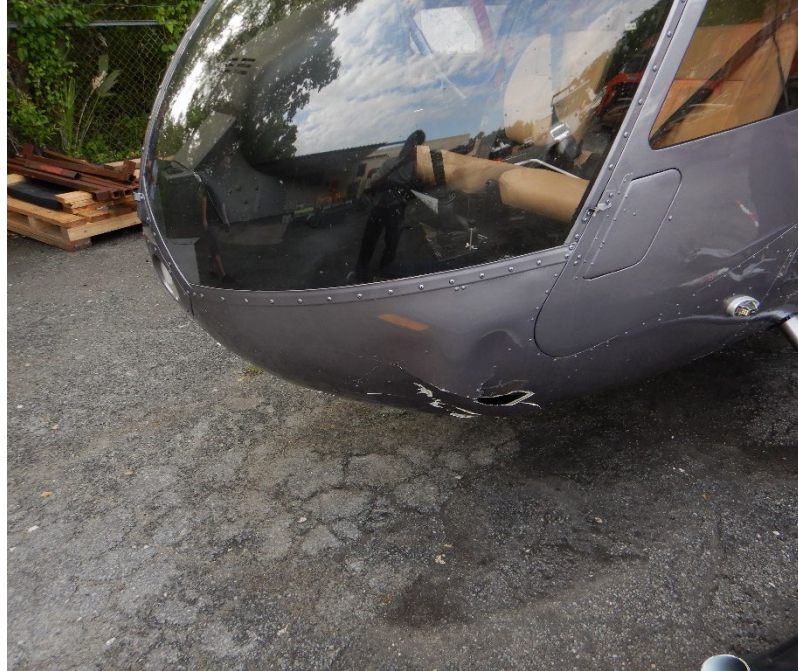
**Photo 6 - View of damage to front left of fuselage and windscreen.**

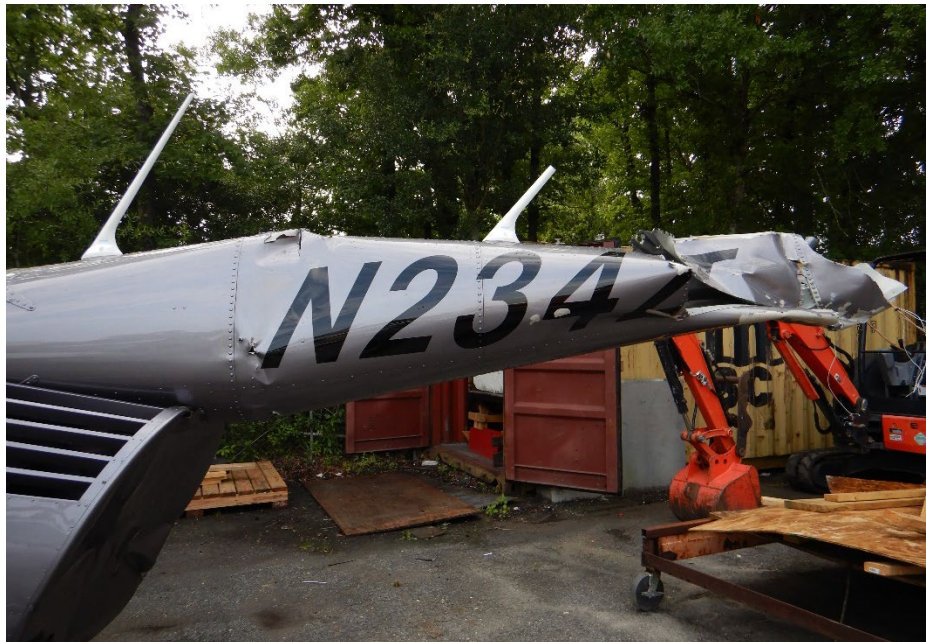
The tailcone was damaged on both sides in the second bay. It was separated in the fourth bay, where there was distortion on the left side with a shape similar to the shape of the main rotor, and some yellow paint transfer. The sixth bay was detached from the rest of the tailcone. The last bay of the tailcone, as well as the tail rotor gearbox, were not present for the examination, but the empennage was. The upper vertical stabilizer had a large dent on the leading edge near the top, and the shape of the dent was similar to the shape of the main rotor, and there was paint smearing evident in the dent. The horizontal stabilizer, lower vertical stabilizer, and tail skid

**Photo 7 - Close-up view of tailcone fracture.**

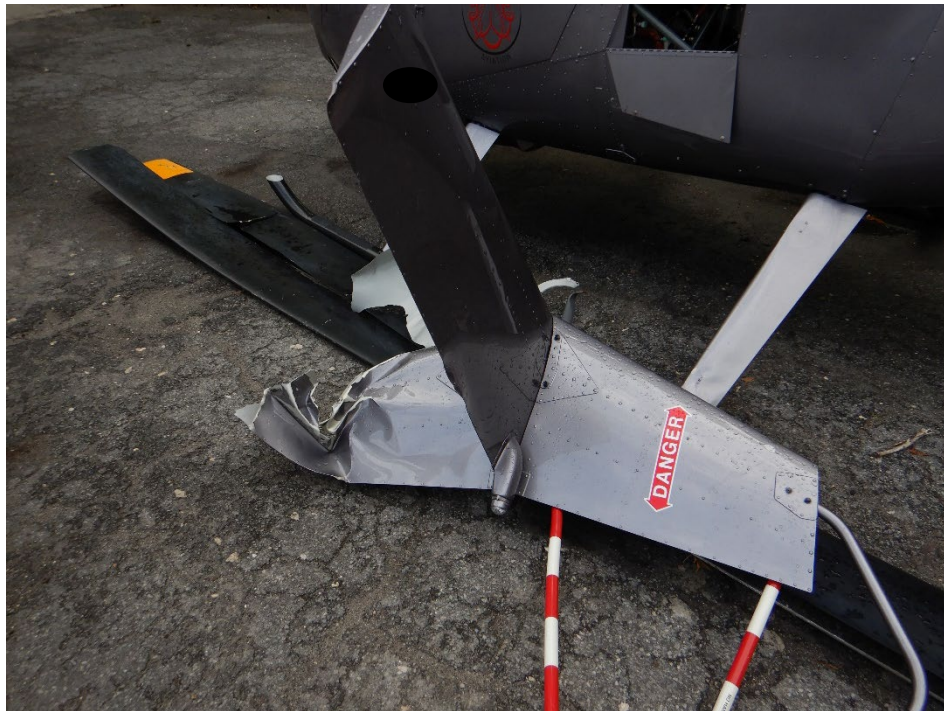
'stinger' were intact and did not appear to be damaged. The tail rotor visual guard was fractured at the lower stabilizer.

**Photo 8 - View of fractured empennage.**

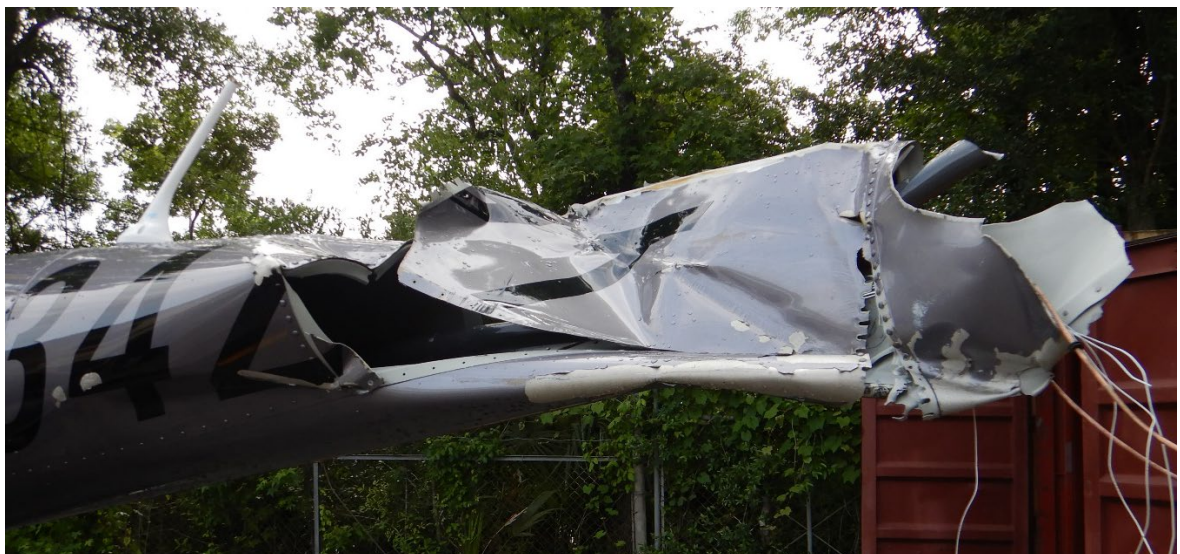
**Photo 9 - Close-up view of main rotor contact on tailboom forward of the empennage.**

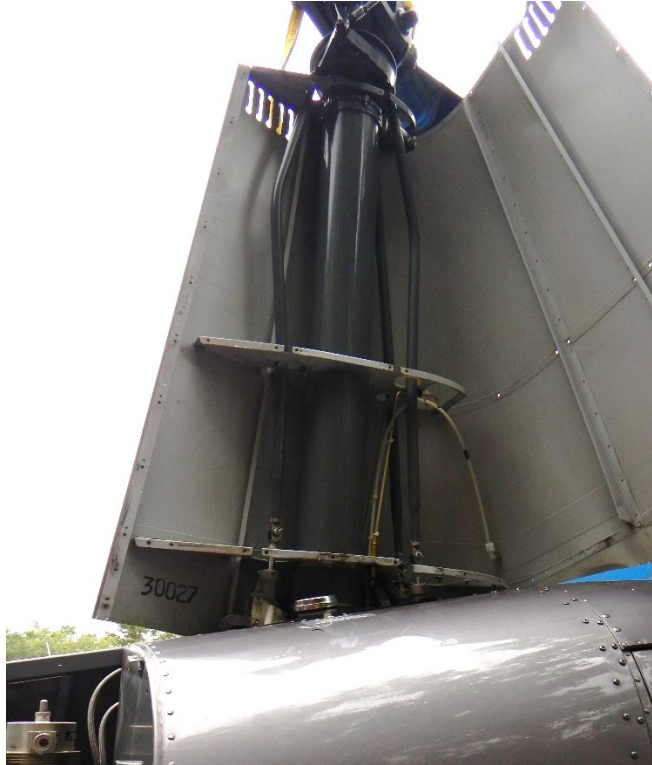
**Photo 12 - View of mast fairing interior and deformed control push-pull tubes.**

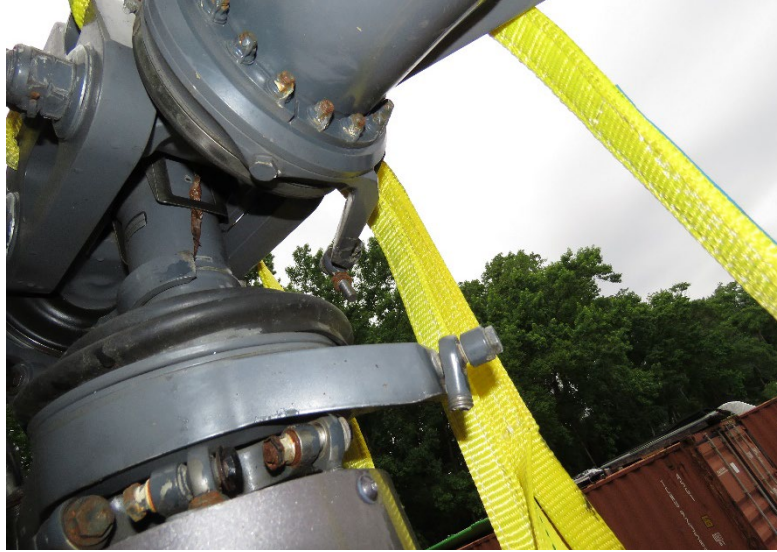
The flight control system had discontinuities consistent with overload in the tail rotor push-pull tube in the tailcone. One of the main rotor pitch links had an overload fracture in the lower rod end, and the upper rod end had unscrewed from the pitch link center body, which was not present for the examination. The drive collar for the upper swashplate had overload fractures at the main rotor mast.

**Photo 14 - View of main rotor hub and fractured pitch link.**

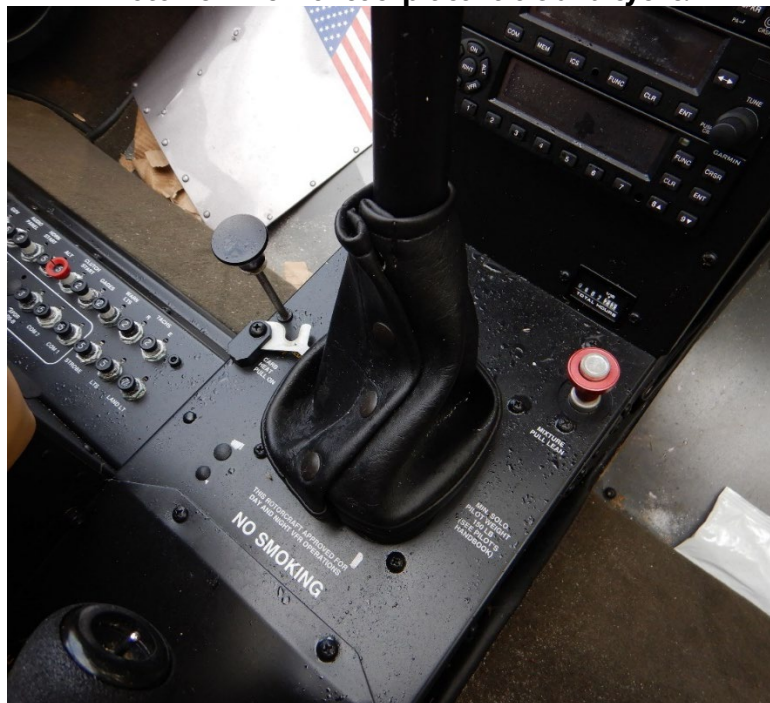
Carburetor heat - Extended about 2.3 inches, and the down-latch was not engaged. (Carburetor heat valve I air filter housing partially open)

Mixture - Full rich (The mixture guard was not located in the wreckage.)

Circuit breakers - Aux Power, Governor, Horn Start, Clutch Start, Gages, Warning Lights tripped; all others set for operation.

**Photo 17 - View of mixture, carburetor heat and circuit breakers.**

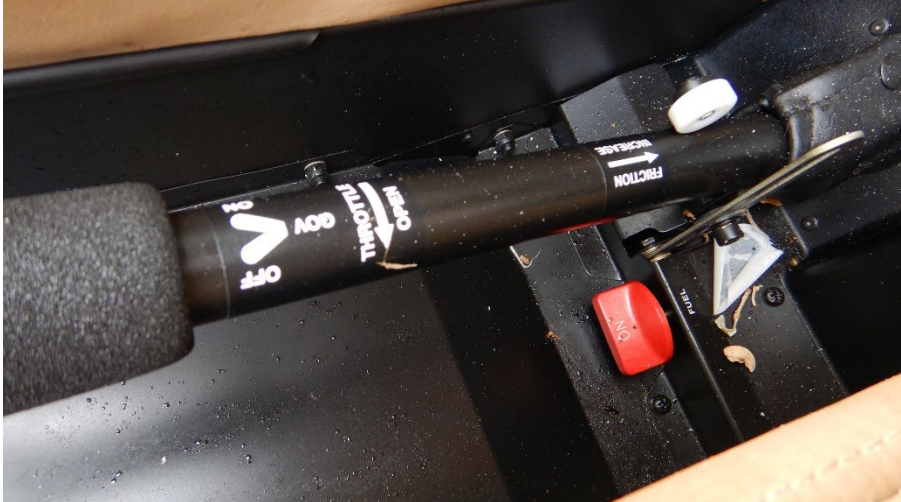
Collective - Mid-travel position; The distance from the top of the collective friction washer to the top of the slider slot was approximately 1.9 inches. This corresponds to a collective position of approximately 35% up from full down.

**Photo 18 - View of collective.**

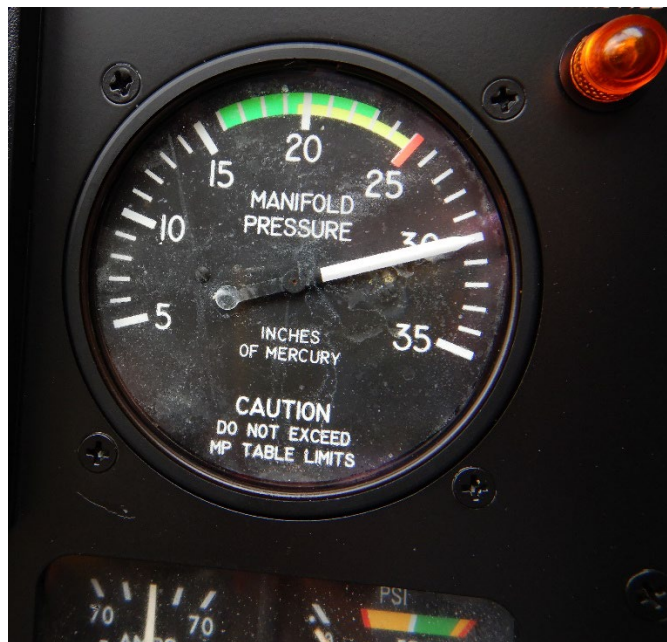
Manifold Pressure - 30 in. Hg.

**Photo 19 - View of manifold pressure gauge.**

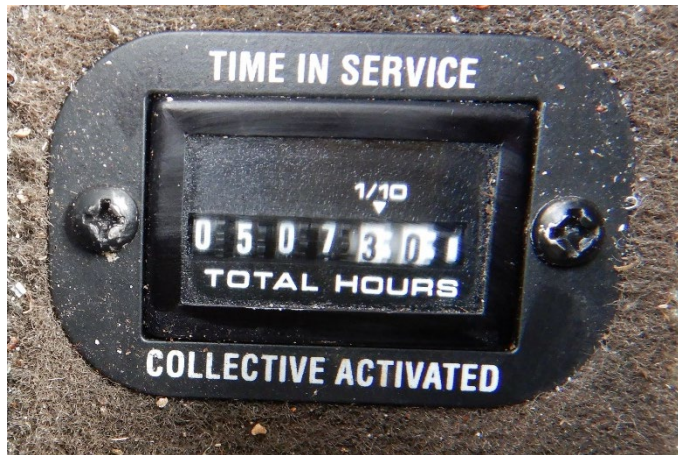
Collective Hobbs - 507.30 hours; clutch switch in the "engaged" position.

**Photo 20 - View of Collective Hobbs**

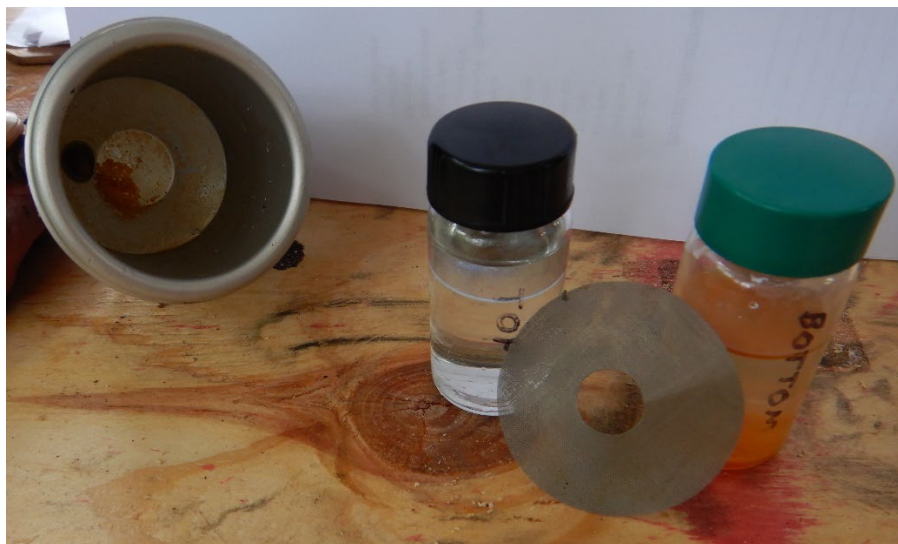
The gascolator was intact and in place. The gascolator was removed and the bowl contained a mixture liquid consistent in color and odor with aviation fuel, some clear liquid that appeared to be water, and a small amount of rust-colored liquid. The drain fitting exhibited rust on its surface. There were no other contaminants visible in the gascolator bowl. The screen was removed and photographed. The screen was replaced, the gascolator was re-assembled, then the fuel tanks were drained into 5-gallon buckets. A total of 10 buckets were filled, containing various mixtures of fuel and water. In all, approximately 22 gallons of fuel and approximately 20 gallons of water were removed from the tanks.

**Photo 23 - View of gascolator bowl, screen and recovered contents.**

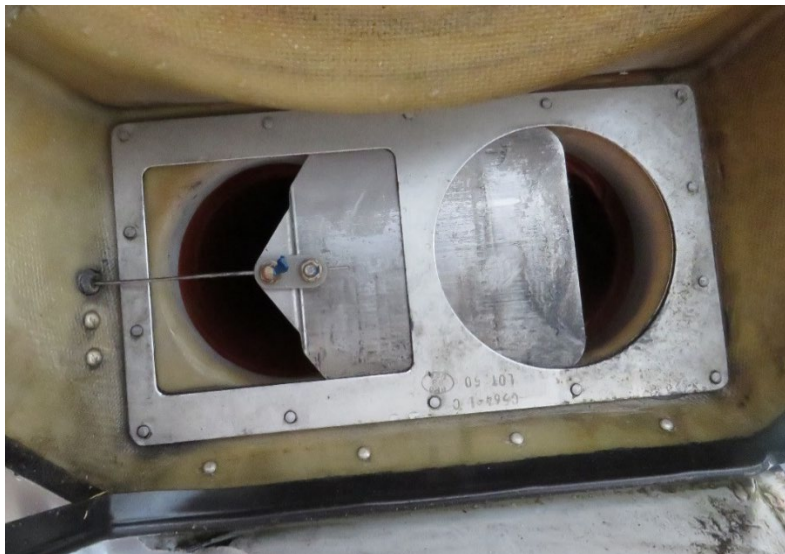
The carburetor heat control was extended approximately 2.3 inches in the cabin but may have moved with the collective control slightly. The slider valve in the airbox was in a position just under halfway 'on', or 'hot'.

**Photo 26: View of carburetor heat valve.**

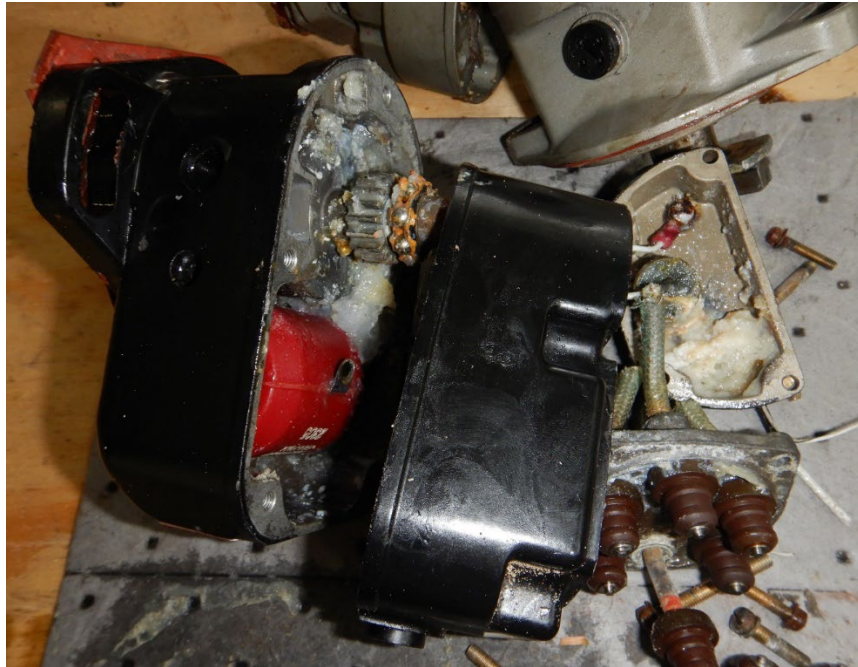
The left magneto remained secured to the engine's accessory housing with the appropriate hardware and was removed and examined. The drive was seized, and the magneto was disassembled and photo documented. The magneto was filled with salt deposits and was severely corroded from submersion in salt water. During the second day of the exam, was able to break the drive free so it could fully rotate, the points were observed opening and closing as the drive was rotated. The magneto was reassembled, and the points were cleaned. The magneto was rotated with a drill, no spark was noted on any of the ignition towers, likely from the overall condition of the magneto from its submersion in salt water.

**Photo 27 - View of magneto 1 upon removal and disassembly.**

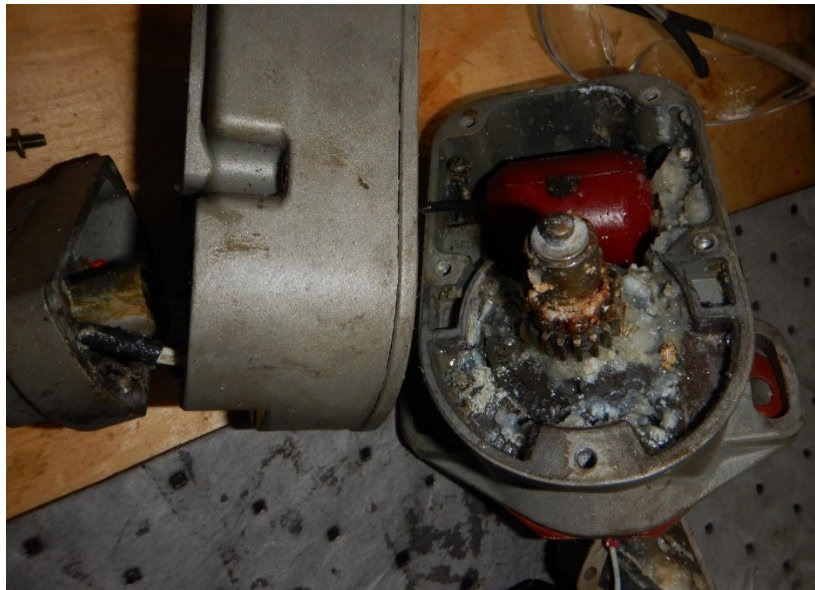
The right magneto remained secured to the engine's accessory housing with the appropriate hardware and was removed and examined. The drive was seized and the magneto was disassembled and photo documented. The magneto was filled with salt deposits and was severely corroded from submersion in salt water. During the second day of the exam, was able to break the drive free so it could fully rotate, the points were observed opening and closing as the drive was rotated. The magneto was reassembled, and the points were cleaned. The magneto was rotated with a drill, no spark was noted on any of the ignition towers, likely from the overall condition of the magneto from its submersion in salt water.

**Photo 28 - View of magneto 2 upon removal and disassembly.**

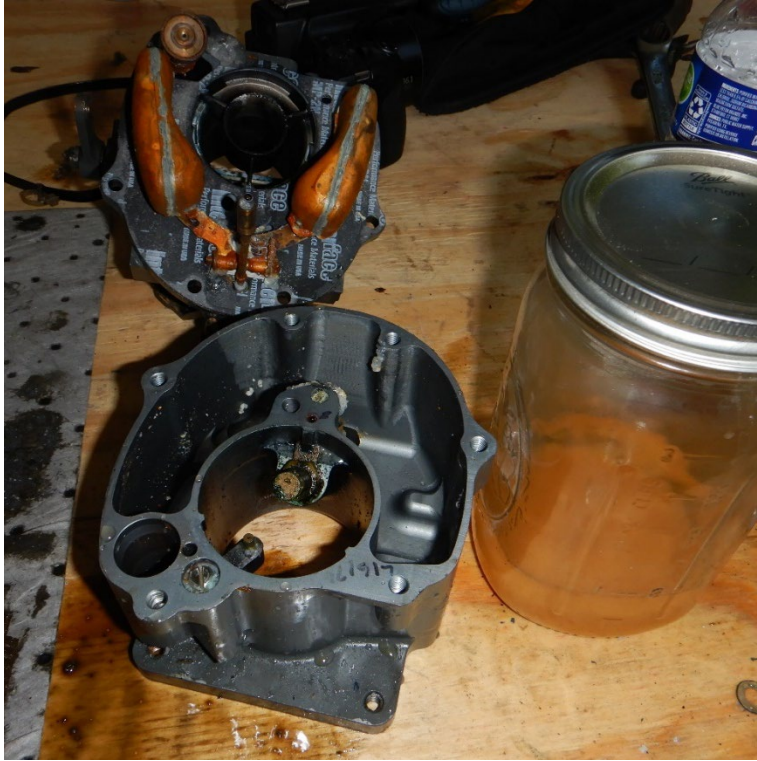
The carburetor float bowl contained murky, rust-colored liquid.

**Photo 29 - Opened carburetor and drained fluid.**

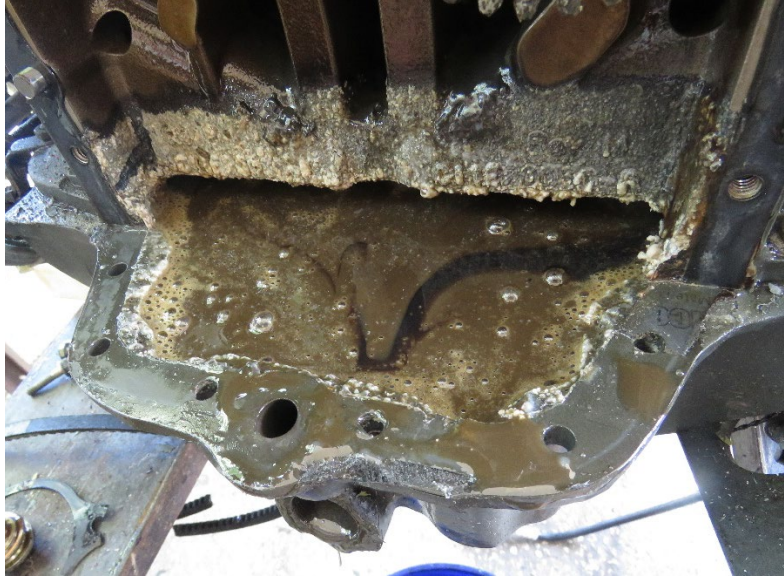
The oil sump was filled with salt water, at the beginning of the exam, the dipstick was removed, and salt water started pouring out of the filler tube. The dipstick was put back in place to prevent water from escaping so the contents could be captured in a container. When the suction screen plug was pulled and the contents drained into a bucket, only a minor amount of oil was present with the salt water. There was a large amount of salt deposits on the bottom of the oil sump, a screwdriver was used to free up the ports that lead to the suction screen plug and the oil contained in the sump was drained into a bucket. The dipstick was reading approximately 11 quarts of oil at the time of examination. The oil suction screen was examined, and some salt deposits and oil sludge noted on the suction screen, no additional contamination was noted. The oil filter remained secured to the oil filter adapter. The oil filter was removed and cut open. The paper element was clean and free of contamination, date and tach time were not recorded on the oil filter body.

**Photo 33 - View of oil sump filled with sludge.**

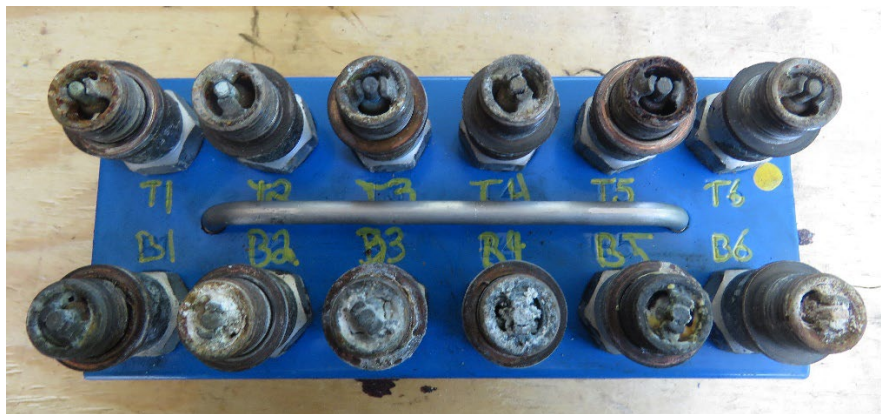
All sparkplugs remained secured in their respective positions on each cylinder. The sparkplugs were removed and photo documented. The faces and electrodes of the plugs varied in color and condition due to submersion in salt water.

**Photo 34 - View of spark plugs.**

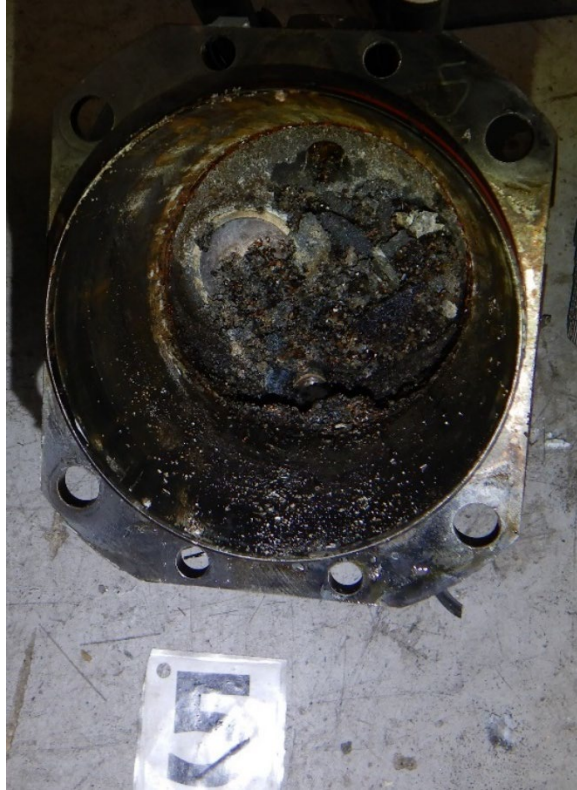
oil. The remaining oil was sufficient for engine operation. All six cylinders were removed. The No. 5 cylinder was difficult to pull free from the piston, and once freed, a large quantity of blackened salt-like deposit was noted between the cylinder and cylinder wall. Once all the cylinders were removed, the crankshaft rotated freely about its axis and was rotated a full 360° multiple times. Each connecting rod moved freely about its journal on the crankshaft. The camshaft rotated when the crankshaft was rotated, no cracks or fractures were noted, and each cam lobe appeared whole and undamaged. The roller tappets appeared undamaged and moved freely against the lobe of the camshaft as it was rotated by the crankshaft. The crankshaft gear was secured and safe tied and the crank gear dowel pin was not sheared. The idler gears remained in position, appeared undamaged, and rotated when the crankshaft was rotated.

**Photo 47 - View of cylinder No. 5 after removal from engine**
