ERA24LA170

## INVESTIGATION PHOTOGRAPHS

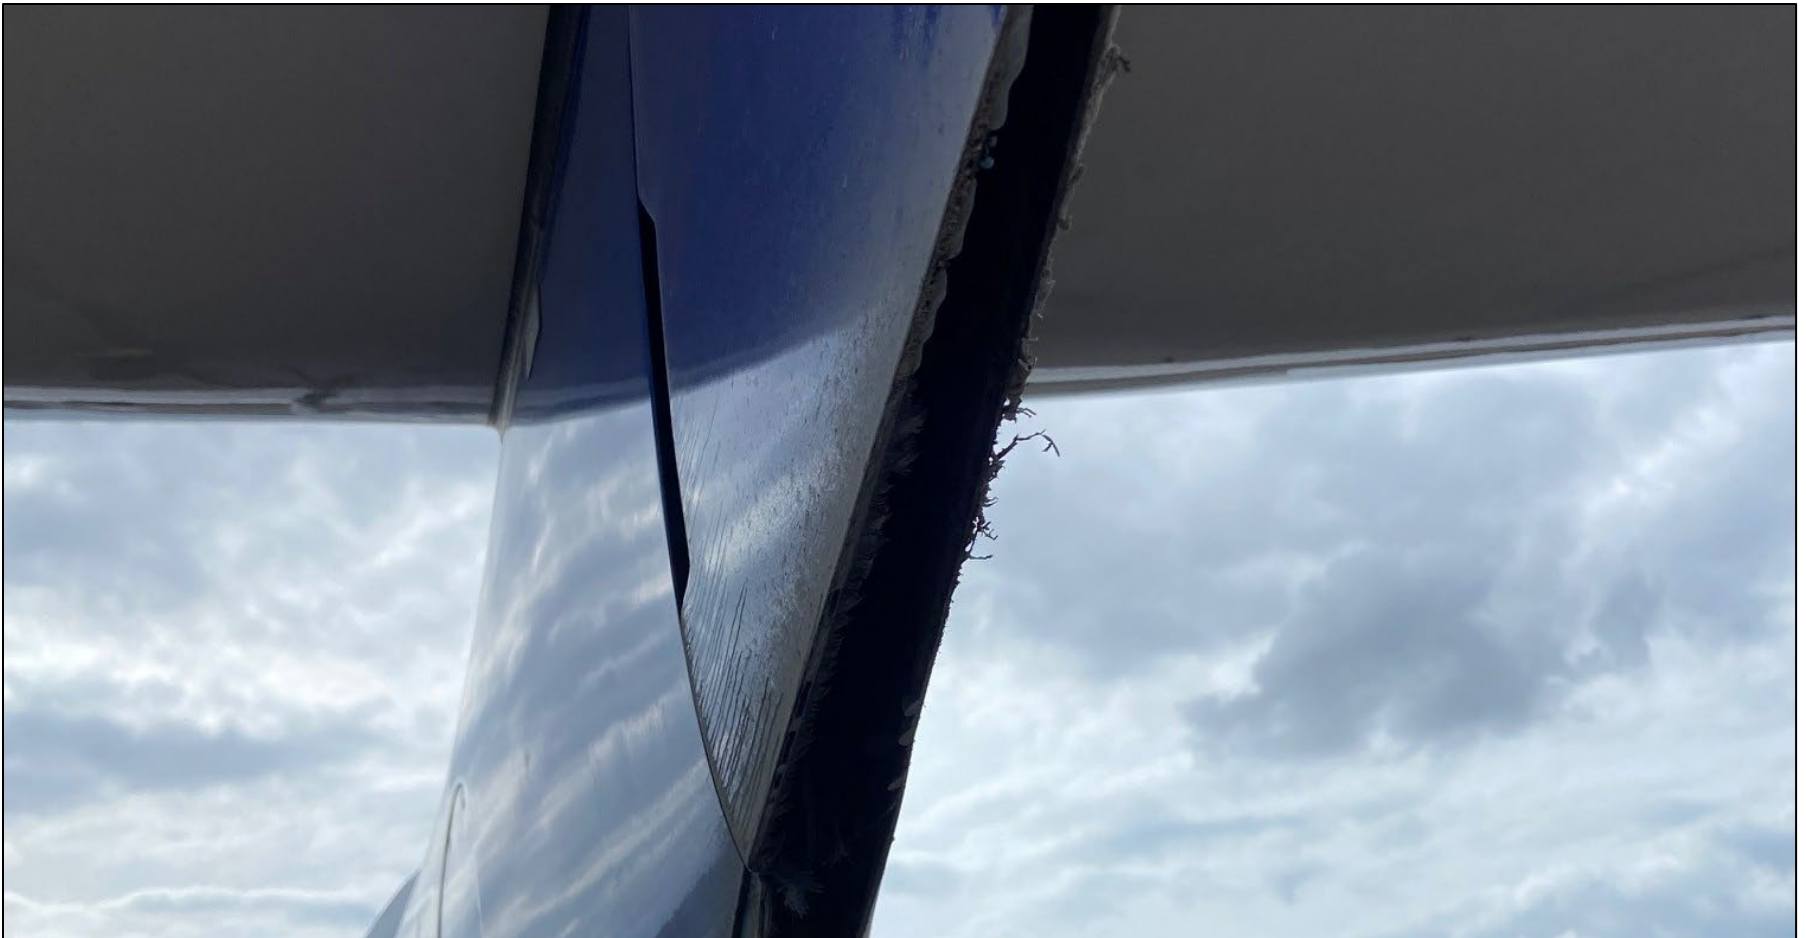
**Photo 1: View of the lower rudder damage (Photo Courtesy of FAA)**

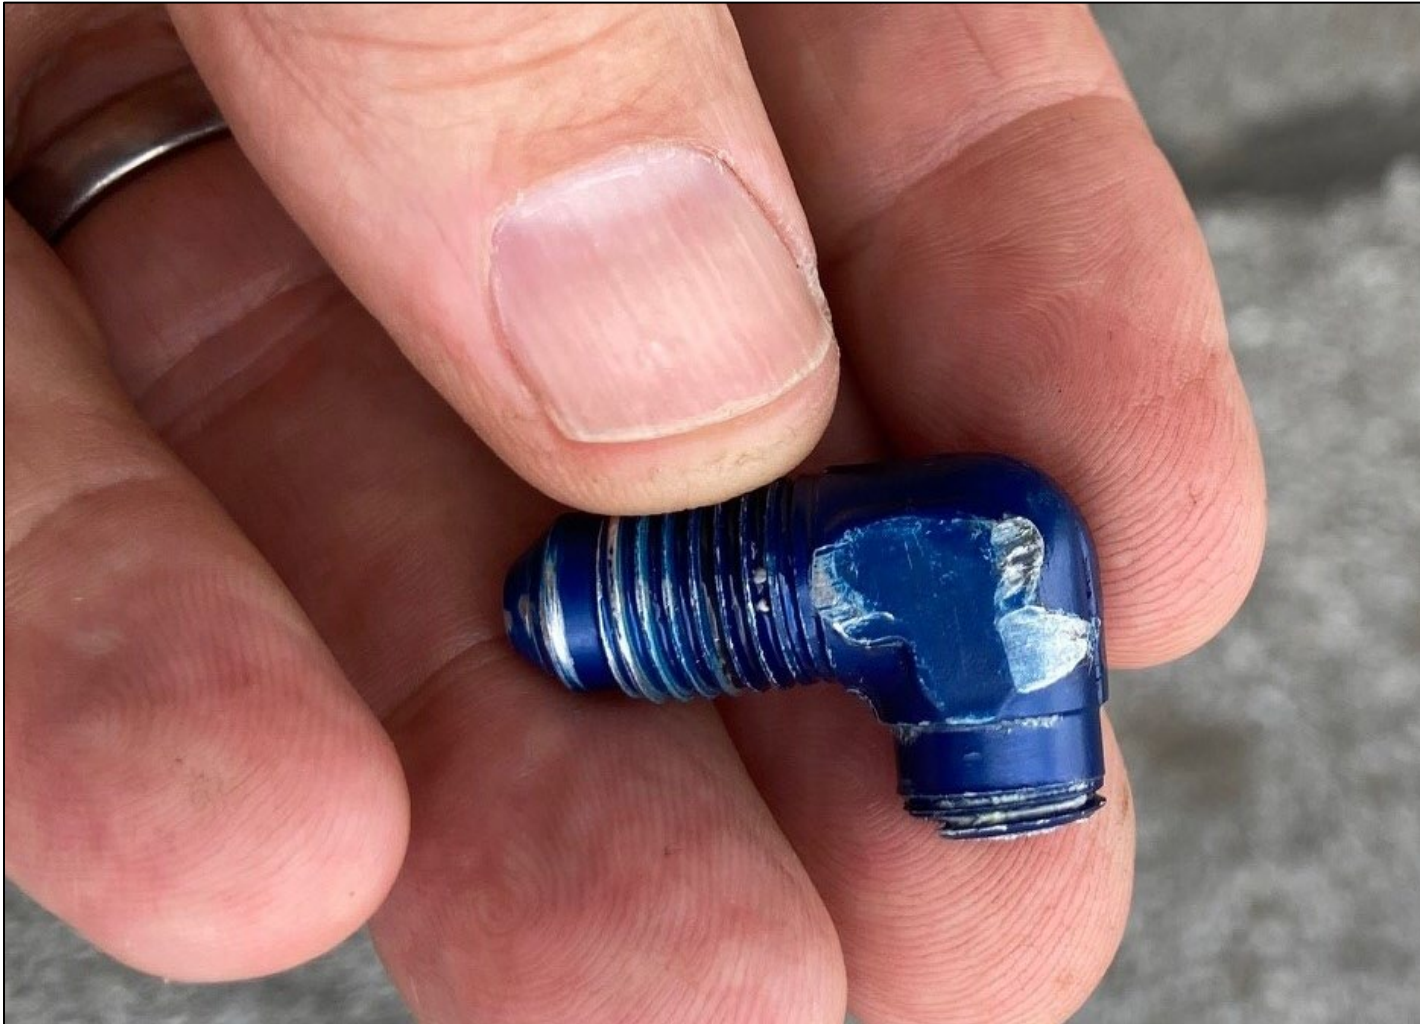
**Photo 2: Nose gear actuator hydraulic fitting (Photo Courtesy of FAA)**

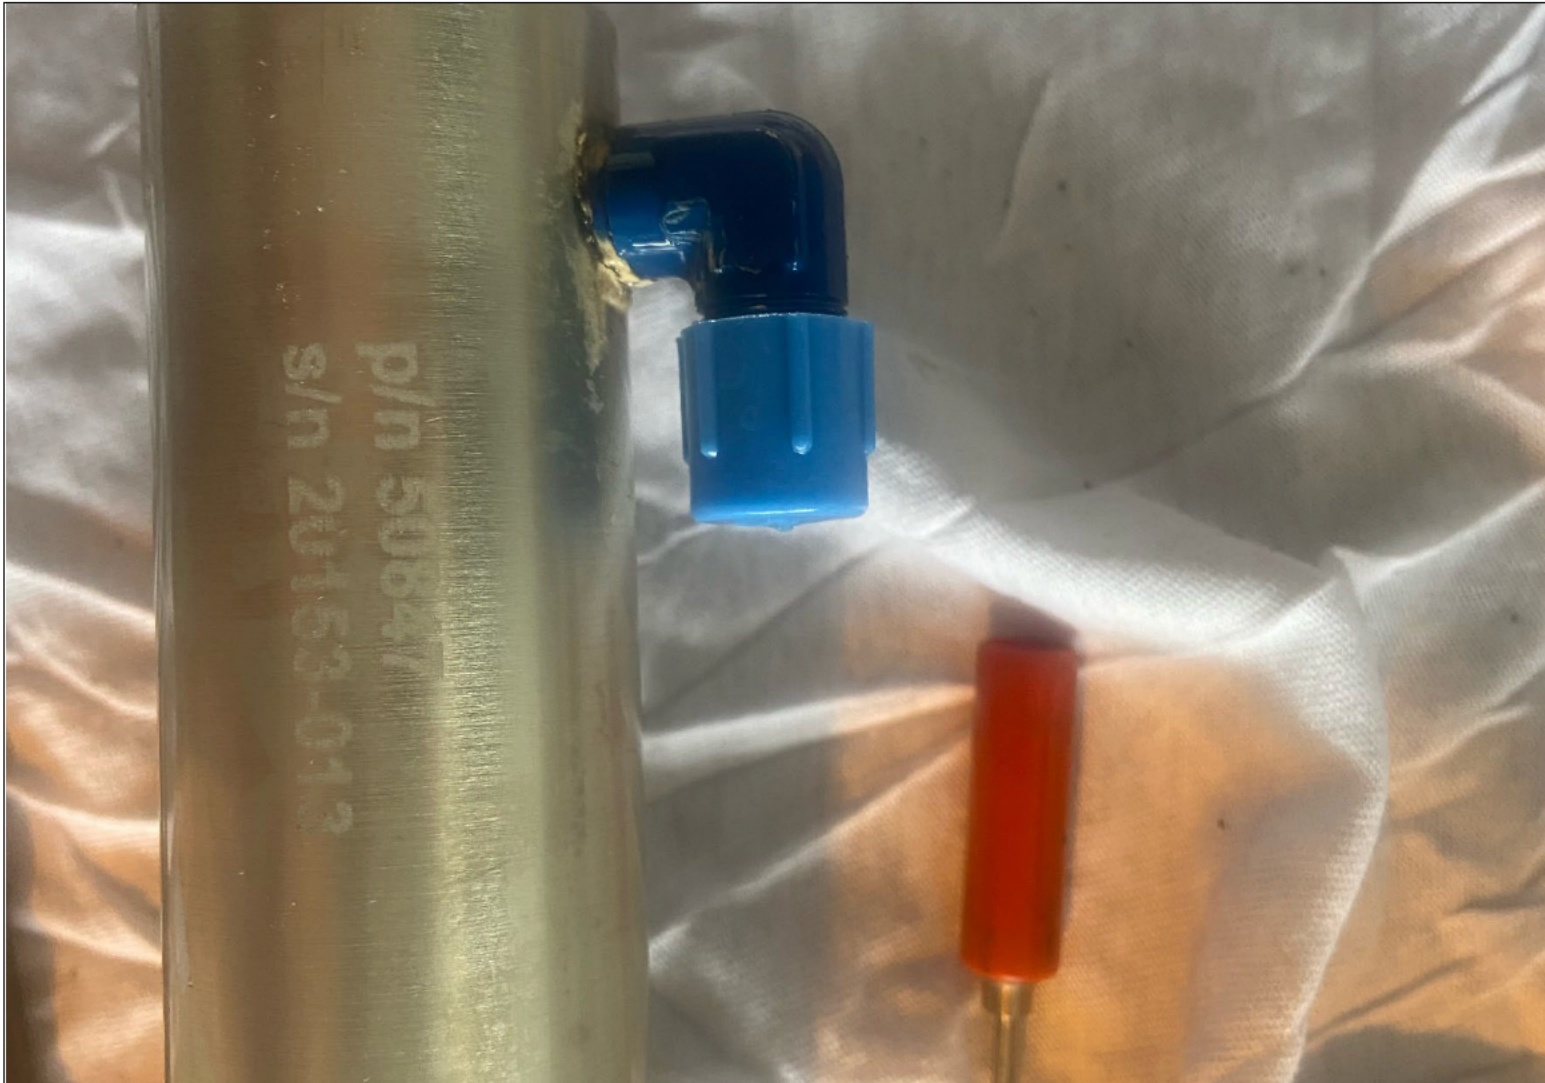
**Photo 3: Exemplar nose gear actuator with hydraulic fitting installed and capped Preaccident (Photo Courtesy of Operator)**

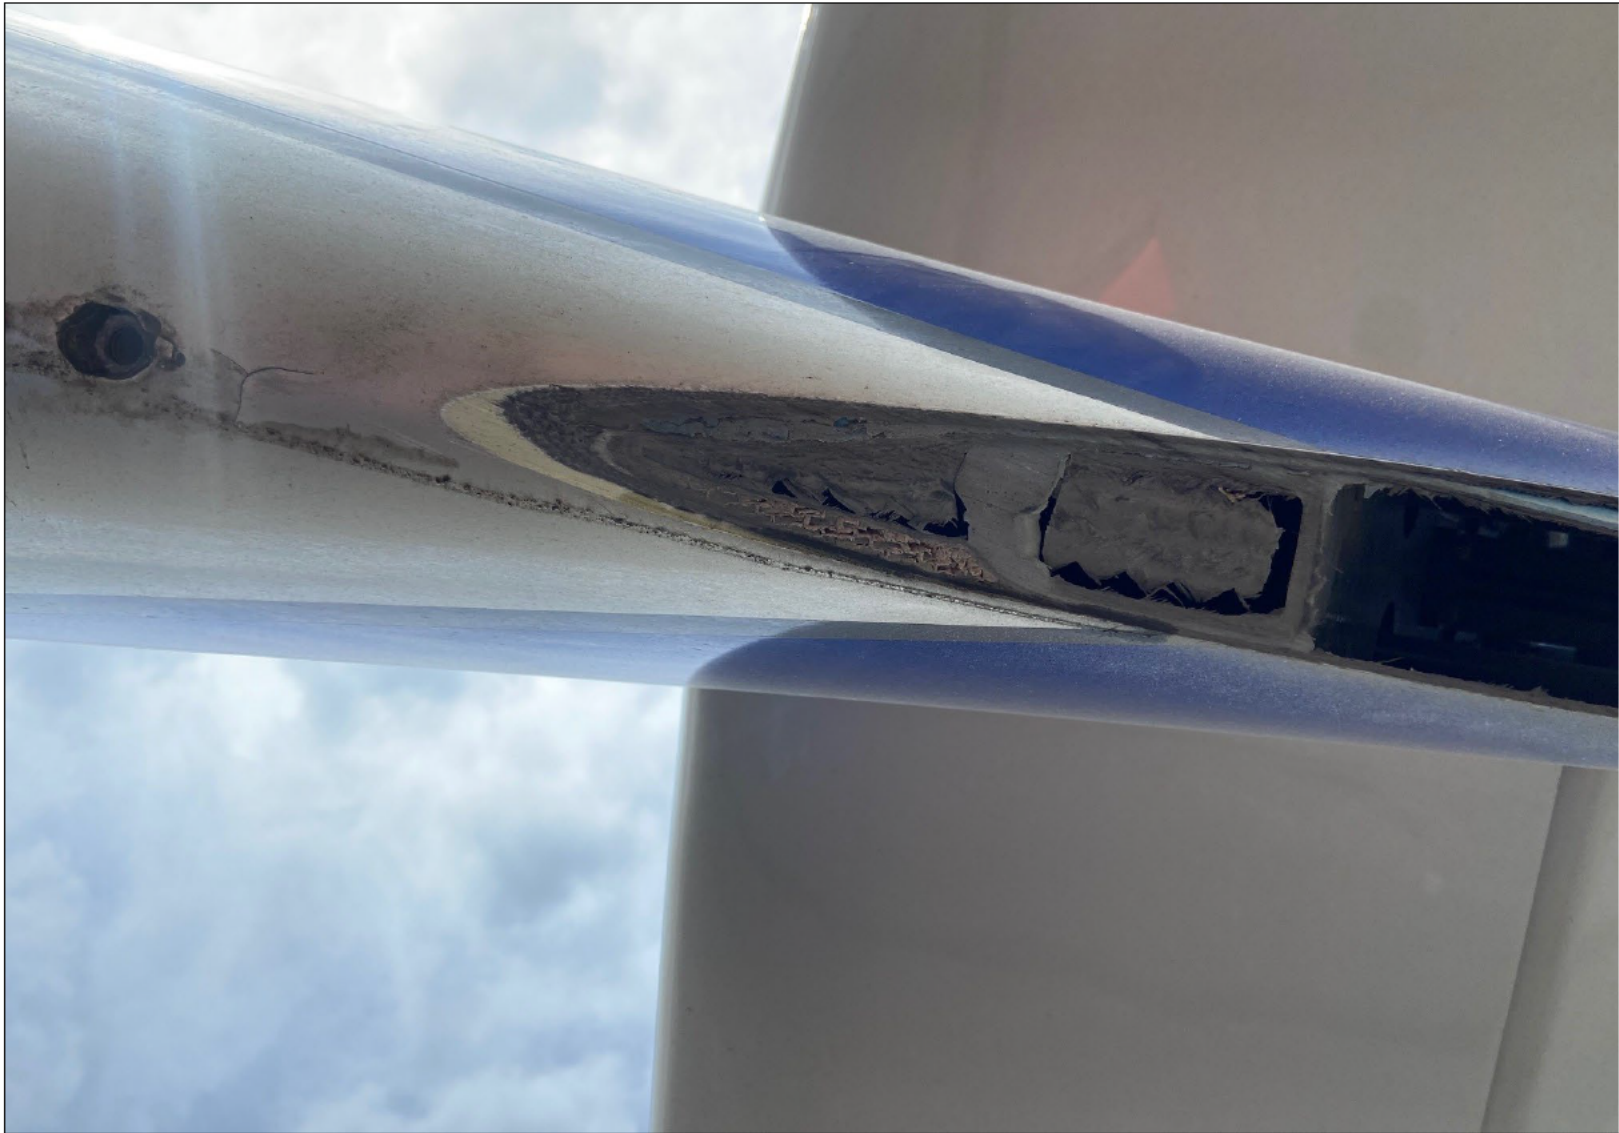
**Photo 4: Empennage and rudder damage (Photo Courtesy of FAA)**

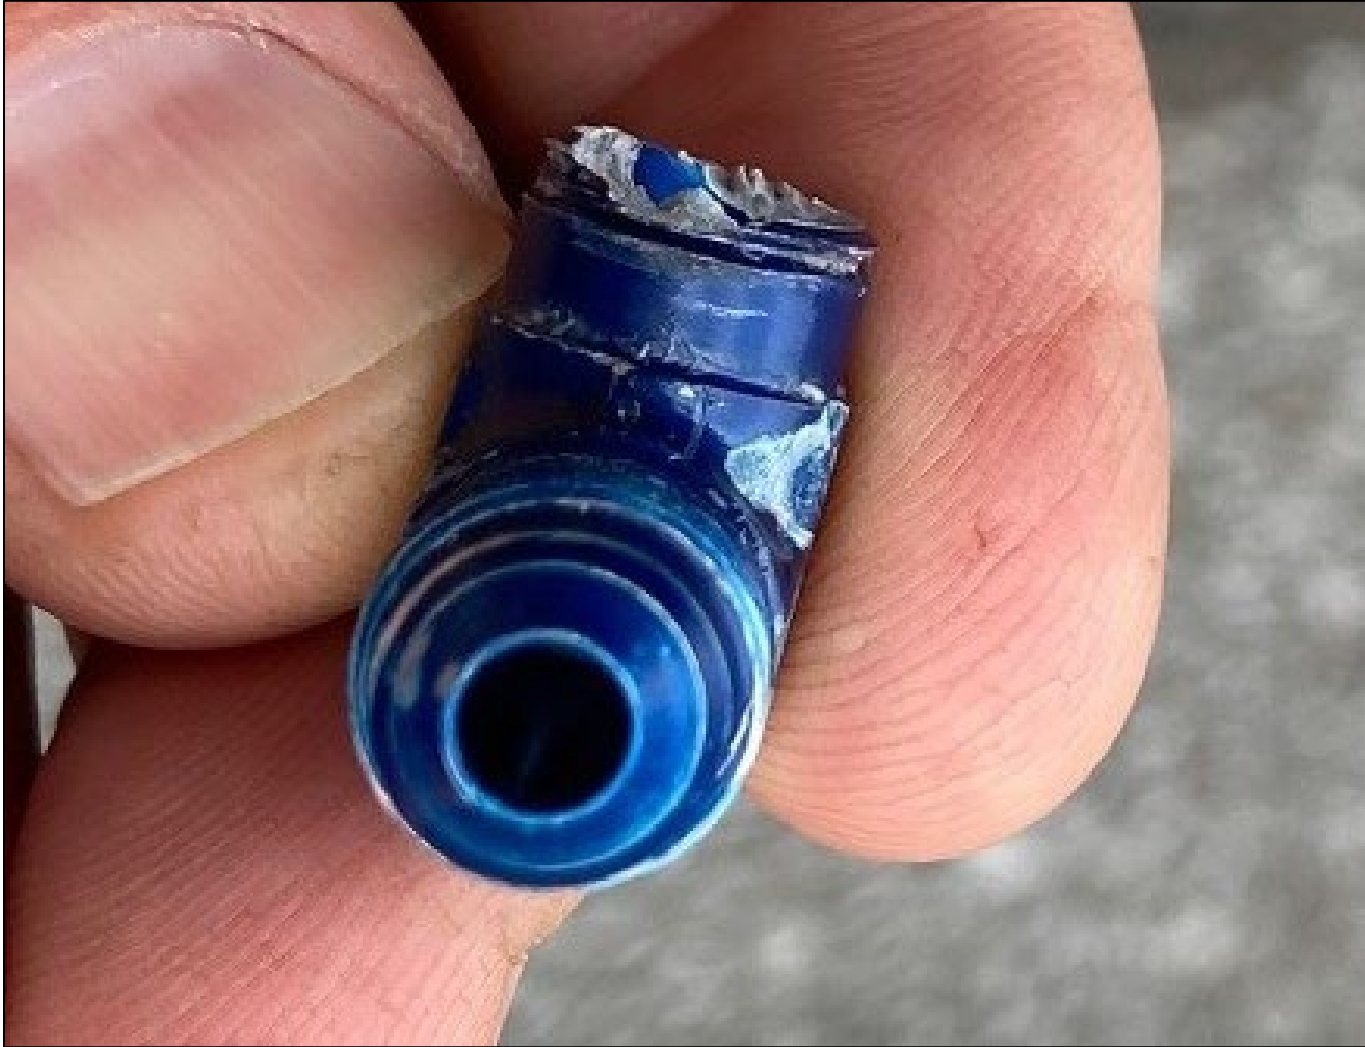
**Photo 5: Additional view of the nose gear actuator hydraulic fitting (Photo Courtesy of Operator)**

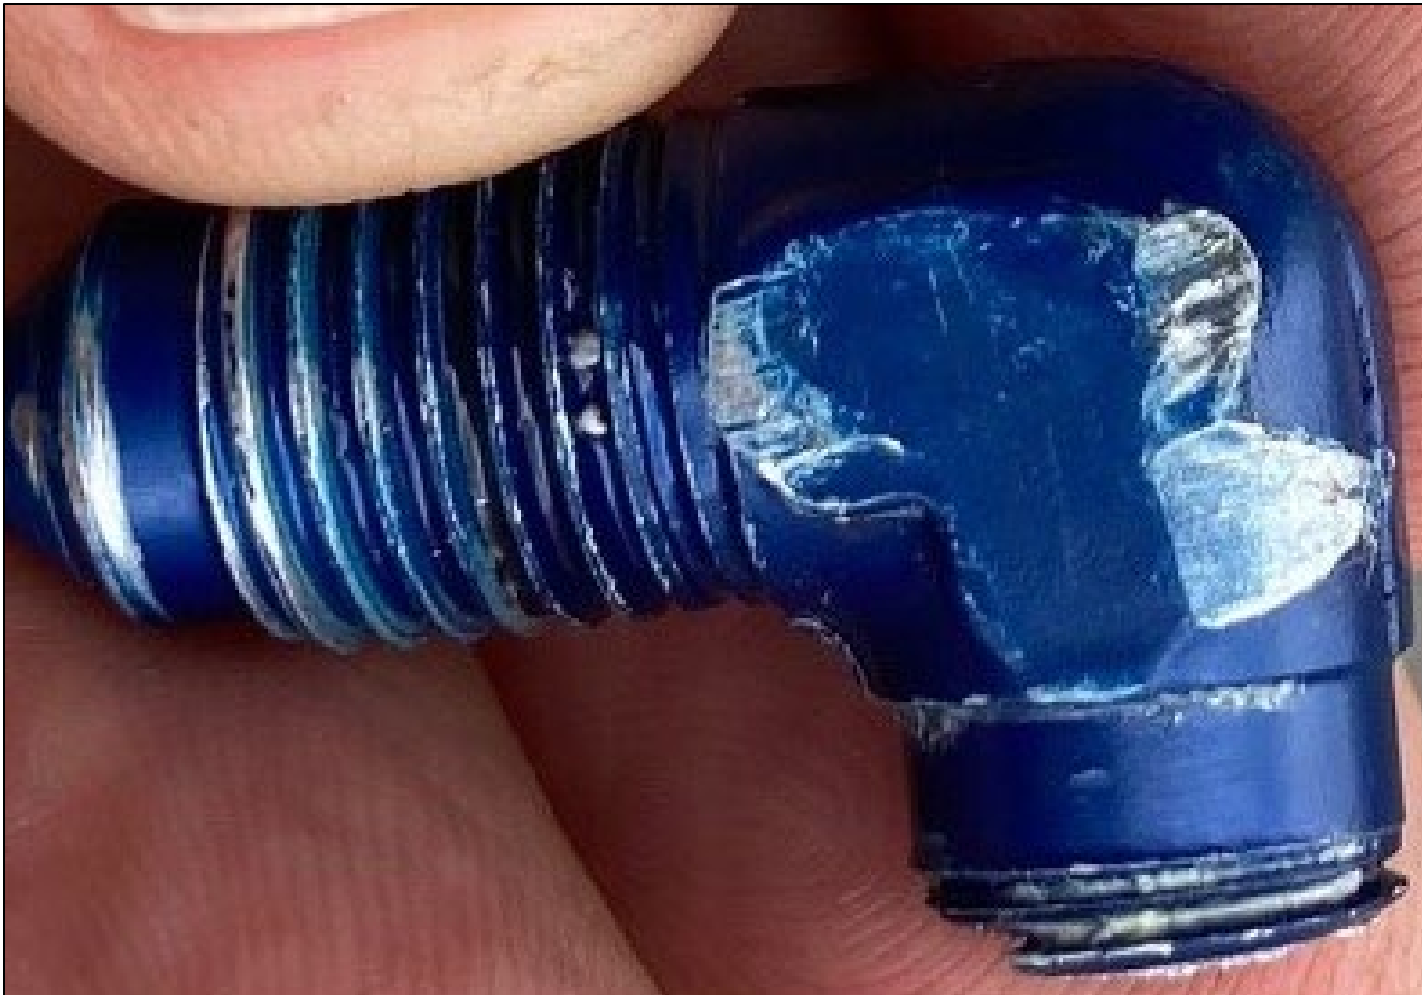
**Photo 6: Additional view of the nose gear actuator hydraulic fitting (Photo Courtesy of Operator)**
