ERA24LA173

## INVESTIGATION PHOTOGRAPHS

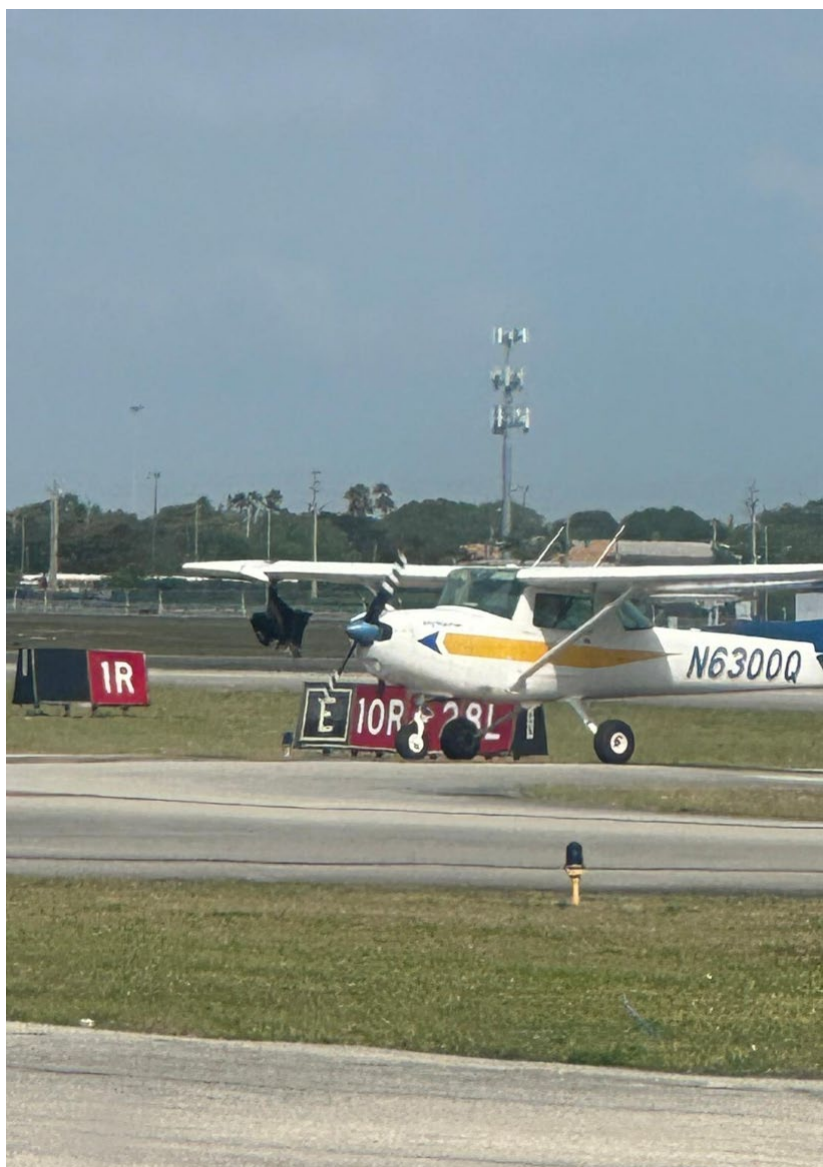
**Photograph 1 - N6300Q Landing After Bird Strike (Courtesy of FAA)**

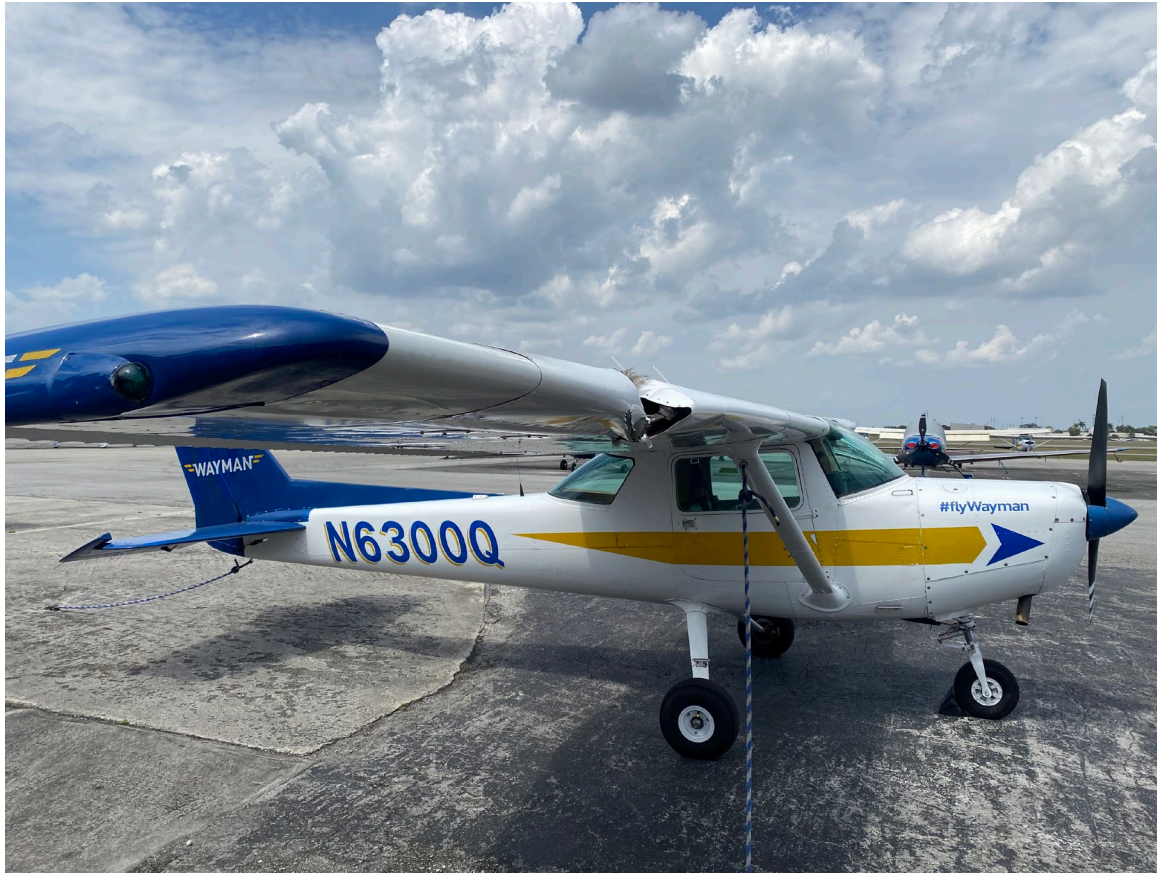
**Photograph 2 - Right Wing Damage (Courtesy of FAA)**

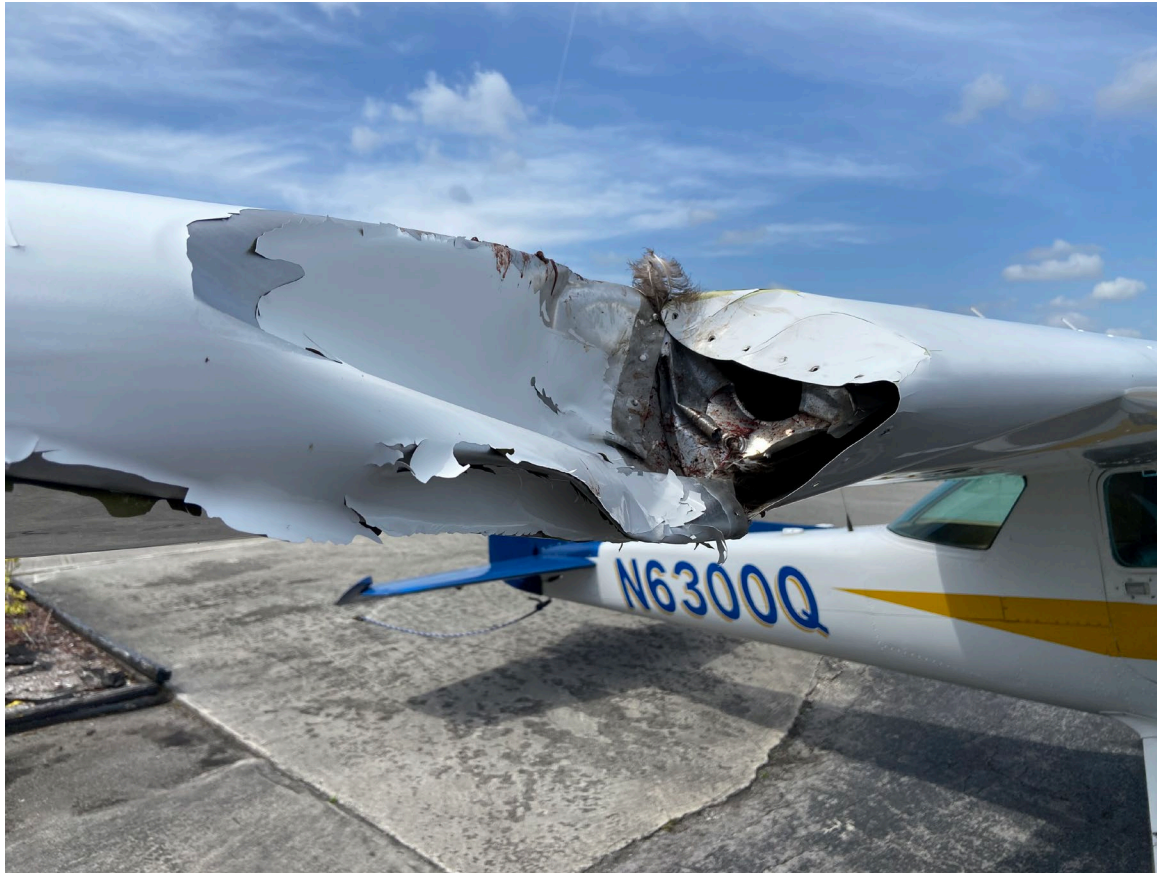
**Photograph 3 - Right Wing Damage (Courtesy of FAA)**

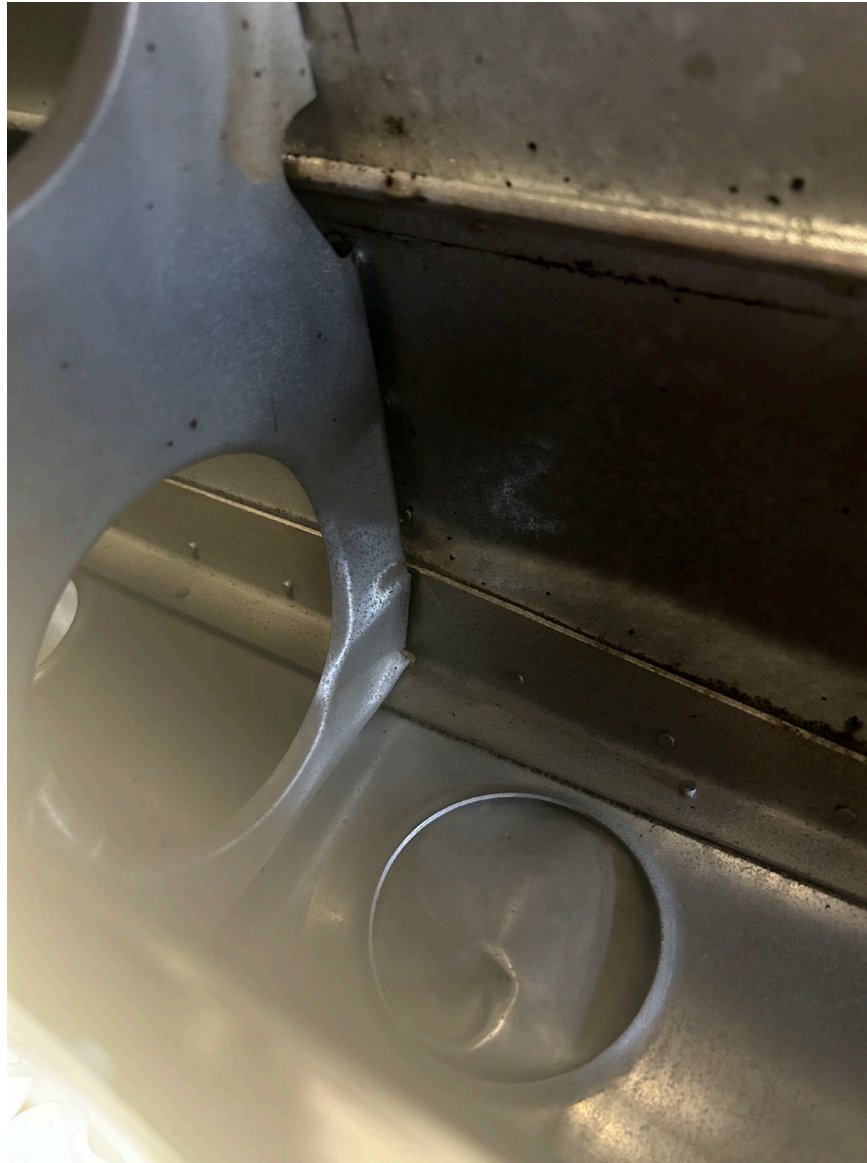
**Photograph 4 - Right Wing Spar Damage (Courtesy of FAA)**
