ERA24LA178

## INVESTIGATION PHOTOGRAPHS

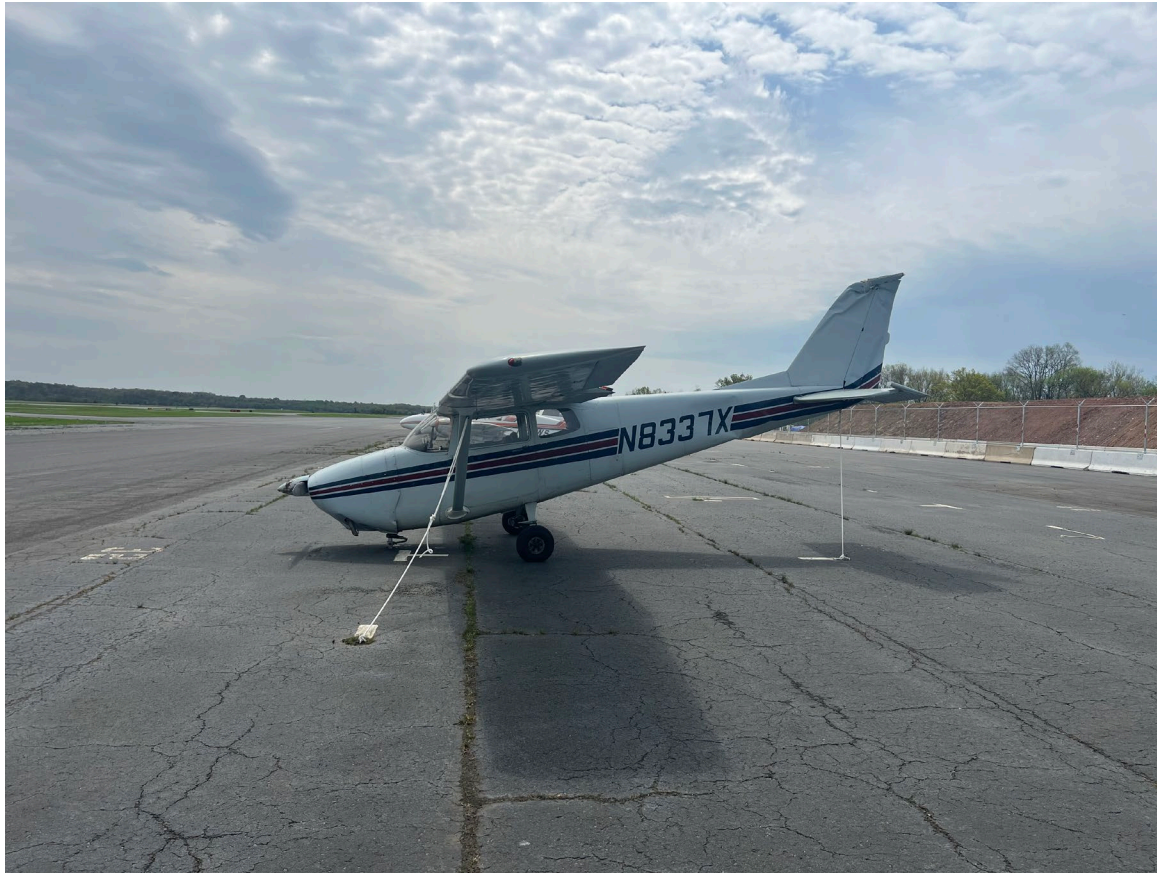
**Photograph 1 - Digital Photograph From Airplane Owner. Left Side View of the Airplane Following Recovery**

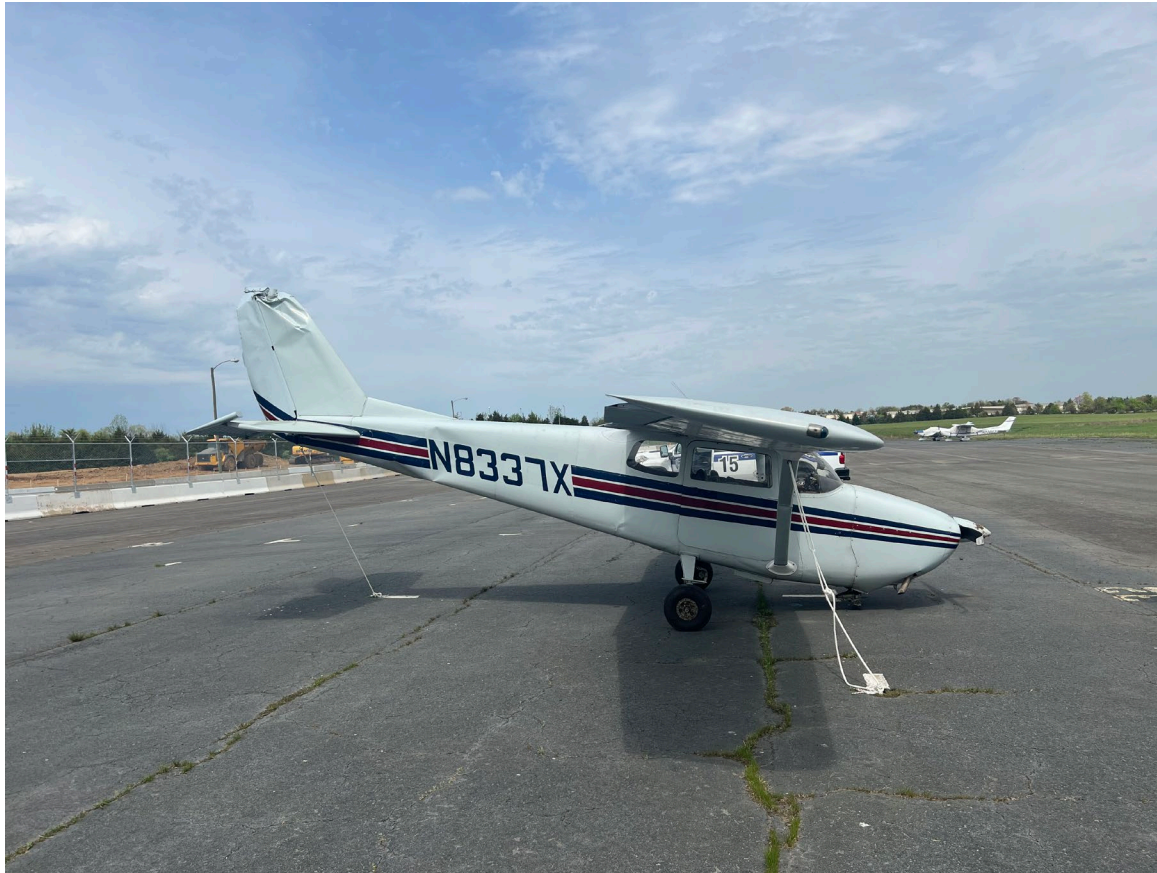
**Photograph 2 - Digital Photograph From Airplane Owner. Right Side View of the Airplane Following Recovery. Note the Substantial Damage to the Vertical Stabilizer**

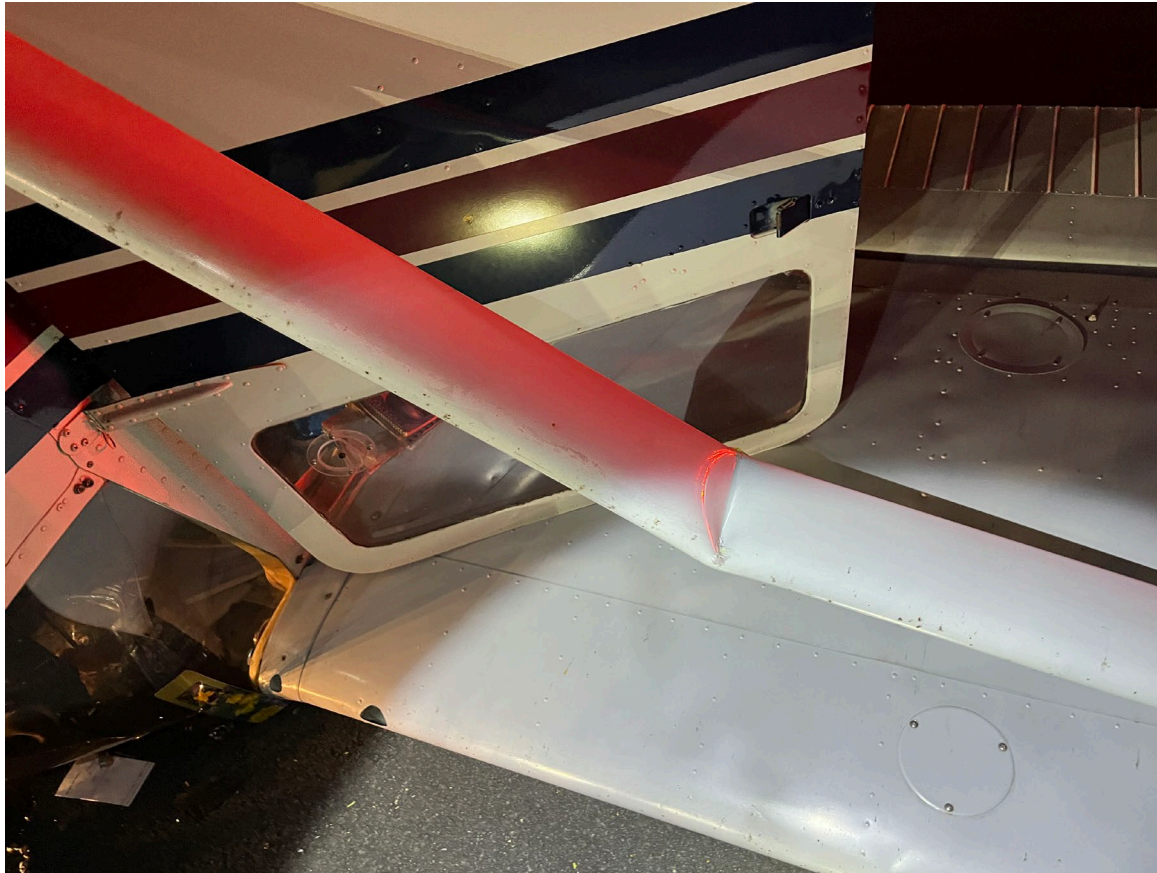
**Photograph 3 - Digital Photograph From Airport Personnel. View of Damaged Right Wing Lift Strut**
