ERA24LA179

## INVESTIGATION PHOTOGRAPHS

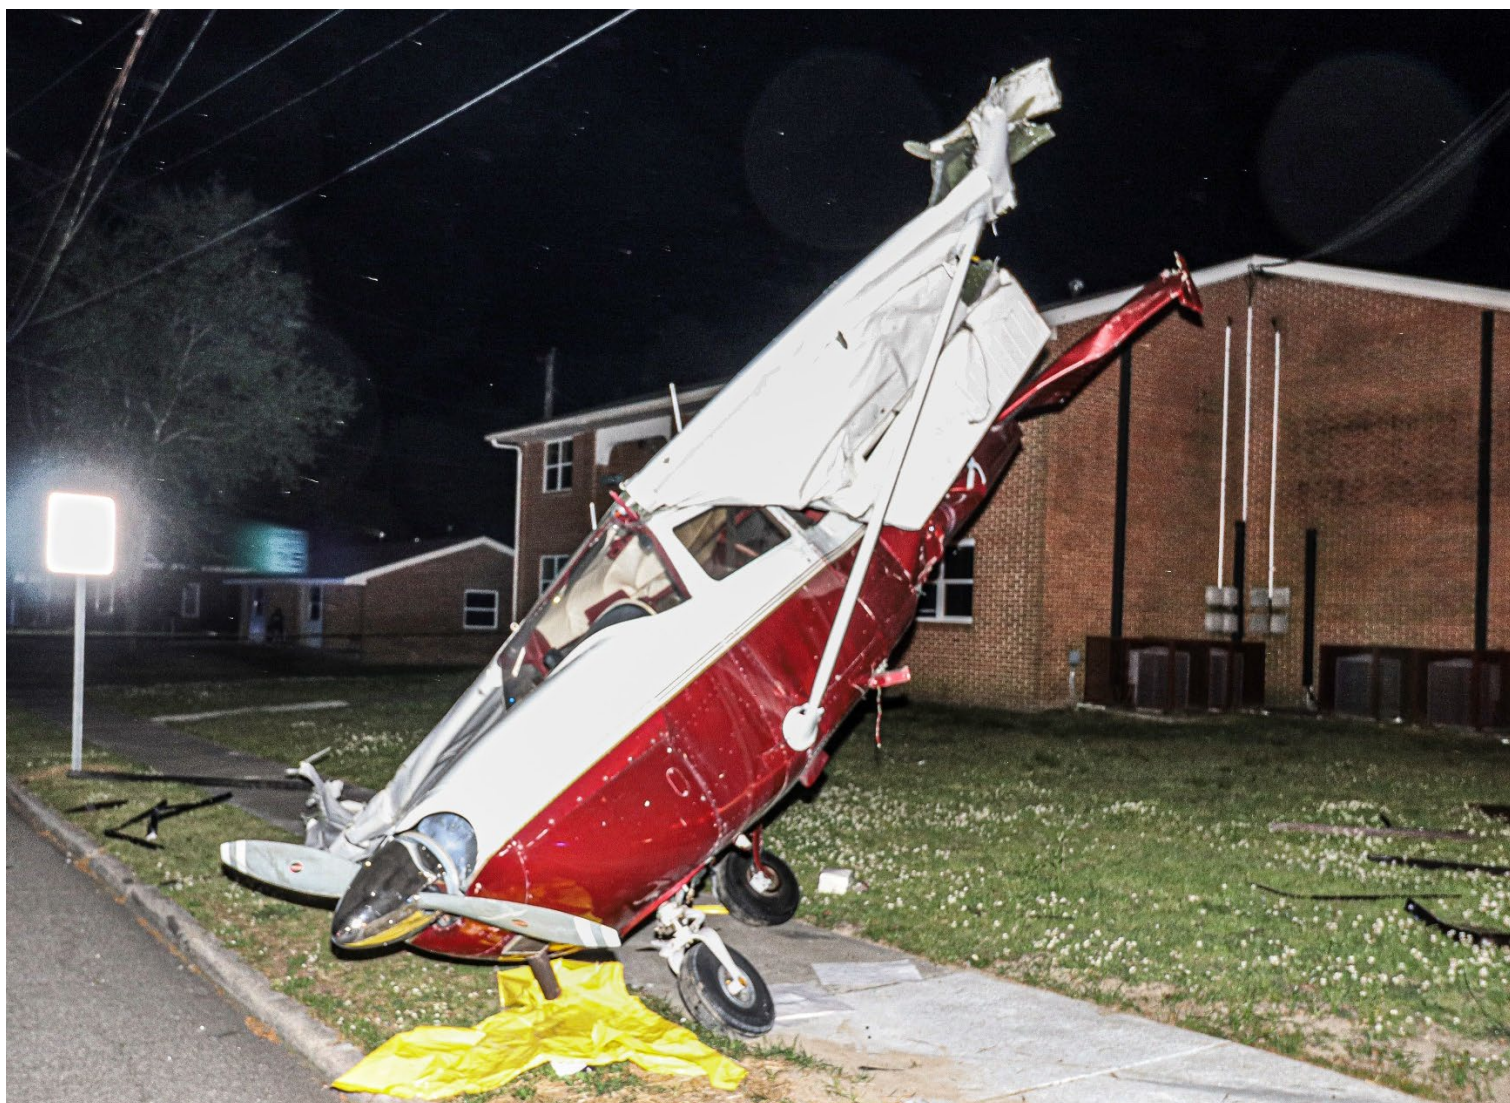
**Photograph 1 - View of airplane at accident site. (Courtesy of FAA)**

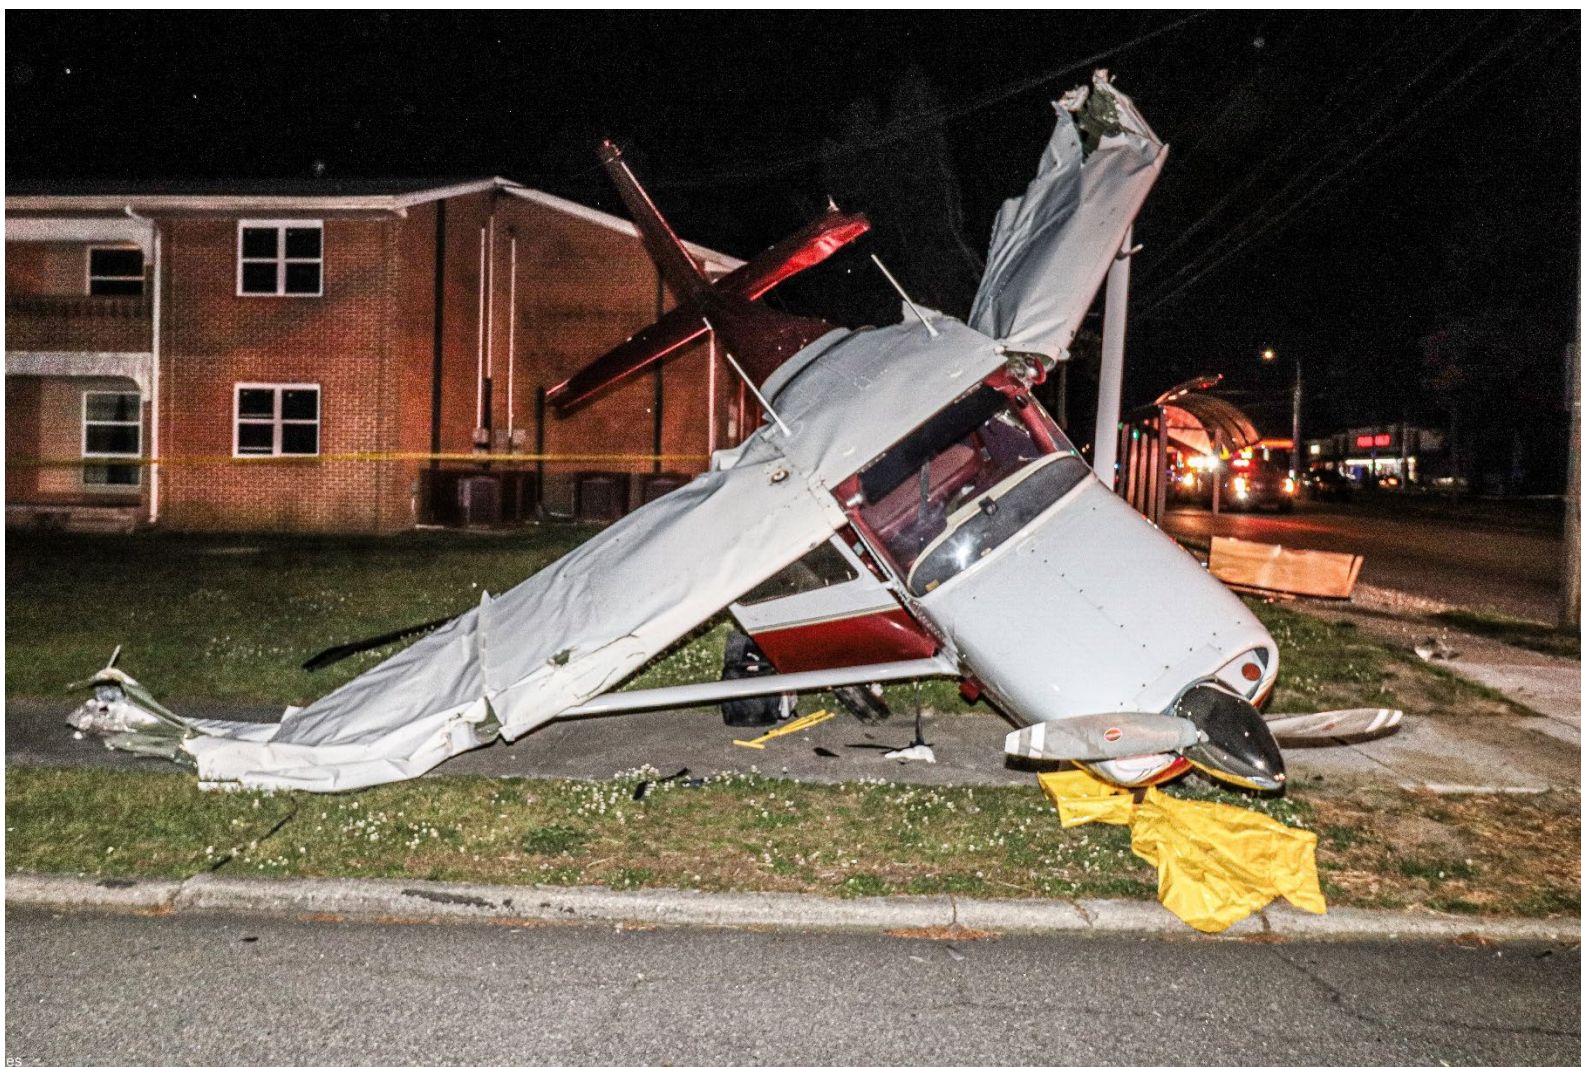
**Photograph 2 - View of airplane from front at accident site. (Courtesy of FAA)**

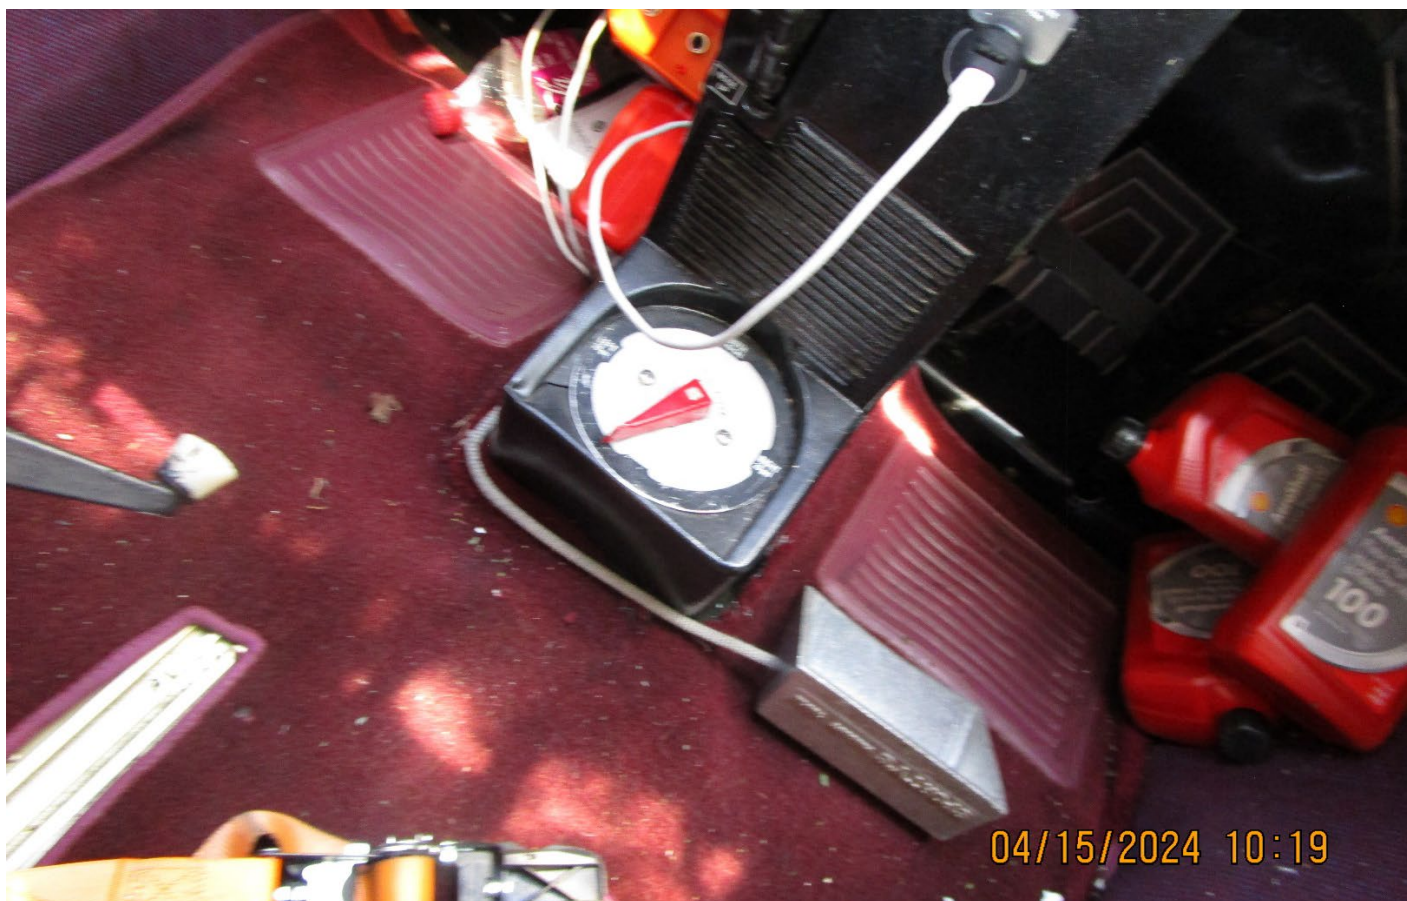
**Photograph 3 - View of fuel selector in OFF position at accident site. (Courtesy of FAA)**

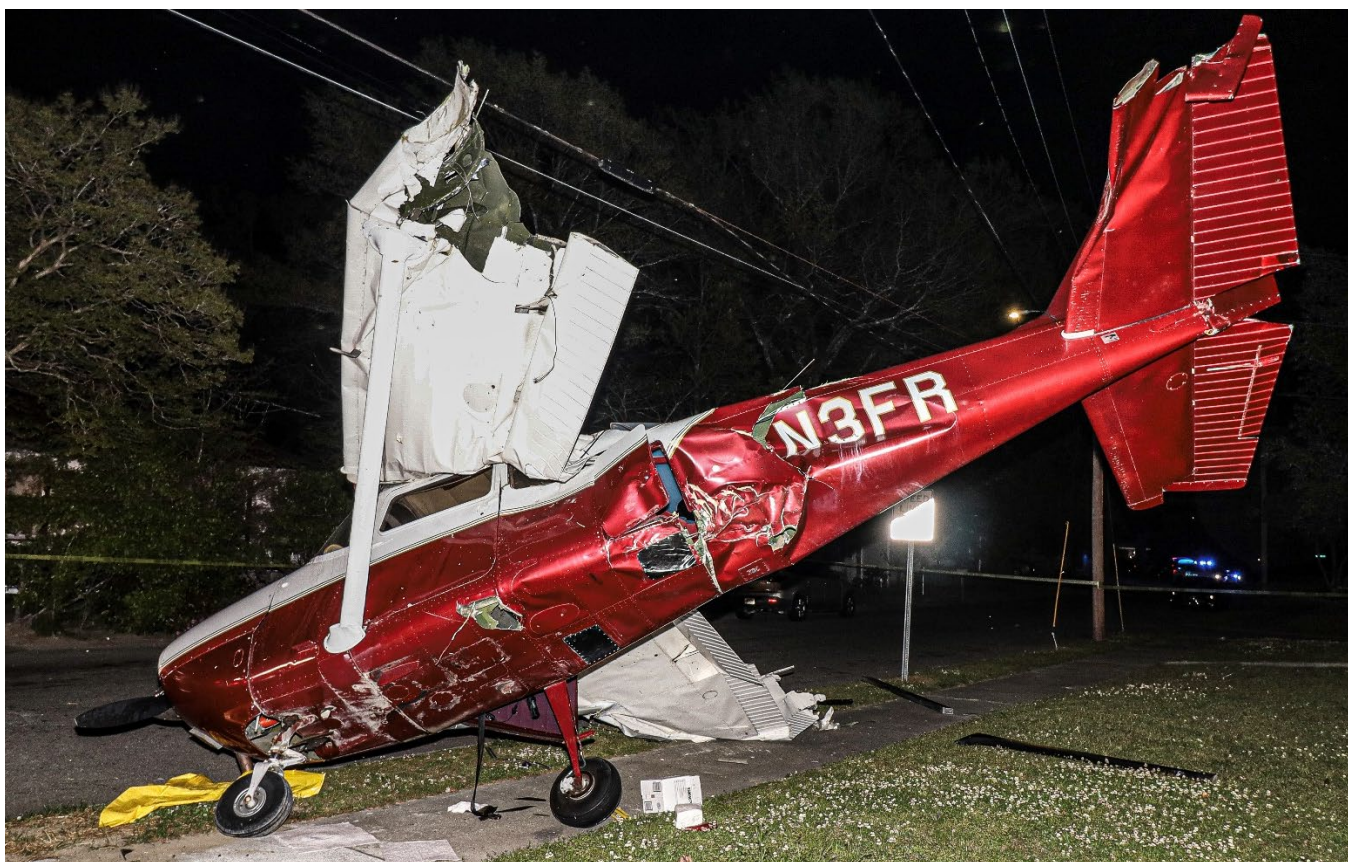
**Photograph 4 - View of airplane from left at accident site. (Courtesy of FAA)**

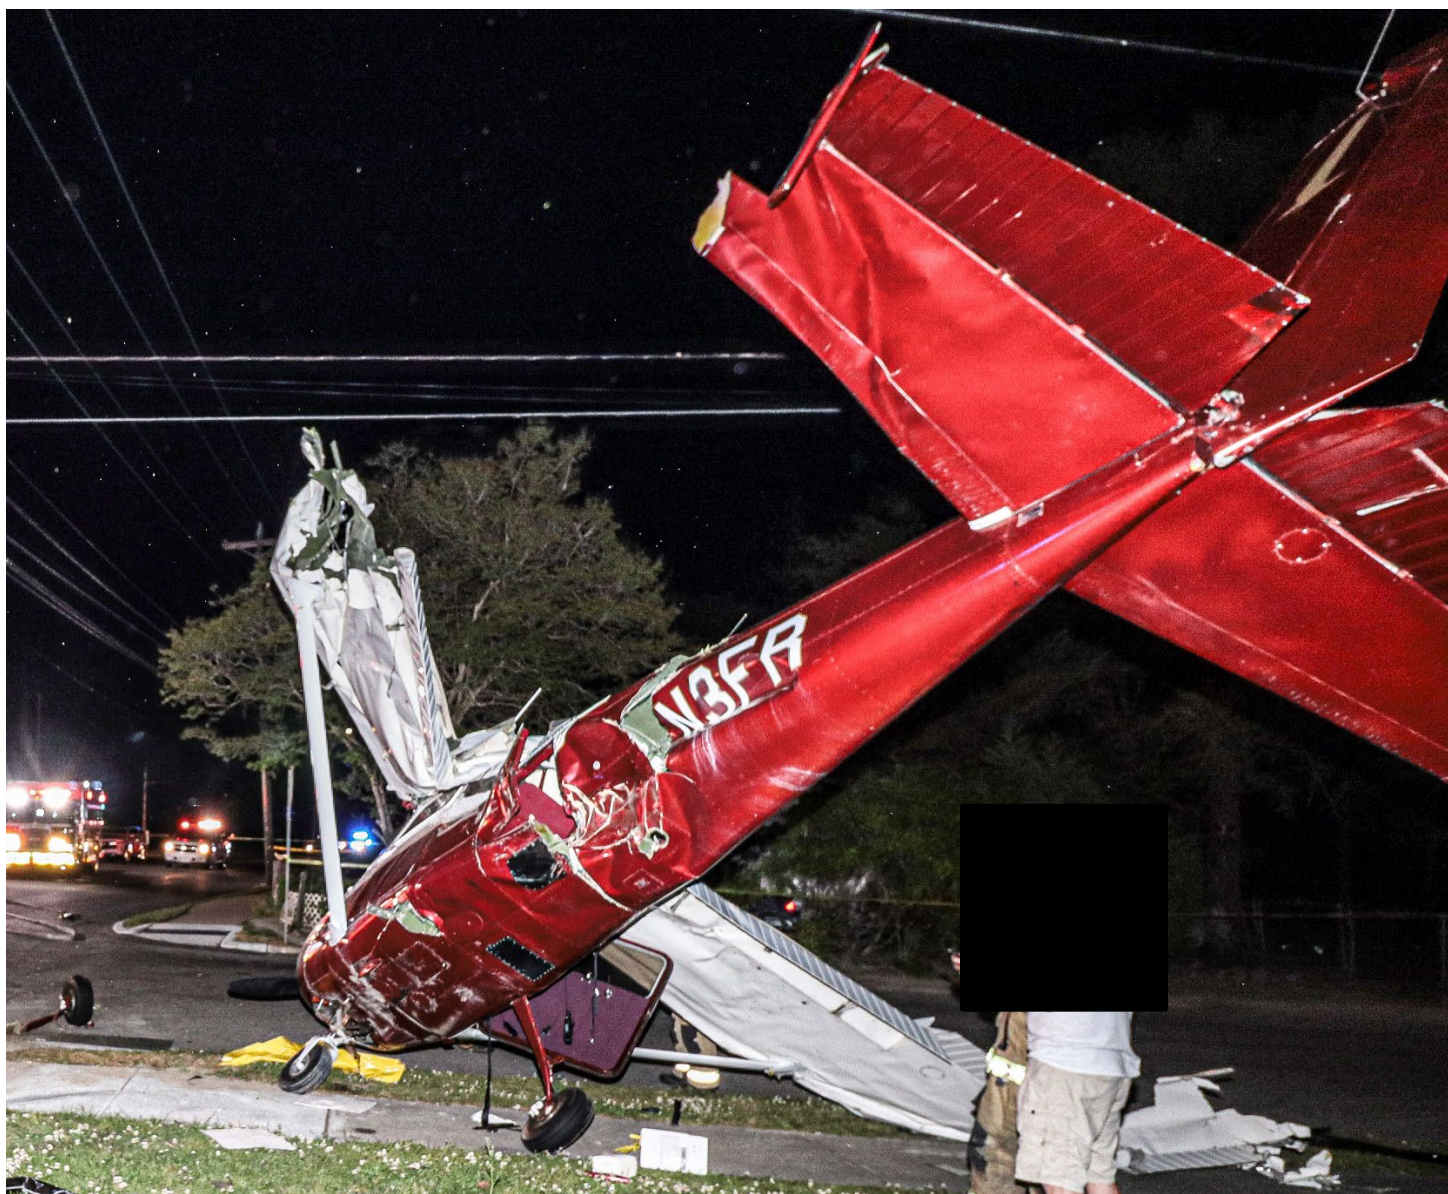
**Photograph 5 - View of airplane from rear at accident site. (Courtesy of FAA)**

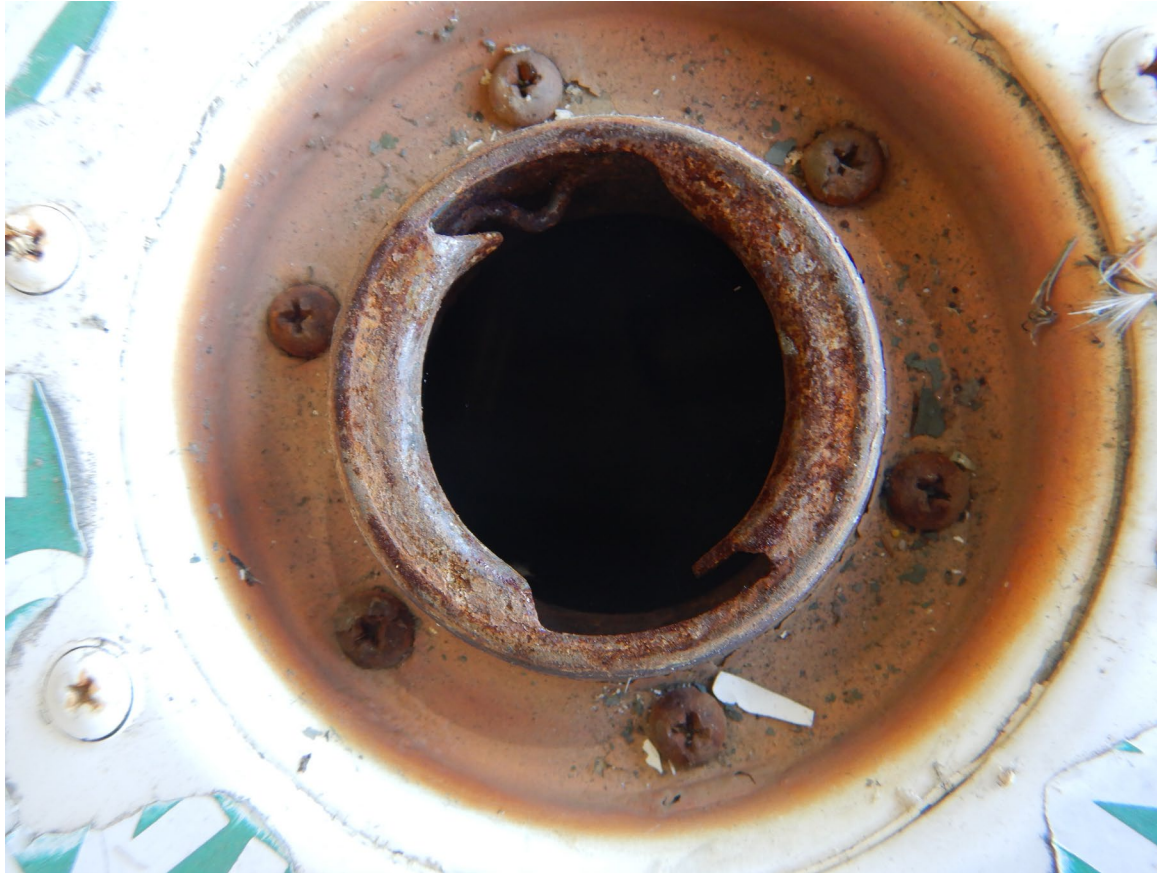
**Photograph 6 - Left wing fuel filler port showing rust.**

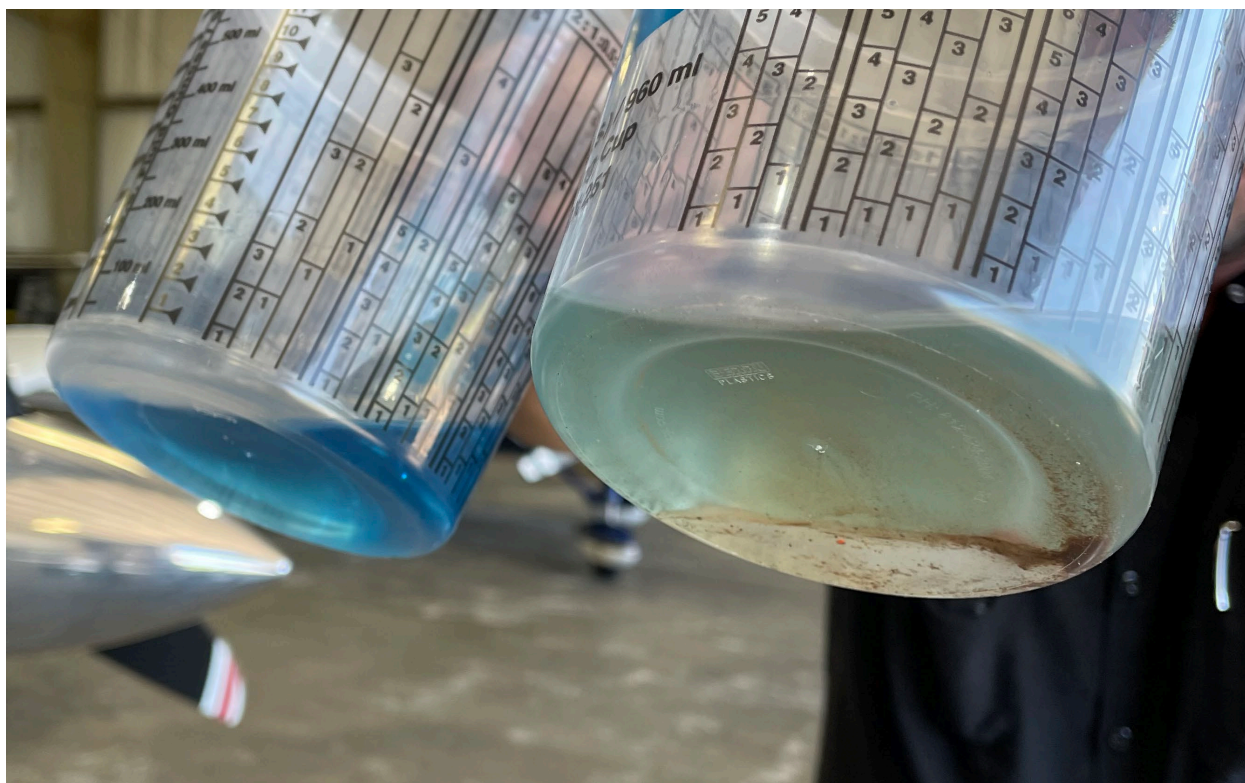
**Photograph 7 - Fuel from left wing (left) and from gascolator and carburetor bowls (right).**
