# National Transportation Safety Board

ERA24LA179

## ENGINE EXAMINATION

N3FR, Cessna R172E

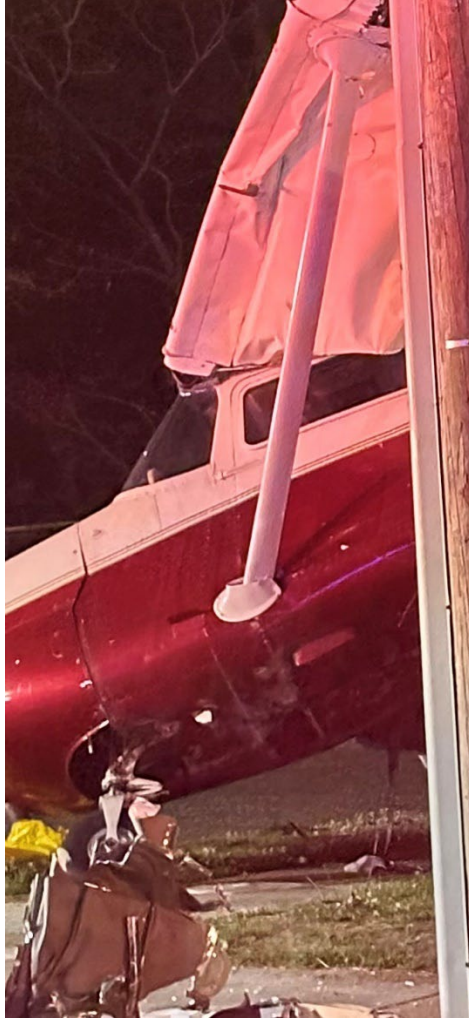
After an uneventful night cross country flight, a few minutes after the pilot reduced engine power to begin the descent, the engine lost power and the propeller continued to windmill. After remedial action failed to restore engine power, the pilot performed a forced landing to a lit road.

**Photo 1- Photo taken by pilot after forced landing (Courtesy of pilot)**

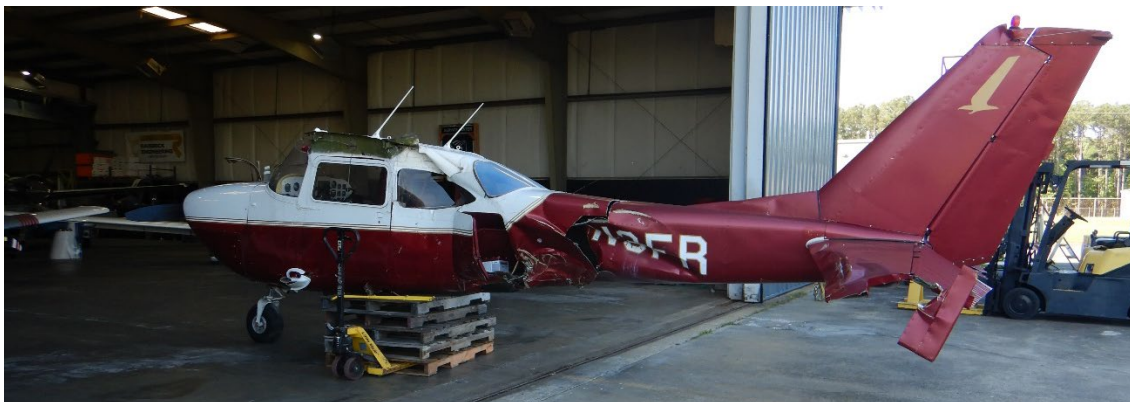
As first viewed, the fuselage and empennage remained intact, and the engine remained attached at its mounts. The empennage was impact crushed on the left side aft of the rear seats and showed deformation on the right side aft of the rear seats. Both wings had been cut for recovery. The tail was intact and undamaged except for the left horizontal stabilizer which sustained substantial damage. The left main landing gear was impact separated from the fuselage.

**Photo 2 - View of airplane from the left (wings removed for recovery).**

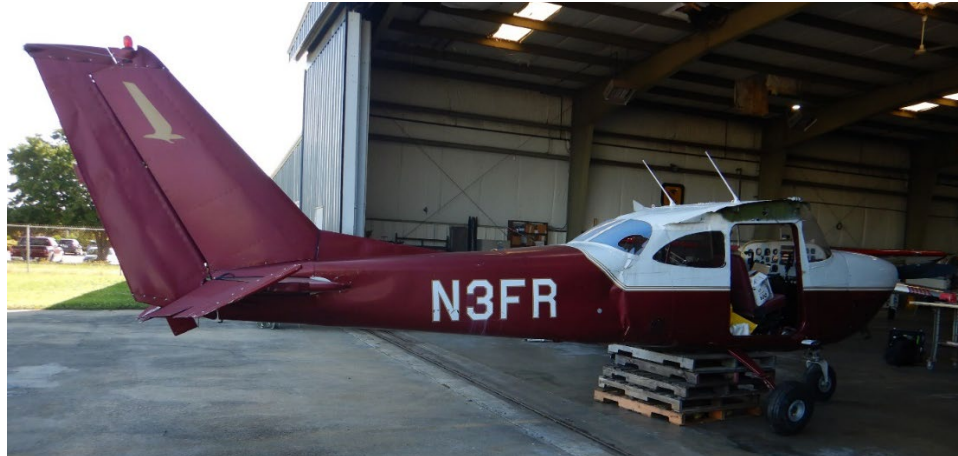
**Photo 3 - View of airplane from the right (wings removed for recovery).**

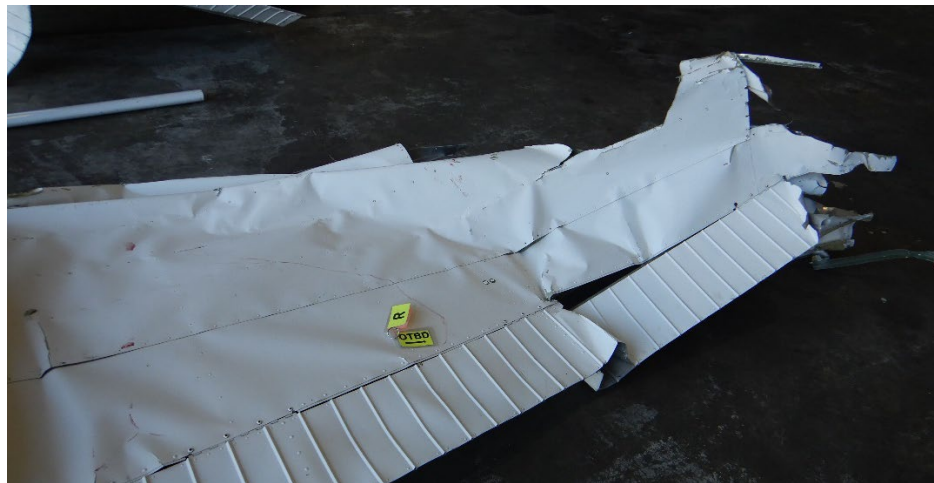
Both wings were substantially impact damaged. The left wing was in two sections, and the fuel tank was fractured. Liquid recovered from the left tank was consistent in color and smell to aviation fuel and free of water and contaminants. The right wing fuel cap was not in place, and no fuel was recovered from the right tank. When the right filler port was covered, air was blown into the right fuel tank and the tank expanded with no leaks readily evident.

**Photo 4 - View of the outboard right wing.**

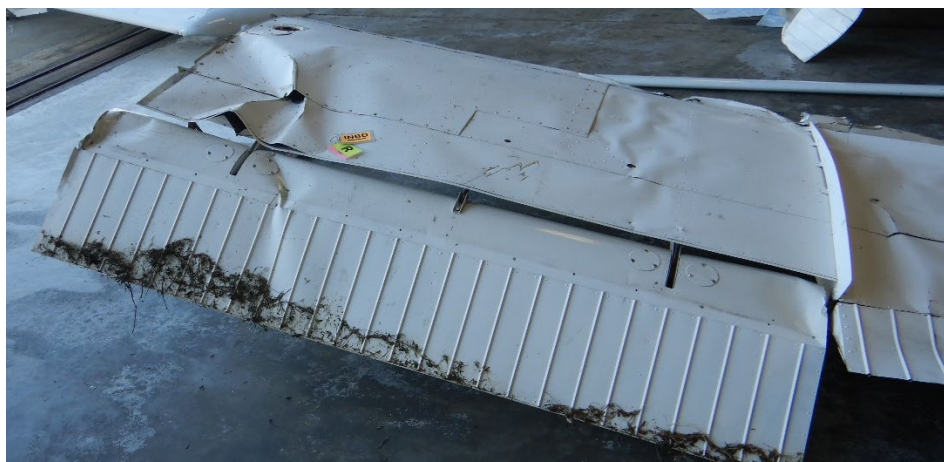
**Photo 5 - View of the inboard right wing.**

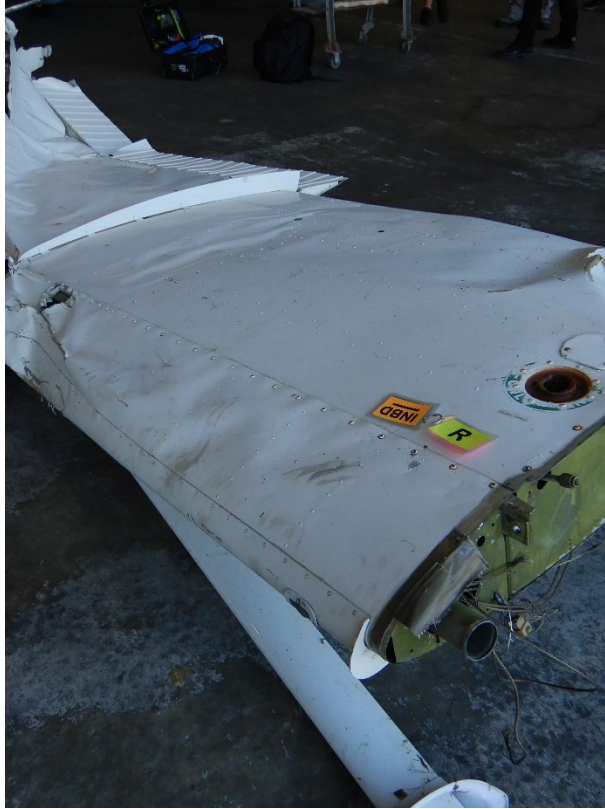
**Photo 6 - View of right wing root with missing fuel cap.**

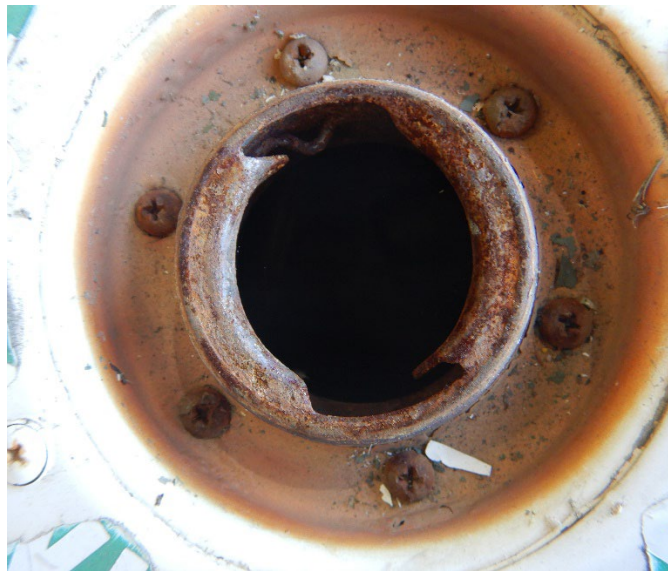
**Photo 7 - View of the right fuel tank filler neck with rust.**

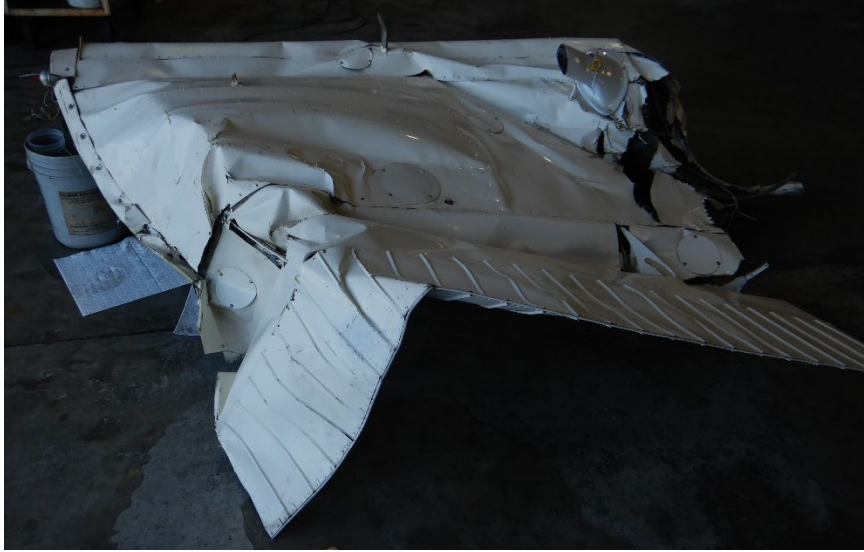
**Photo 8 - View of the inboard section of left wing (inverted).**

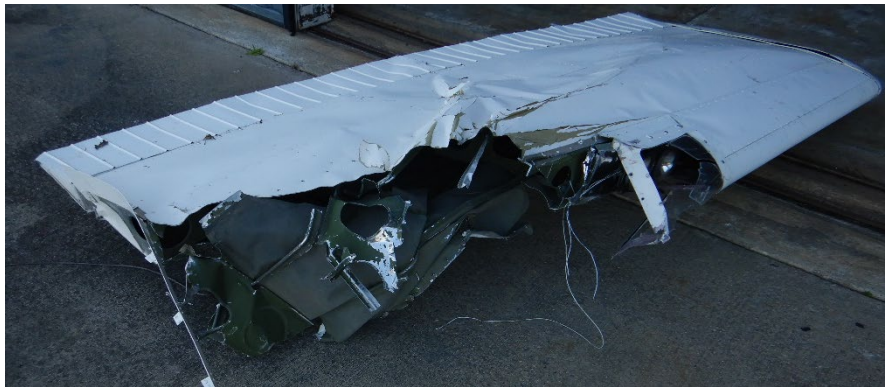
**Photo 9 - View of the outboard section of left wing.**

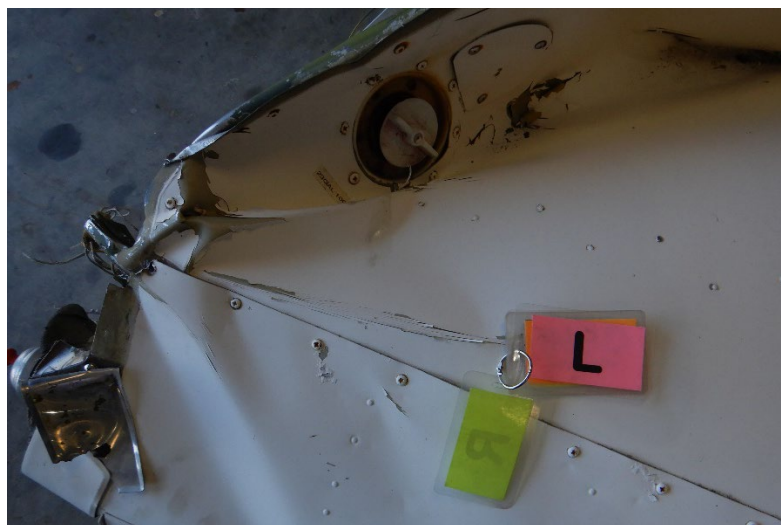
**Photo 10 - Left tank fuel port with fuel cap in place.**

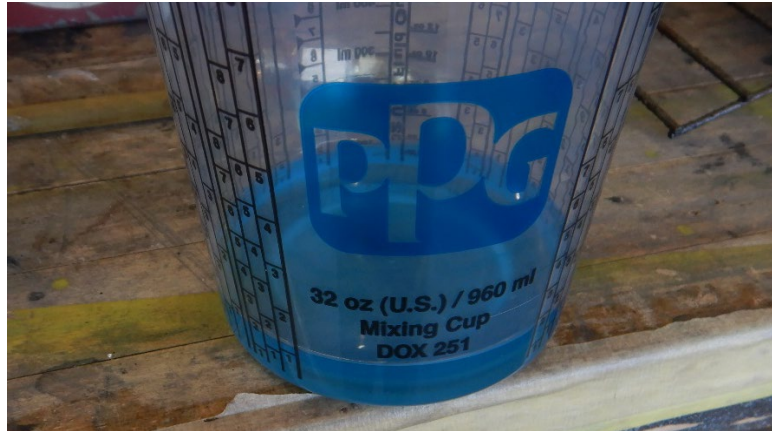
**Photo 11 - Fuel sample recovered from left wing fuel tank.**

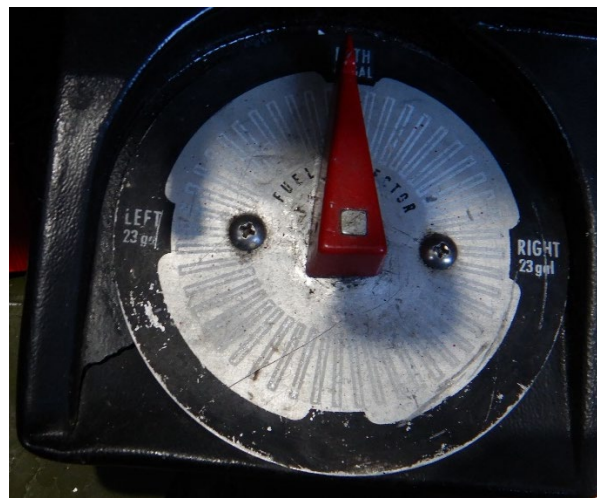
Fuel selector - BOTH (Photo taken at the accident site showed fuel selector in OFF position)

**Photo 12 - Fuel selector in BOTH position.**

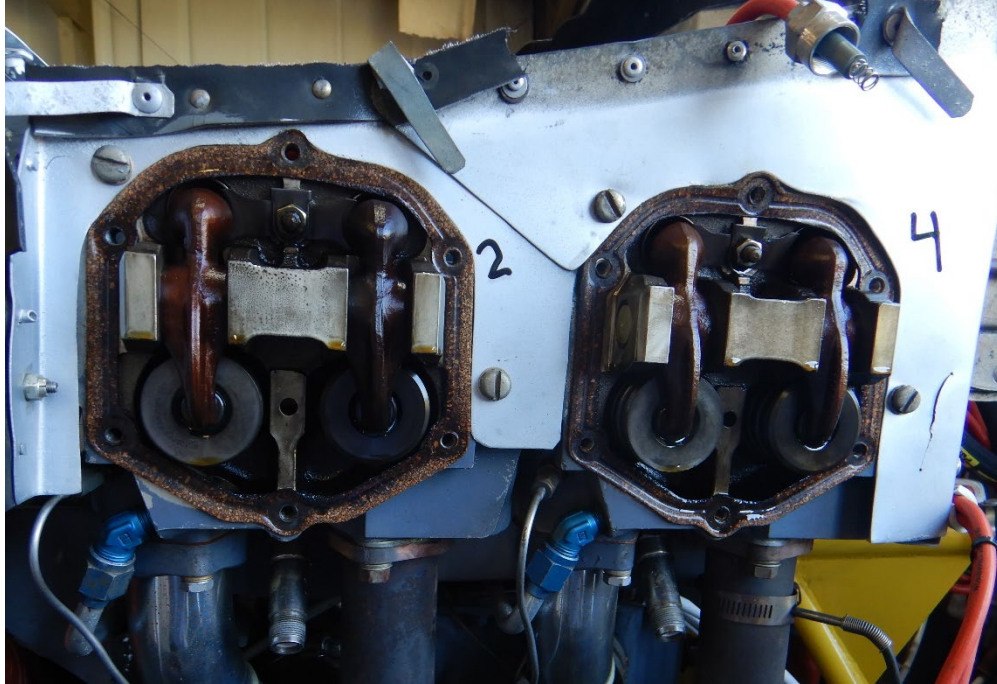
**Photo 13 - Cylinder Nos. 2 and 4 with rocker covers removed.**

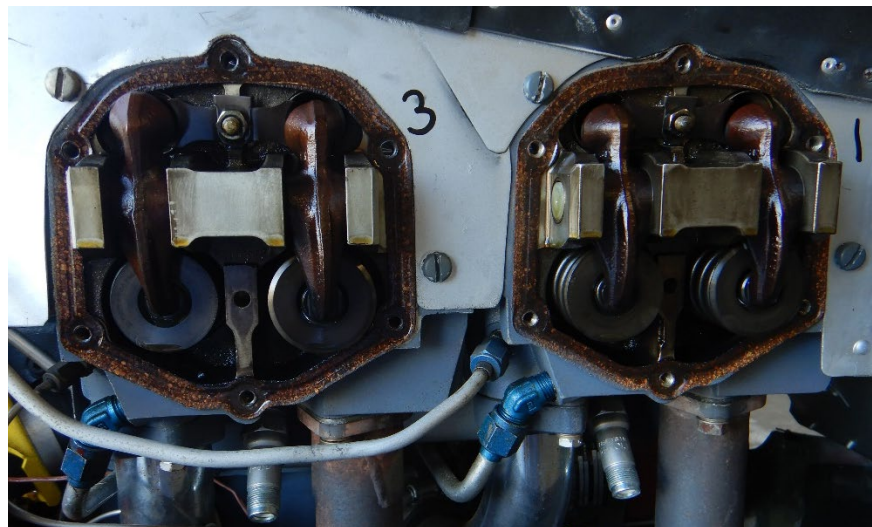
seem to be properly seated. The lower spark plugs were removed and showed normal wear when compared to a Champion Aviation Check-A-Plug chart with Nos. 1 and 3 spark plugs oil fouled. The pushrod tube retainer lock tabs were incorrectly installed, 90° to the correct position. Cylinder No. 3 was removed for further examination and documentation.

**Photo 14 - Cylinder Nos. 1 and 3 with rocker covers removed.**

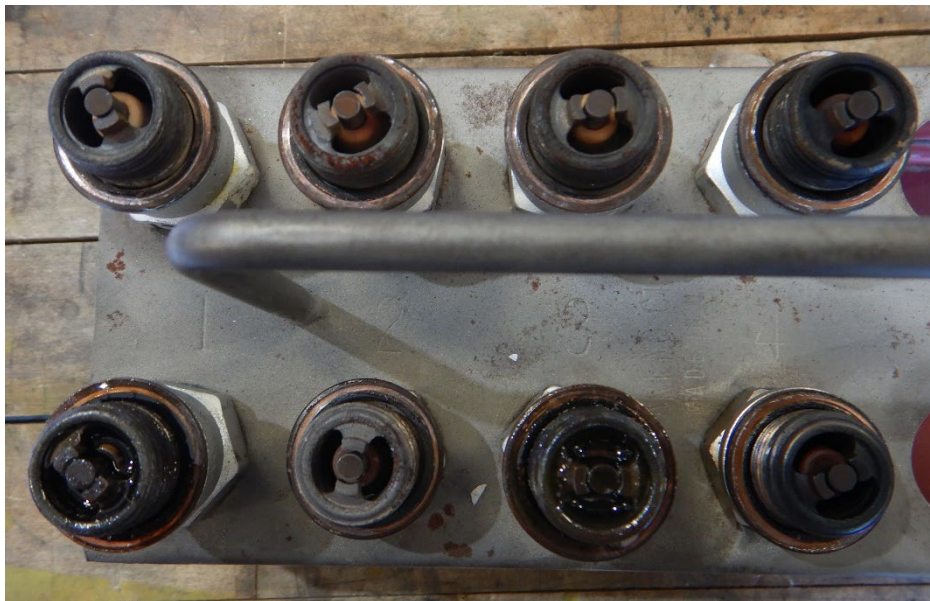
**Photo 16 - Spark plugs (lower Nos. 1 and 3 oil fowled).**

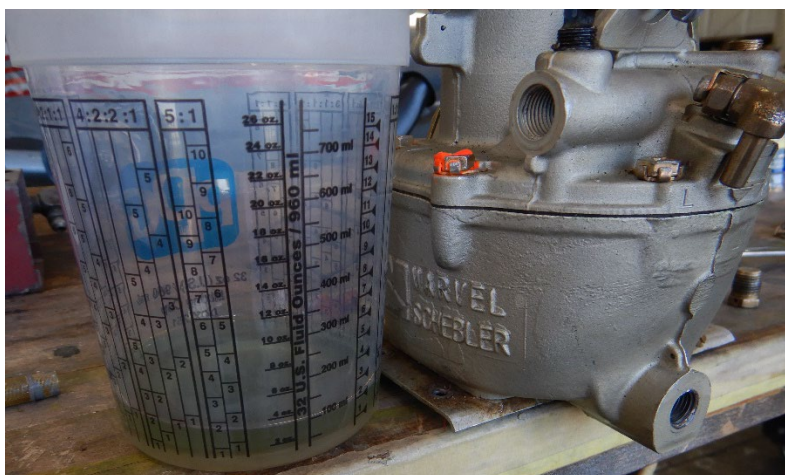
The fuel lines to the carburetor were secure and the carburetor was moved from the engine. The throttle and mixture arms were actuated from stop to stop. The fuel inlet screen had been affixed with a putty like material to the carburetor and was removed with plyers. There was a small amount of debris on the fuel filter screen. The carburetor floats were free from deformation and the needle valve and needle valve seat were unremarkable. 100 ml of liquid was recovered from the carburetor bowl. It was a very light green color with about 1 teaspoon of water along with large amounts of sediment. The gascolator bowl contained 100 ml of liquid that was also a very light green color with another teaspoon of water and large amounts of sediment. The gascolator strainer contacted a white gel-like contamination on its interior.

**Photo 17 - Liquid recovered from carburetor bowl.**

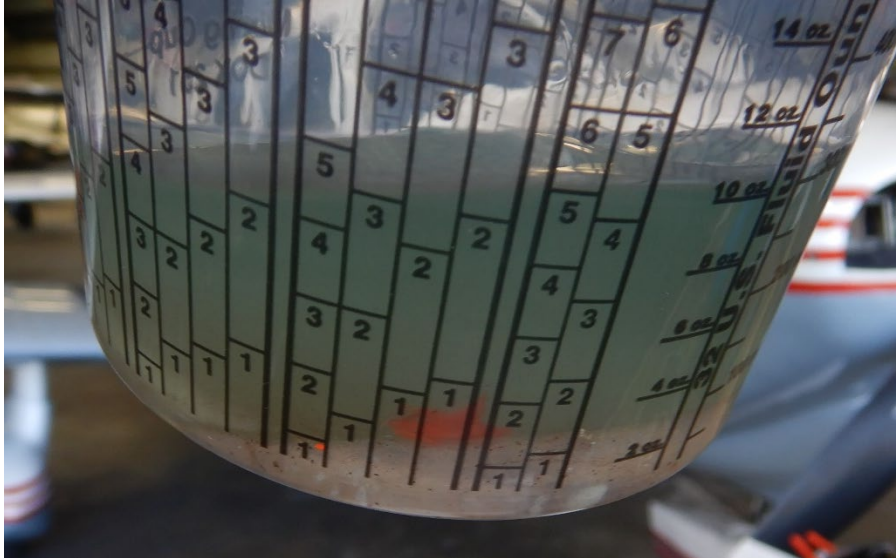
**Photo 18 - Contaminated fuel from carburetor and gasolator bowls (combined).**

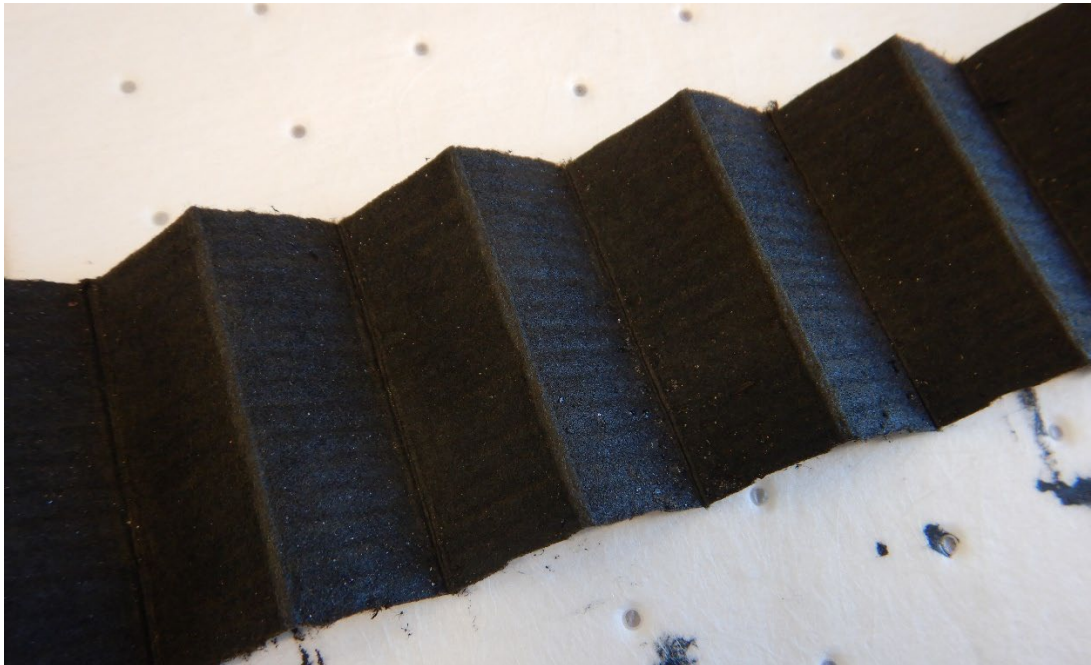
The oil level was just under 4 quarts when measured with the dipstick. The oil filter was removed, and the oil filter element displayed minimal specks of metallic debris.

**Photo 19 - Oil filter element.**

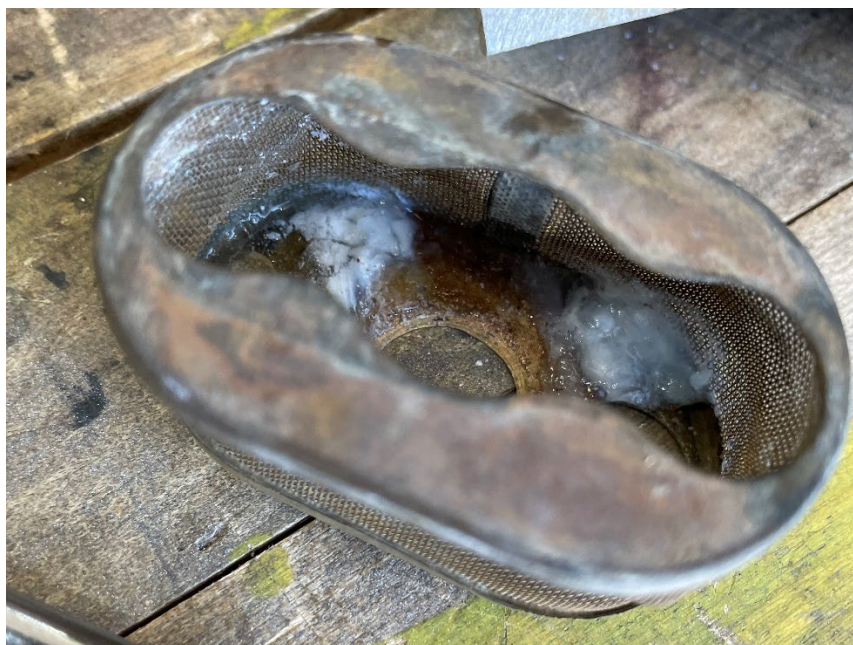
**Photo 20 - White gel-like substance within gascolator stainer.**

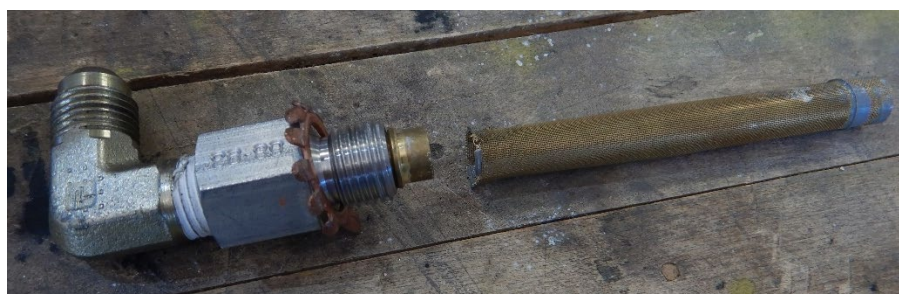
**Photo 21 - Carburetor fuel screen.**

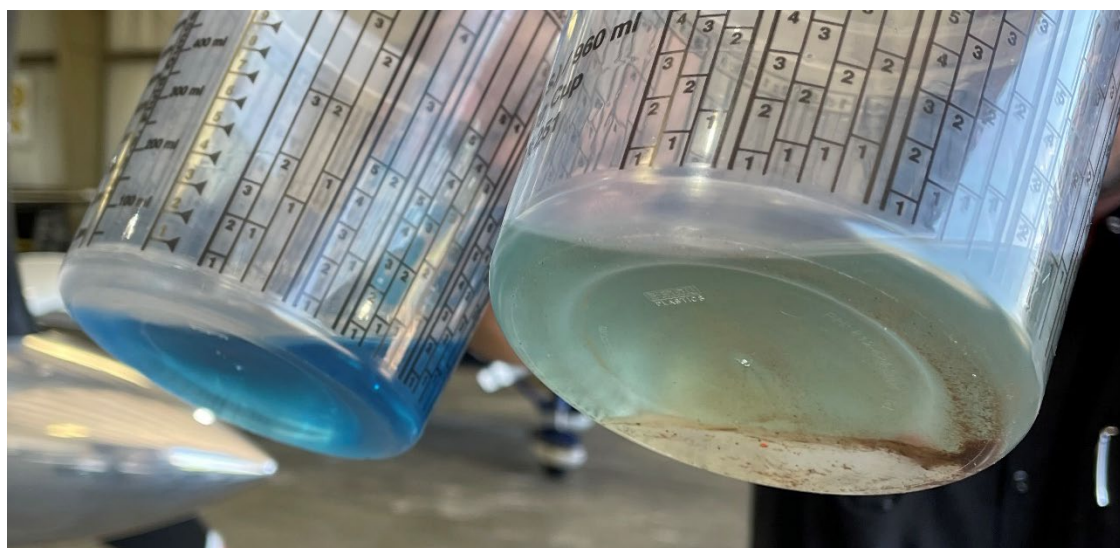
**Photo 22 - Fuel from wing tank (left) and carburetor and gascolator bowls (right).**

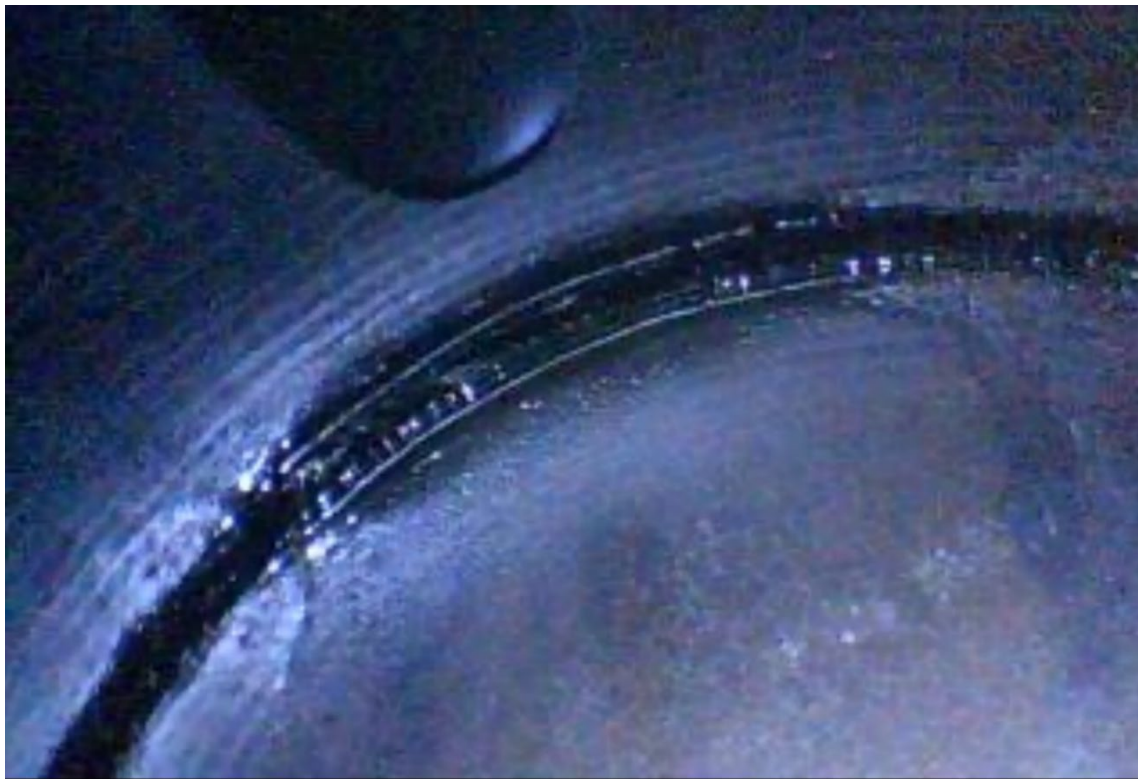
The spark plug ignition leads were disconnected and the top spark plugs were removed. The top spark plugs showed normal wear when compared to a Champion Aviation Check-A-Plug chart. The rocker covers were removed. When the crankshaft was rotated by hand, no thumb compression or suction could be achieved on cylinder No. 3. Borescope examination of the cylinders revealed that the intake valve on the No. 3 cylinder was stuck open, and the cylinder walls displayed circumferential markings. The piston rings were evident at the edge of the piston face and did not

**Photo 24 - Borescope photo of cylinder No. 3 with piston rings visible/gap between piston face and cylinder wall.**

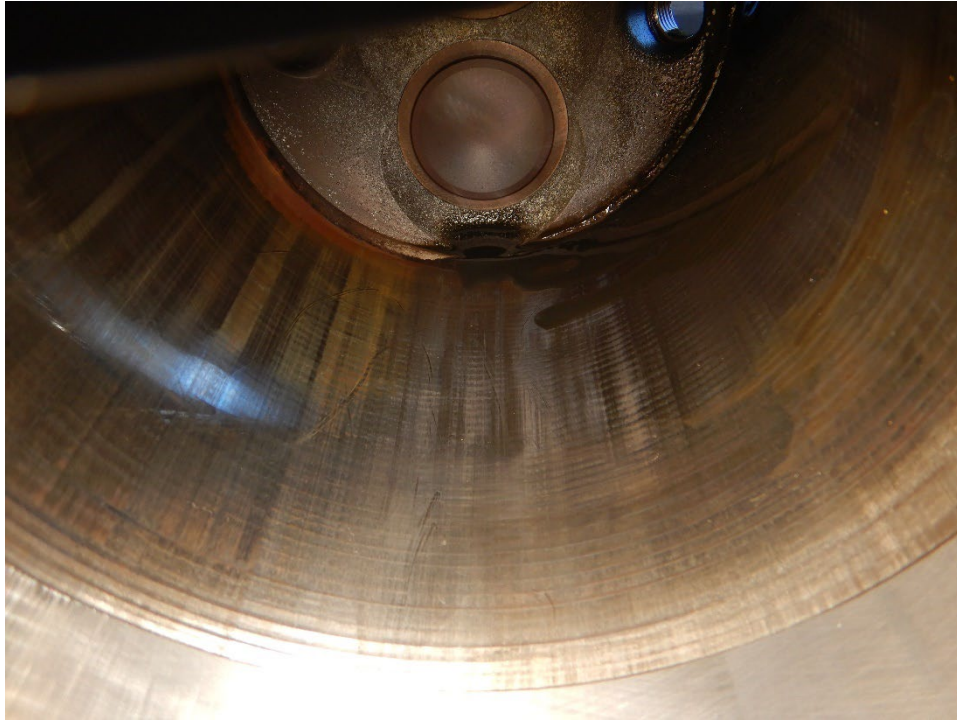
**Photo 25 - Interior of cylinder No. 3 after removal of cylinder from engine.**

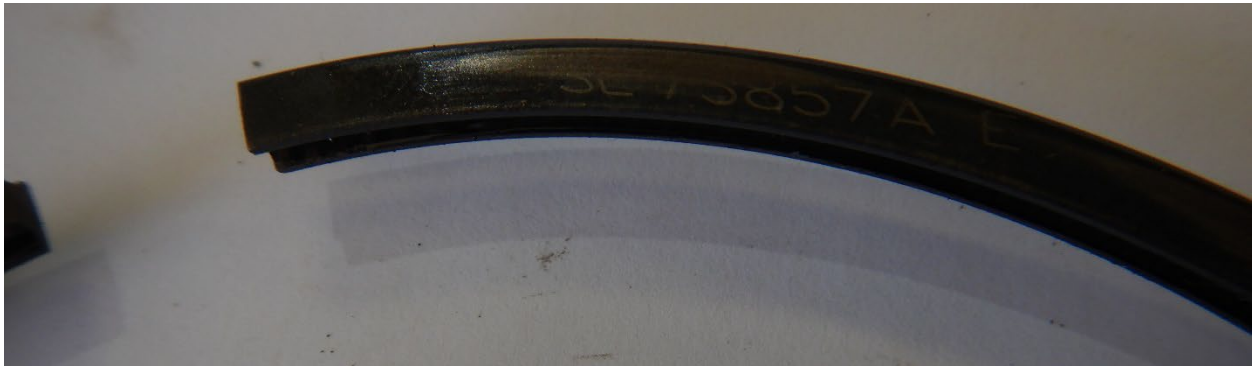
**Photo 26 - Close-up view of oil control ring after removal from No. 3 piston.**

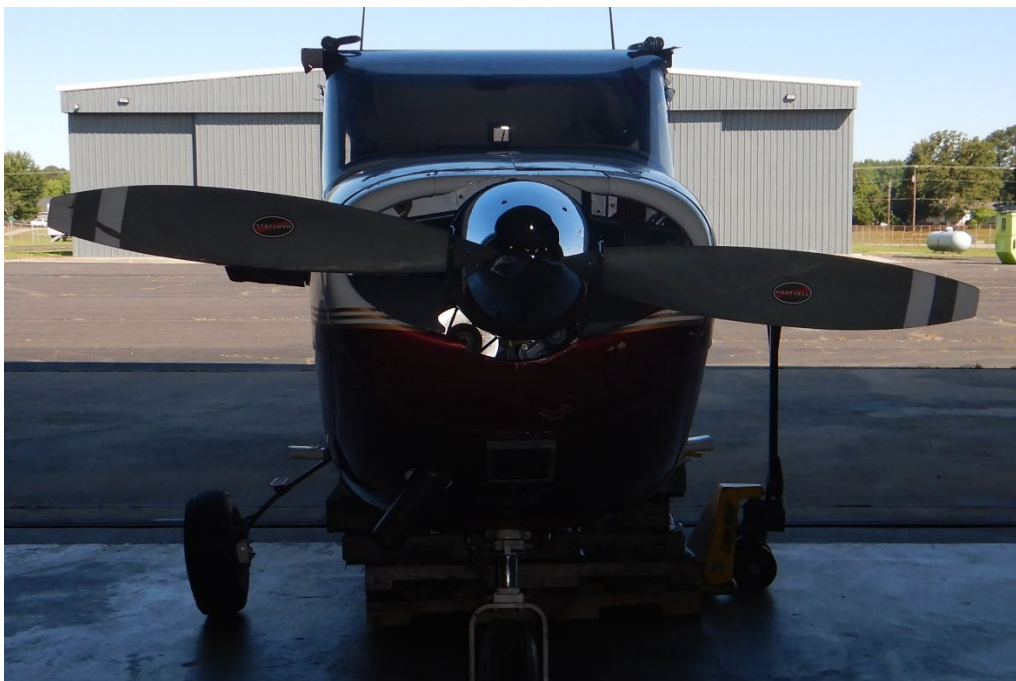
The variable pitch propeller remained attached to the crankshaft flange and the two blades remained attached to the hub. The spinner was in place. Examination of both propeller blades revealed no twisting, bending, or leading edge damage. No chordwise scratching was evident.

**Photo 27 - View of airplane and propellers from front.**
