ERA24LA180

## INVESTIGATION PHOTOGRAPHS

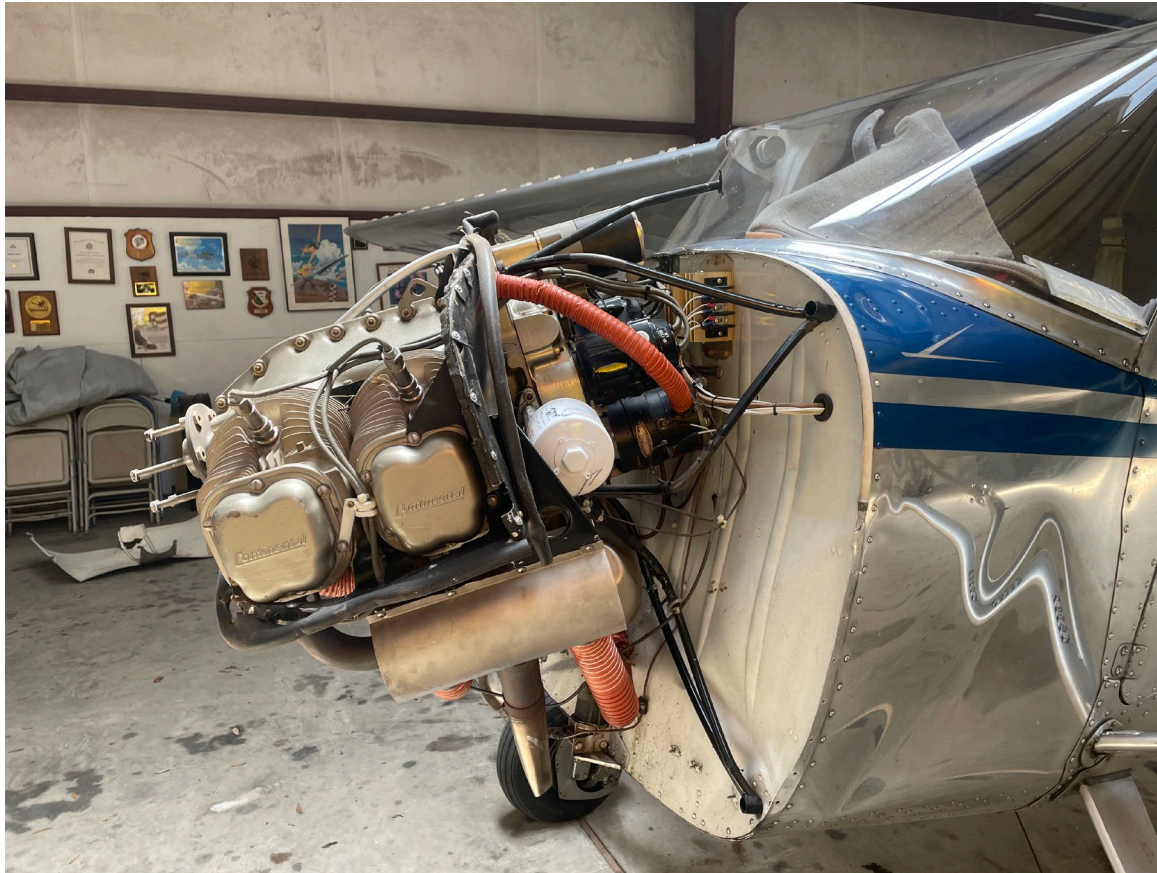
**Photograph 1 - Engine Mount Damage (Courtesy of FAA)**

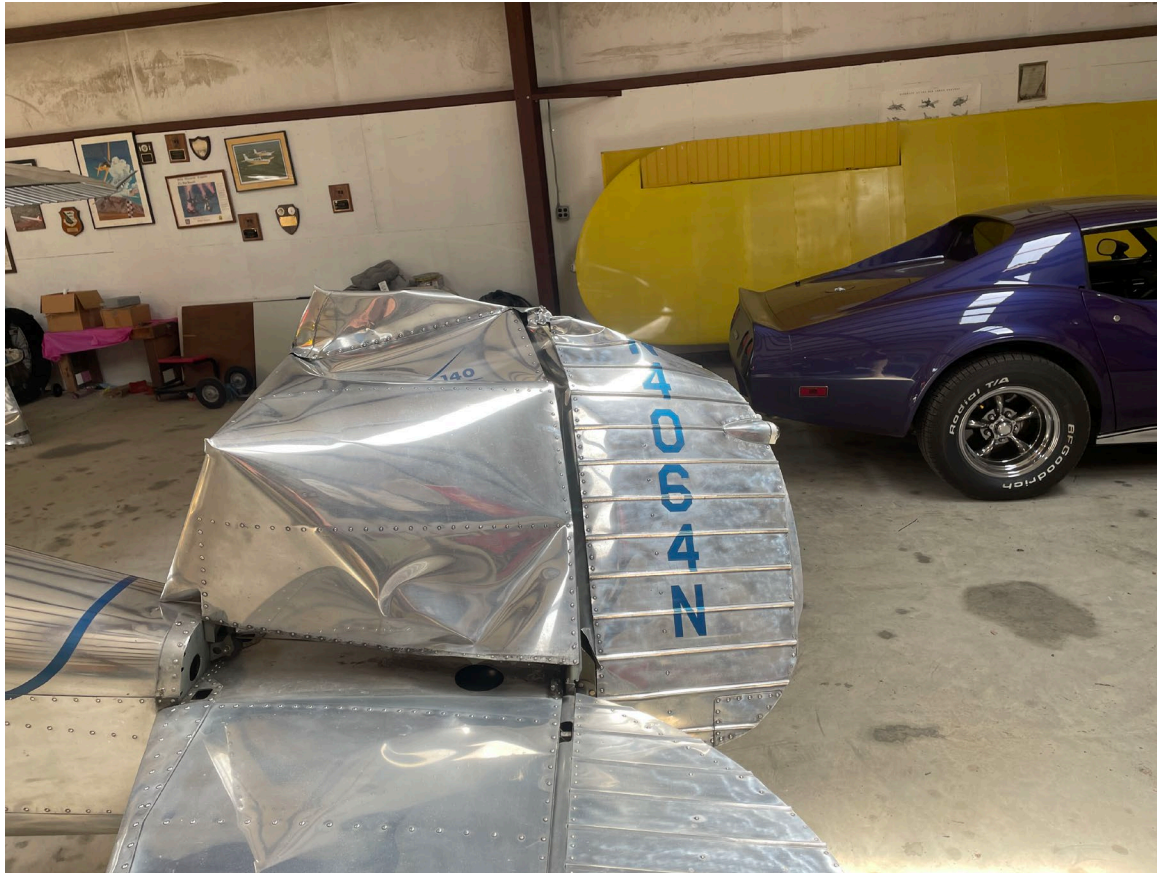
**Photograph 2 - Empennage Damage (Courtesy of FAA)**

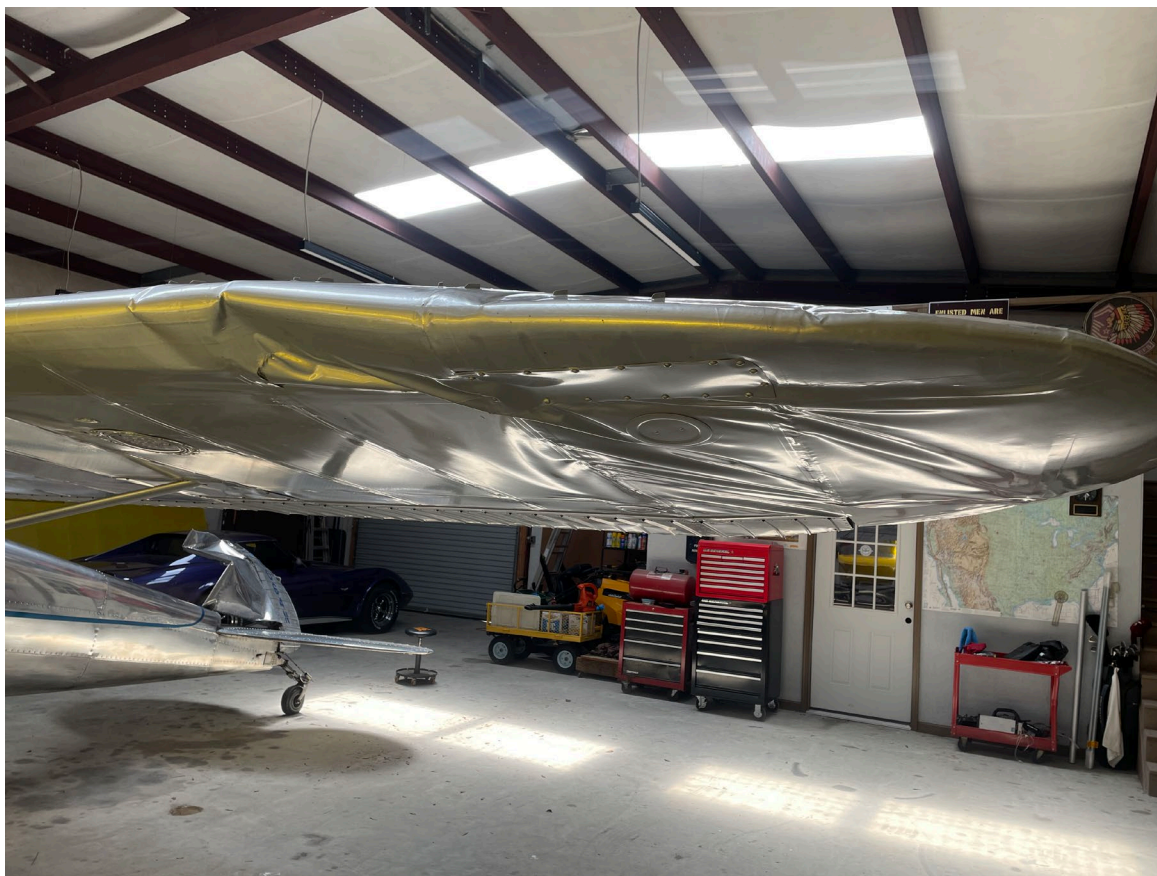
**Photograph 3 - Left Wing Damage (Courtesy of FAA)**
