ERA24LA181

## INVESTIGATION PHOTOGRAPHS

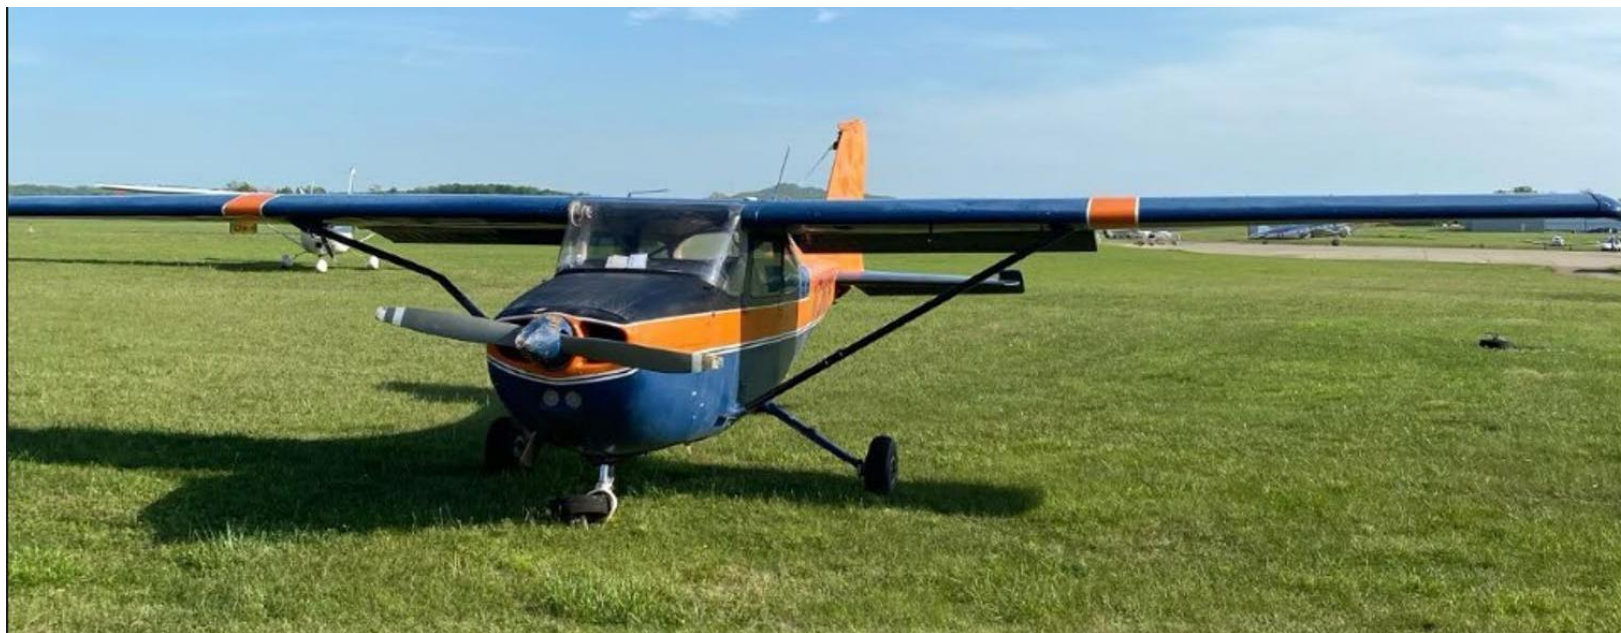
**Photograph 1 - View of airplane after it was up righted. (Courtesy of FAA)**

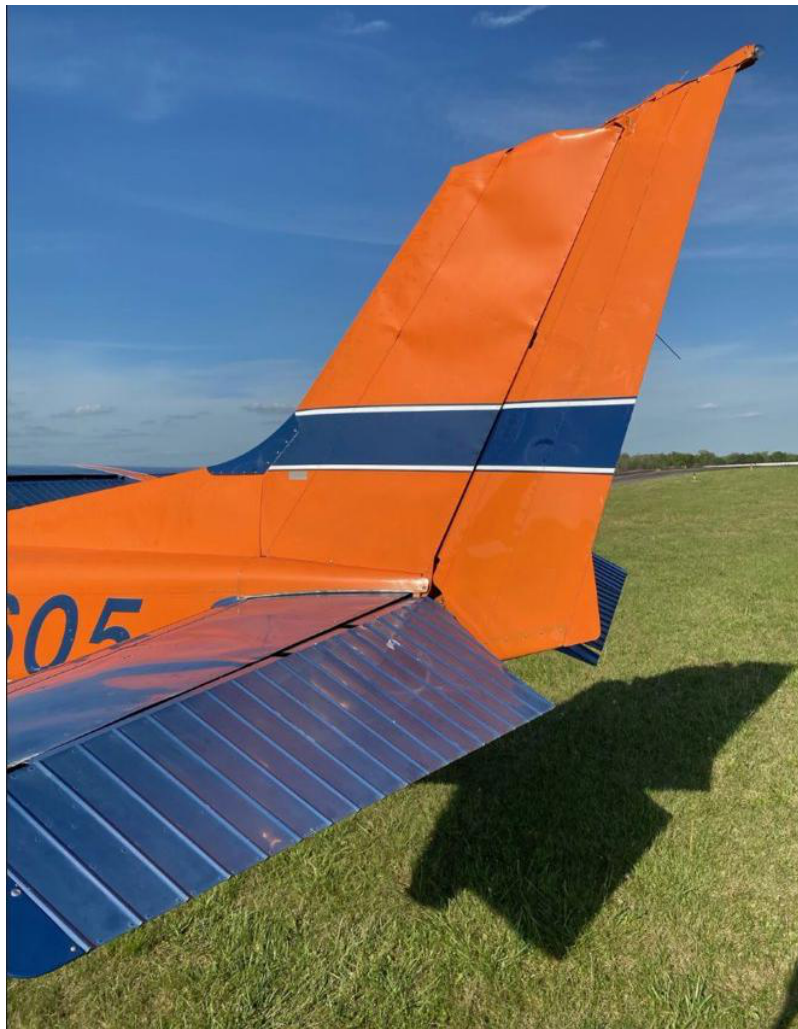
**Photograph 2 - View of damaged vertical stabilizer. (Courtesy of FAA)**

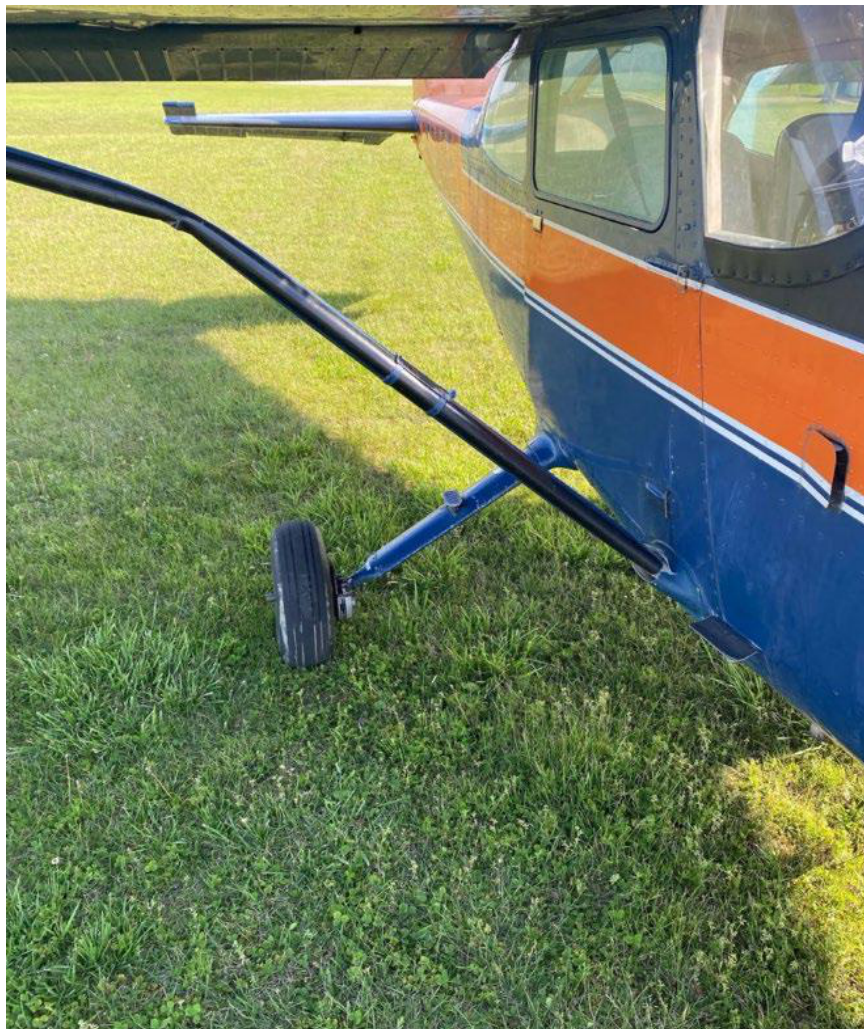
**Photograph 3 - View of right wing strut damage. (Courtesy of FAA)**

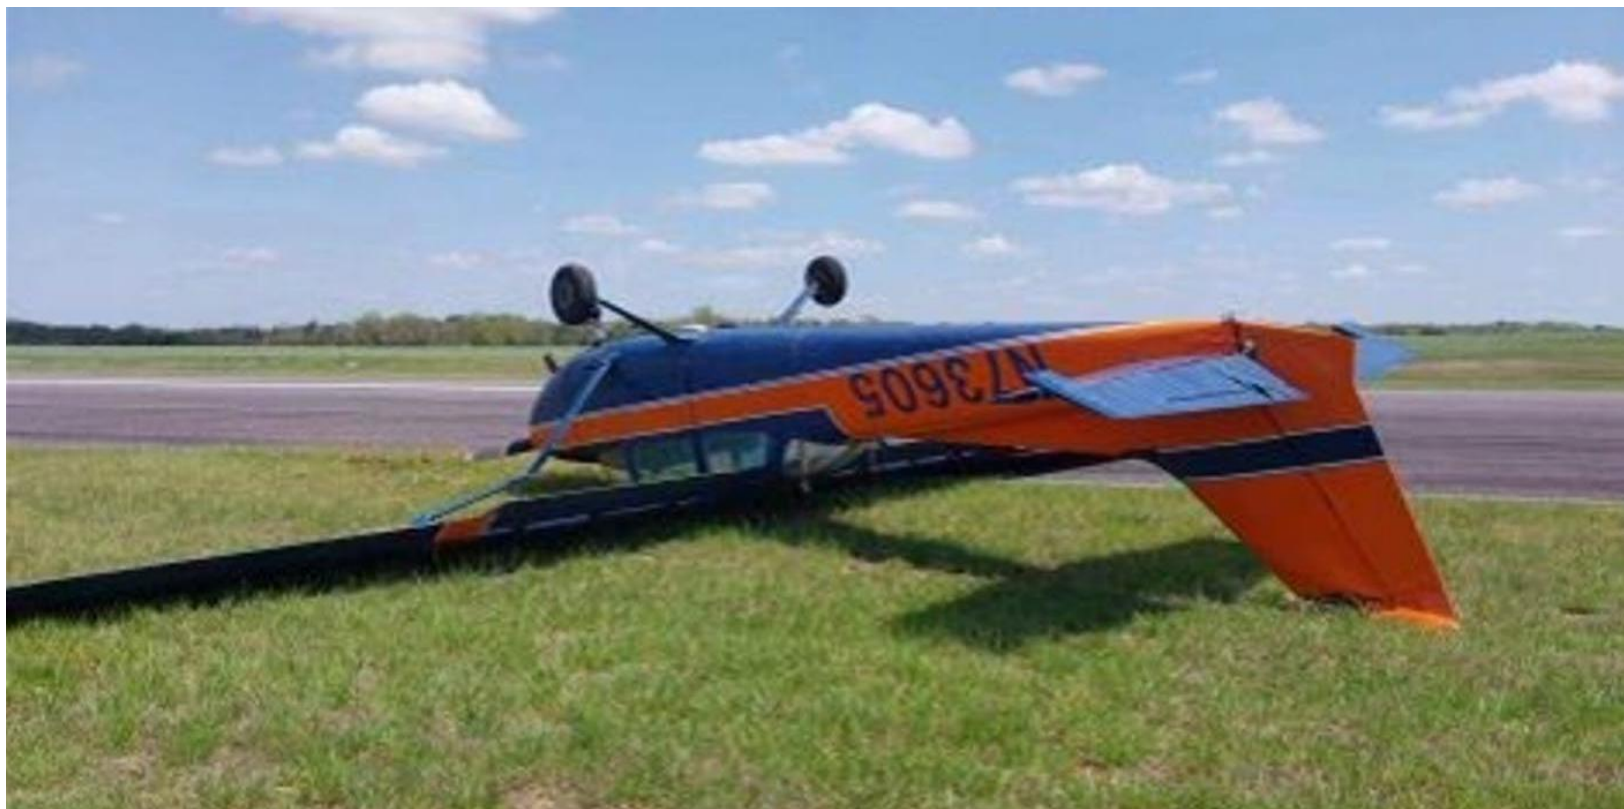
**Photograph 4 - View of airplane inverted next to runway. (Courtesy of FAA)**
