ERA24LA183

## INVESTIGATION PHOTOGRAPHS

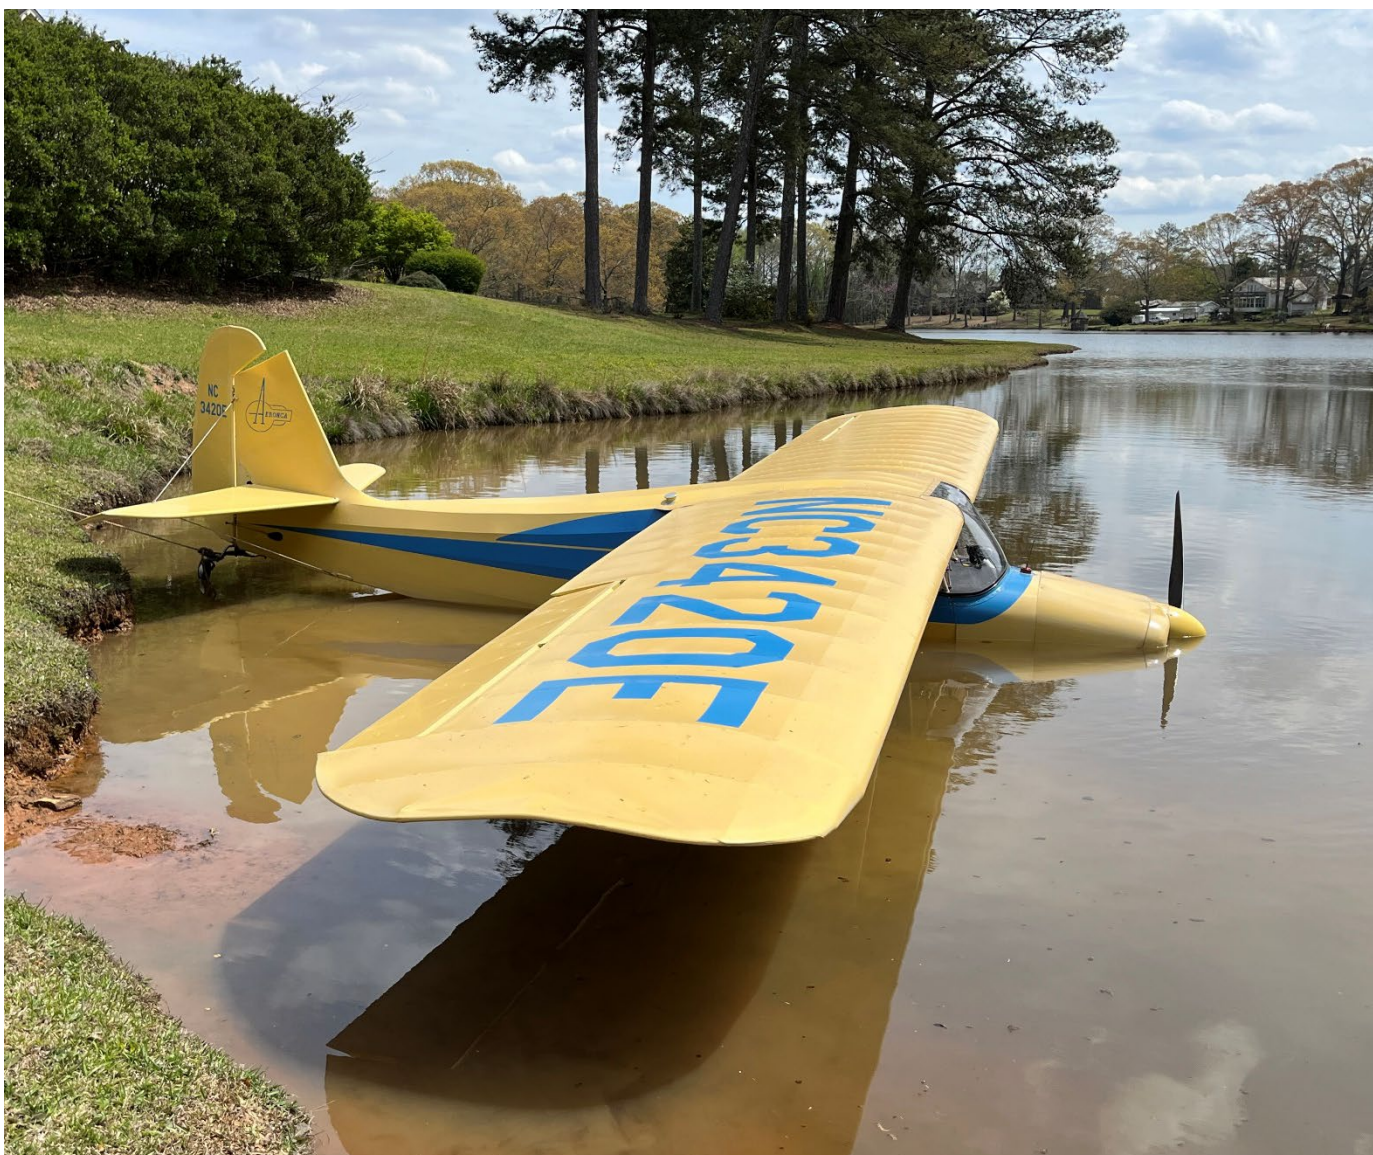
**Photograph 1 - Airplane at accident site (Courtesy of pilot)**

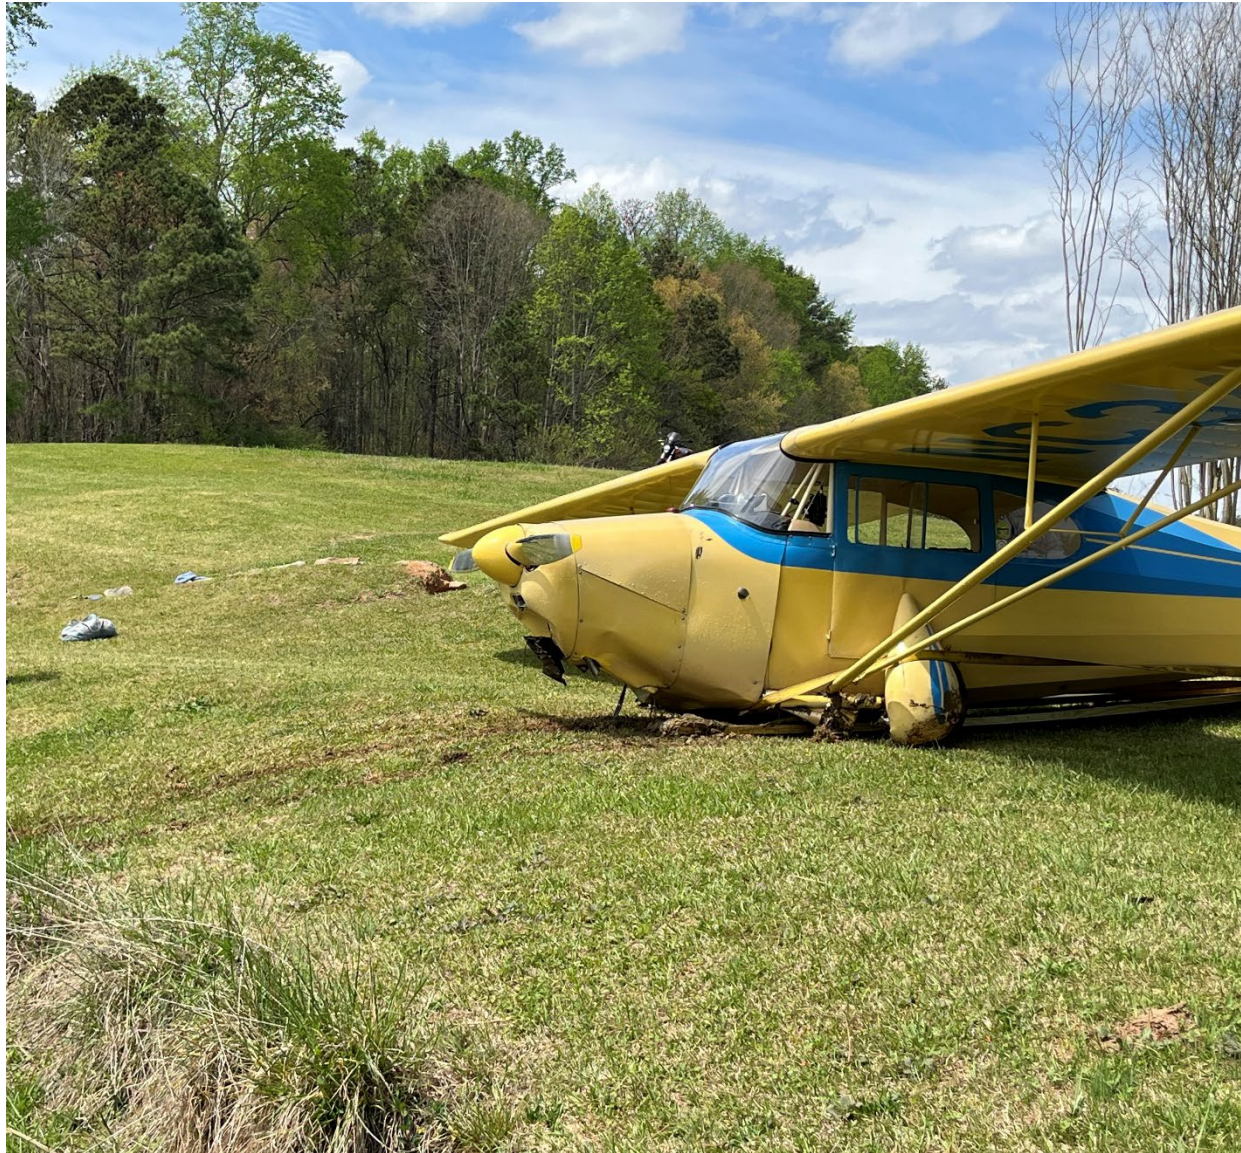
**Photograph 2 - Airplane after recovery from lake (Courtesy of pilot)**

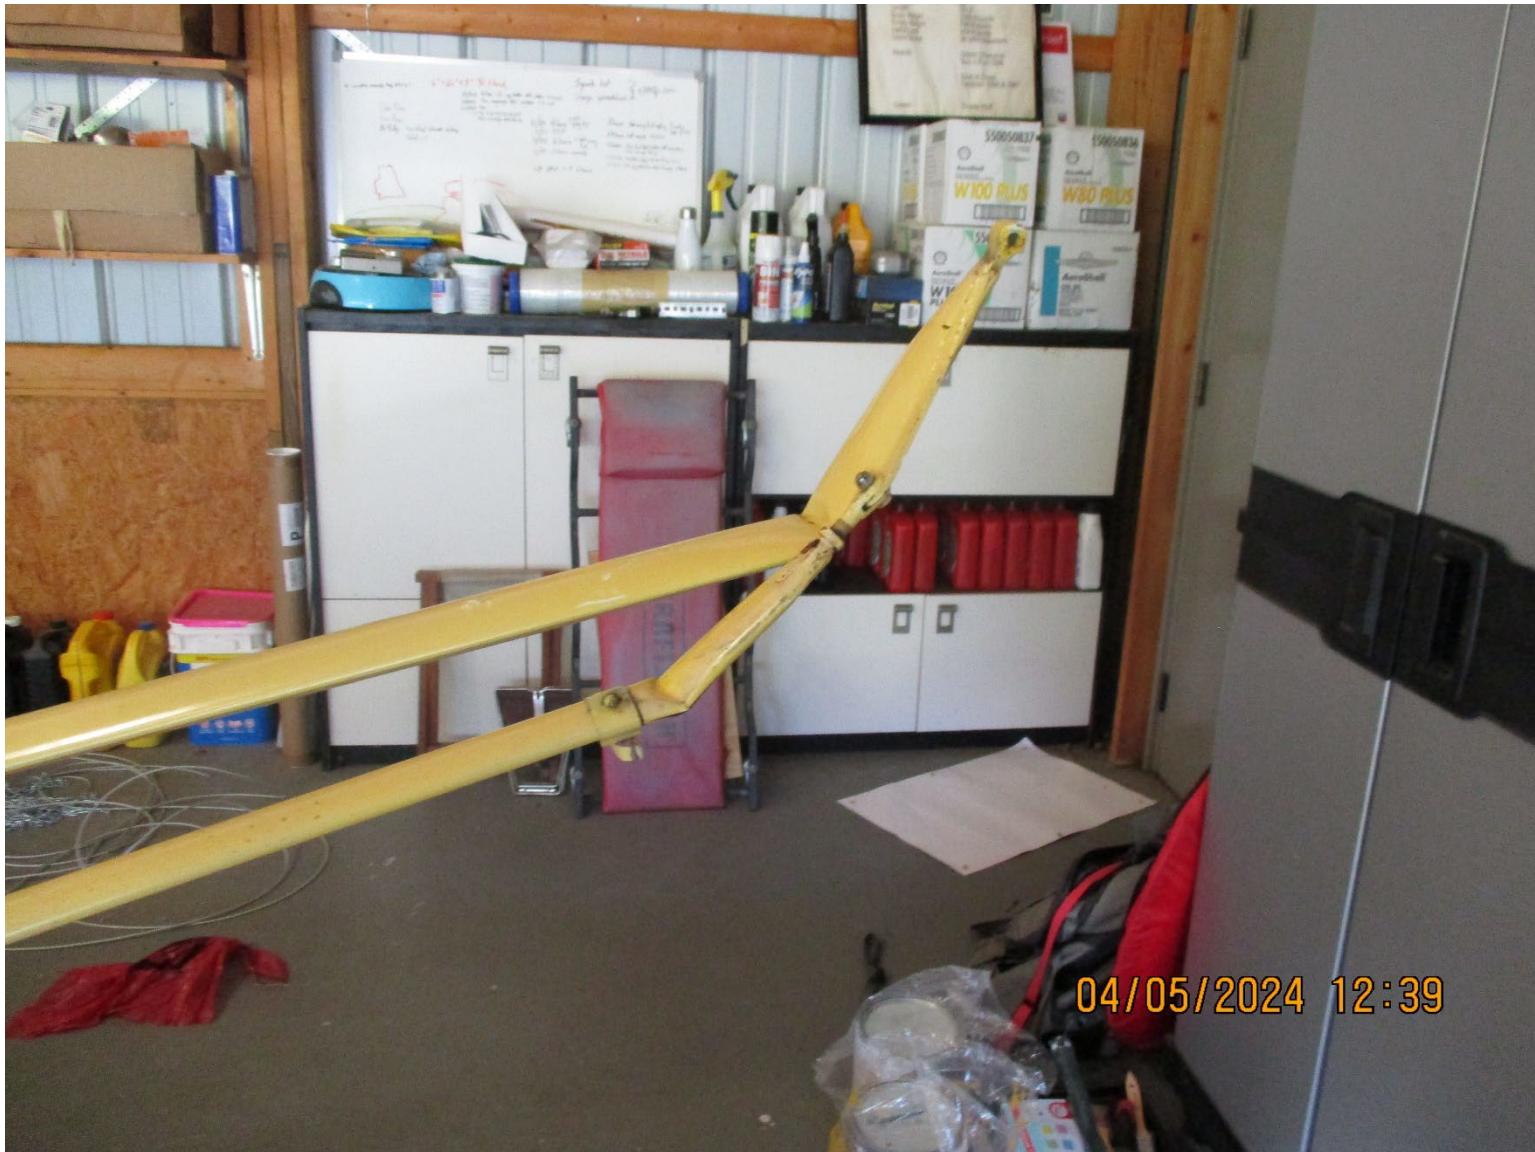
**Photograph 3 - Bent wing strut (Courtesy of FAA)**

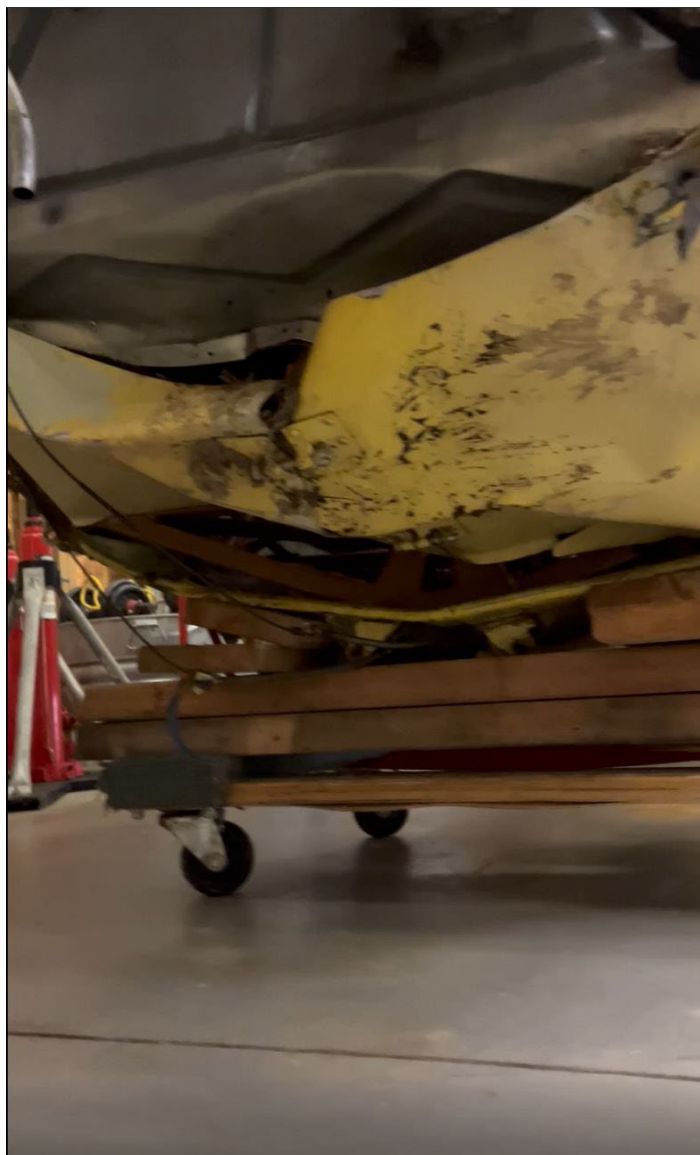
**Photograph 4 - Fuselage damage (Courtesy of pilot)**
