ERA24LA185

## INVESTIGATION PHOTOGRAPHS

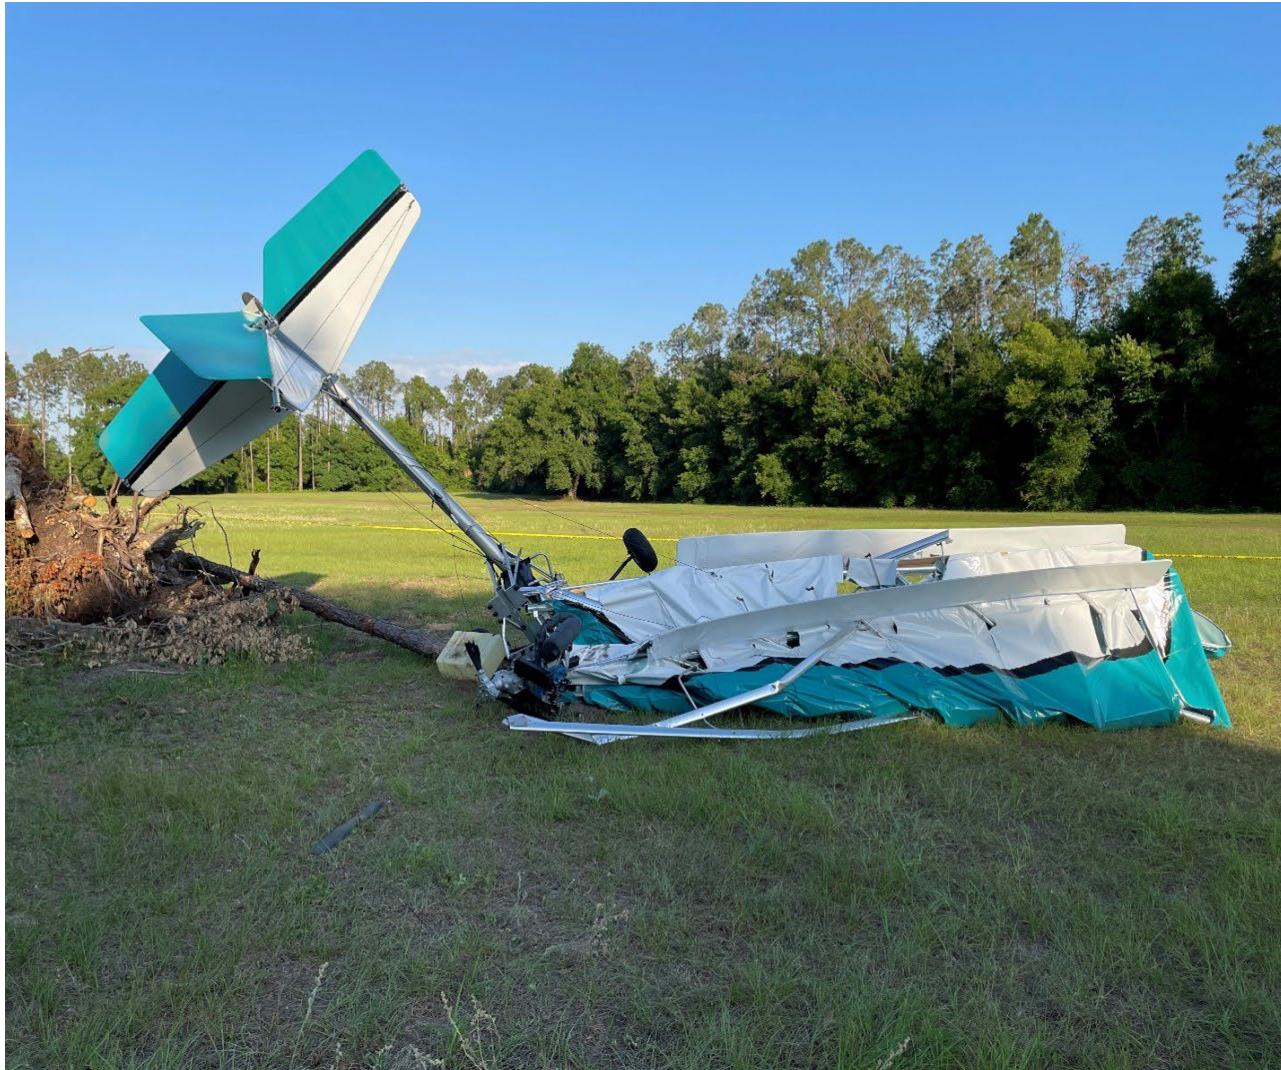
**Photograph 1 - View of wreckage at accident site. (Courtesy of FAA)**

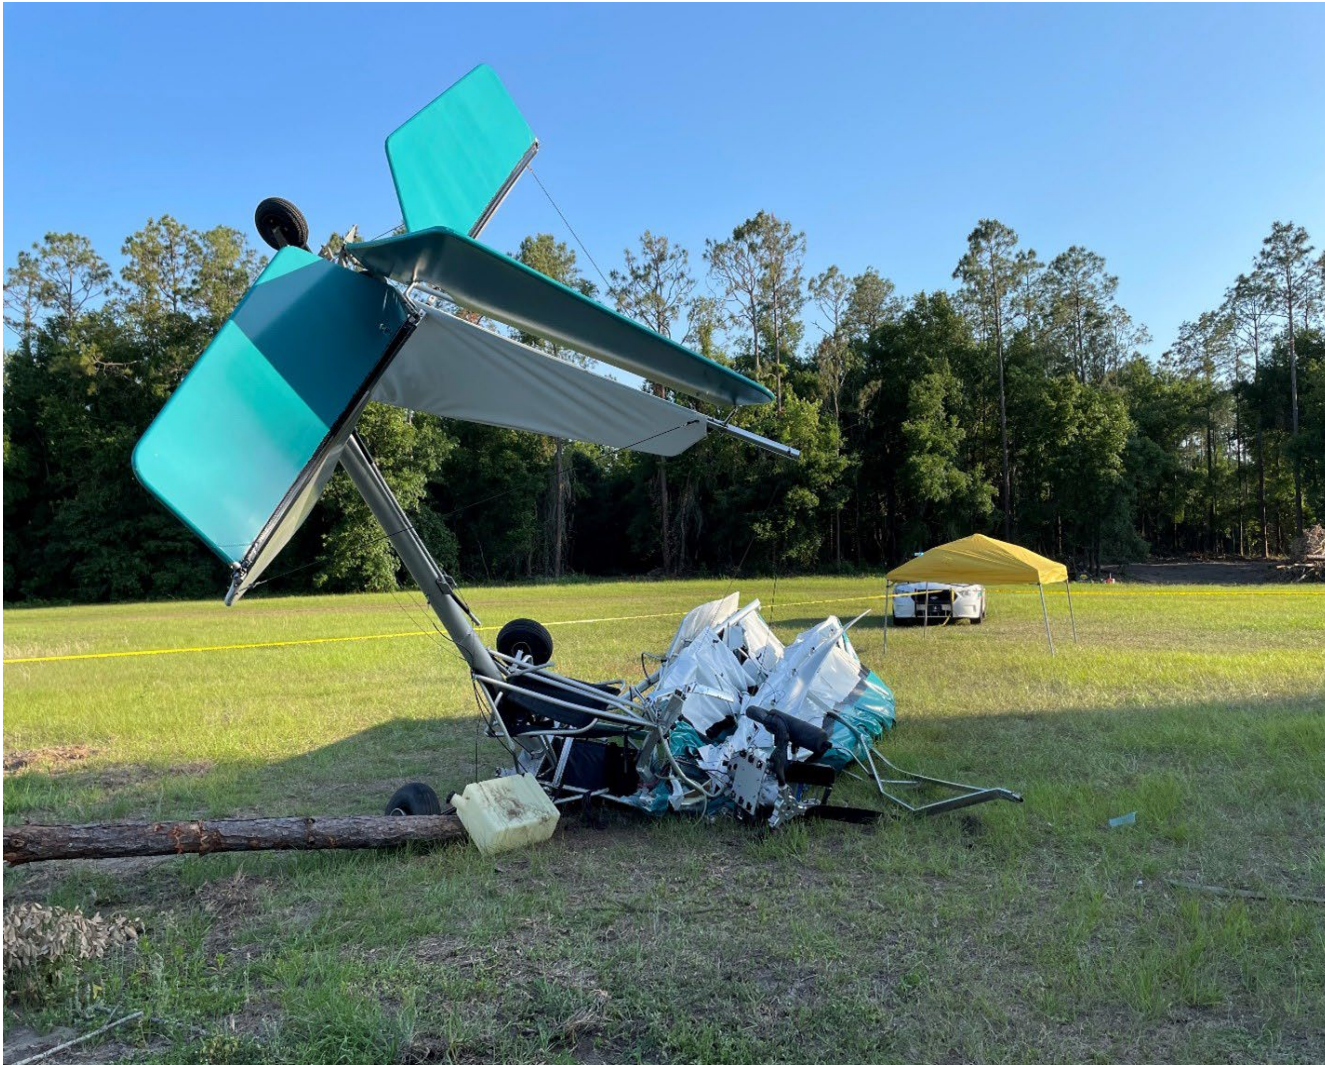
**Photograph 2 - View of wreckage facing aft. (Courtesy of FAA)**

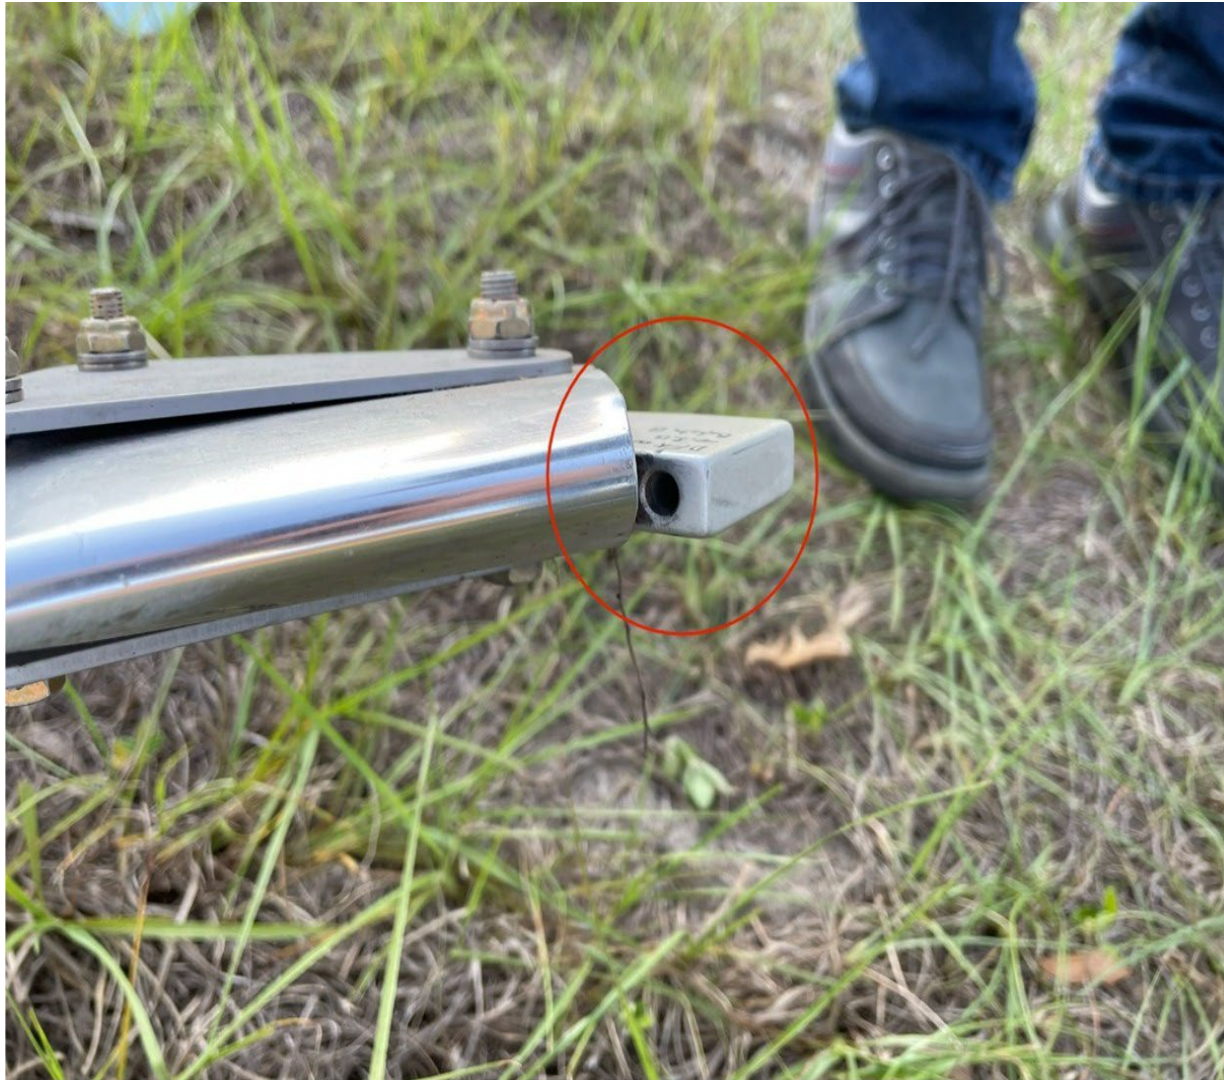
**Photograph 3 - Wing Strut connection point (Courtesy of FAA)**

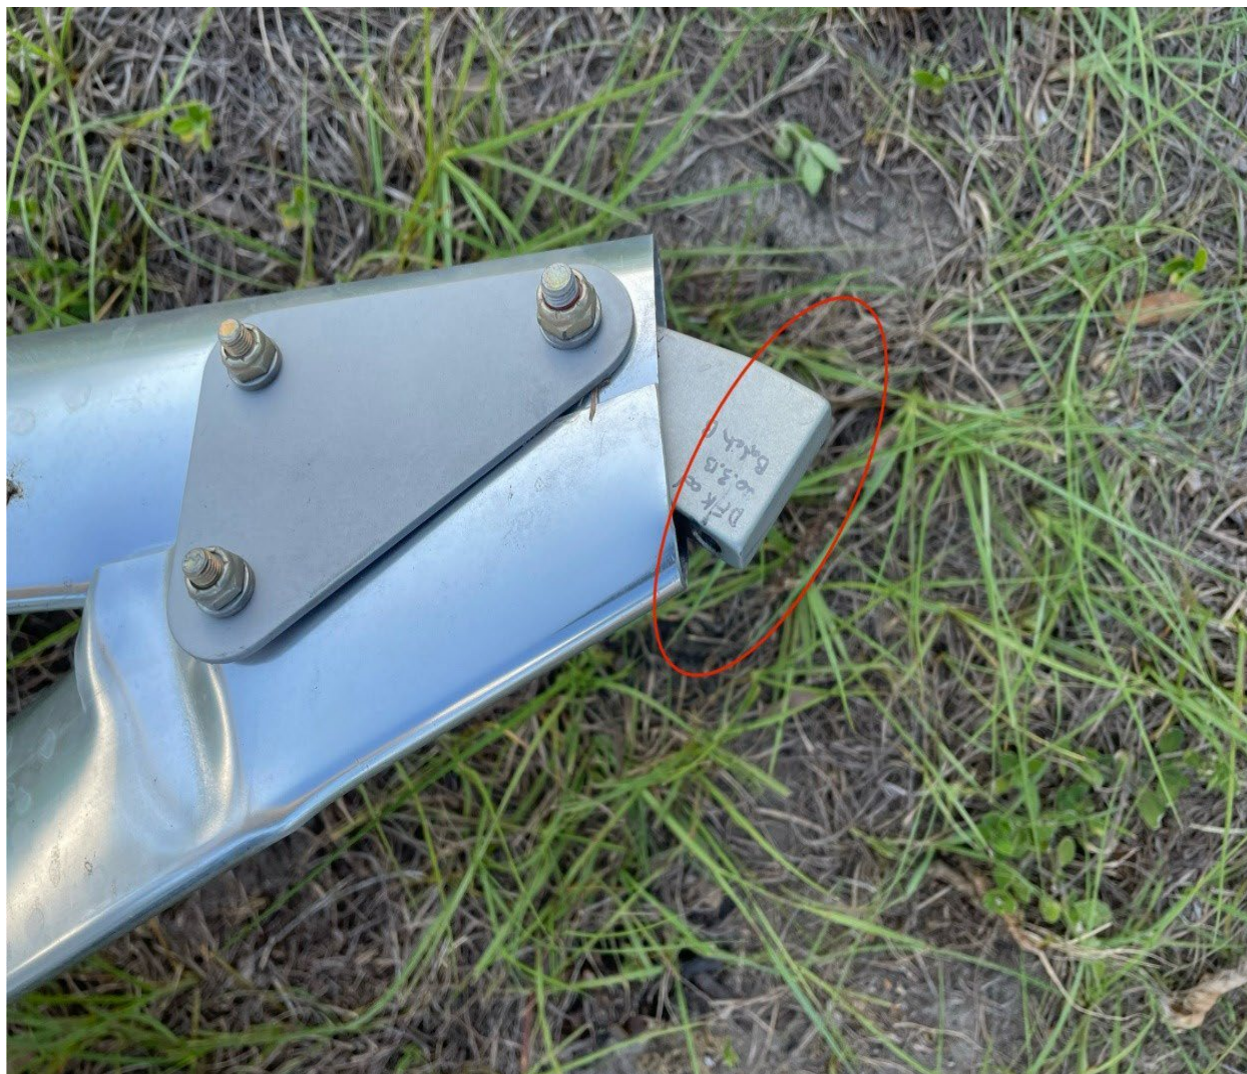
**Photograph 4 - Wing Attachment point top view. (Courtesy of FAA)**

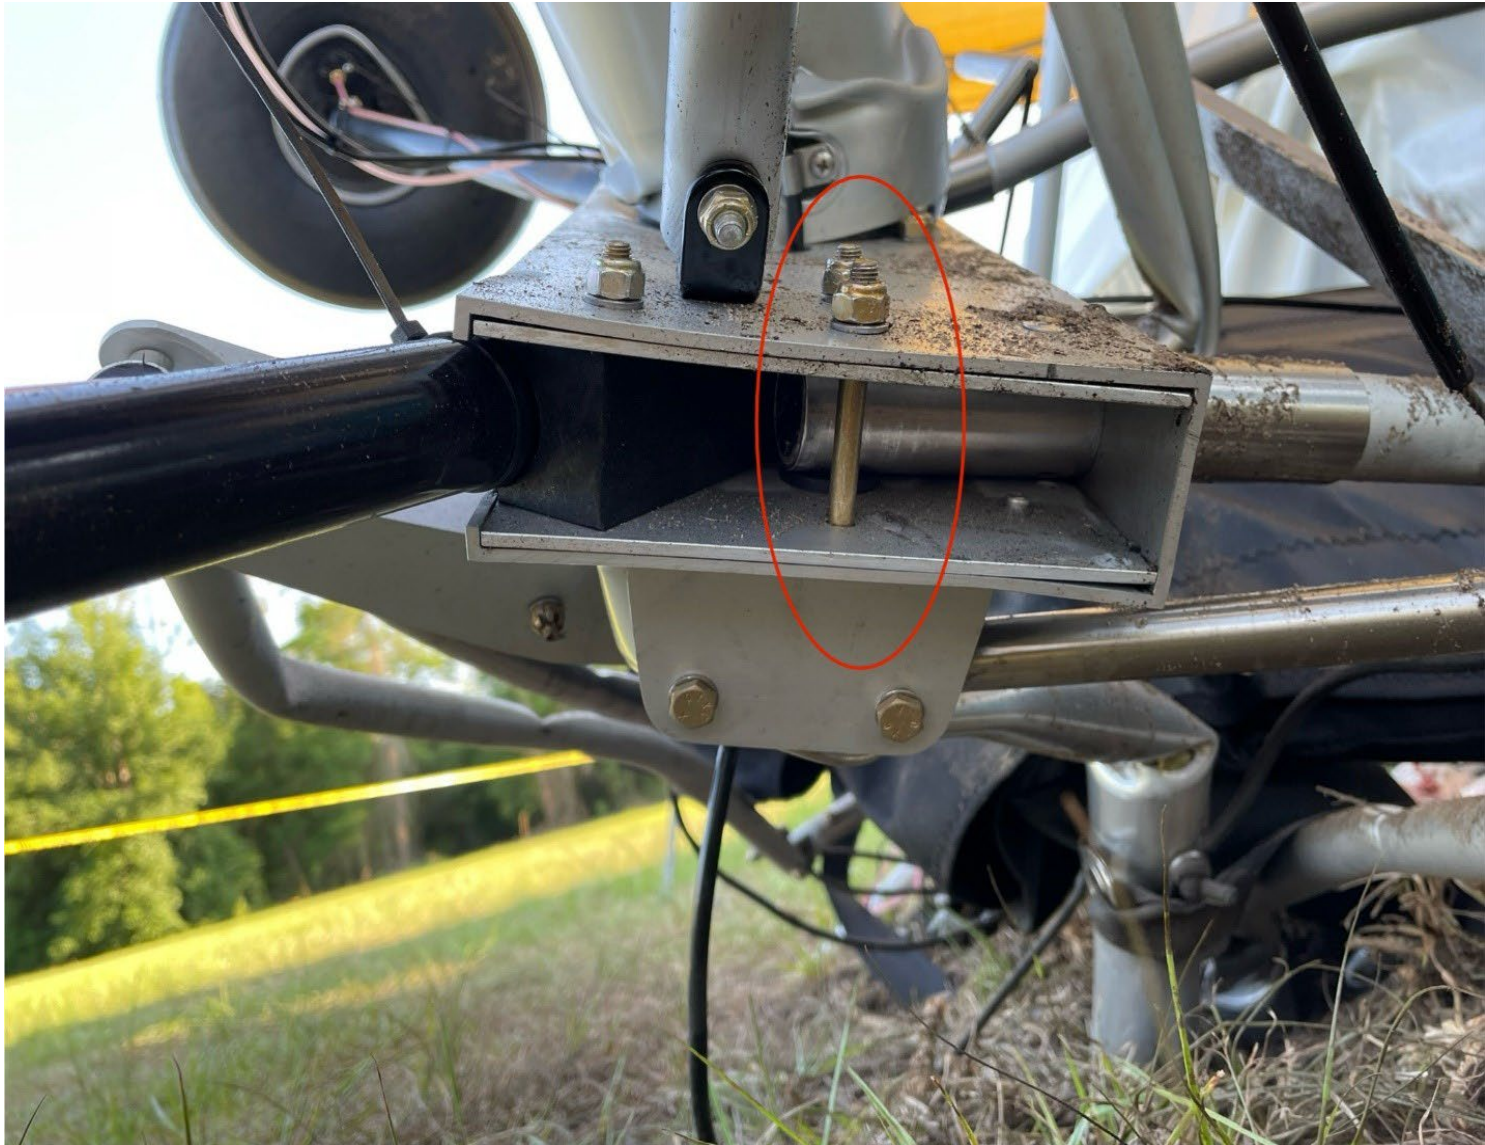
**Photograph 5 - Fuselage connection point with bolt shown installed. (Courtesy of FAA)**

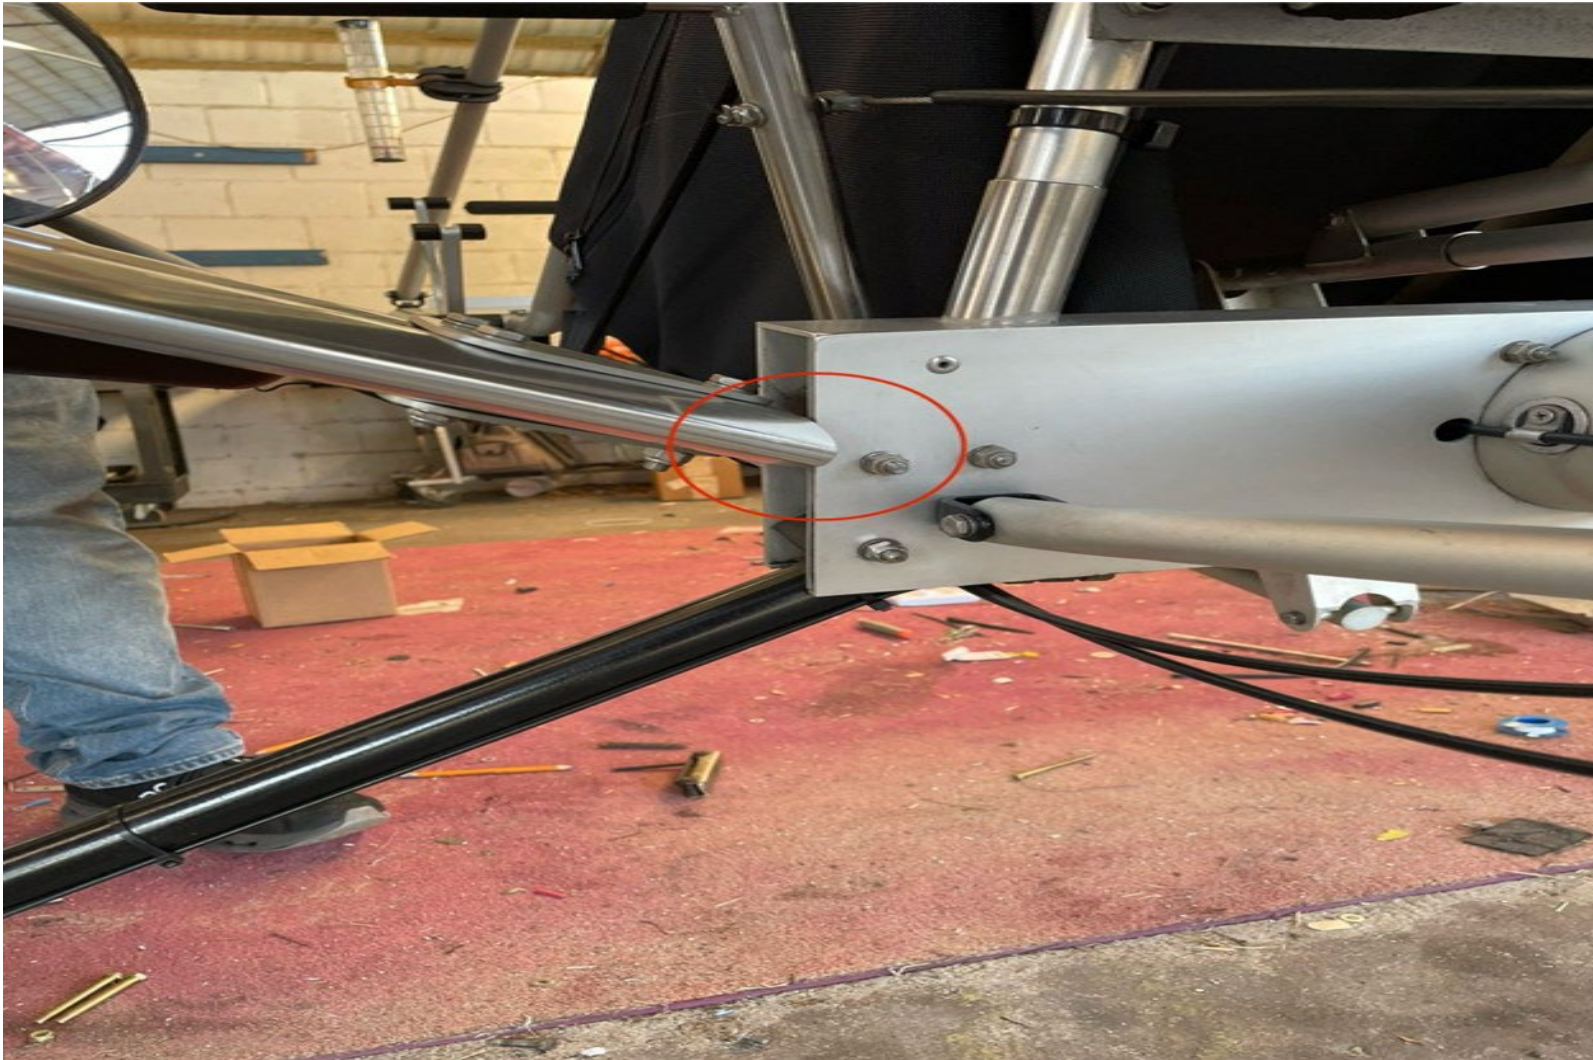
**Photograph 6 - Wing connection point properly installed - Non-Accident Aircraft Side 1  
(Courtesy of FAA)**

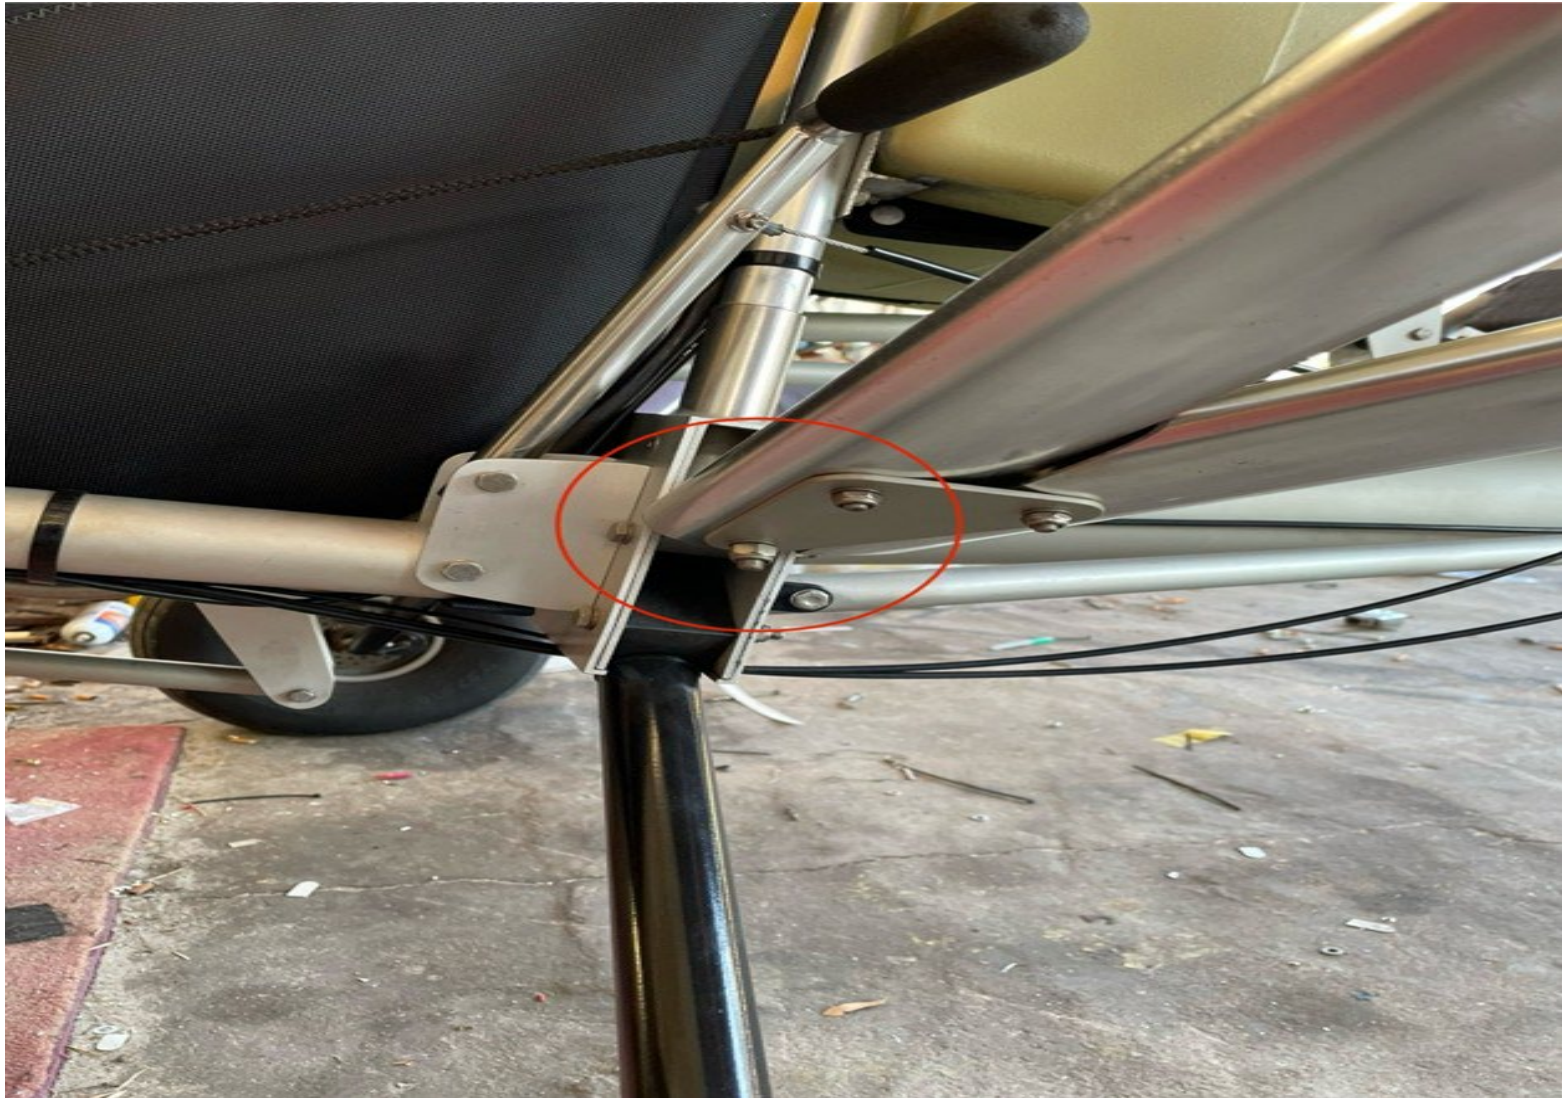
**Photograph 7 - Wing connection point properly installed - Non-Accident Aircraft Side 2  
(Courtesy of FAA)**

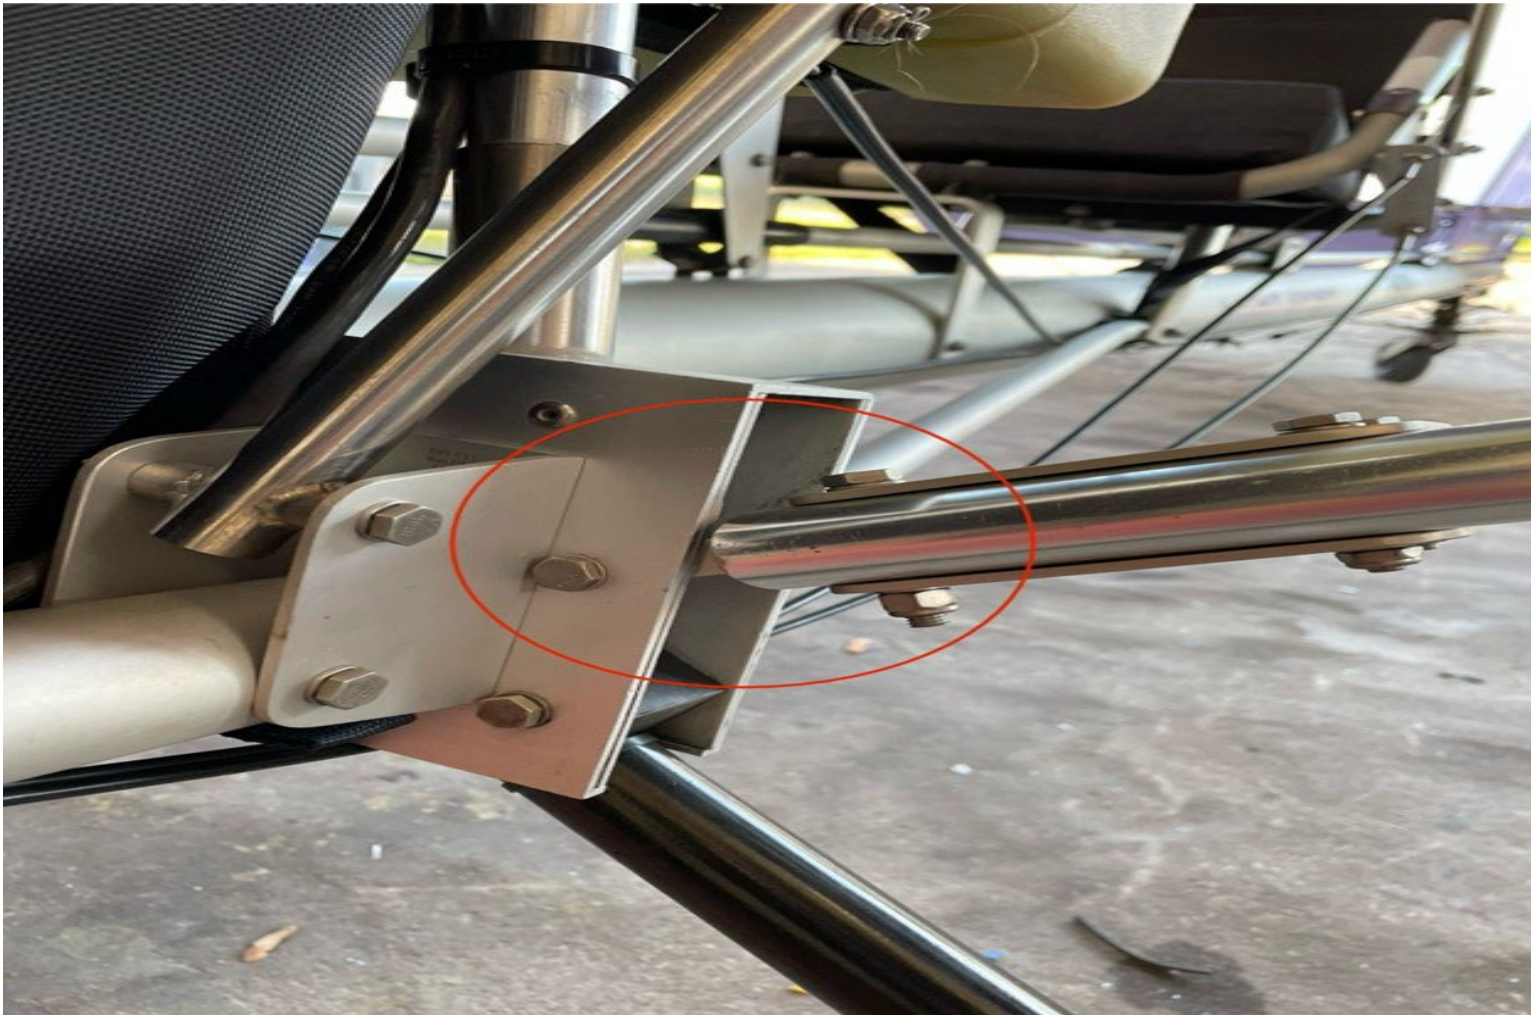
**Photograph 8-Wing Connection Point Properly Installed - Non-Accident Aircraft Side 3  
(Courtesy of FAA)**
