ERA24LA192

## INVESTIGATION PHOTOGRAPHS

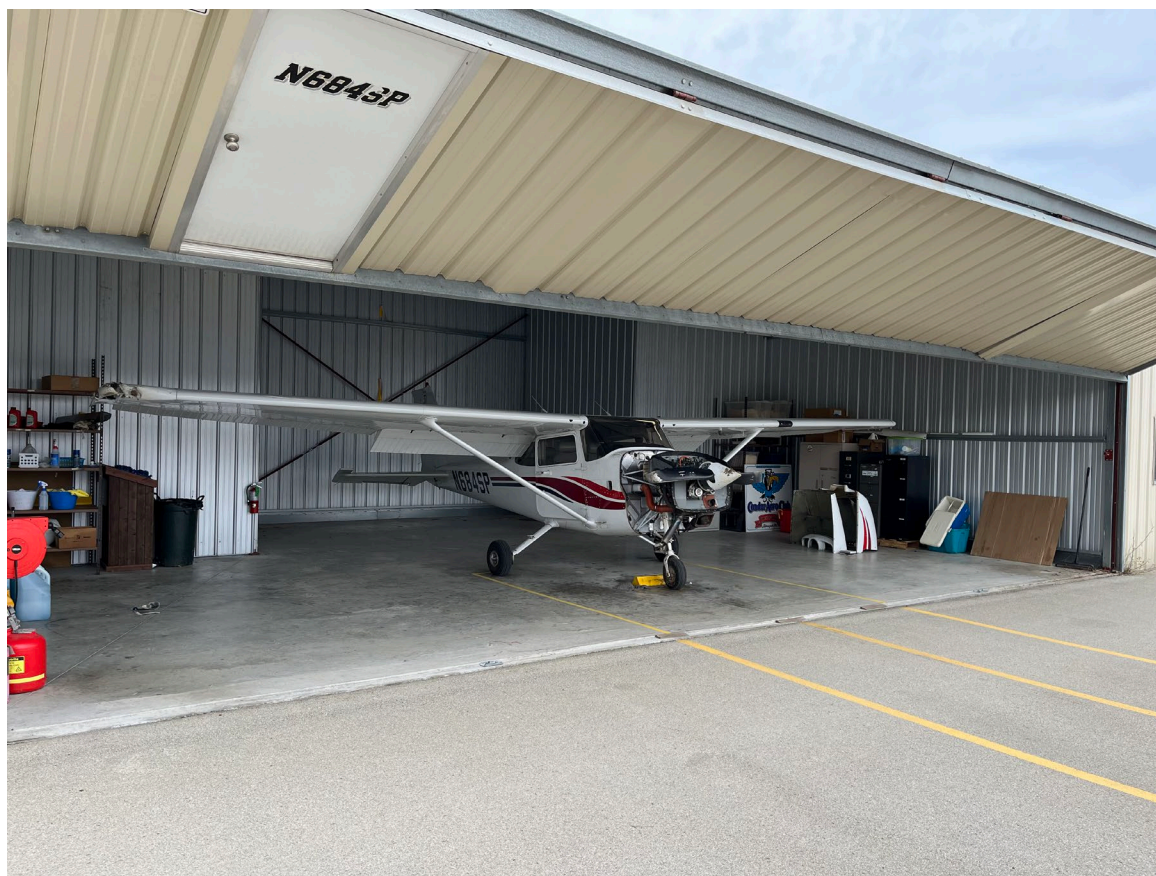
**Photograph 1 - FAA Digital Photograph. Right Forward Quartering View of the Airplane Following Recovery. Note Damage to the Right Wingtip.**

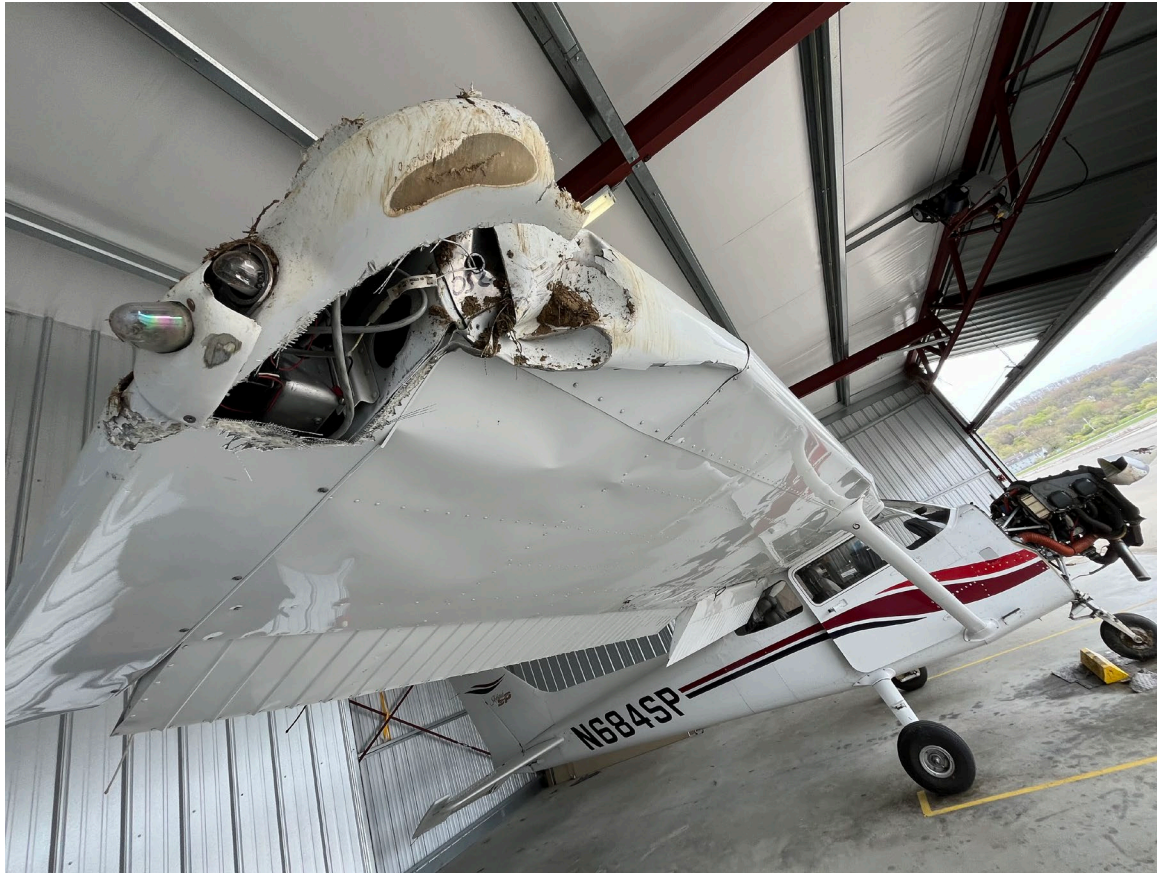
**Photograph 2 - FAA Digital Photograph. Right Side View of the Airplane Following Recovery.  
Note the Damage Aft of the Leading Edge Skin of the Bottom Wing Skin**

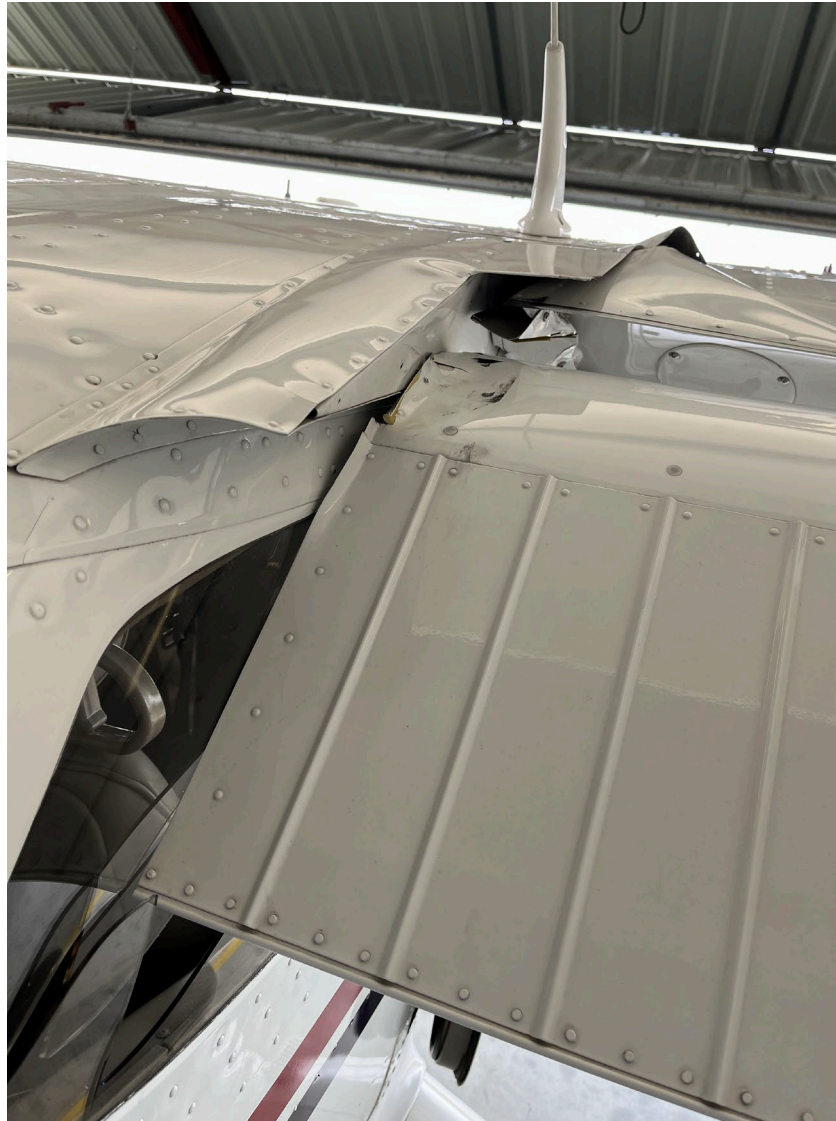
**Photograph 3 - FAA Digital Photograph. Aft View of the Inboard Portion of the Right Wing.  
Note the Buckling of the Upper Skin of the Wing Near the Wing Root**
