ERA24LA196

## INVESTIGATION PHOTOGRAPHS

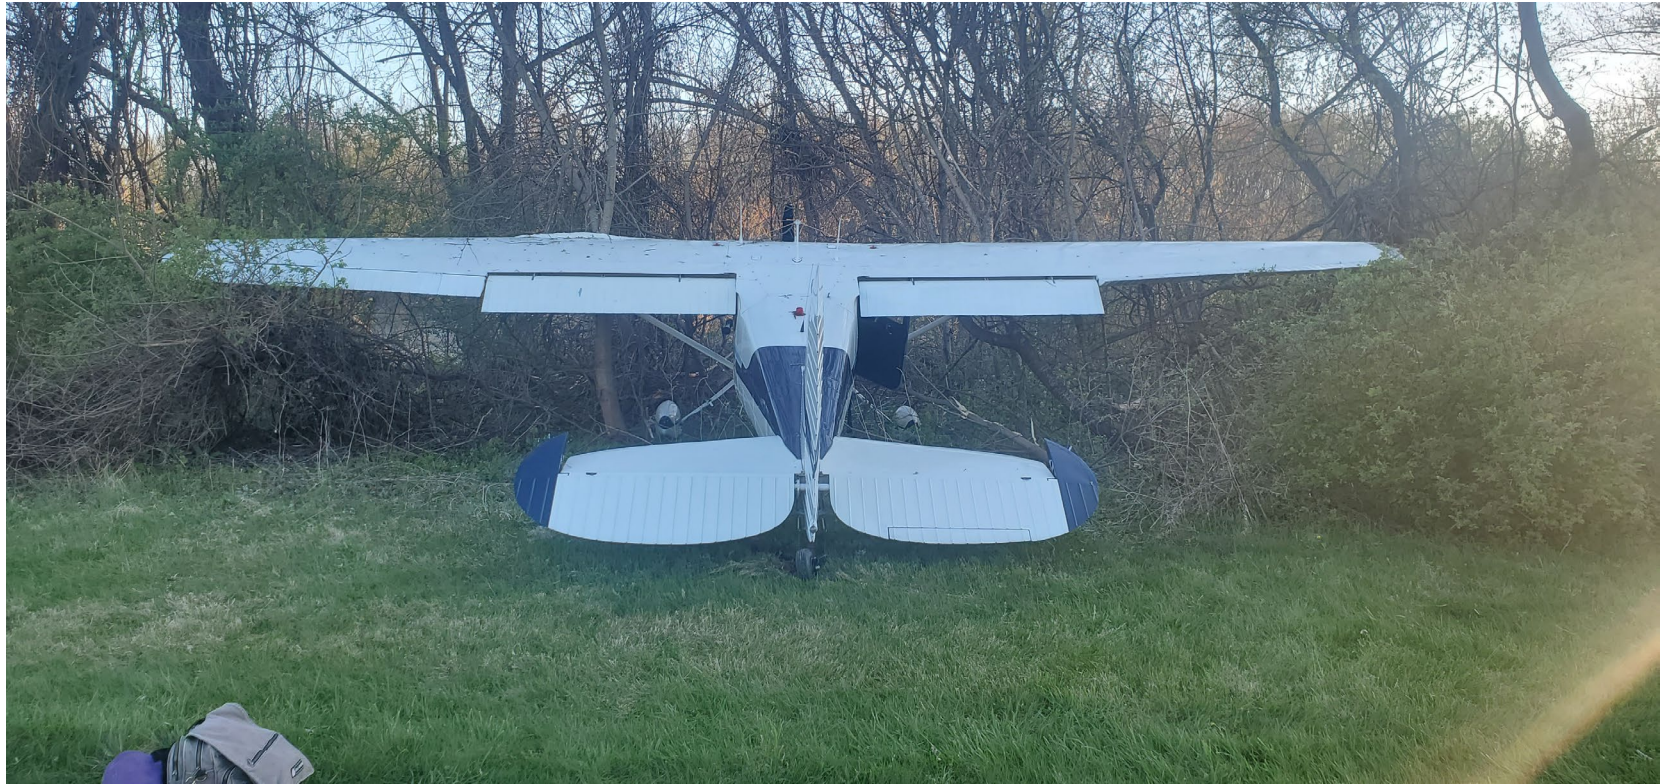
**Photograph 1 - Aircraft postaccident (Courtesy of FAA)**

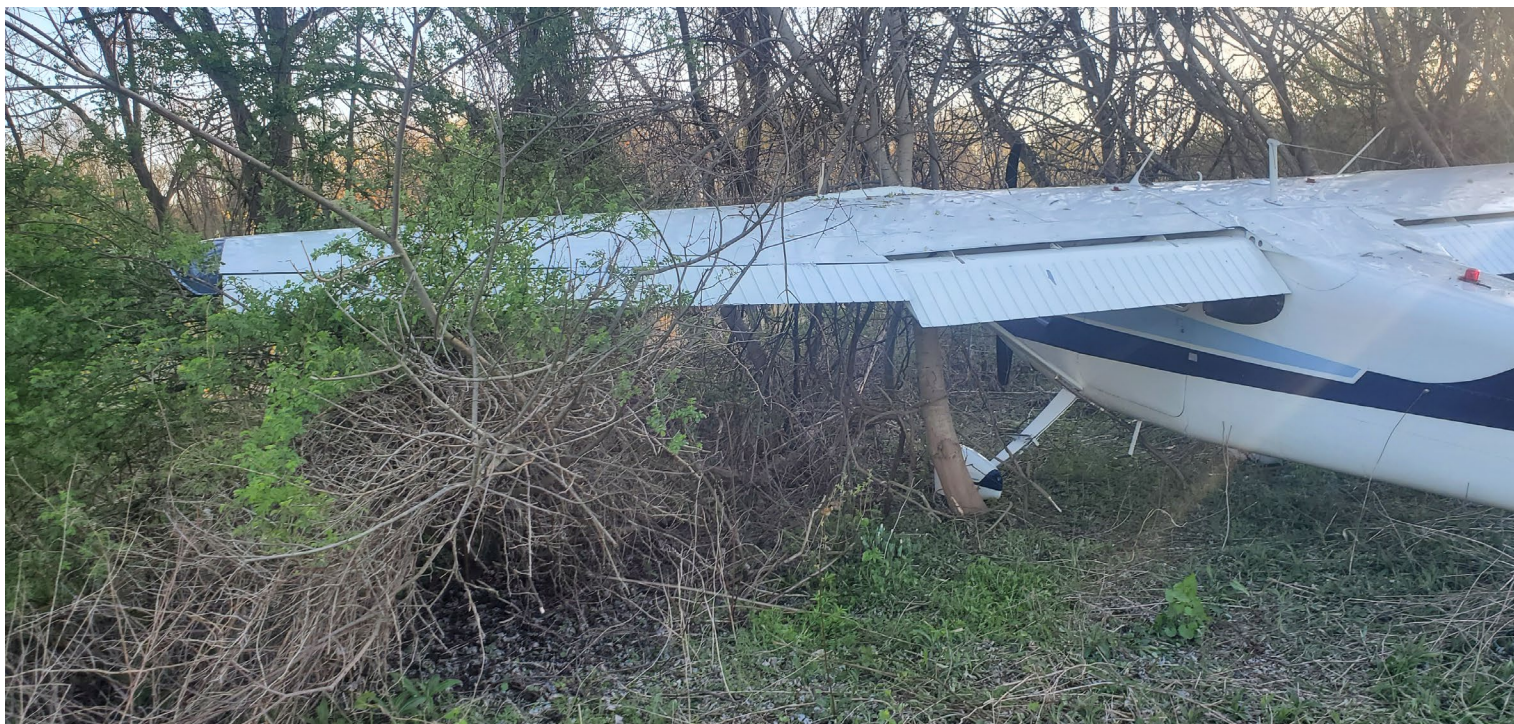
**Photograph 2 - Aircraft postaccident. Note left wing damage (Courtesy of FAA)**

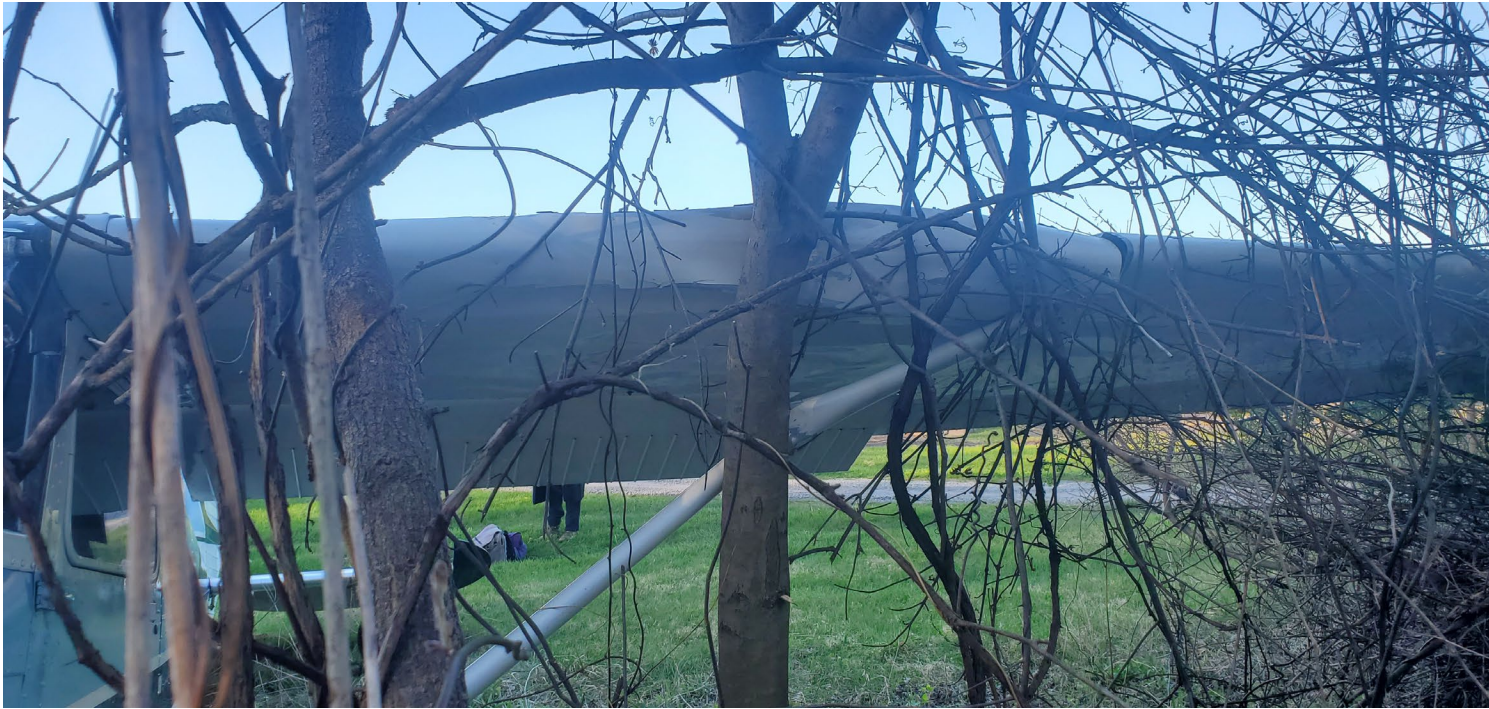
**Photograph 3 - Left wing tree impact and damage (Courtesy of FAA)**

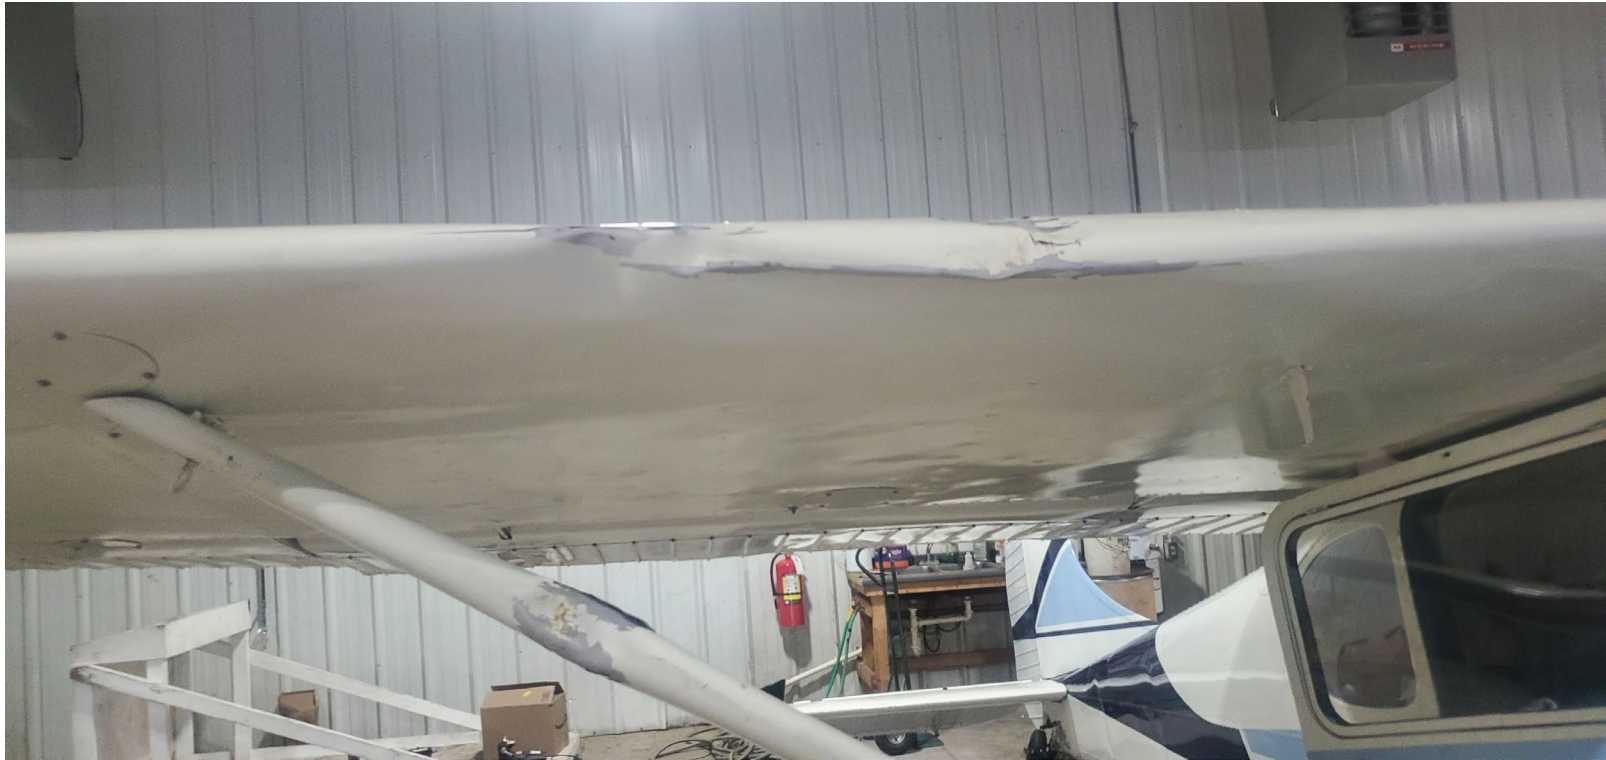
**Photograph 4 - Right wing and wing strut damage (Courtesy of FAA)**

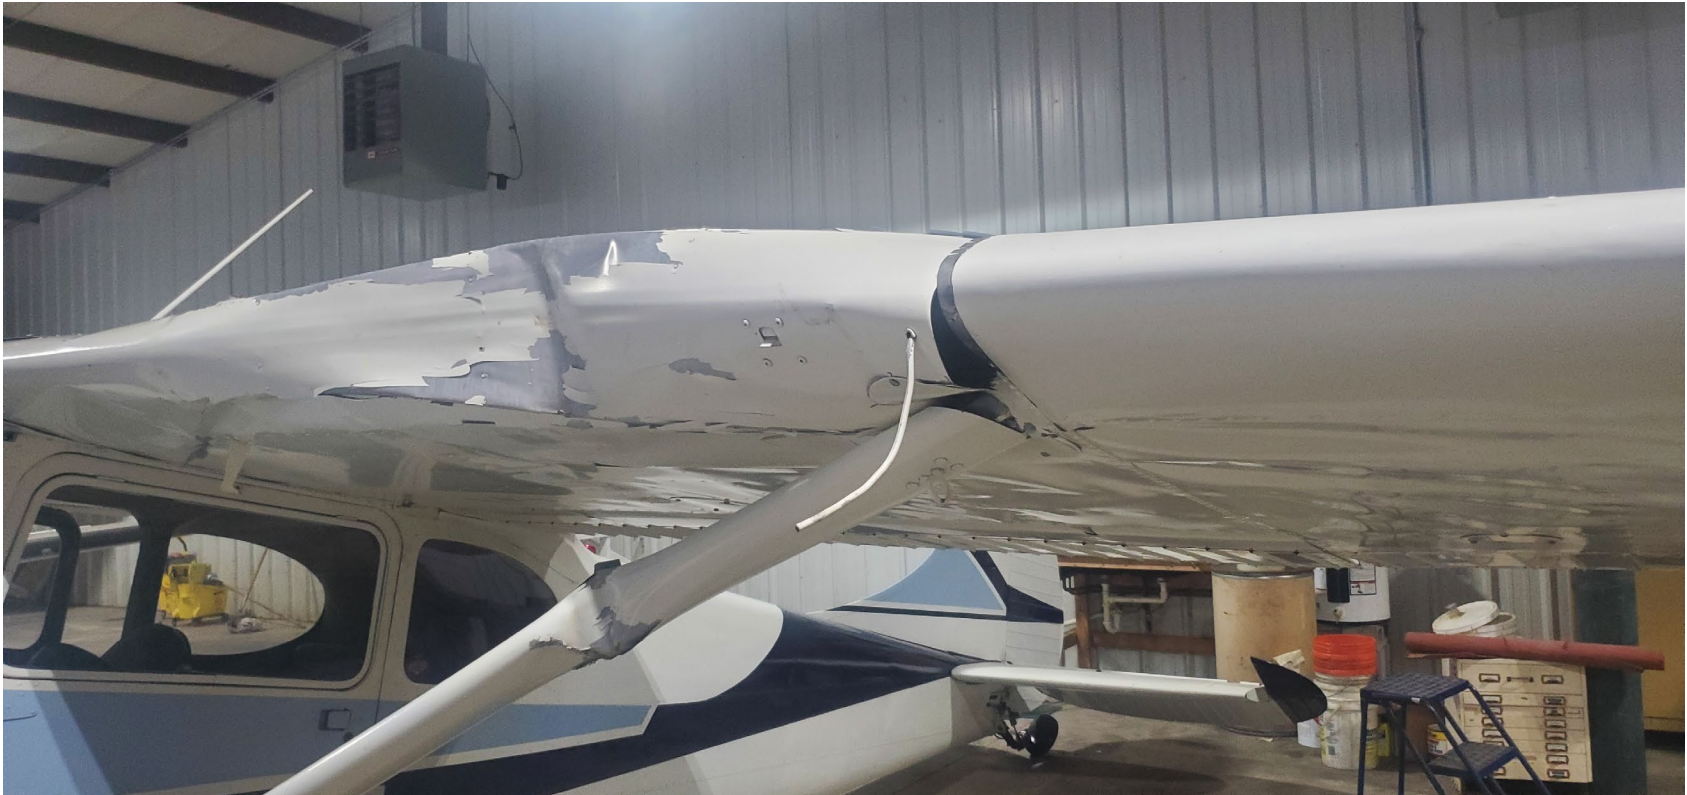
**Photograph 5 - Left wing and wing strut damage (Courtesy of FAA)**
