# National Transportation Safety Board

ERA24LA198

## **WRECKAGE EXAMINATION**

Location: Palatka, FL  
Date: April 29, 2024  
Time: 1645 EDT  
2045 UTC  
Airplane: N99442; Cessna 172P

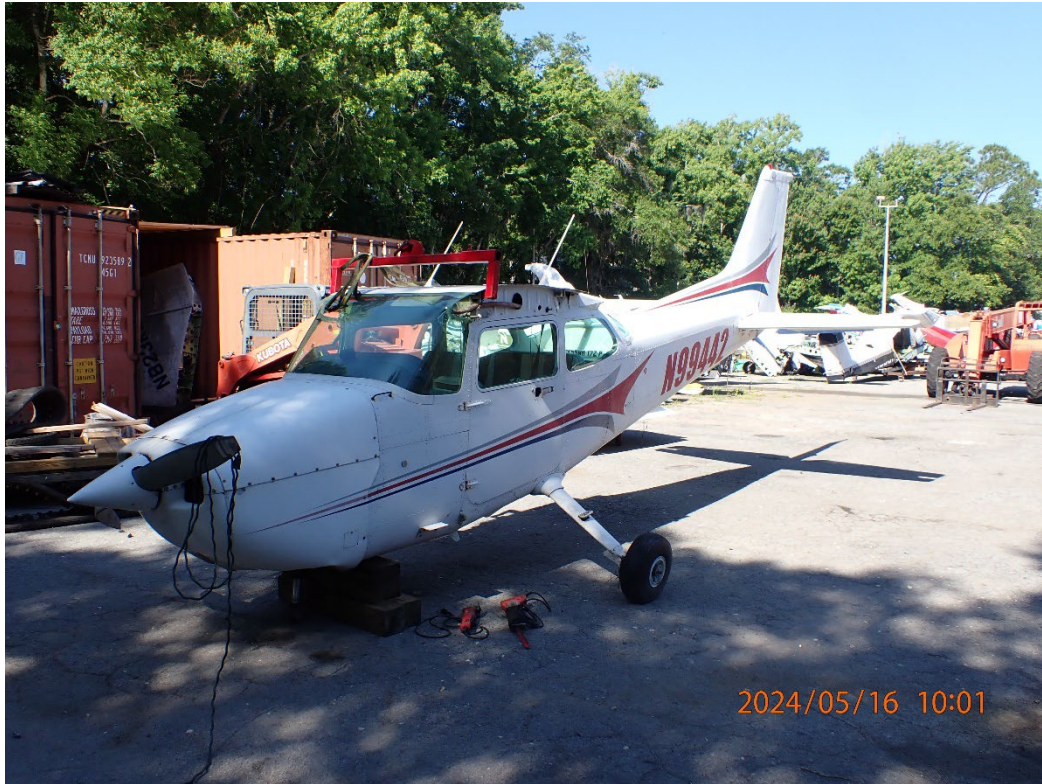
As first seen at the recovery facility the wings had been separated from the fuselage to facilitate recovery of the airplane. The nose of the airplane was on the ground and the tail was in the air due to damage sustained by the nose landing gear.

**Photo 1: View of the airplane as first seen at the salvage yard.**

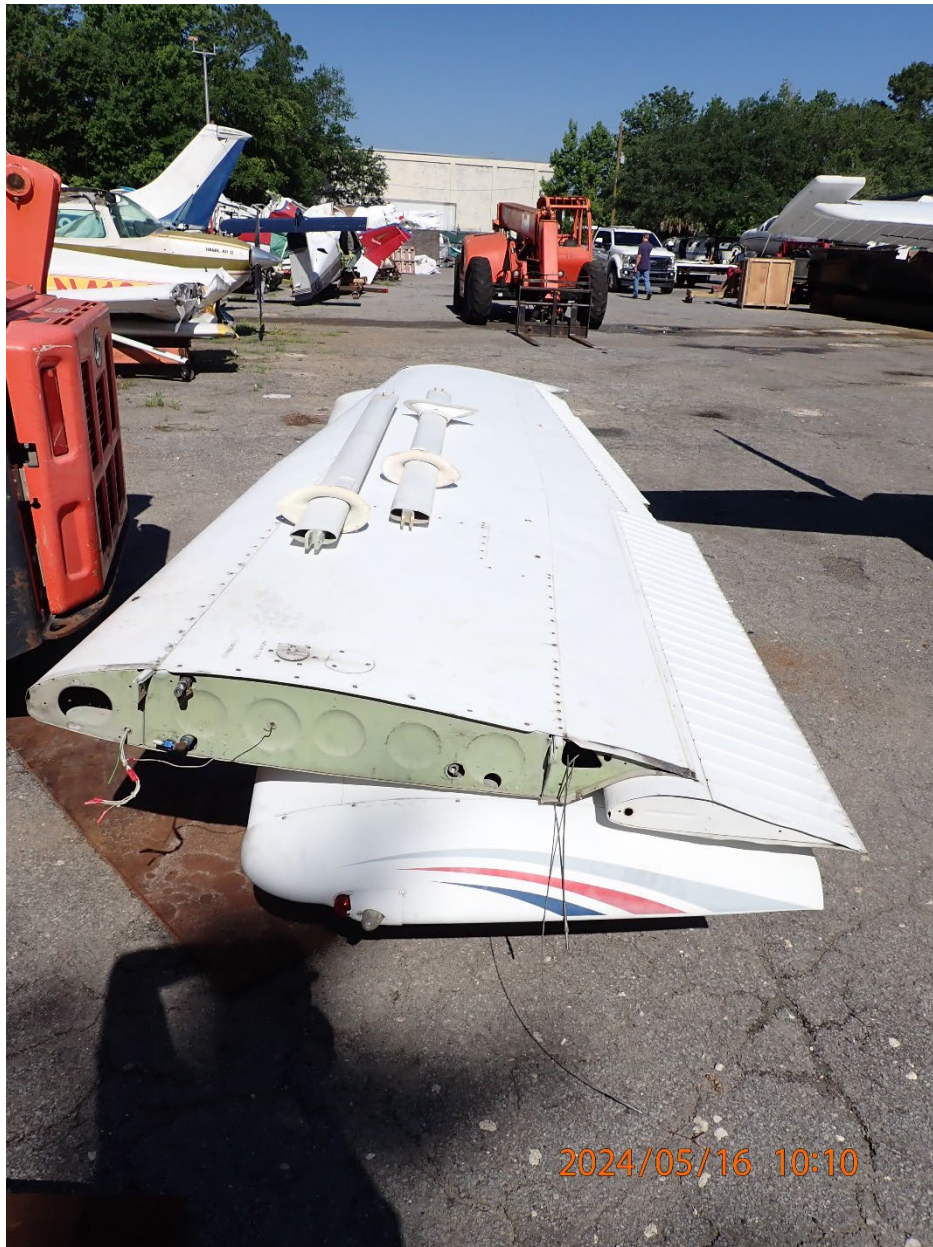
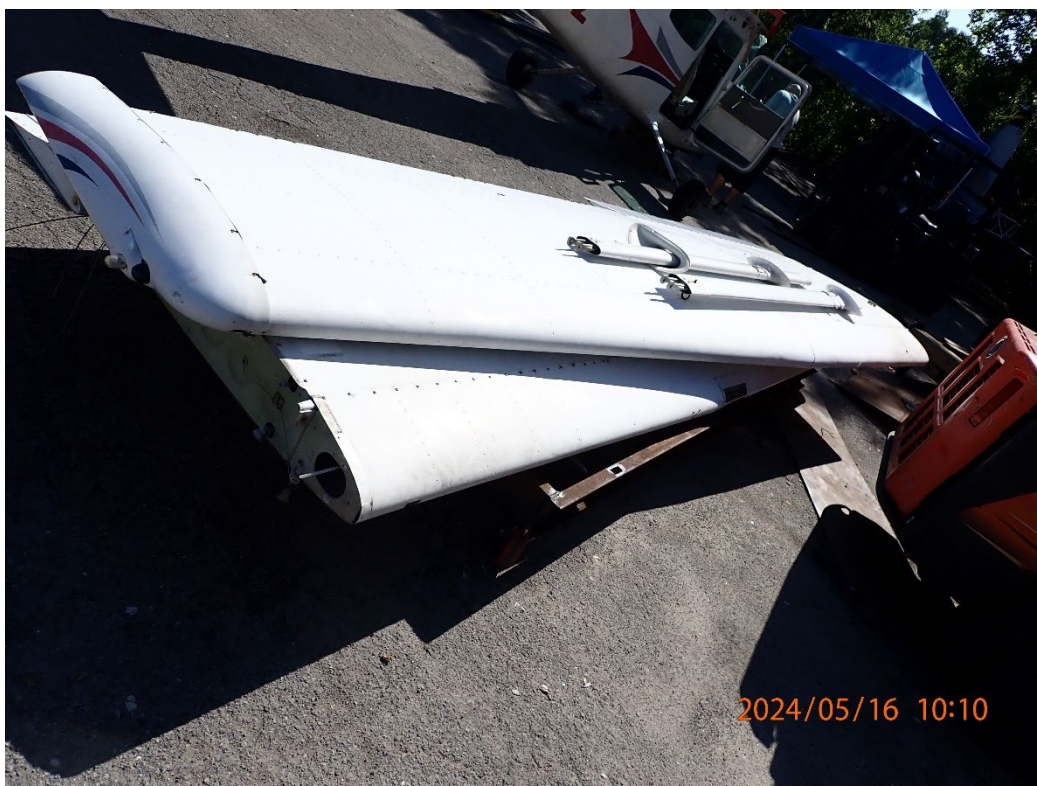
Both wings were removed from the fuselage by recovery personnel to facilitate recovery of the airplane. Both lift struts were removed by recovery personnel to facilitate recovery.

**Photo 2: View of the wings at the recovery facility.**

**Photo 3: View of the wings at the recovery facility.**

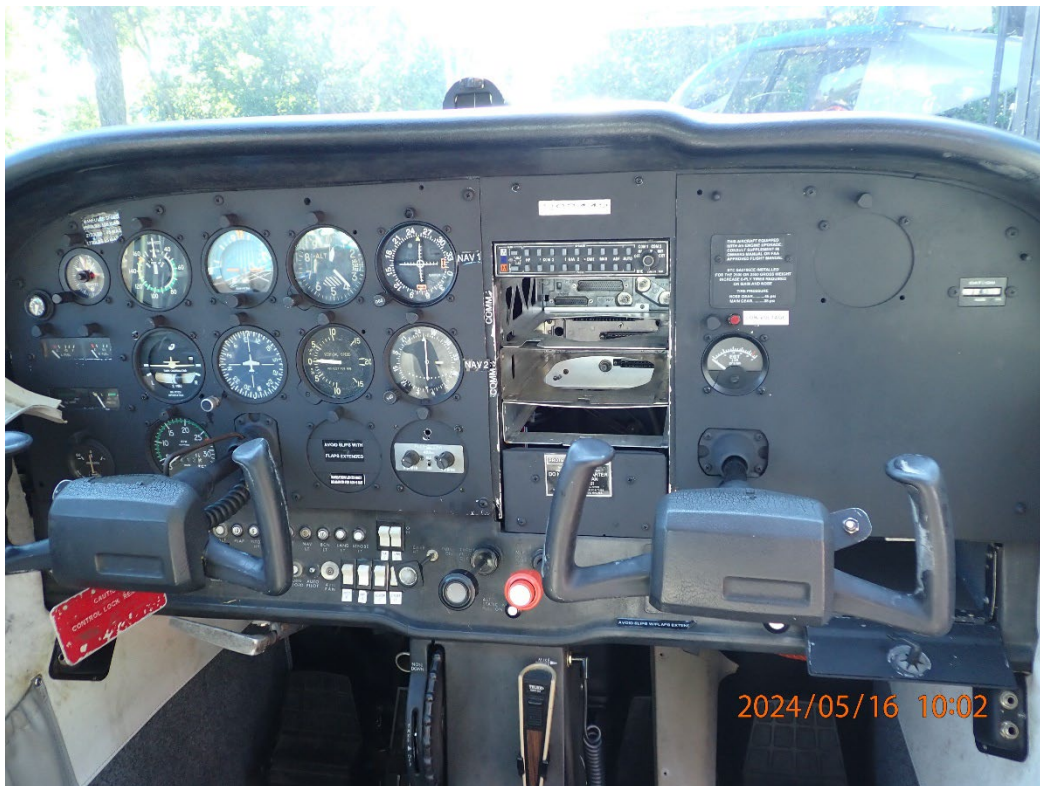
Upon first inspection at the recovery facility the flap handle was in the fully up position. The carburetor heat control was in the fully aft position and when operated by hand moved from stop to stop on the carburetor. The throttle control was in the fully aft position and when operated by hand moved from stop to stop on the carburetor. The mixture control was in the fully aft position and when operated by hand moved from stop to stop on the carburetor. The rudder trim was set slightly to the right of center indicating nose right trim. The elevator trim was set about halfway from the takeoff position to the nose down stop indicating nose down trim. One exhaust gas temperature gauge was installed, and the sensor was on the No. 4 cylinder exhaust pipe. The ignition key was not in the ignition and was set to the OFF

position. None of the circuit breakers were popped out. The following switch positions were observed:

**Photo 4: View of the cockpit.**

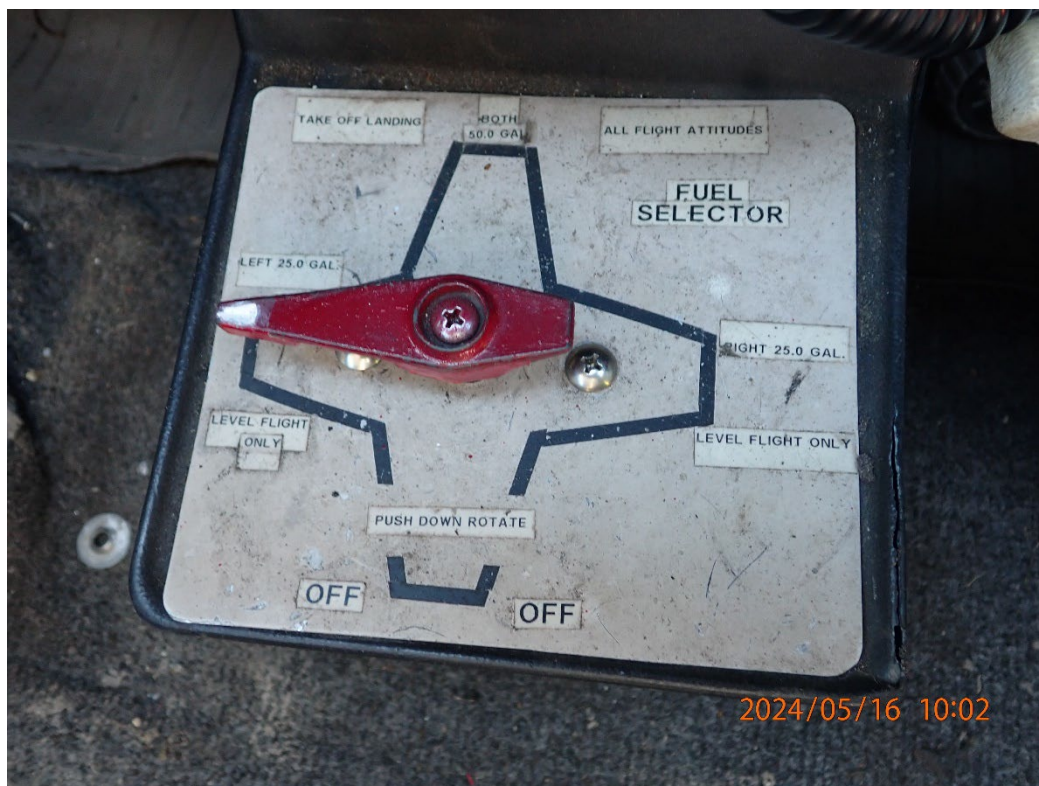
Both wings had been removed from the airplane and the fuel caps were seated and locked on their respective wings. The fuel selector was set to left. The fuel strainer screen was removed and examined and showed minimal organic debris.

**Photo 5: View of the fuel selector.**

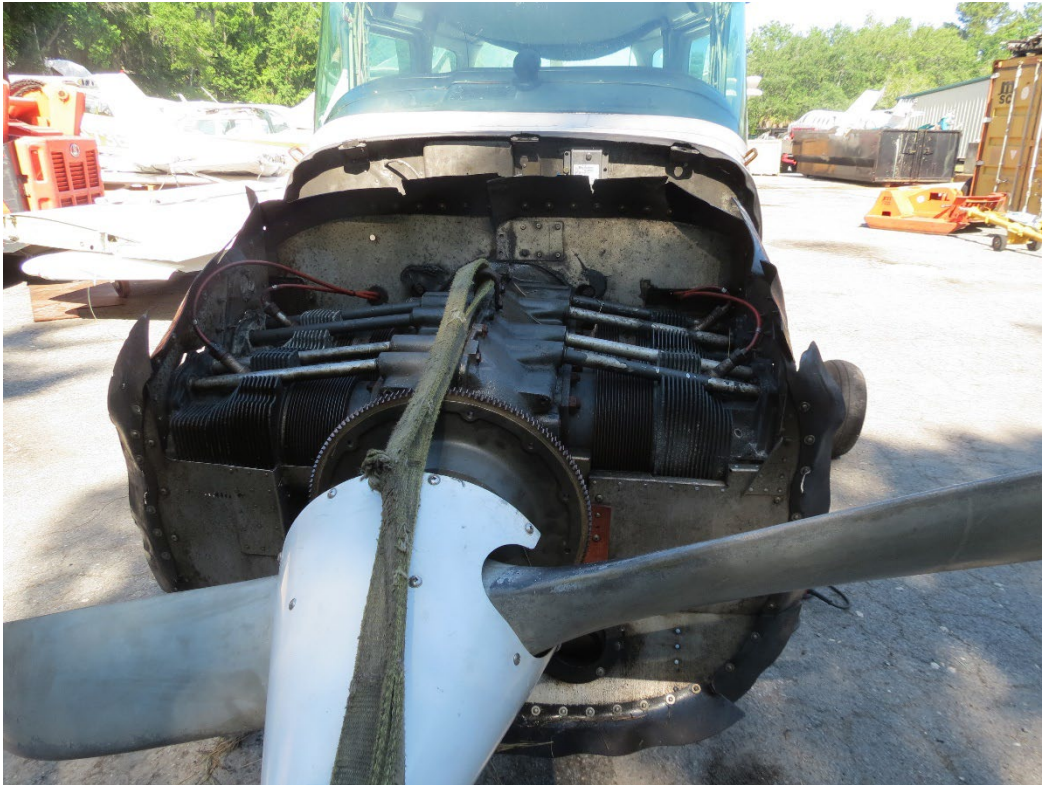
The engine as first observed remained attached to the fuselage through the tubular engine mount with the cowling still attached. The cowling was removed. Oil was observed on the upper and lower surfaces of the engine crankcase and on the forward surface of the forward engine baffles. Oil was observed on the interior surface of the lower cowling. Epoxy sealing material was observed smeared in the upper area where the two crankcase halves meet. Oil was observed on the crankcase nose in the area behind the starter ring gear support. Compression and suction were confirmed on all cylinders when the crankshaft was rotated through multiple 360° of rotation by hand using the propeller. Continuity of the crankshaft to the rear gears and valvetrain was established by rotating the crankshaft through multiple 360° of rotation by hand using the propeller. It was observed that some valves lifted considerably less than others, upon further examination it was found the camshaft lobes had been severely worn. The Nos. 2 and 4 intake pushrod tubes were dented. The propeller was removed and the crankcase nose oil seal protruding about 3/8 inch from its recess in the crankcase nose. Sealing material was observed smeared on the forward surface of the seal. The crankcase was split to facilitate further examination of the engine. The cylinders and pistons were removed. No damage to the cylinders, pistons, piston pins, valves or valve springs was observed. The connecting rods were rotated freely by hand on their respective crankshaft rod

**Photo 6: Overview of engine still attached to airframe.**

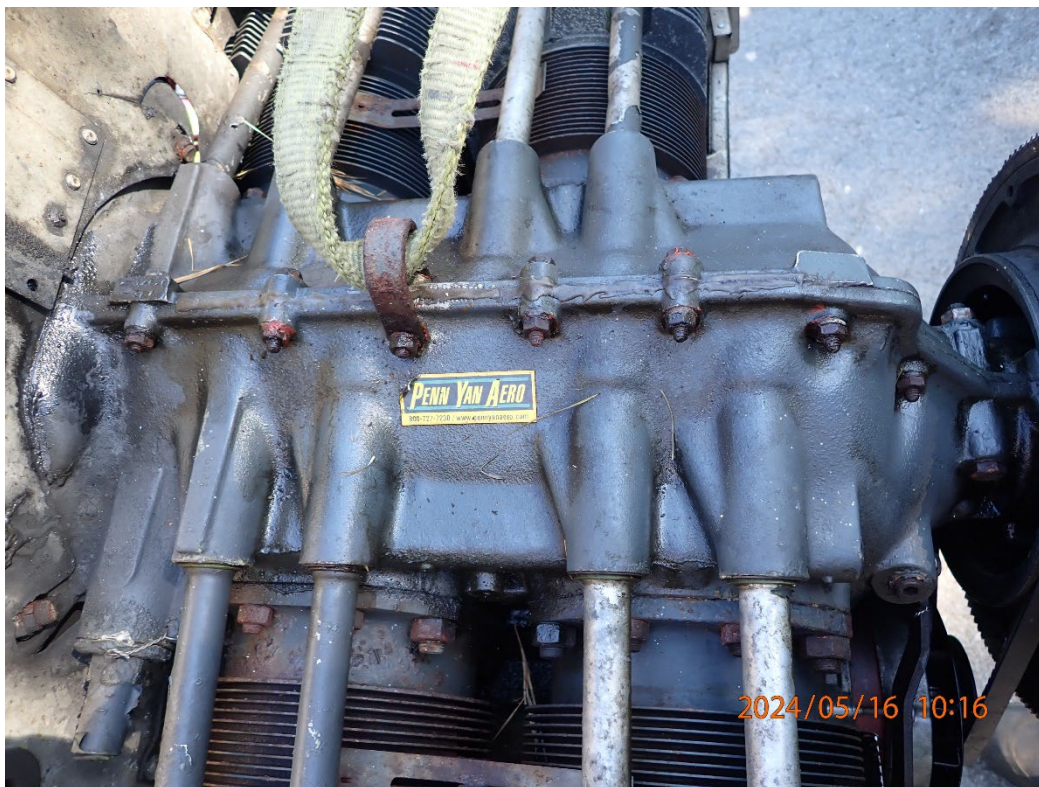
**Photo 7: View of sealant on the spine of the crankcase.**

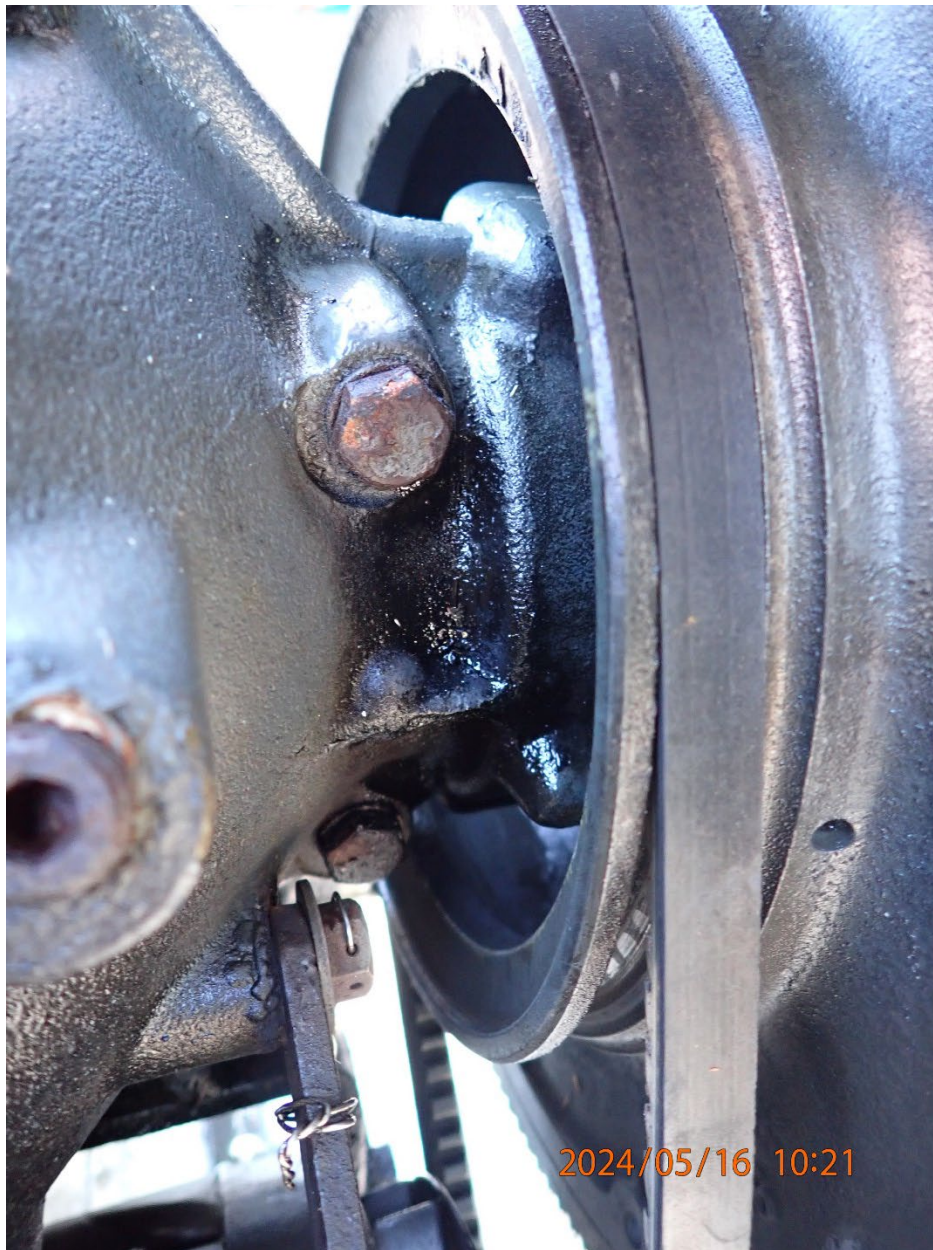
**Photo 8: Oil behind the starter ring gear support.**

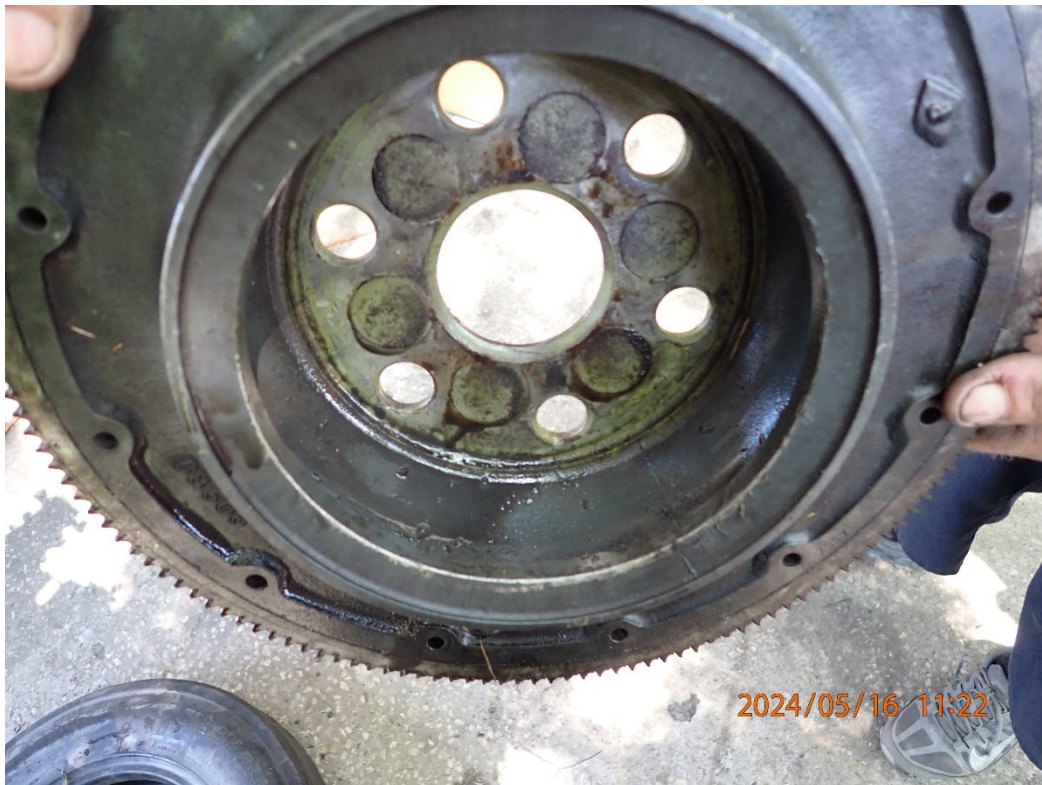
**Photo 9: Oil pooled in the back of the starter gear ring.**

Upon initial inspection of the engine oil was seen streaked on the exterior of the crankcase. The quick drain oil plug remained secured and was opened to facilitate the draining of any oil that remained in the engine. About 2 quarts of oil were drained from the engine. The oil suction screen was unobstructed. The oil filter was removed and cut open and contained a small amount of metallic debris. The oil pump produced oil when the oil pump was rotated by hand in the accessory case. The pump was disassembled and no damage to the gears observed. Light scoring was observed on the oil pump cavity walls. Oil was observed pooled on the back of the starter gear ring.

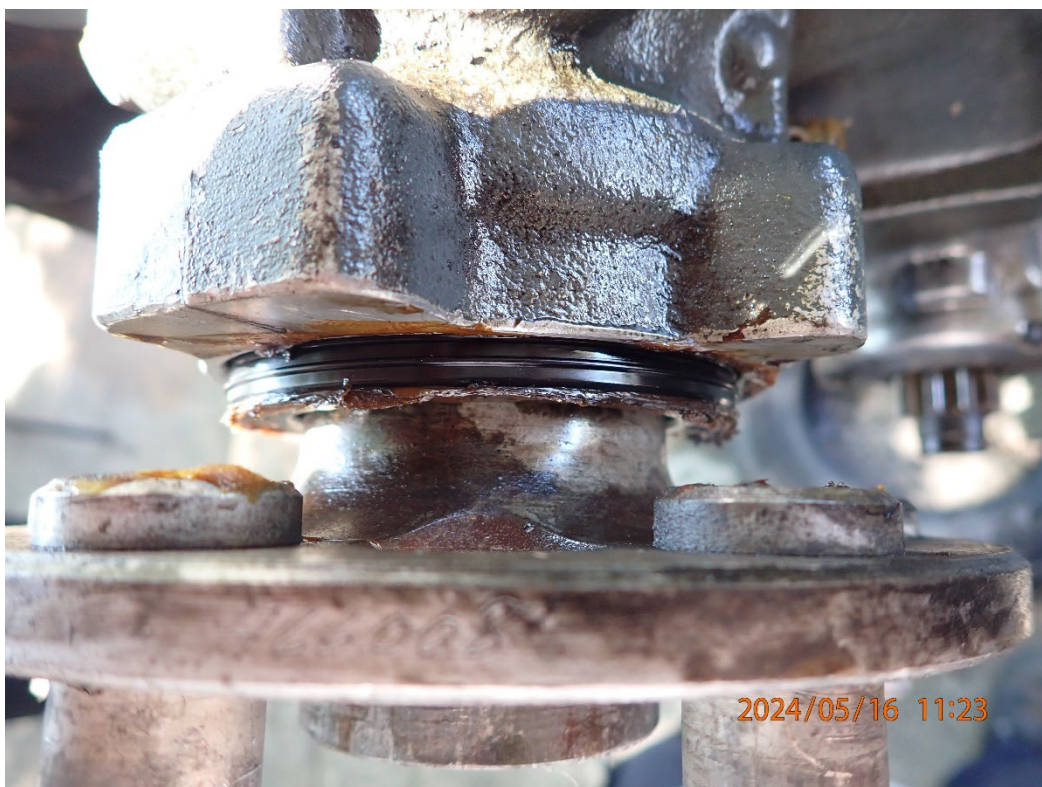
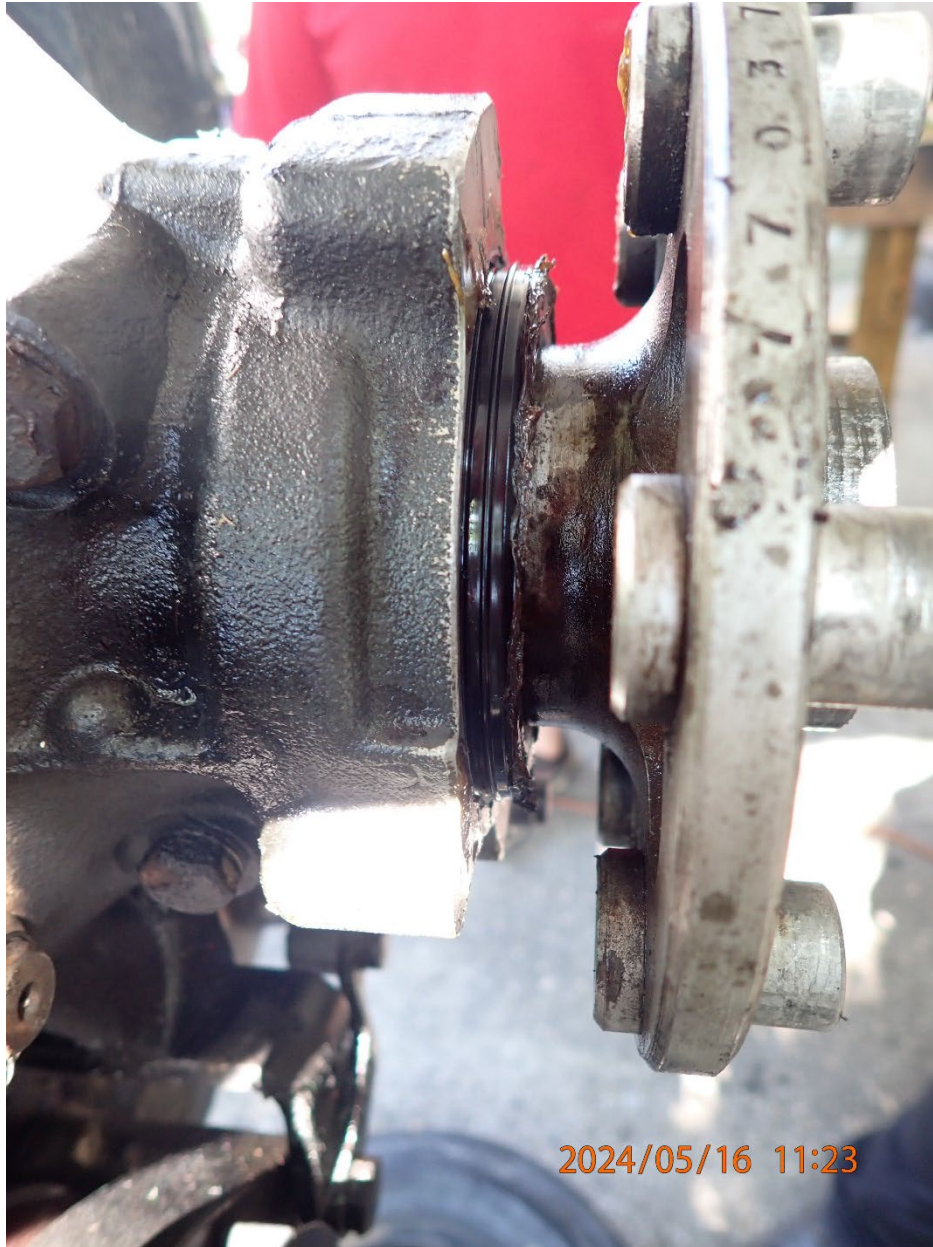
**Photo 10: View of the crankcase nose oil seal as first observed.**

**Photo 11: View of the crankcase nose oil seal as first observed.**

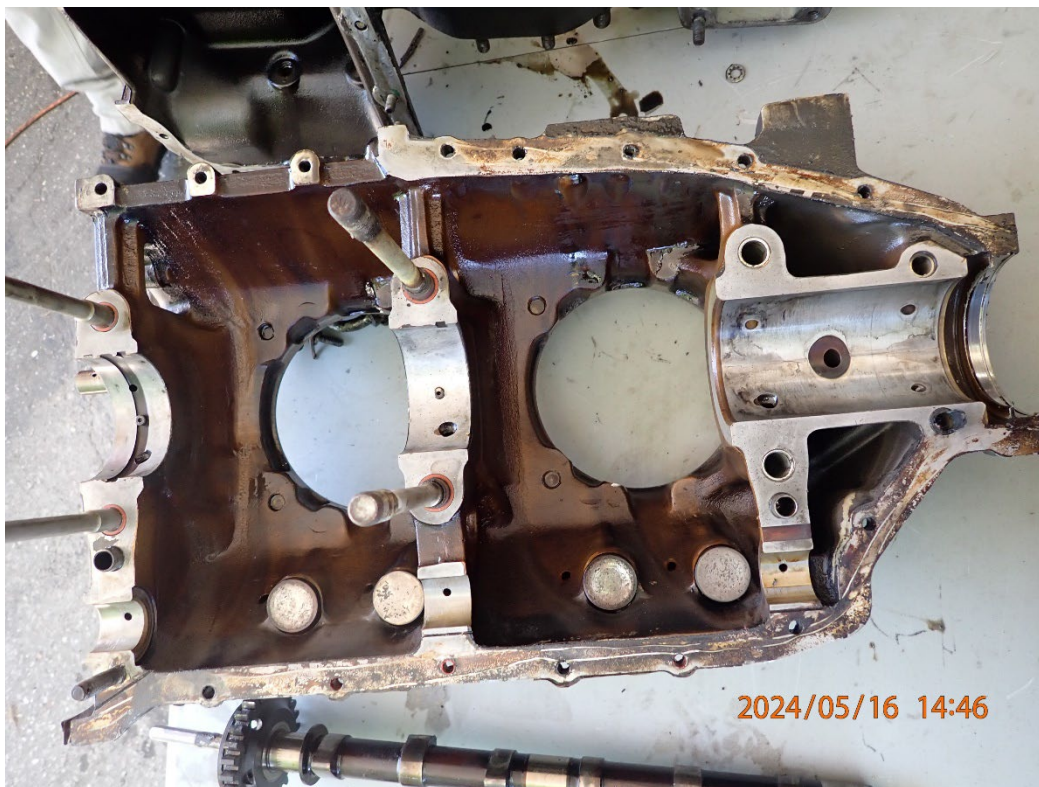
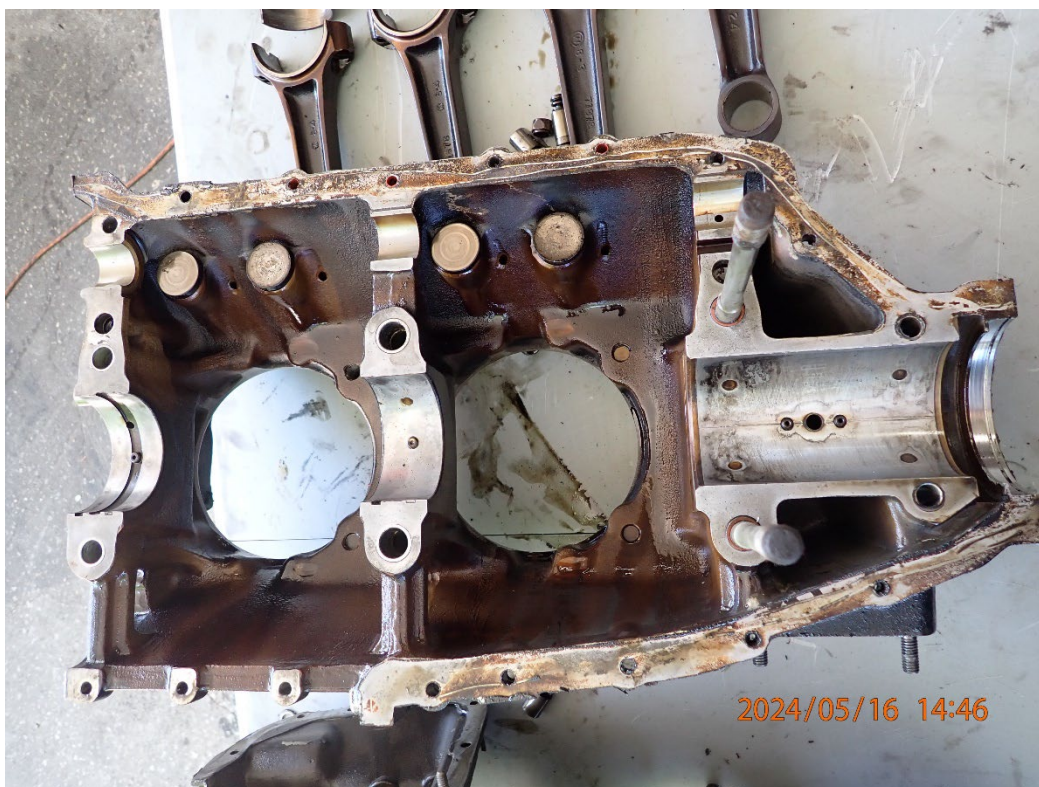
journals. The crankcase halves were separated, and the crankshaft and camshaft removed. The faces of all four hydraulic tappet bodies in the right crankcase half exhibited significant corrosion pitting. The faces of three of the four hydraulic tappet bodies in the left crankcase half exhibited significant corrosion pitting. Three of the six camshaft lobes exhibited significant wear. The crankshaft main journals and rod journals exhibited light scoring. The crankshaft main bearings and the rod bearings also exhibited light scoring.

**Photo 12: View of the right crankcase half.**

**Photo 13: View of the left crankcase half.**

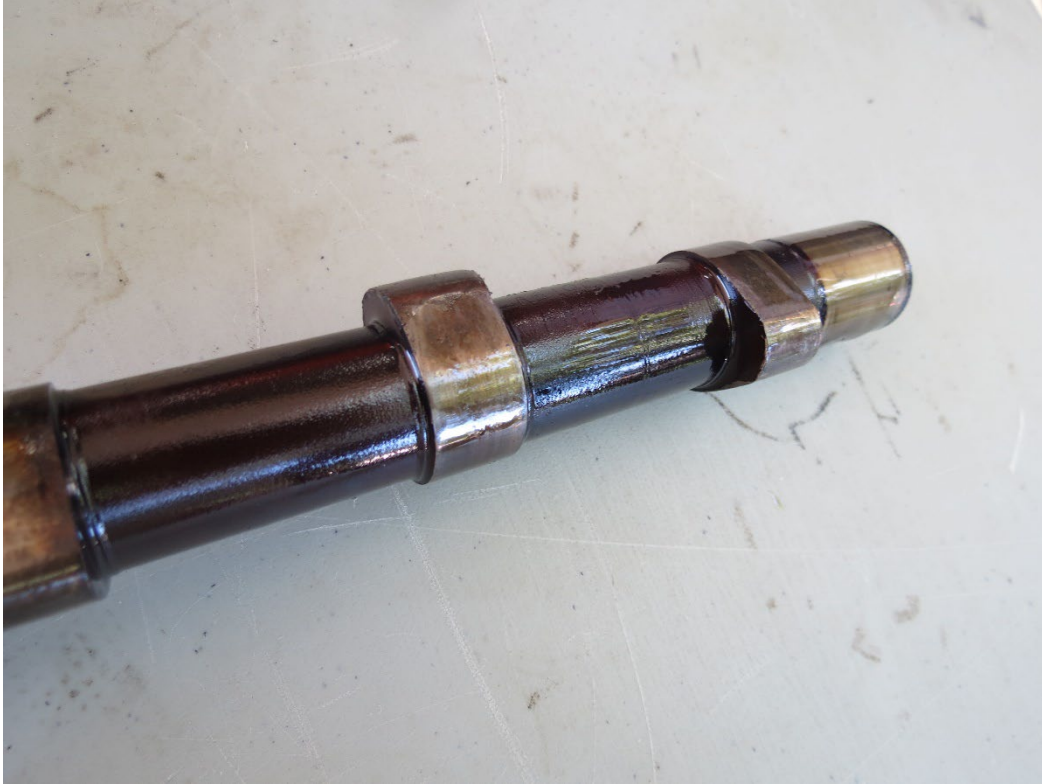
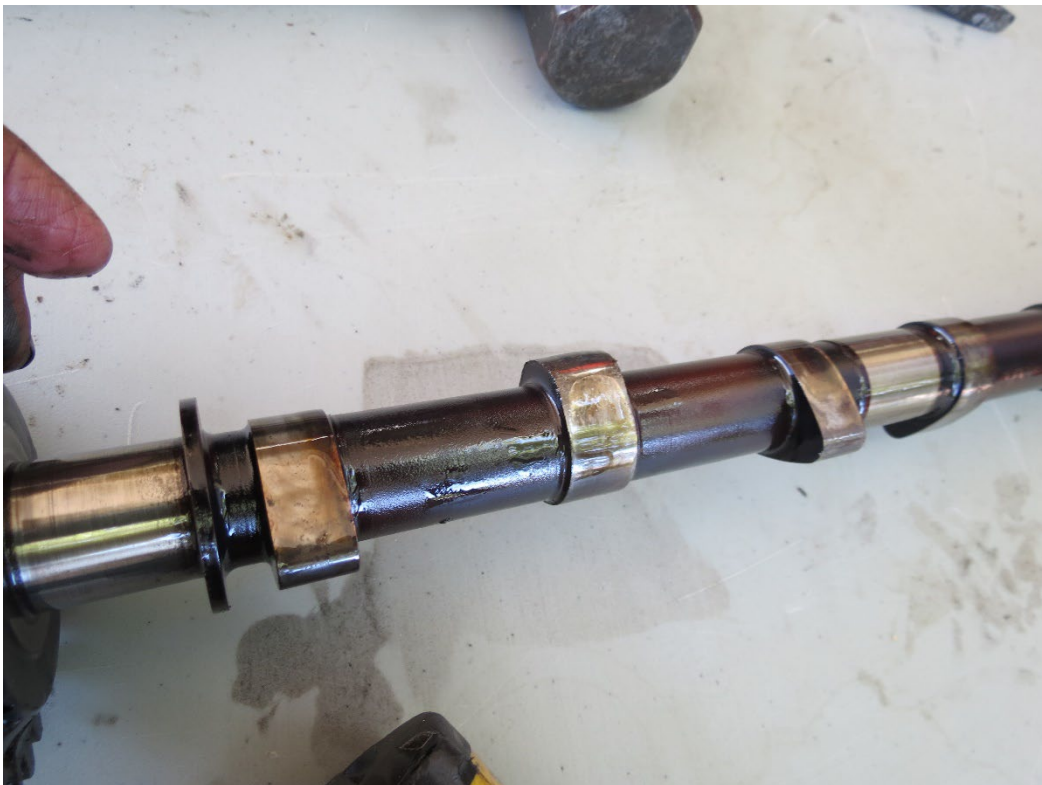
**Photo 14: View of the forward camshaft lobes.**

**Photo 15: View of the aft camshaft lobes.**

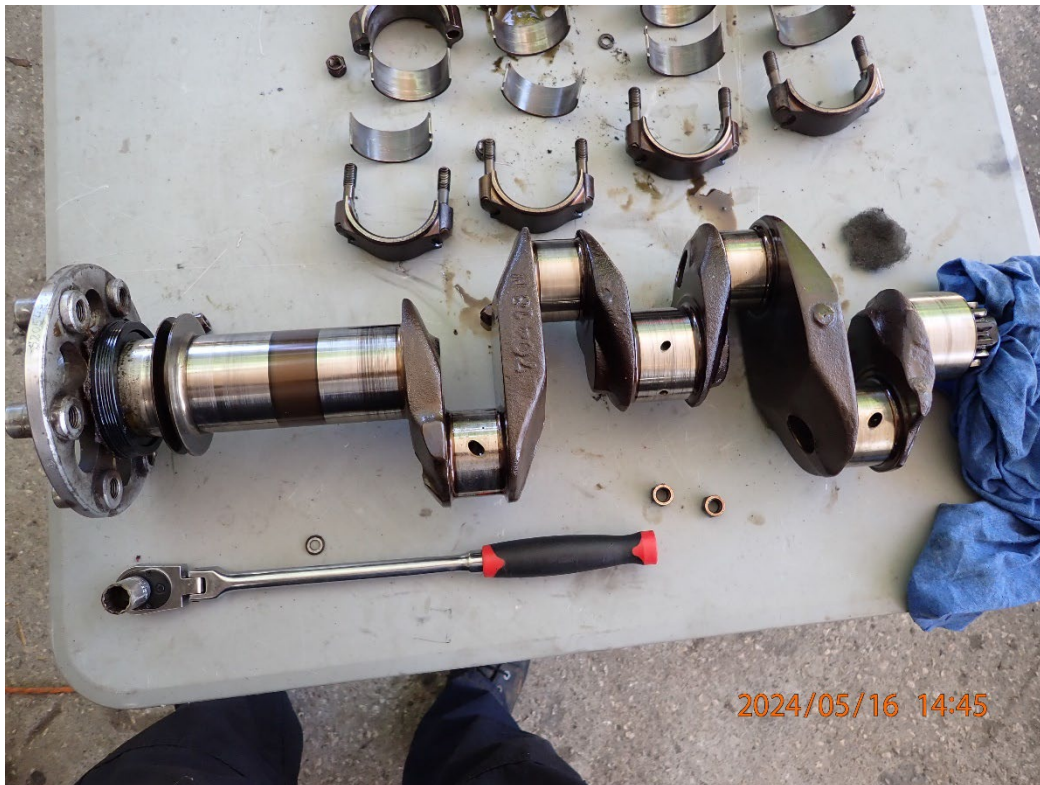
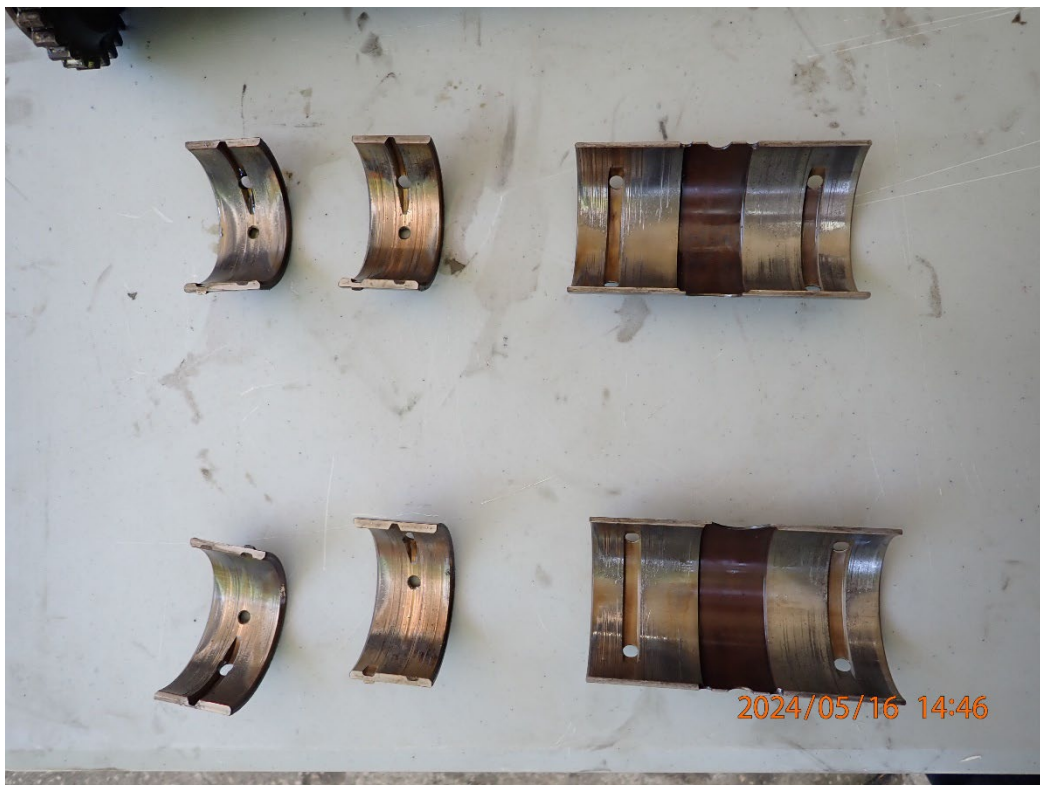
**Photo 16: View of the crankshaft.**

**Photo 17: View of the crankshaft bearings.**

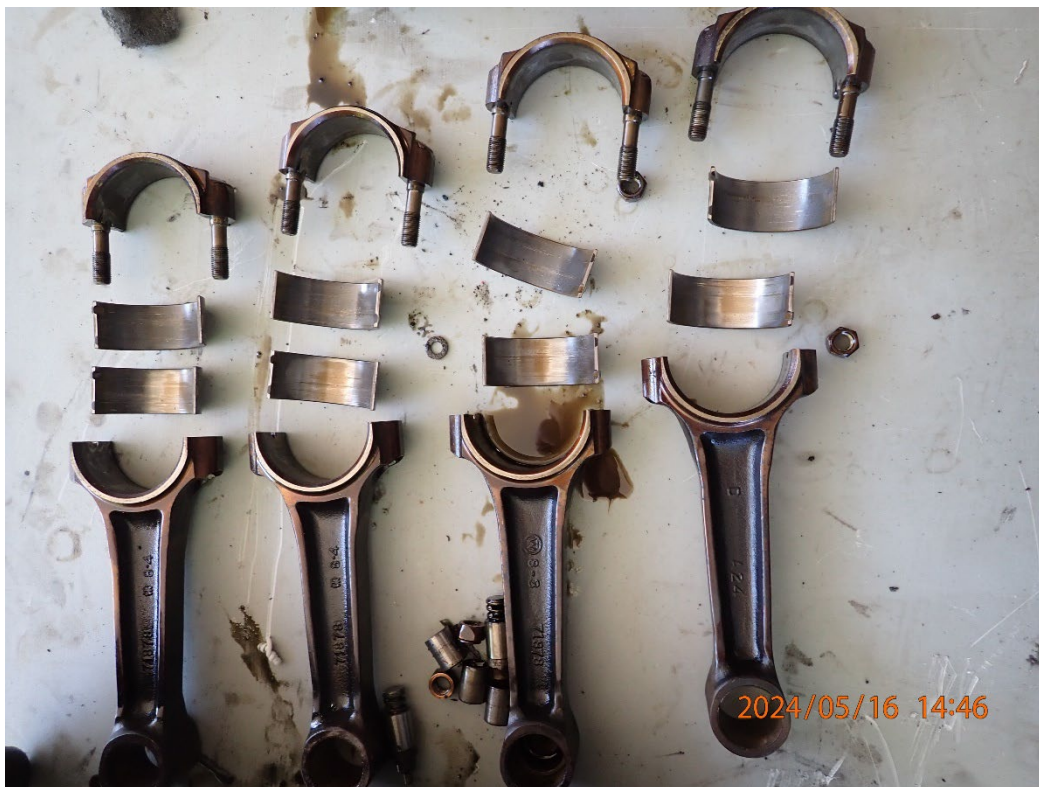
**Photo 18: View of the disassembled connecting rods.**

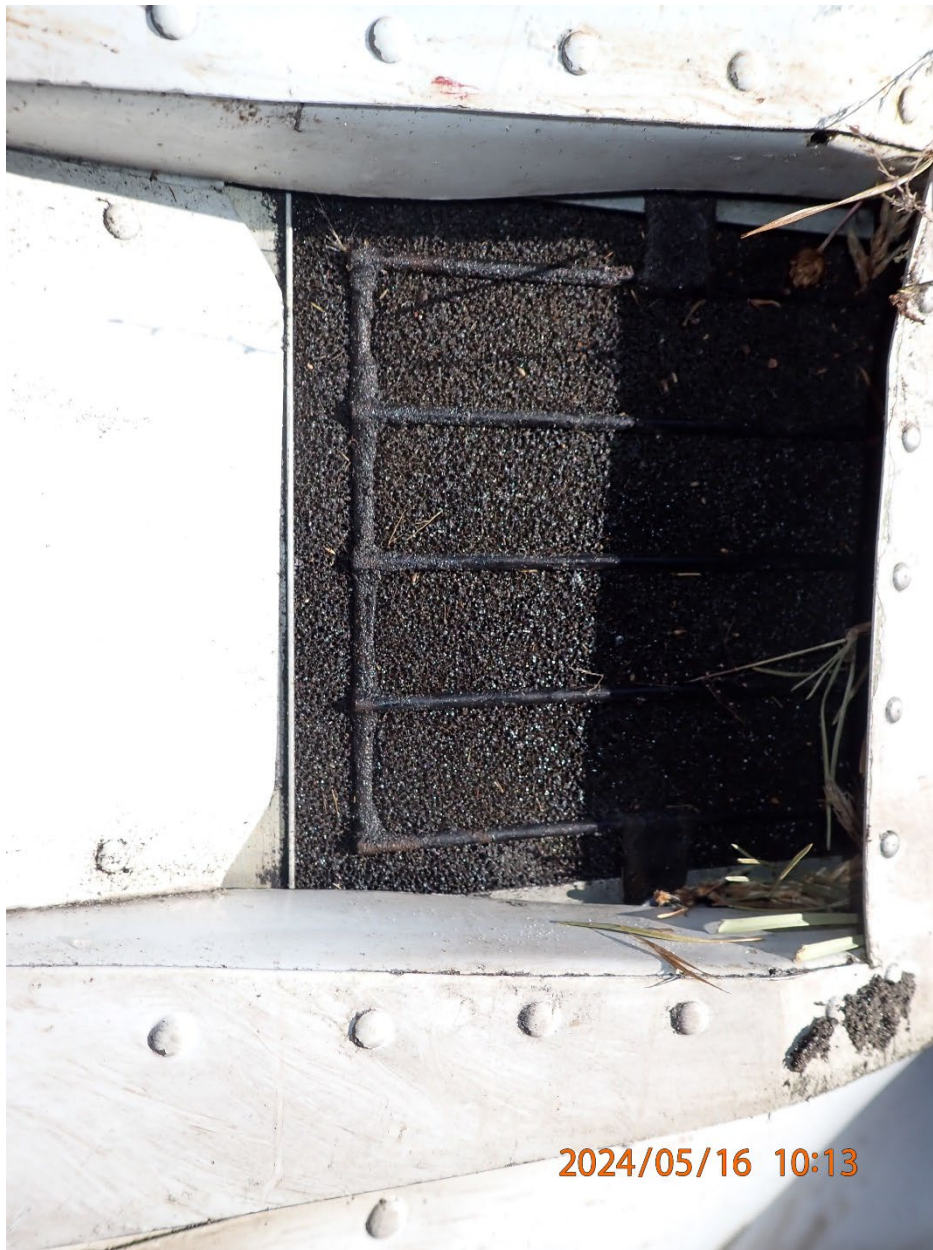
**Photo 19: View of the air intake filter.**

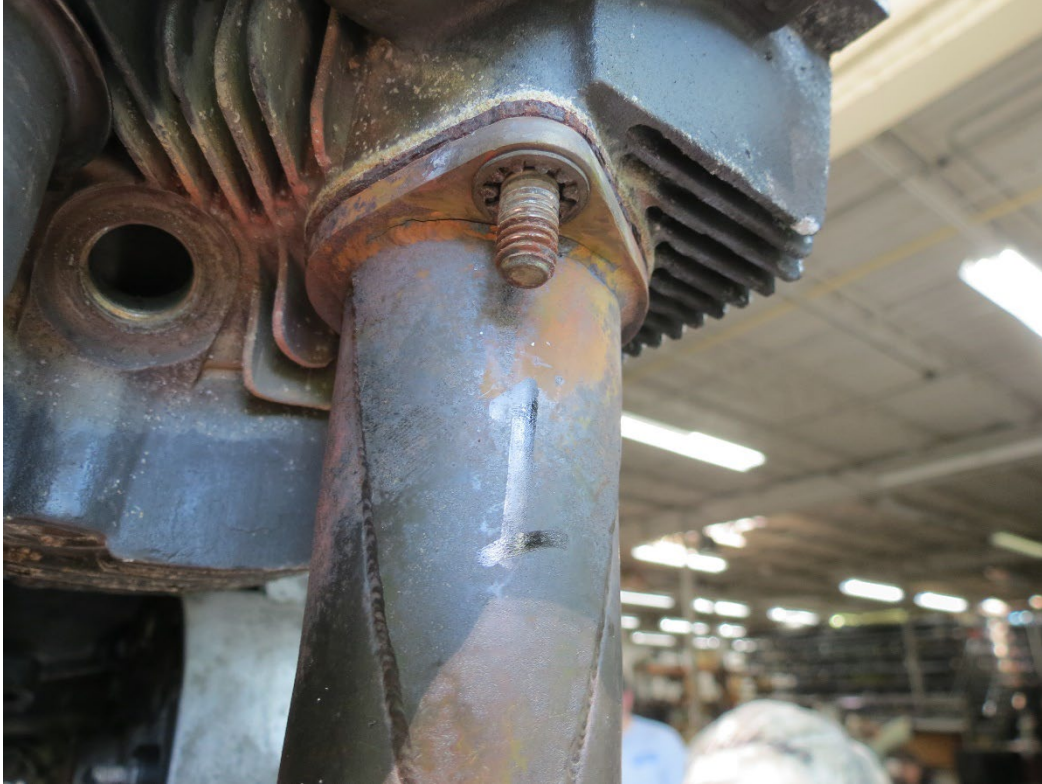
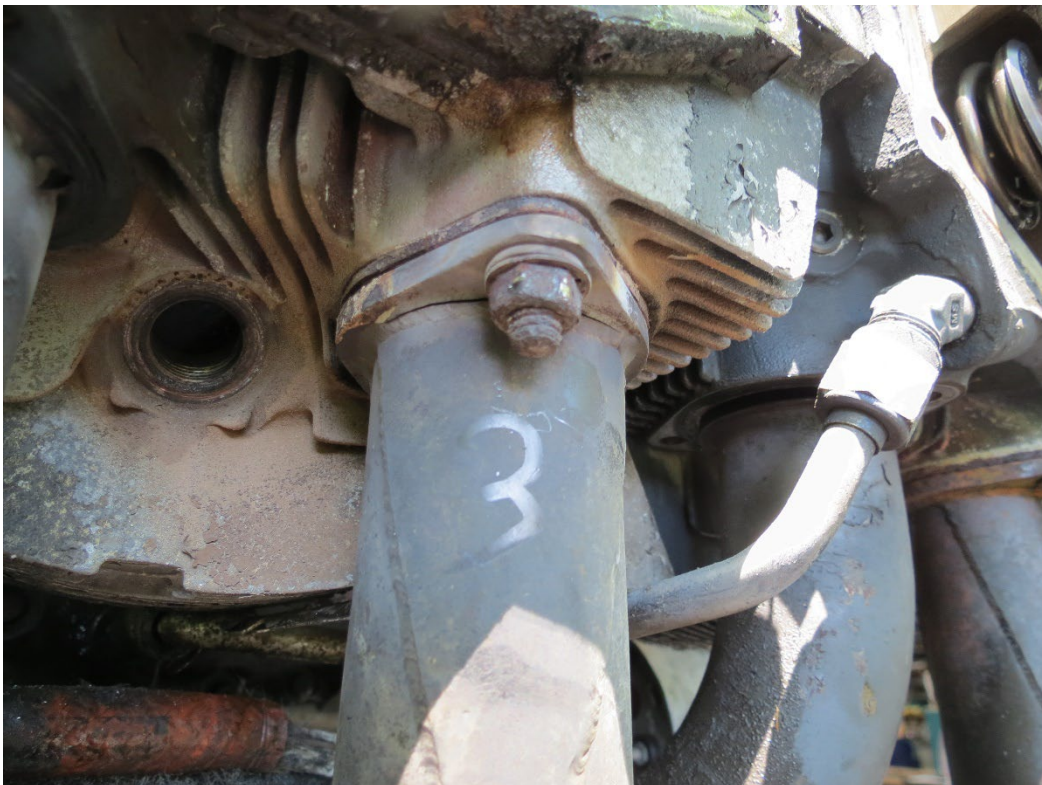
The air intake filter remained in the cowling and had minimal organic debris. The passageway from the air filter to the carburetor was unobstructed. The engine exhaust system was removed. The Nos. 1 and 3 exhaust flanges were observed cracked. The exhaust muffler was not obstructed.

**Photo 20: View of the No. 1 exhaust flange. (Lycoming Photo)**

**Photo 21: View of the No. 3 exhaust flange. (Lycoming Photo)**

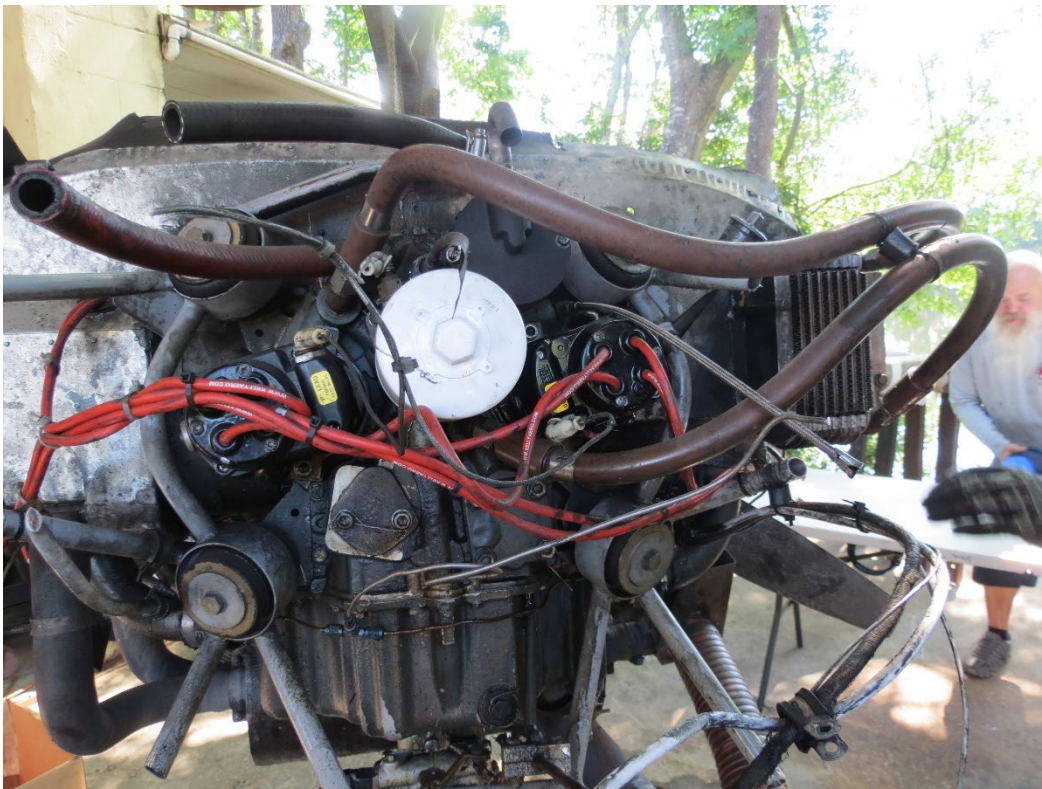
Both the left and right magneto remained attached to the engine at all attachment points. A review of maintenance records found the right magneto had been replaced on April 11, 2024, 17 days prior to the accident. The right magneto did not have the ground wire attached and did not have an impulse coupling. The right magneto sparked on all leads when the drive gear was rotated by hand. The left magneto was equipped with an impulse coupling and sparked from all leads when the drive gear was rotated by hand.

**Photo 22: View of the magnetos installed on the engine.**

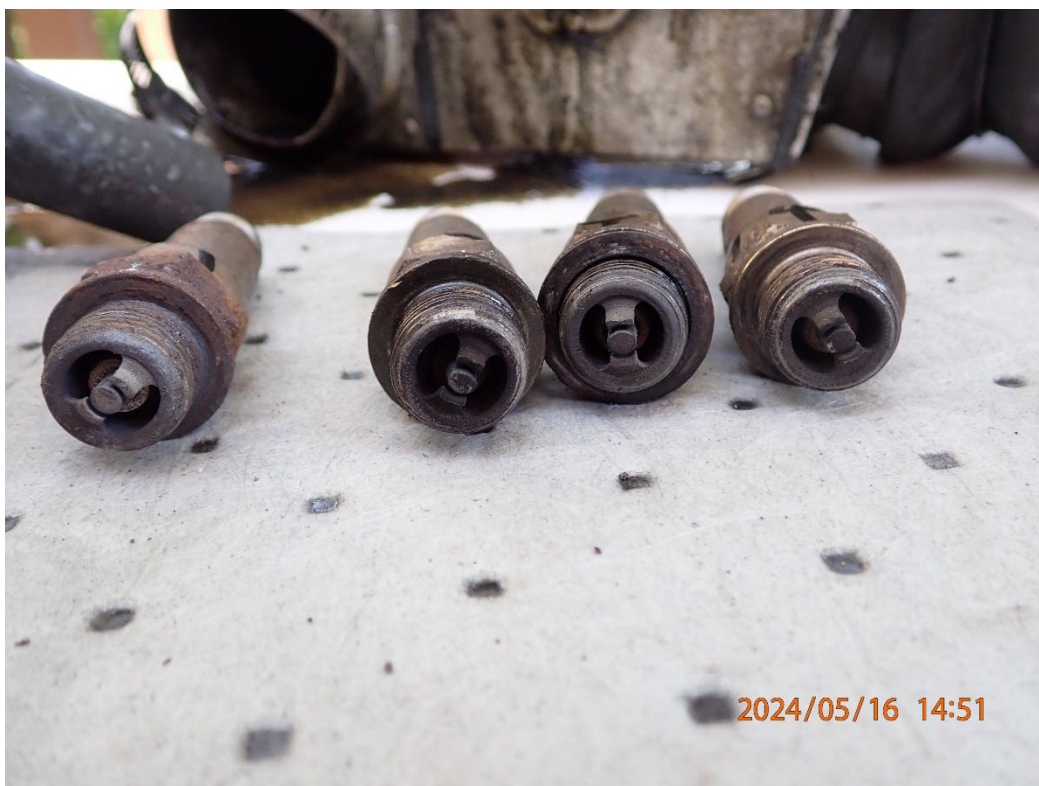
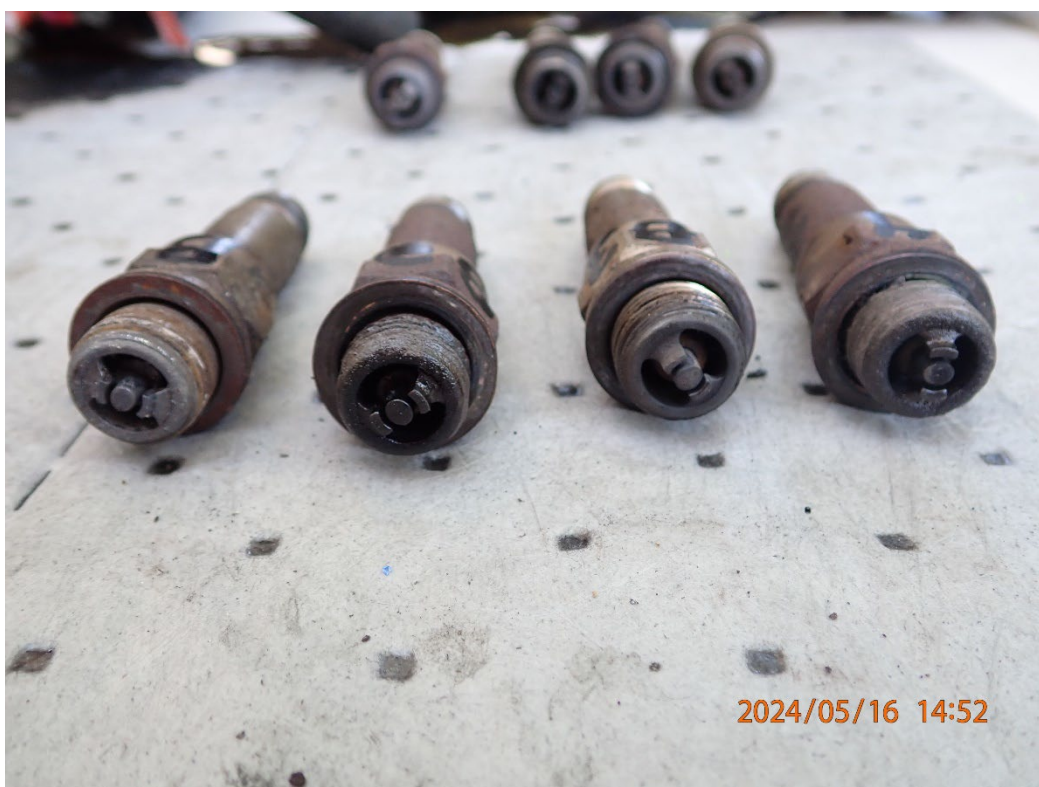
The spark plugs remained installed in their respective cylinder heads and were undamaged. All spark plugs were removed and exhibited worn normal wear when compared to the Champion Aviation AV-27 Check-A-Plug chart.

**Photo 23: View of the top sparkplugs.**

**Photo 24: View of the bottom sparkplugs.**
