# National Transportation Safety Board

ERA24LA198

## **WRECKAGE EXAMINATION**

Location: Palatka, FL  
Date: April 29, 2024  
Time: 1645 EDT  
2045 UTC  
Airplane: N99442; Cessna 172P

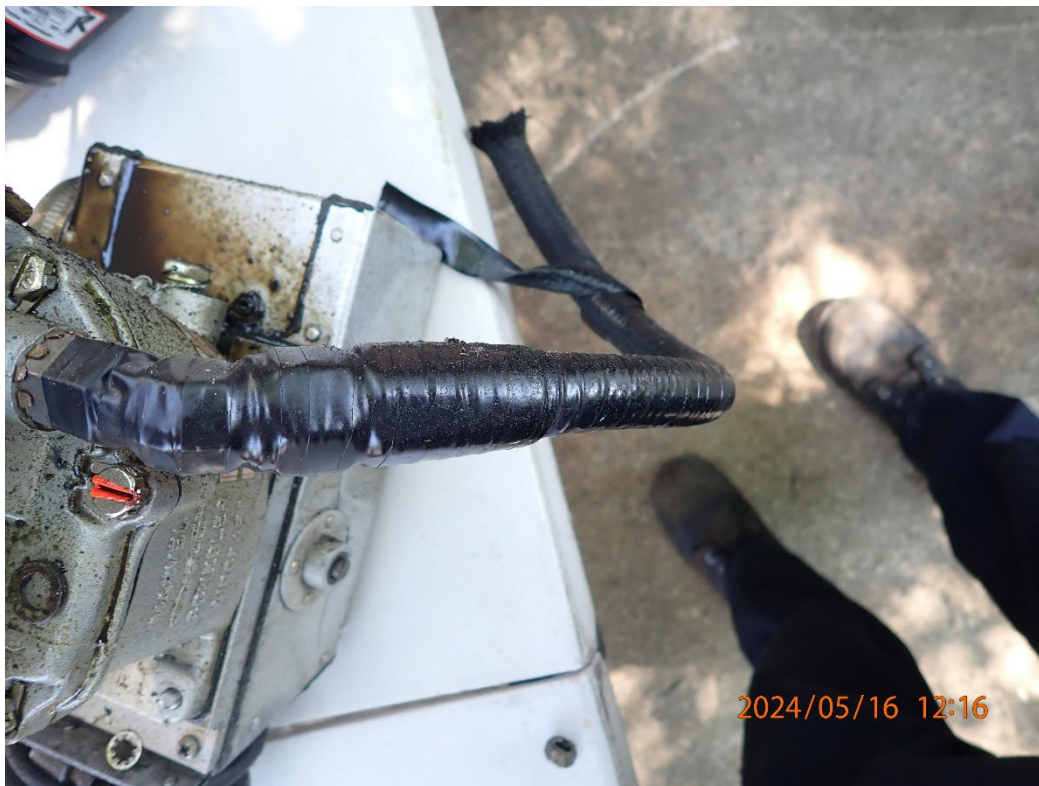
Fuel was found in the lines between the fuel strainer and the carburetor. The fuel line from the fuel strainer to the carburetor was wrapped with tape consistent with black electrical tape. The carburetor remained attached to the engine. The cockpit throttle control cable knob was observed in an aft position. The cable remained attached to the carburetor throttle control arm and the arm was positioned about 1/8 inch from the idle stop. The cockpit mixture control cable knob was observed in an aft position. The cable remained attached to the carburetor mixture control arm and the arm was positioned at the idle cut-off stop. The cockpit carburetor heat control cable knob was observed in an aft position. The cable remained attached to the induction air box control arm and the arm was positioned fully aft.

**Photo 25: View of the fuel line from the fuel strainer to the carburetor.**

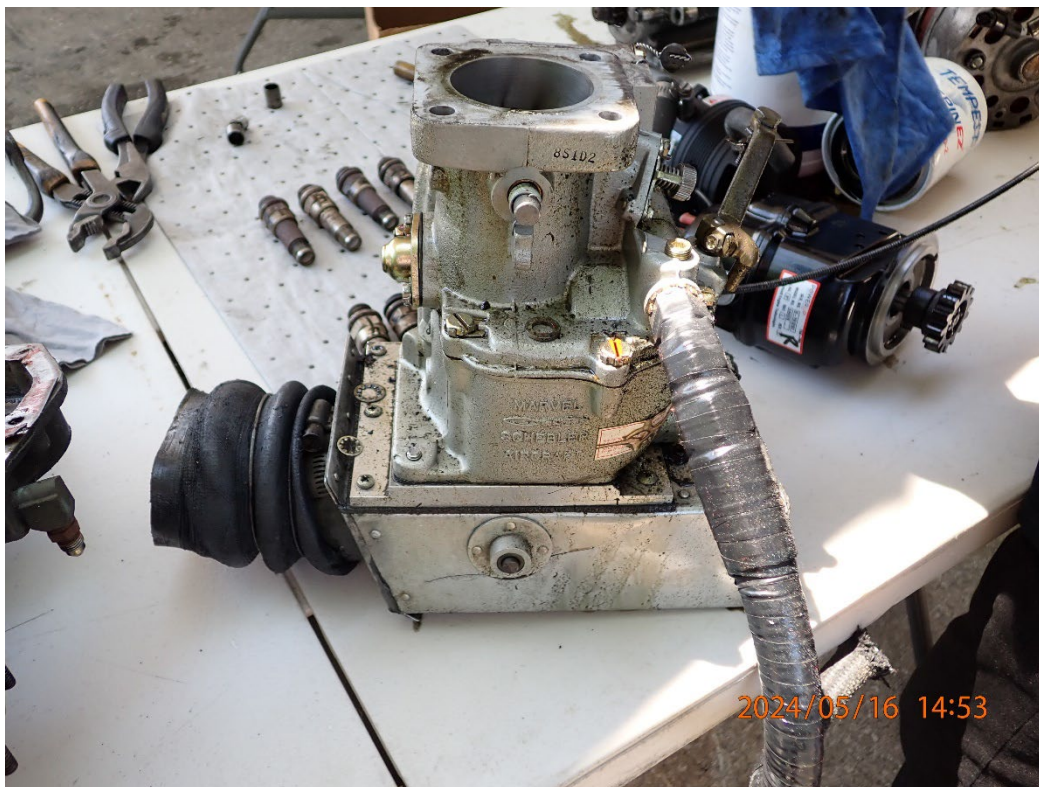
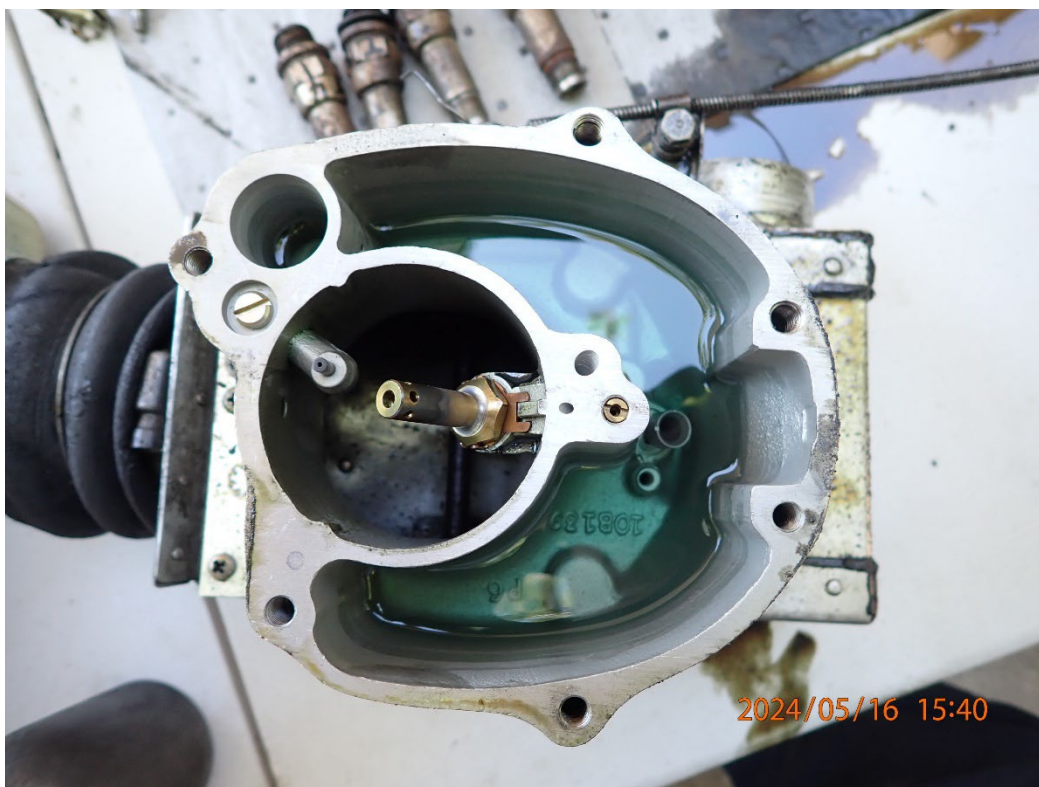
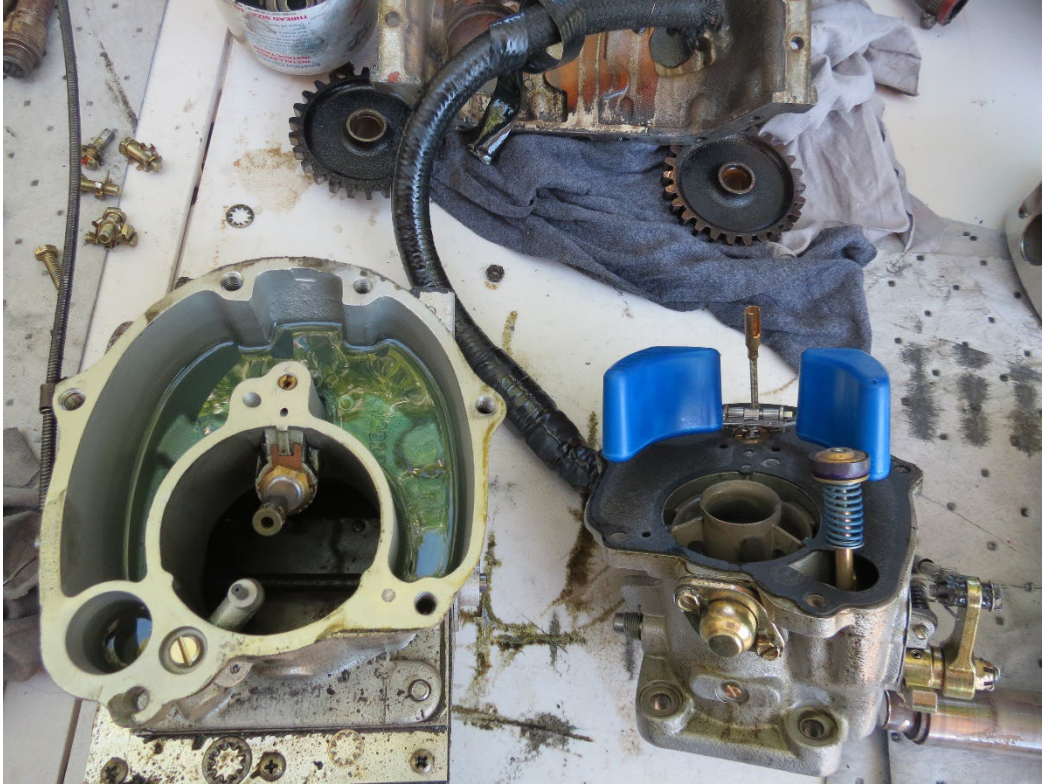
The carburetor was removed and partially disassembled. The carburetor float bowl was about half full of blue liquid with an odor consistent with aviation gasoline. No debris was noted in the bowl. No damage to the composite bowl floats or other internal carburetor parts was noted. The carburetor fuel inlet screen was unobstructed.

**Photo 26: View of the carburetor removed from the engine.**

**Photo 27: View of fuel in the carburetor float bowl.**

**Photo 28: View of the disassembled carburetor. (Lycoming Photo)**

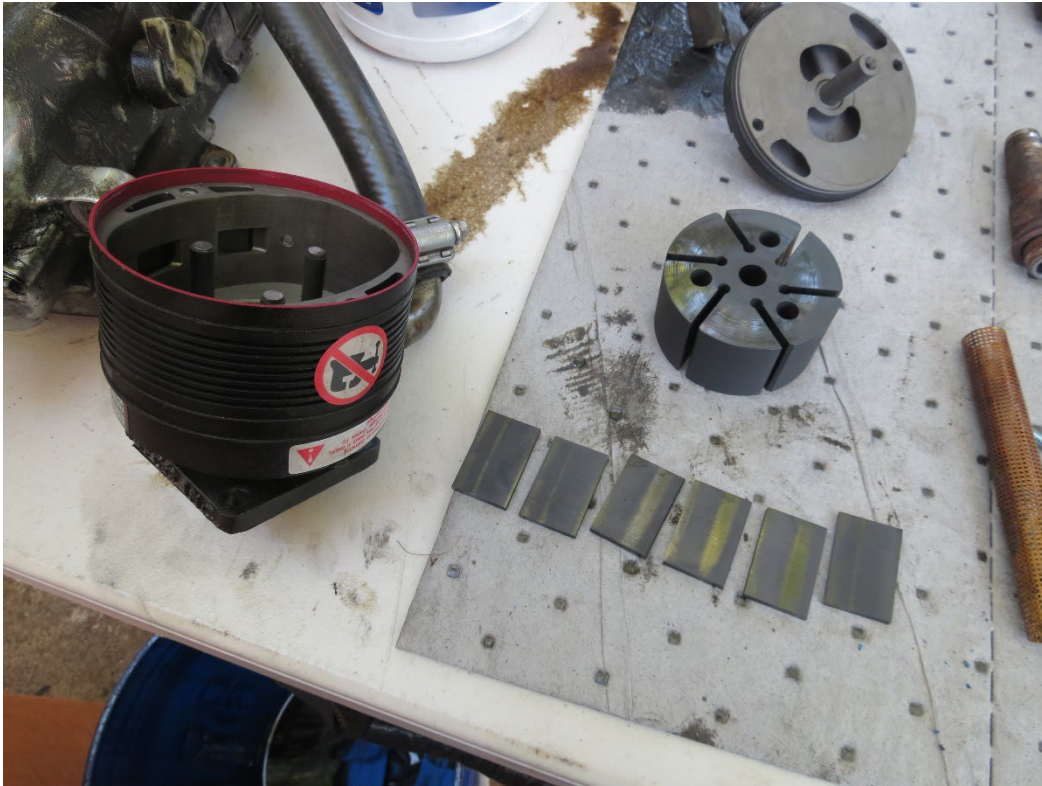
The vacuum pump was removed, and the shear drive gear remained intact. The pump sucked and pumped air when the drive gear was rotated by hand. The pump was disassembled and found all the carbon veins and core were undamaged and intact.

**Photo 32: View of the disassembled vacuum pump. (Lycoming Photo)**

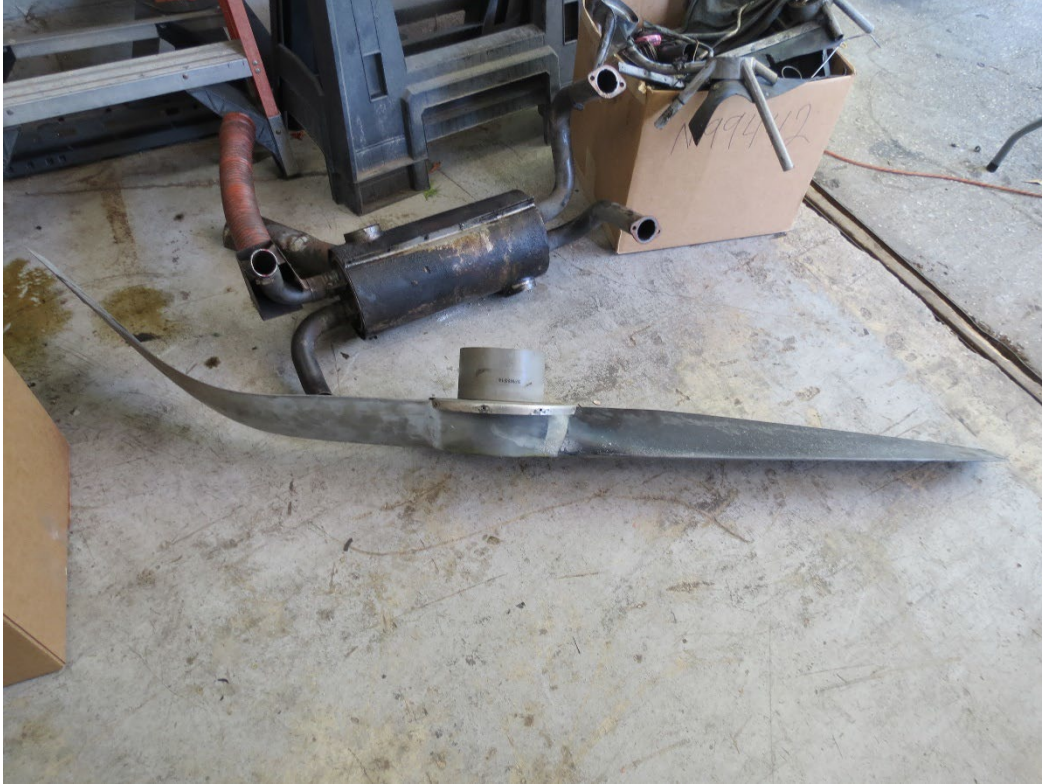
The propeller was a single piece aluminum 76 inch Sensenich 76EM8S5-0-60 with a fixed pitch. One blade of the propeller was bent aft about 45° about the midspan. The other blade was undamaged.

**Photo 33: Overview of the propeller. (Lycoming Photo)**
