# National Transportation Safety Board

ERA24LA205

Group Chair's Factual Report

Location:     Plant City, Florida  
Date:          May 1, 2024  
Time:          1610 eastern daylight time  
Helicopter:   Airbus Helicopters AS350 B3e, registration N413JM

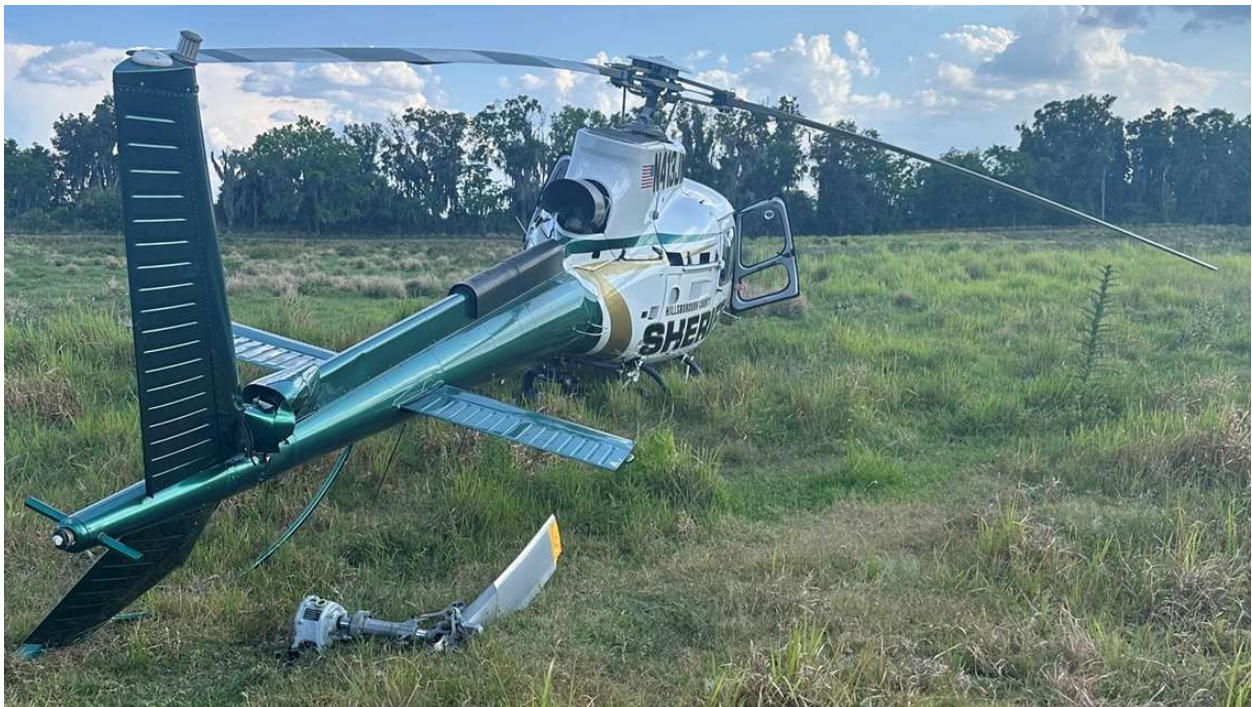
The helicopter came to rest upright in a field with a slight right bank. The main rotor blades did not show evidence of ground contact damage. The tail boom skin exhibited a wrinkled appearance near where the tail boom attaches to the fuselage, below the engine exhaust. The lower vertical fin exhibited deformation due to ground contact. The tail rotor gearbox had separated from the airframe and was found on the ground near its normally installed location (**Figure 2**). The fairing that housed the tail rotor gearbox was partially fractured and deformed. The 'blue' tail rotor blade remained attached to the tail rotor head. The 'red' tail rotor blade was found on the ground about 40 feet south of the helicopter (**Figure 3**).

**Figure 2.** The accident helicopter and the separated tail rotor gearbox.

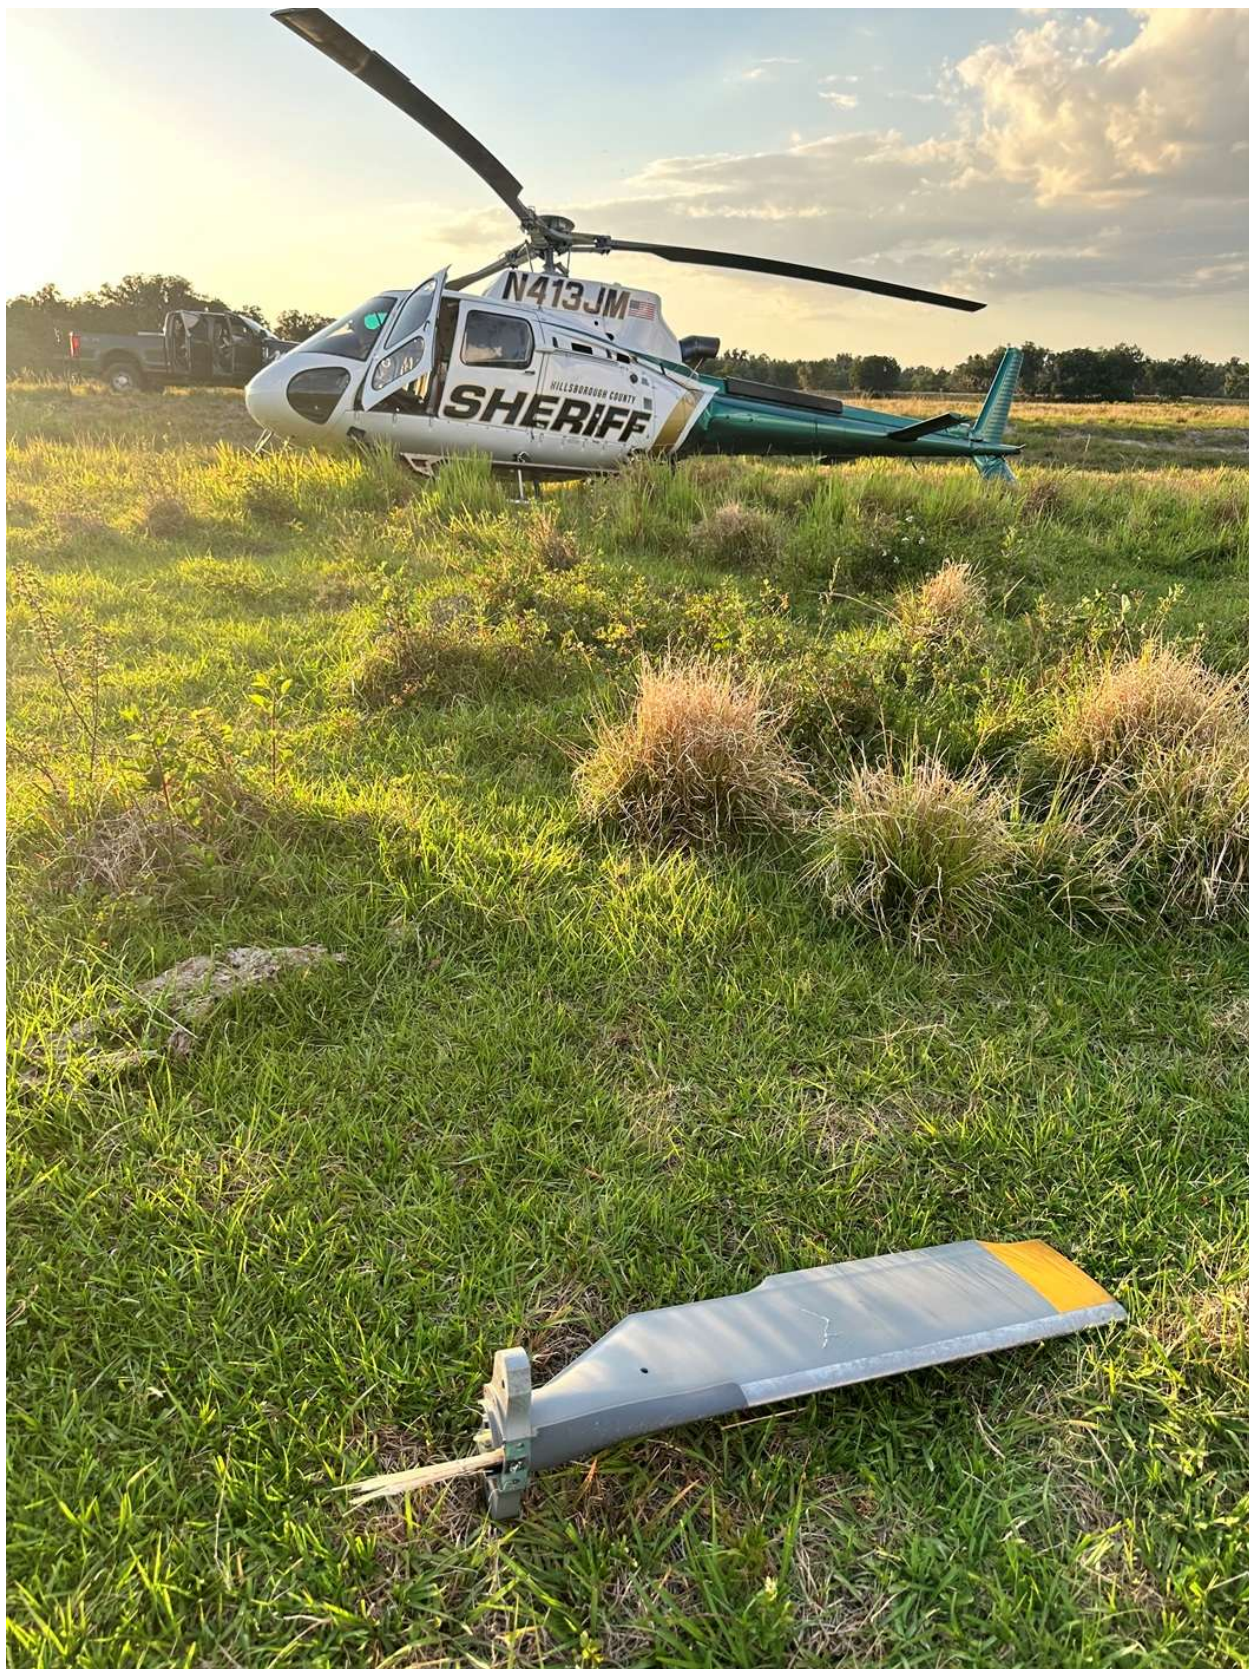
**Figure 3.** The separated tail rotor blade as found at the accident site.

The 'blue' tail rotor blade remained attached to the tail rotor head and did not exhibit fragmentation. The 'blue' tail rotor blade exhibited coning deformation to aircraft-left direction. The 'red' tail rotor blade had separated at the tail rotor head due to its fractured spar. The 'red' tail rotor blade outboard tab had deformed inward and a V-shaped crack was present on its inboard skin.

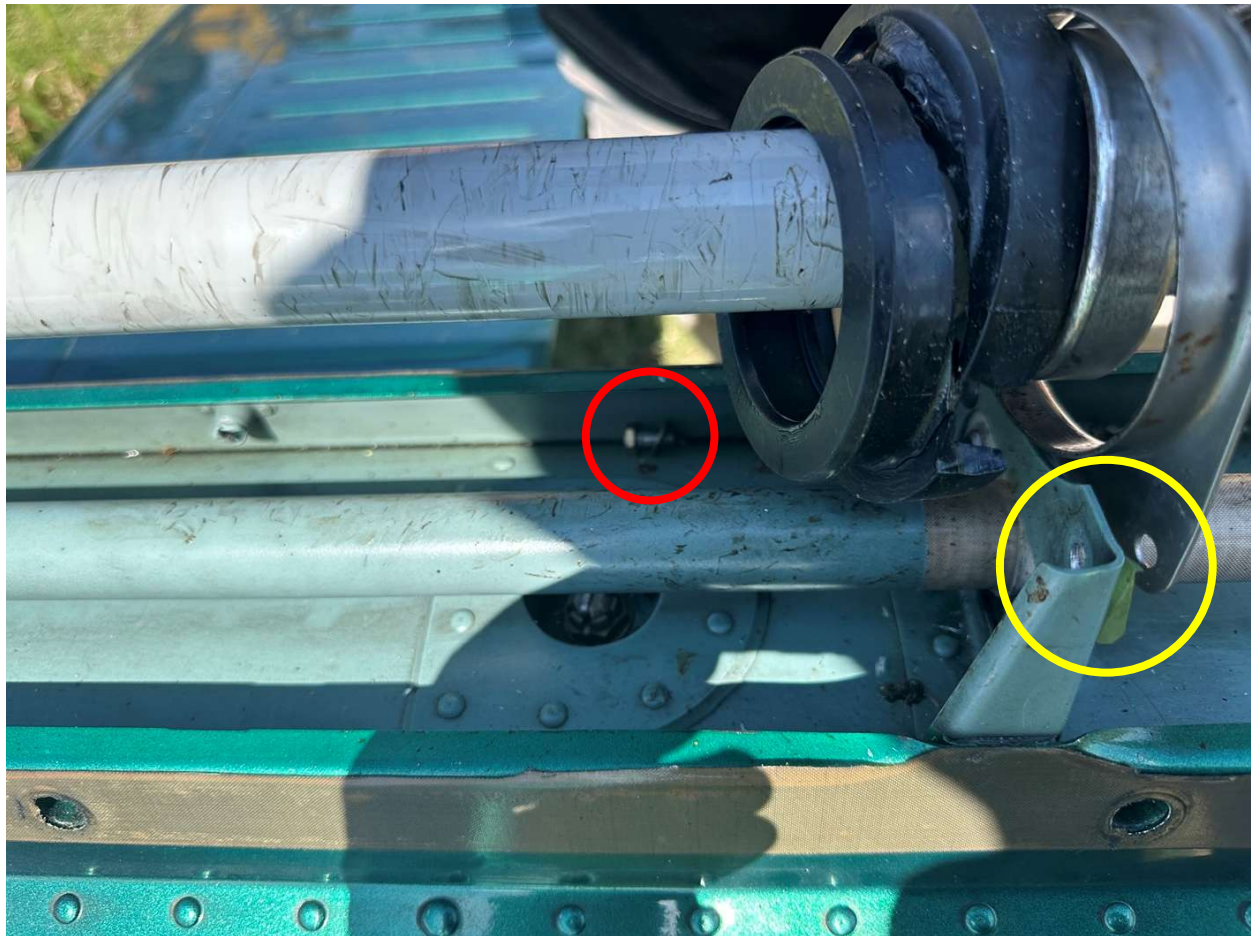
The TRDS covers were opened and the No. 1 TRDS hanger bearing support, near the trailing edge of the horizontal stabilizer, was found partially disconnected from its support mount. On the No. 1 TRDS hanger bearing support, the left attachment bolt and nut were not installed and was found within the tray area of the TRDS cover, while the right attachment bolt and nut remained installed but with minimal bolt threads visible (**Figure 4**). The six attachment bolts and nuts for the tail rotor control rod support remained installed on the No. 1 TRDS hanger bearing support mount. Additionally, the attaching hardware for the four remaining TRDS hanger bearing support mounts were reported by HCSO to have low torque.

**Figure 4.** The separated left attachment bolt (red circle) found in the tray area of the TRDS cover and the location where this bolt is normally installed (yellow circle).

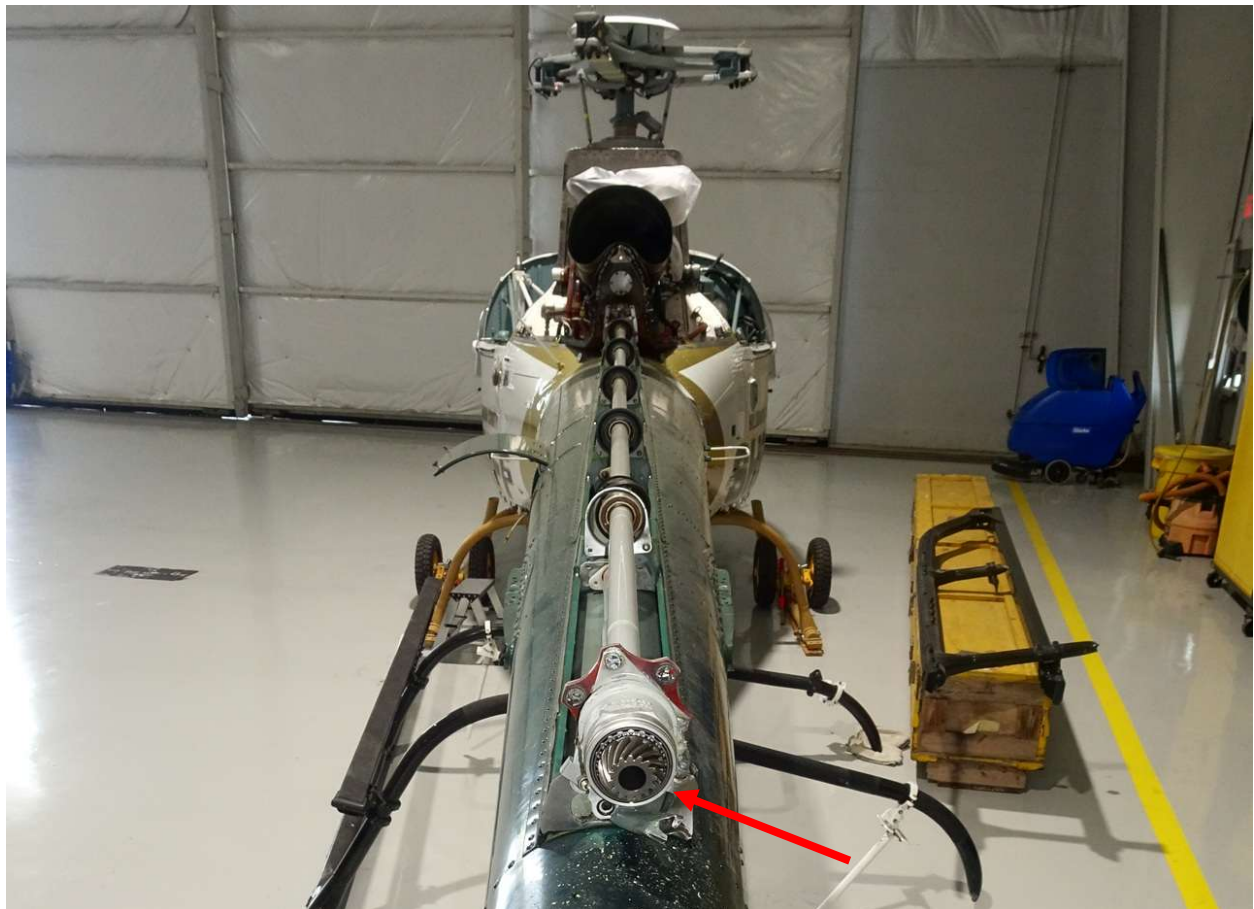
Continuity of drive to the main rotor was confirmed when rotating the tail rotor drive shaft (**Figure 5**). Forward flange of tail rotor drive shaft to the engine reduction gearbox was intact and the flexible coupling did not exhibit splaying or fracture.

**Figure 5.** The tail rotor drive system. The red arrow identifies the tail rotor gearbox forward pinion.

The tail rotor gearbox had fractured and separated at the forward pinion housing's flanged attachment to the center housing. The fractures exhibited a mix of overload and smearing from secondary contact damage. The tail rotor gearbox output shaft and pitch change spider were able to be rotated manually and exhibited smooth rotation with no evidence of binding.

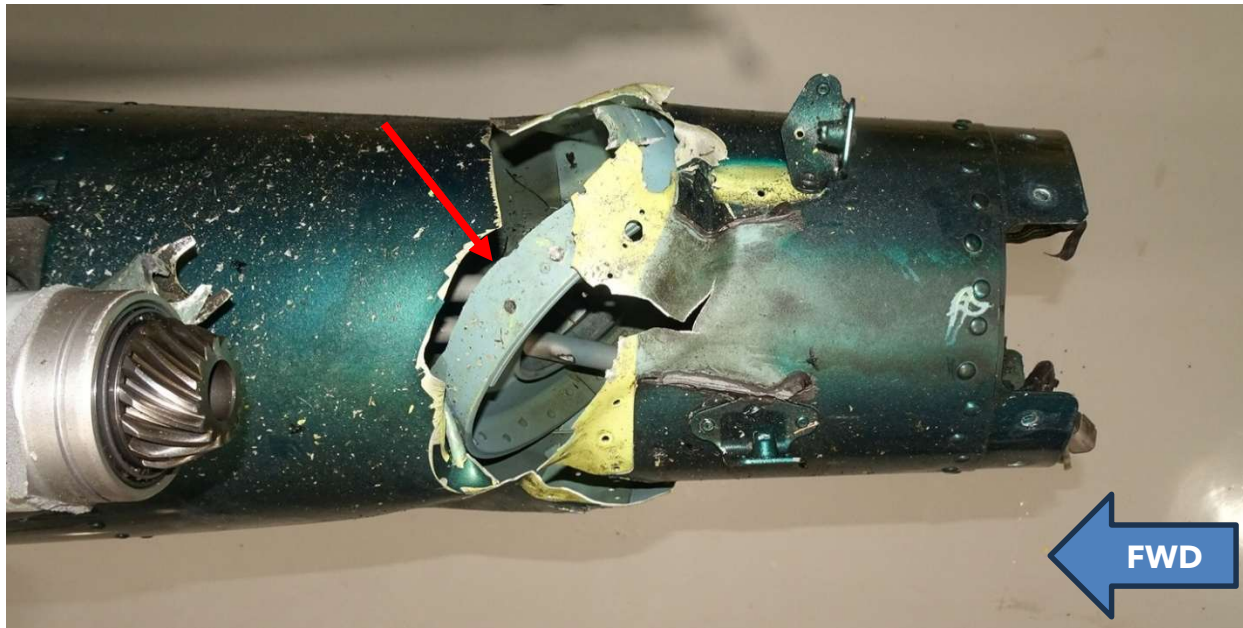
The aft ring frame for the vertical fin and tail rotor gearbox was partially separated from the tail boom and had rotated to the right about 45 degrees (**Figure 6**). The aft ring frame exhibited overload signatures on the forward-upper portion of the ring frame to which the tail rotor gearbox mount was attached. The rivets that attach the ring frame to the tail boom skin were sheared and did not exhibit evidence of working loose over an extended period of time. The upper vertical fin did not exhibit anomalous damage. The lower vertical fin was deformed to the left. The stinger remained attached and did not exhibit significant upward deformation. The tail gearbox mounting bolts remained installed on the gearbox but had separated from the aft ring frame.

**Figure 6.** The aft ring frame (red arrow) that rotated to the right about 45 degrees. This view is top-looking-down.
