# National Transportation Safety Board

ERA24LA208

## **WRECKAGE EXAMINATION SUMMARY & MAINTENANCE RECORDS REVIEW**

Location: DeLand, Florida  
Date: May 2, 2024  
Time: 1404 EDT  
1804 coordinated universal time (UTC)  
Airplane: N848HP, AirCam

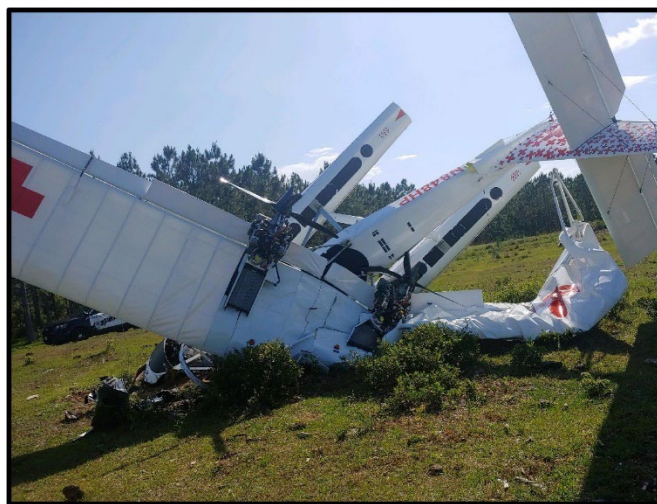
Examination of the wreckage was performed by a Federal Aviation Administration airworthiness inspector. As first viewed, the airplane was in a nose-low attitude with the empennage and right wing slightly elevated positions (Figure 6). The left wing and cockpit were extensively damaged.

**Figure 6: View of the Wreckage At the Accident Site.**

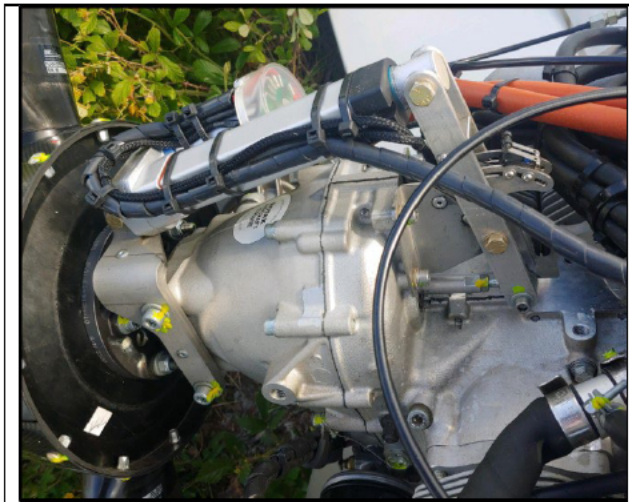
**Figure 7: Left Propeller Actuator**

Examination of the left propeller actuator revealed it was fully retracted, consistent with reverse position (Figure 7).

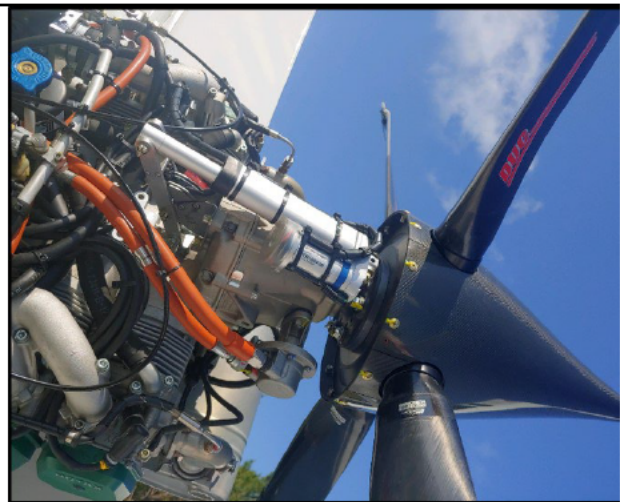
**Figure 8: Right Propeller Actuator**

Examination of the right propeller actuator revealed it was in an extended position consistent with cruise position (Figure 8).

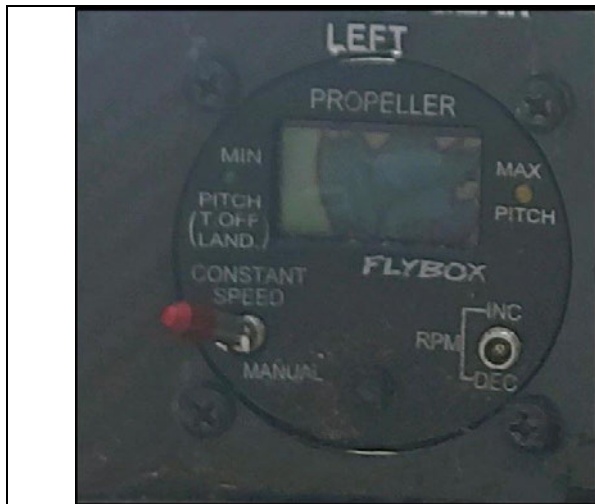
**Figure 9: Left Propeller Regulator**

Examination of the left propeller regulator revealed it remained installed in the instrument panel. The Operating Mode Switch was in the "CONSTANT SPEED" Position and the RPM INC/DEC switch was broken (Figure 9).

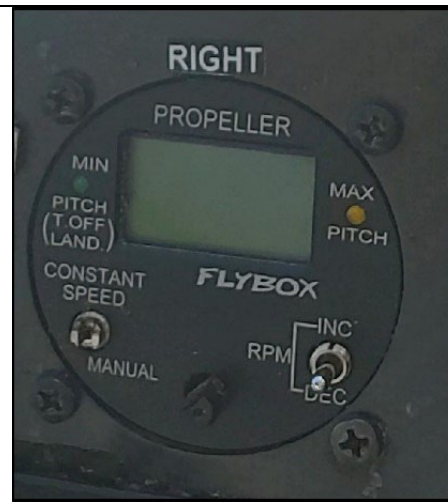
**Figure 10: Right Propeller Regulator**

Examination of the right propeller regulator revealed it remained installed in the instrument panel. The Operating Mode Switch was broken and the RPM INC/DEC was centered; the position of the Operating Mode Switch was not determined at that time (Figure 10).

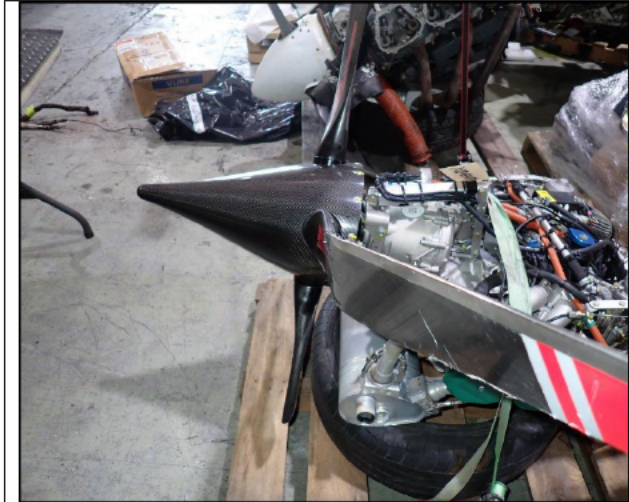
**Figure 11: View of Left Propeller**

Visual examination of the left propeller blades revealed the blade angle appeared in the reverse range (Figure 11).

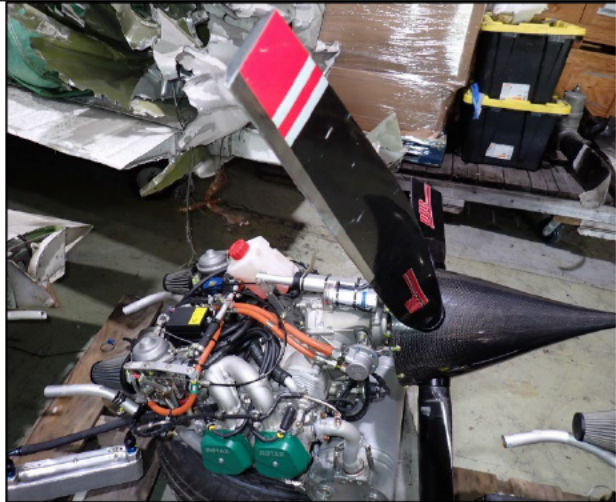
**Figure 12: View of Right Propeller**

Visual examination of the right propeller blades revealed the blade angle appeared to be in the cruise range (Figure 12).

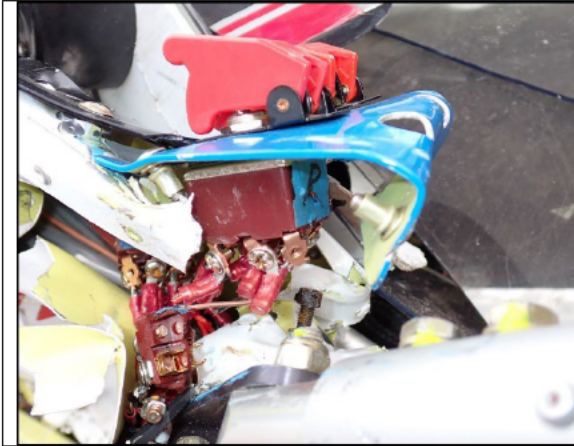
**Figure 13: Left Red Guarded Switch**

Examination of the side rail of the instrument panel housing the left guarded switch revealed the left guard was down, cruise position and the switch remained installed in the panel. A look below the panel at the left switch revealed a piece of tape affixed to it was marked with "R" (Figure 13). Several wires of the switch were fractured either at the terminal fitting or in close proximity to it. The bottom portion of the switch was also impact damaged.

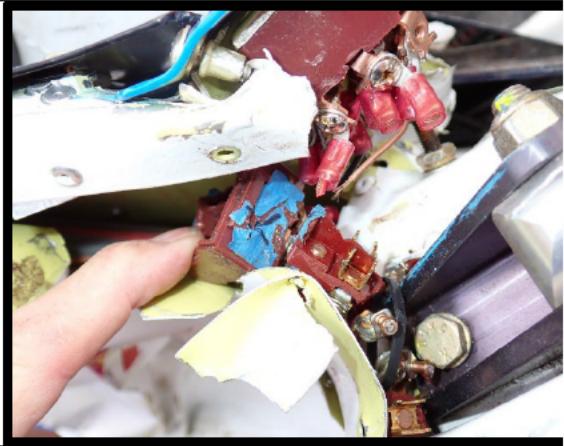
Examination of the side rail of the instrument panel housing the right guarded switch revealed the right guard was down, cruise position and the switch was separated from the panel. A look below the panel revealed the right switch was impact damaged and a piece of tape affixed to it was marked with "L" (Figure 14).

**Figure 14: Separated Right Red Guarded Switch**
