**Subject:** ERA24LA208, Record of Conversation/Interview

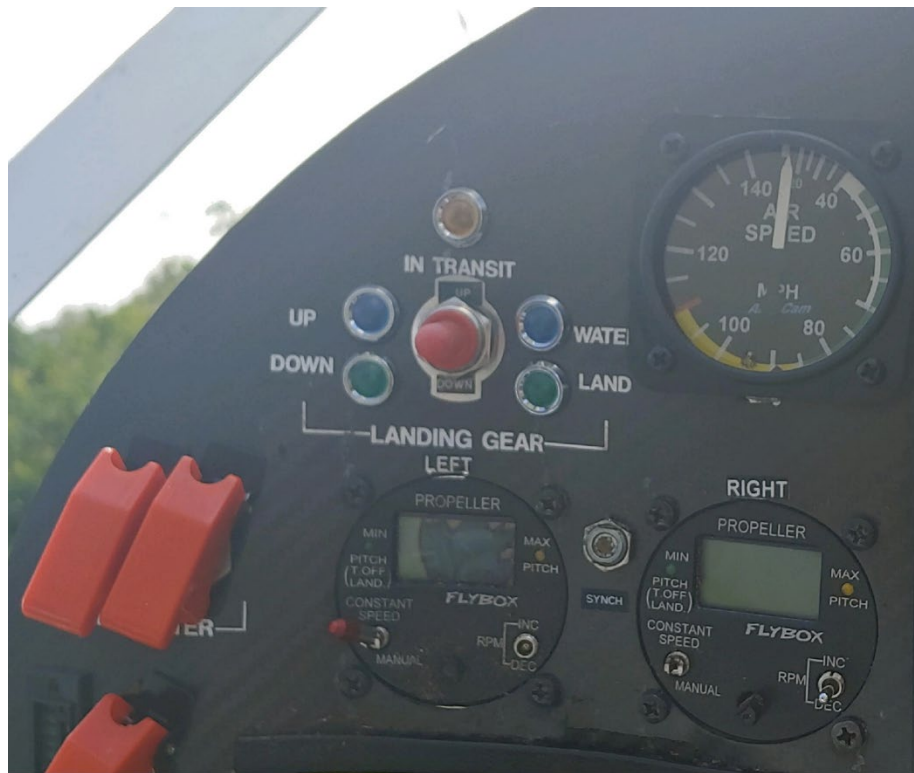
They were switches, and he could not see them from the back seat. At the rear seat position, he has a throttle control and stick and rudder controls, but no propeller control system. The front seat pilot had a throttle control, no mixture control, and propeller switches. The front seat pilot also had ignition/starter, primer, auxiliary fuel pump, trim, and propeller controllers for the propeller pitch control (Figure 1).

**Figure 1: View of Left Side of Front Seat Instrument Panel Showing Left and Right FlyBox Propeller Regulator.**

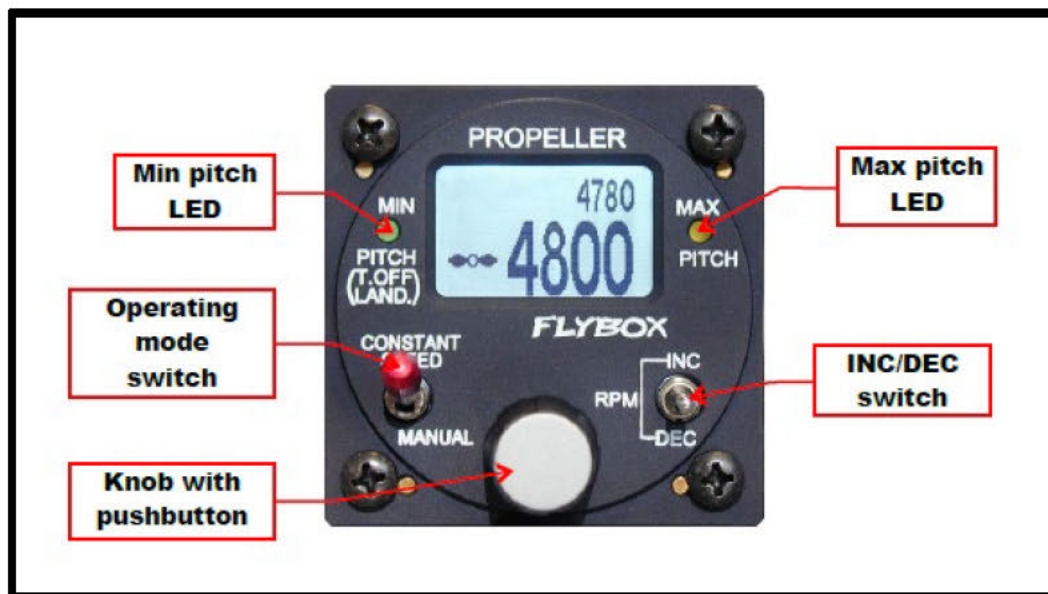
After landing on the water, the pilot opened the red guarded switches for propeller reverse and maneuvered on the water. The red guarded switches were then closed and each Operating Mode Switch of the Propeller Regulator (Figure 1) were placed in the constant speed position. Mr. Smith indicated that the rpm difference was likely because the low pitch stops were mismatched resulting in a rpm and manifold pressure difference.

**Figure 1: View of PR1-P Propeller Regulator Panel.**

During takeoff with the Operating Mode Switch in constant speed mode, the rpm would be off about 300 between the left and right when manifold pressures were matched, and if the rpm's were matched, the manifold pressures were off about 3 inches.

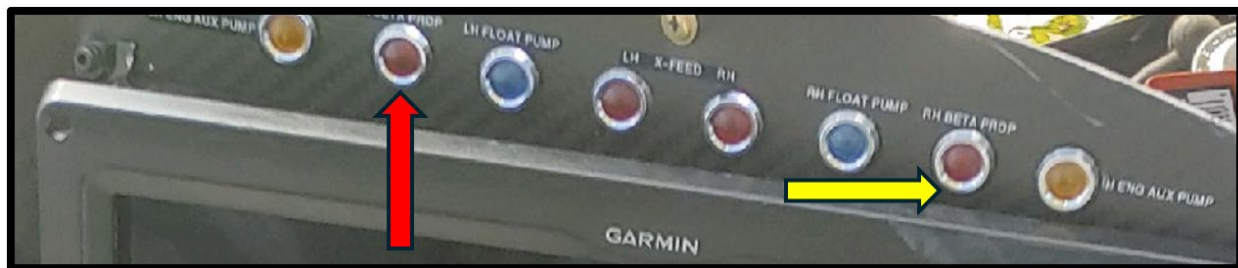
There were 2 illuminated red lights on each side of the instrument panel. The light-emitting diode (LED) lights went on when the red guards of the propeller reverse were opened. They maneuvered on the water with 1 propeller in course pitch and the other in reverse pitch, and then repeated that with the other engine with no propeller issues noted. The flight departed with the FlyBox Operating Mode Switch set to Constant Speed mode then was placed in Manual and adjusted manually.

**Figure 2: View of the upper central portion of the Instrument Panel showing the annunciator lights. Red arrow points to Left (LH) Beta Prop Annunciator Light while Yellow Arrow Points to Right (RH) Beta Prop Annunciator Light.**
