ERA24LA210

## INVESTIGATION PHOTOGRAPHS

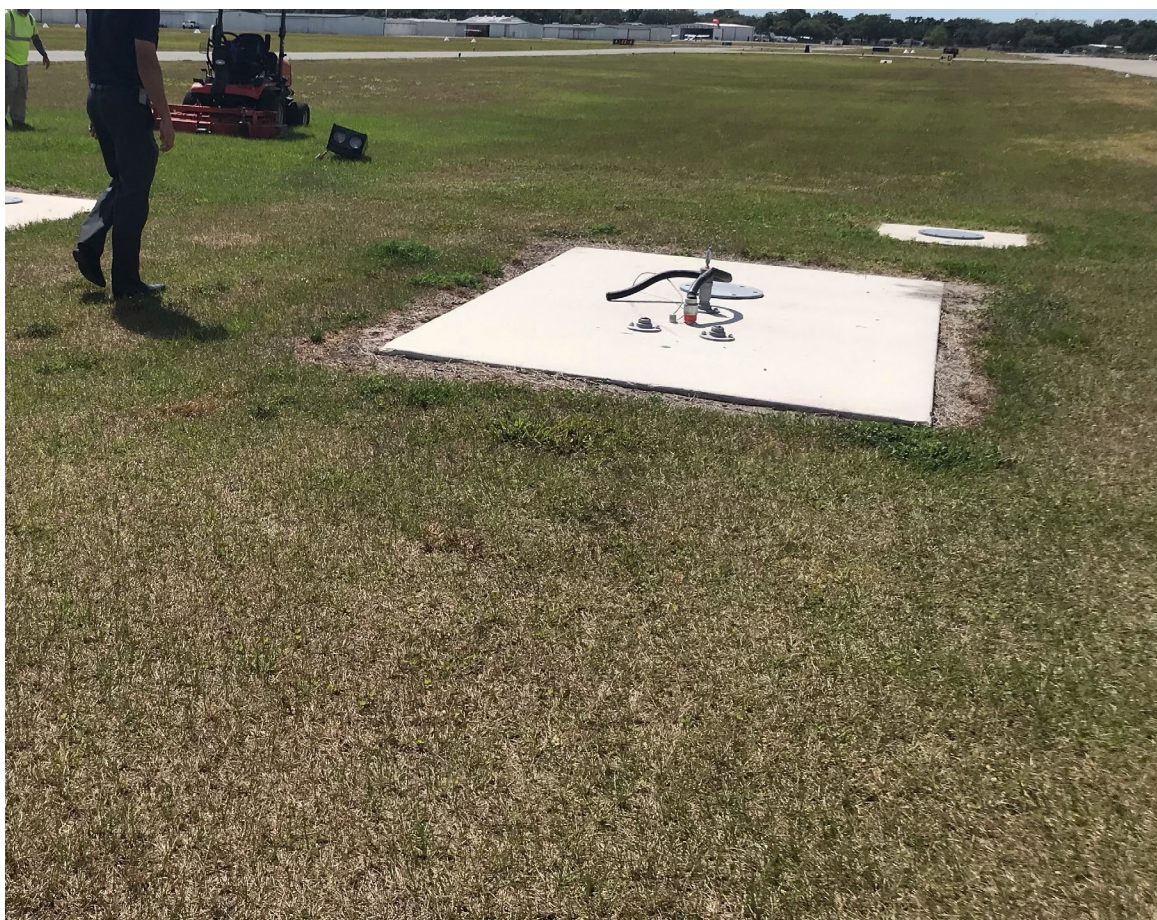
**Photograph 1 - Postaccident damage to airport PAPI light (Courtesy of FAA)**

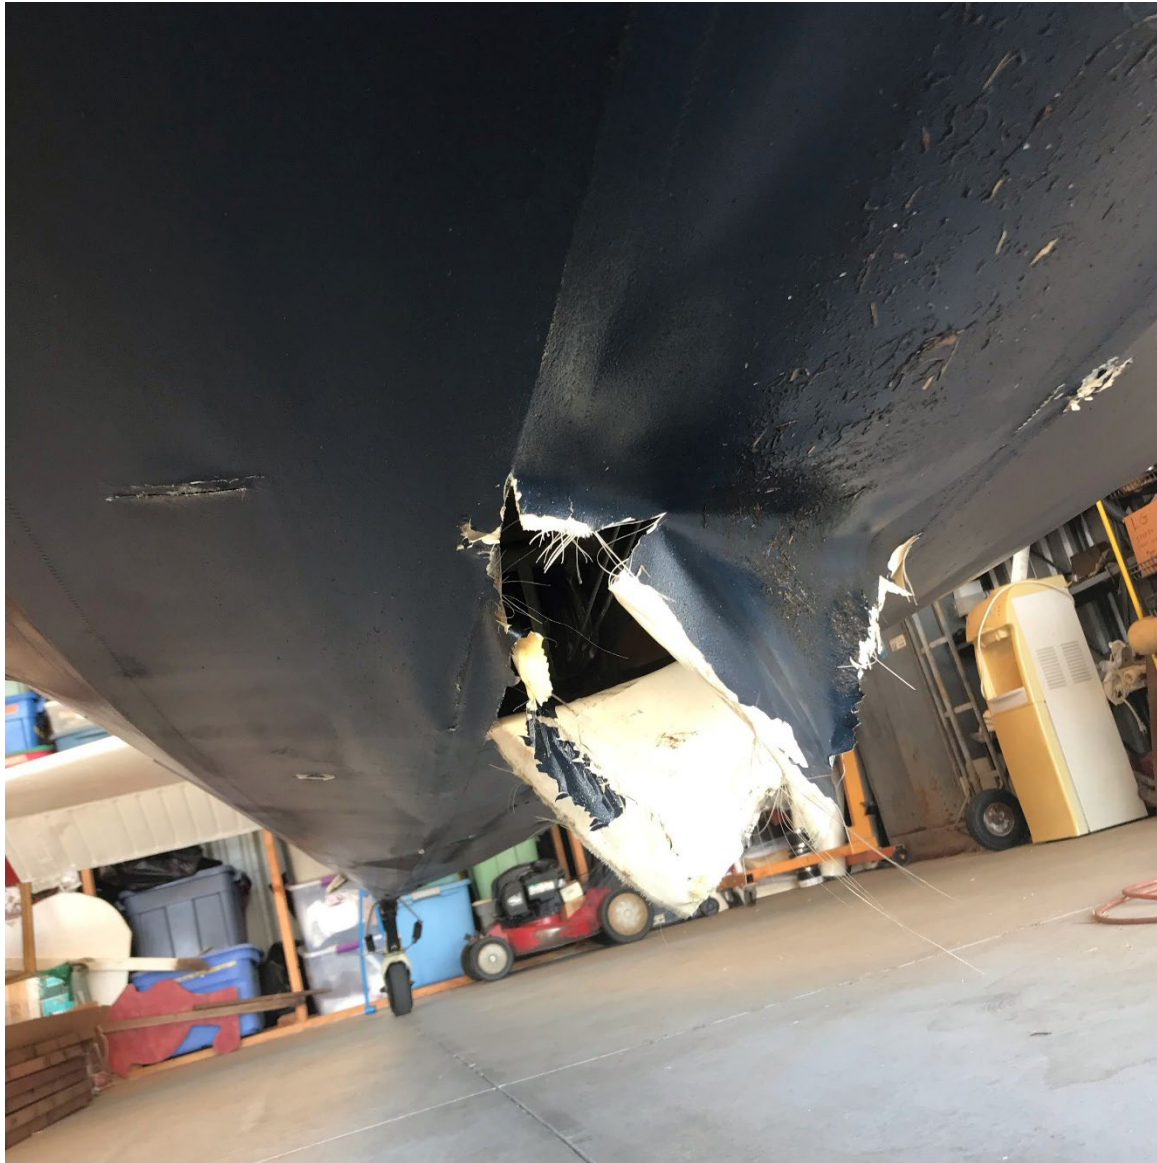
**Photograph 2 - Postaccident damage to wing (Courtesy of FAA)**

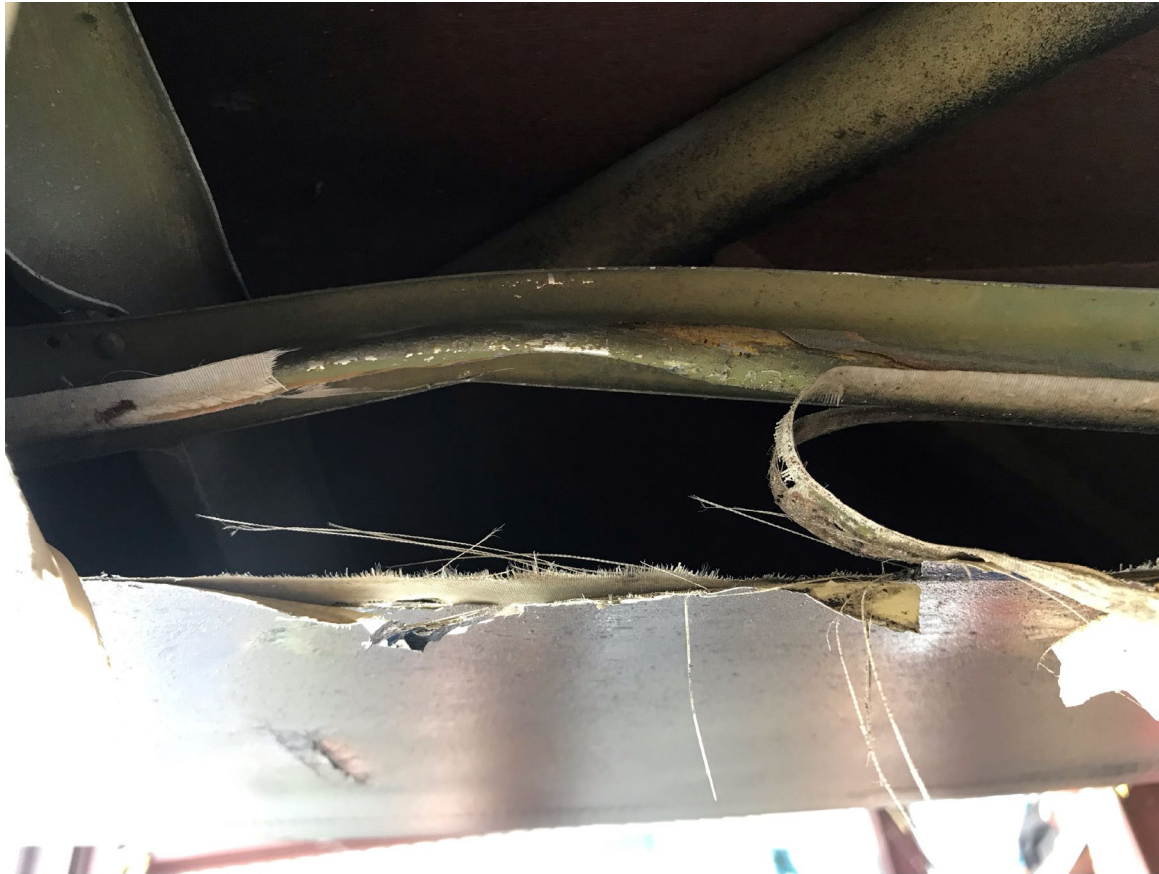
**Photograph 3 - Postaccident internal wing damage (Courtesy of FAA)**
