# National Transportation Safety Board

ERA24LA211

## **ENGINE EXAMINATION**

Location: Apopka, FL  
Date: 5/8/2024  
Time: 1130 EDT  
1530 UTC  
Airplane: N908DK; PA-32-300

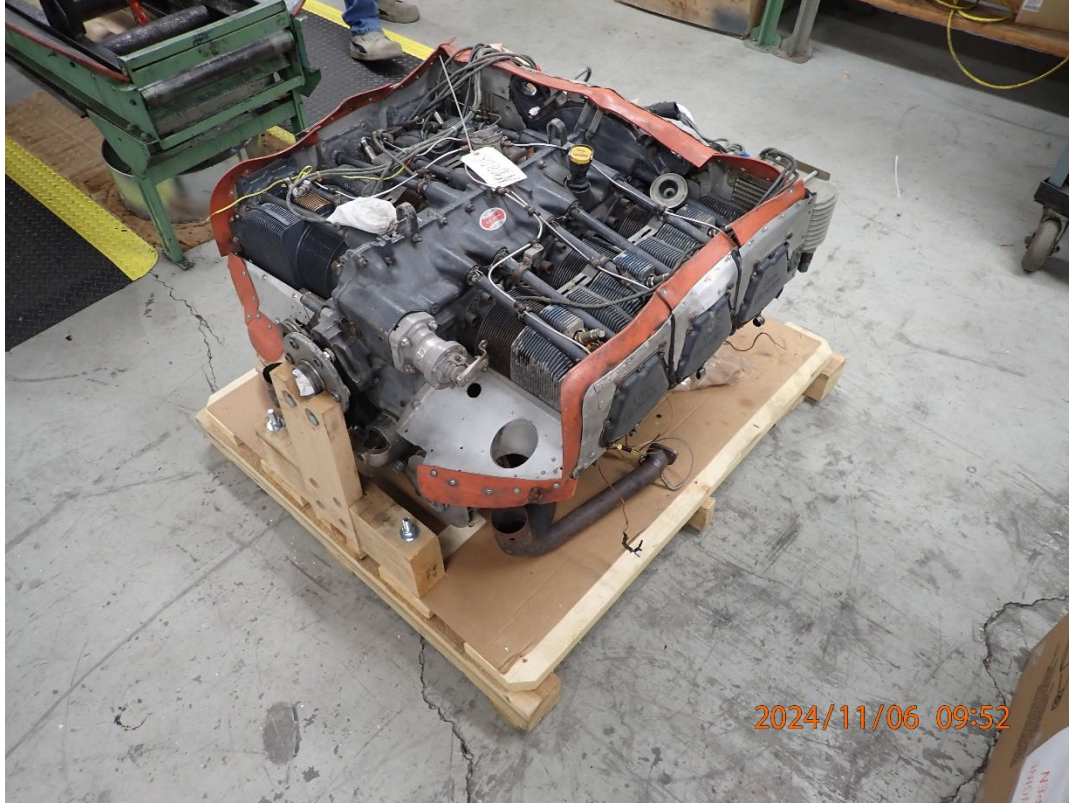
**Photo 1: The engine as first seen after the removal of the cardboard shipping box.**

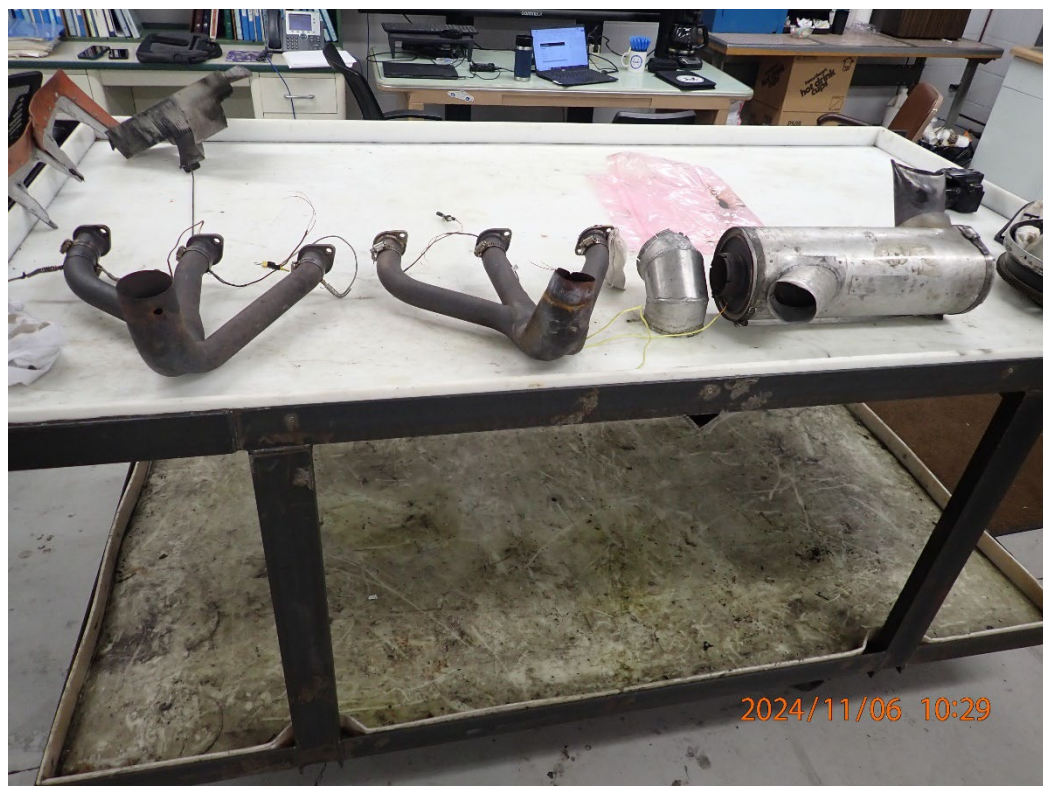
The exhaust system exhibited minimal damage and was removed for the engine test run.

**Photo 2: View of the removed exhaust system.**

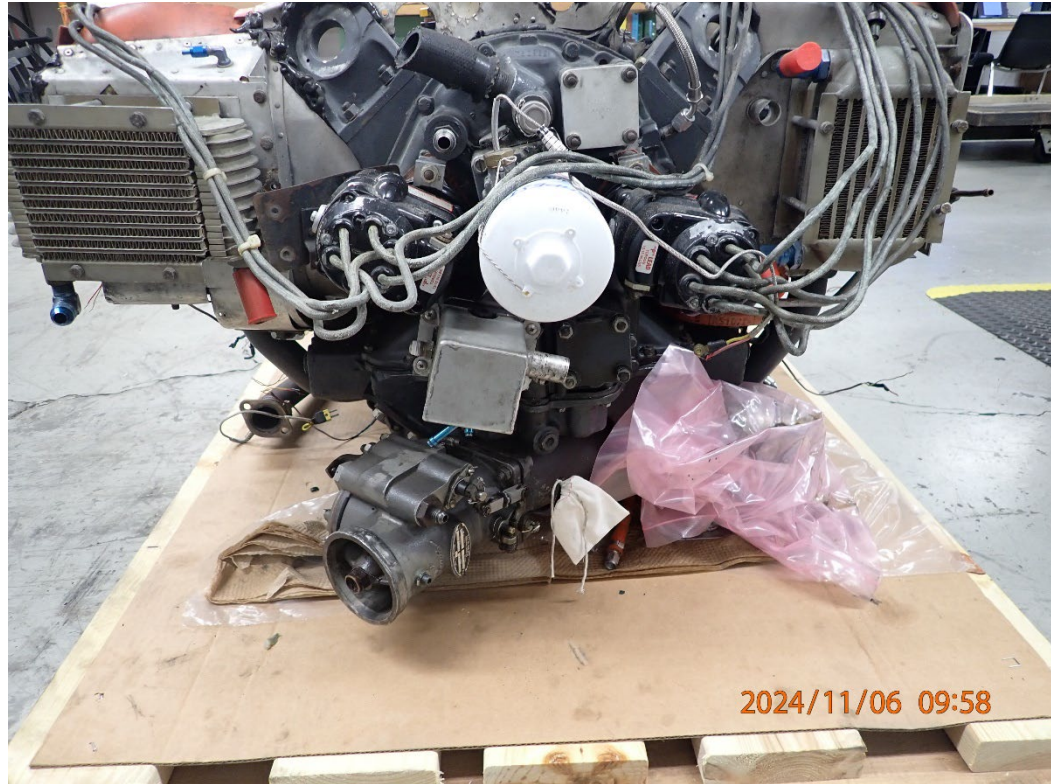
The left and right hand magnetos remained secured to their mounting flanges on the accessory house. Magneto to engine timing was checked, both magnetos were timed at 18 degrees BTC. Spark advance should be set at 20 degrees BTC for this engine model. 18 degrees would have a minimal effect on engine performance.

**Photo 3: View of the magnetos installed in the accessory case.**

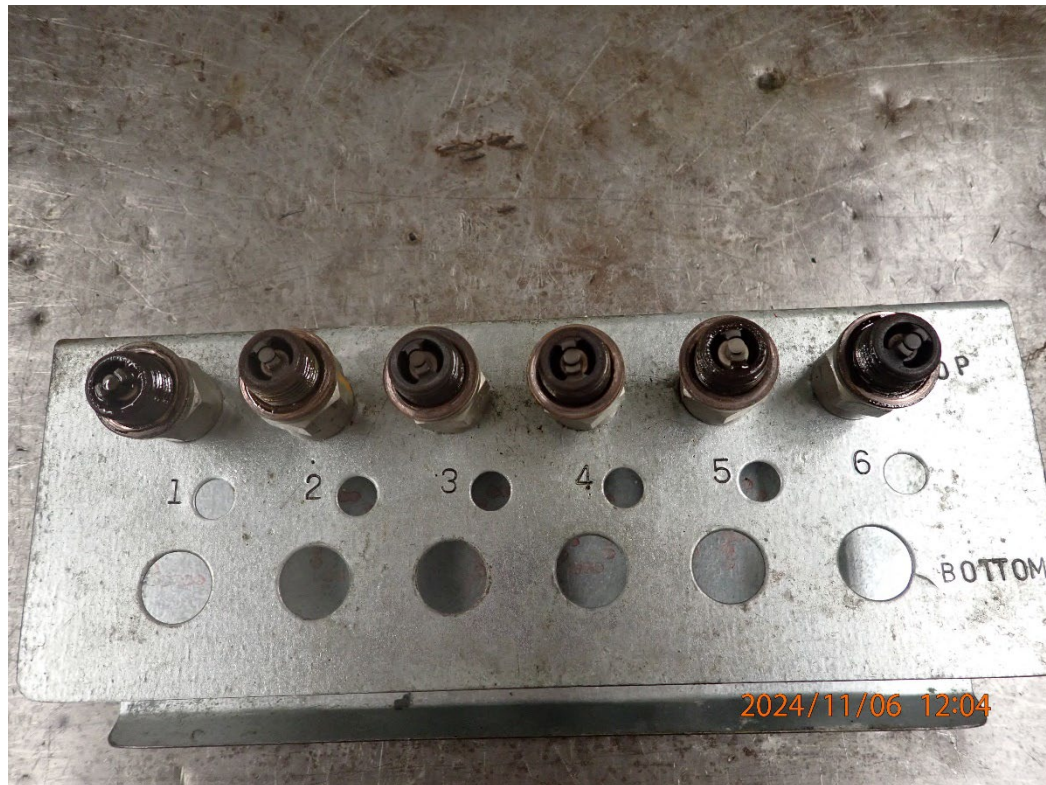
The upper 6 spark plugs were removed and examined; the ground electrodes appeared normal. Some oil noted on the upper plugs of cylinders 1 and 5.

The ignition harness appeared undamaged from the impact sequence. Chaffing damage was observed along the lengths of each lead. The chaffing appears to have occurred during normal operation of the engine, it did not appear deep enough to cause arcing or shorting to ground of the ignition system.

**Photo 4: View of the spark plugs.**

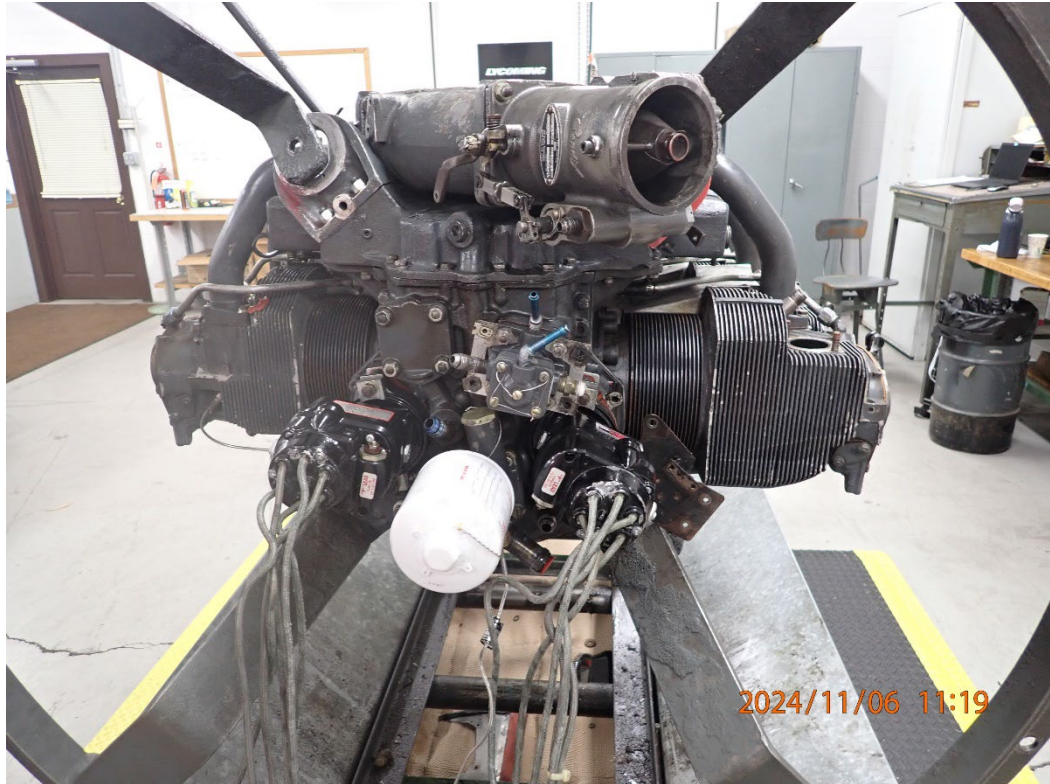
The Bendix fuel injection servo remained secured to the engine's induction plenum. The throttle and mixture cables were removed from the servo prior to its shipment to Lycoming. The fuel injection servo was removed from the engine and fuel pressure was applied to its inlet fitting to test for leaks. None were observed and it was reinstalled on the engine prior to the engine run.

The AN style fuel pump remained secured to the accessory housing; it was not removed for further examination to facilitate the "as is" engine run.

**Photo 5: View of the fuel servo and fuel pump installed on the engine.**

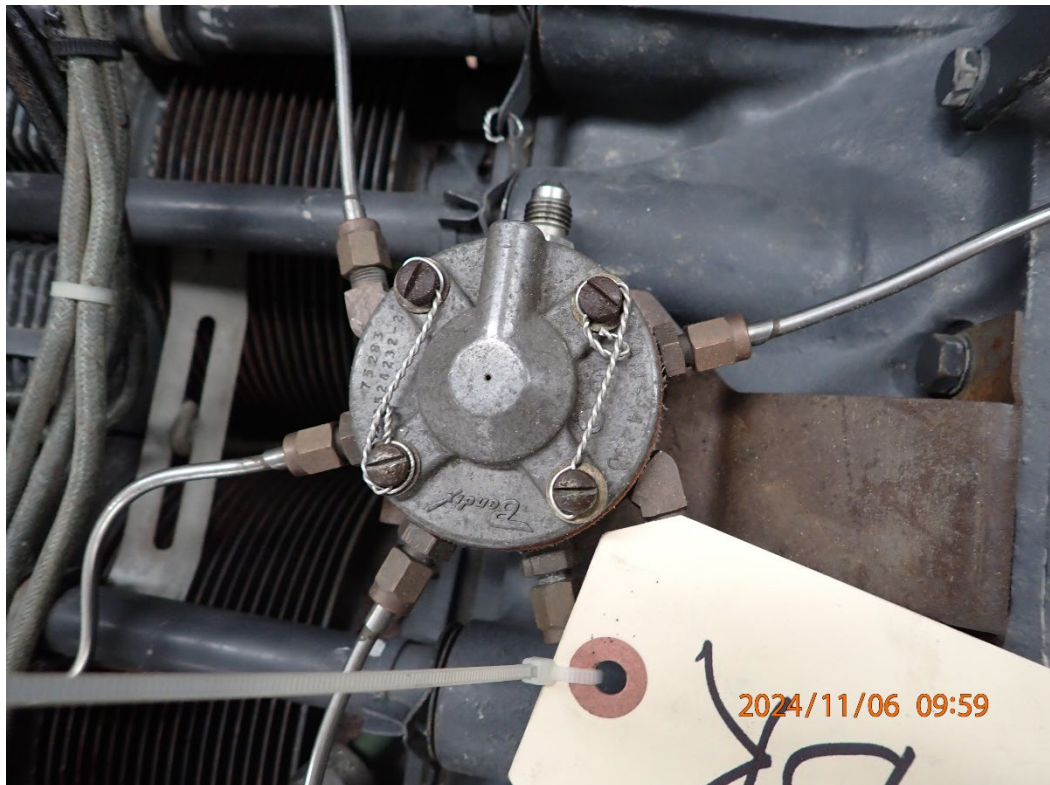
The flow divider remained secured to the spline of the crankcase, the fuel inlet line to the flow divider was disconnected and was reassembled prior to the engine test run. The fuel injection lines remained secured to the flow divider and their respective fuel injection nozzles. The flow divider and the fuel injection nozzles were not removed for examination.

**Photo 6: View of the flow divider secured to the engine.**

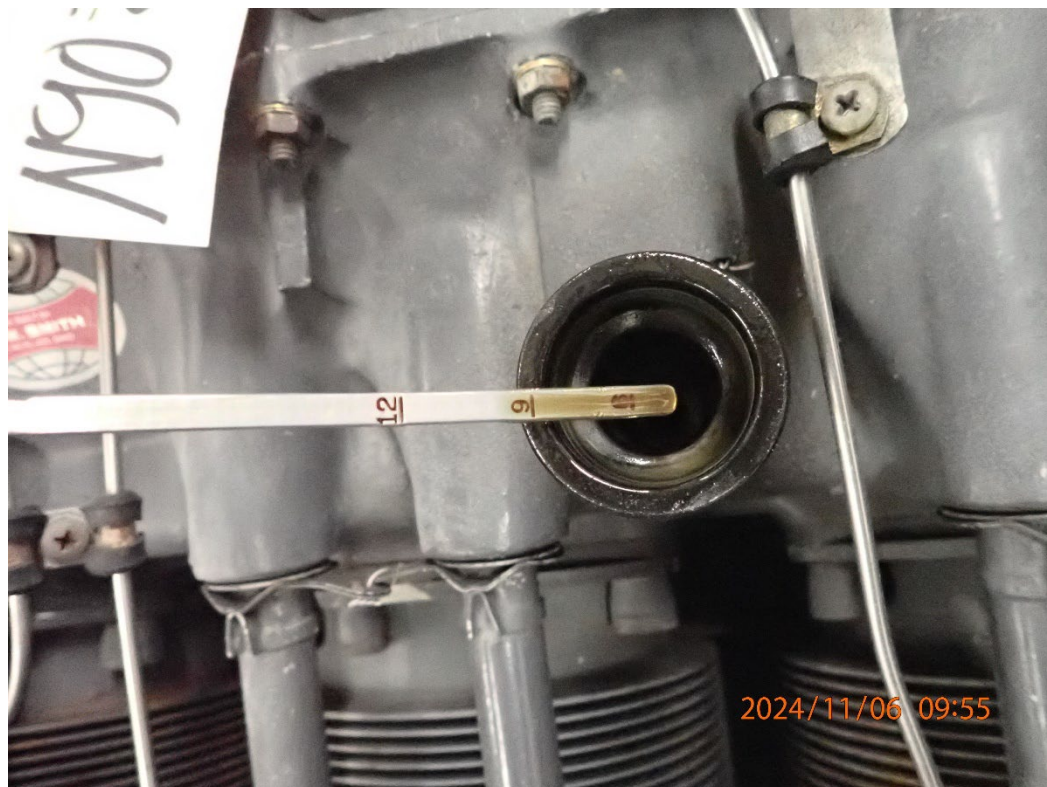
**Photo 7: Oil dipstick showing about 9 quarts of oil.**

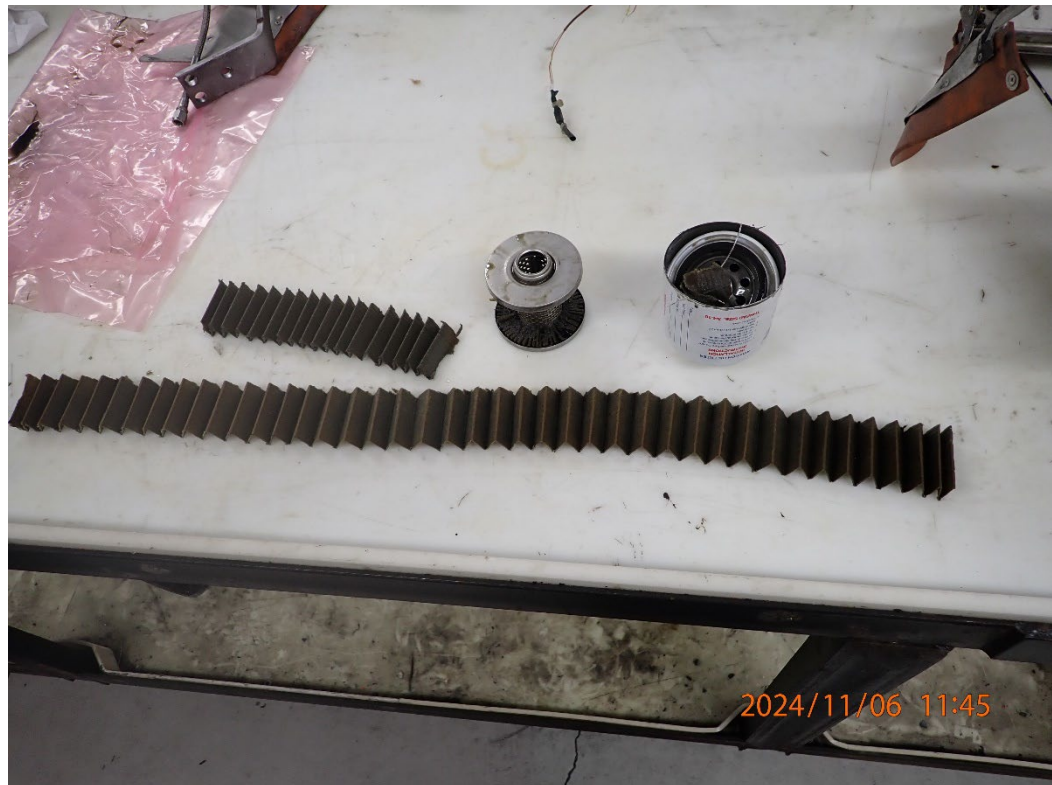
About 9 quarts of oil was read on the oil dipstick. The oil filter was secured to the oil filter adapter and was safety-wired. The oil filter was removed and cut-open. No contamination or metal particulates were observed in the pleats of the oil filters paper element. The oil suction screen was removed and examined; no contamination was observed.

**Photo 8: Oil filter removed and cut open.**

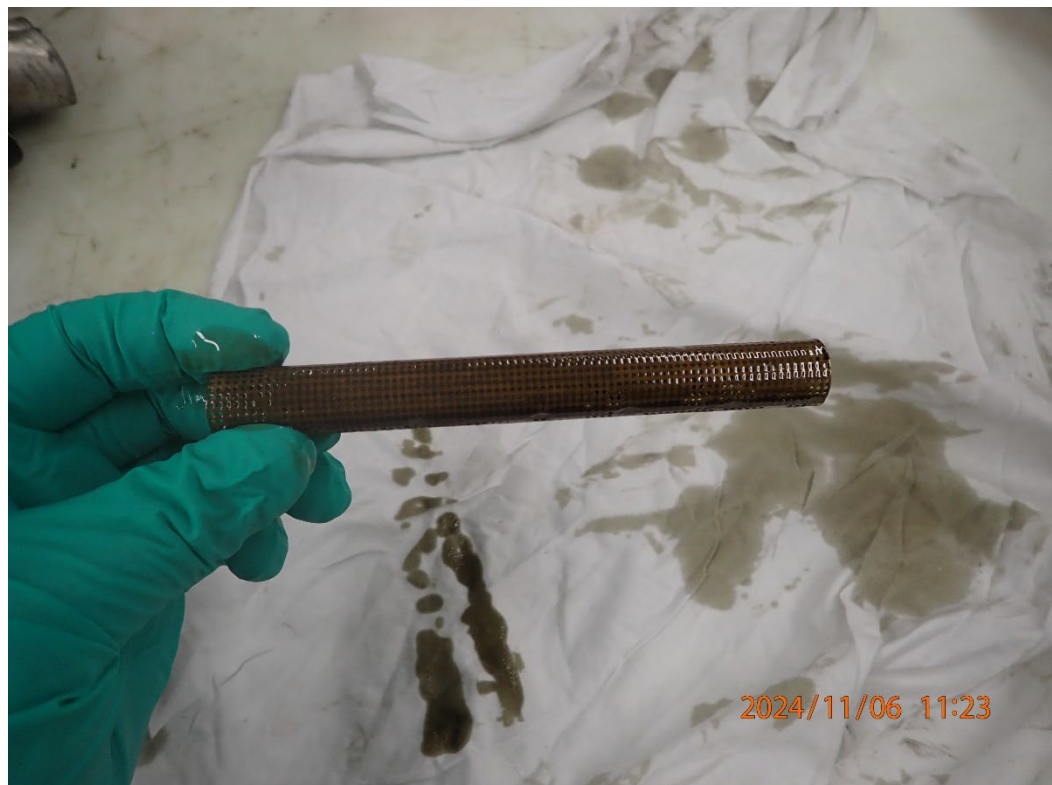
**Photo 9: View of the unobstructed oil suction screen.**

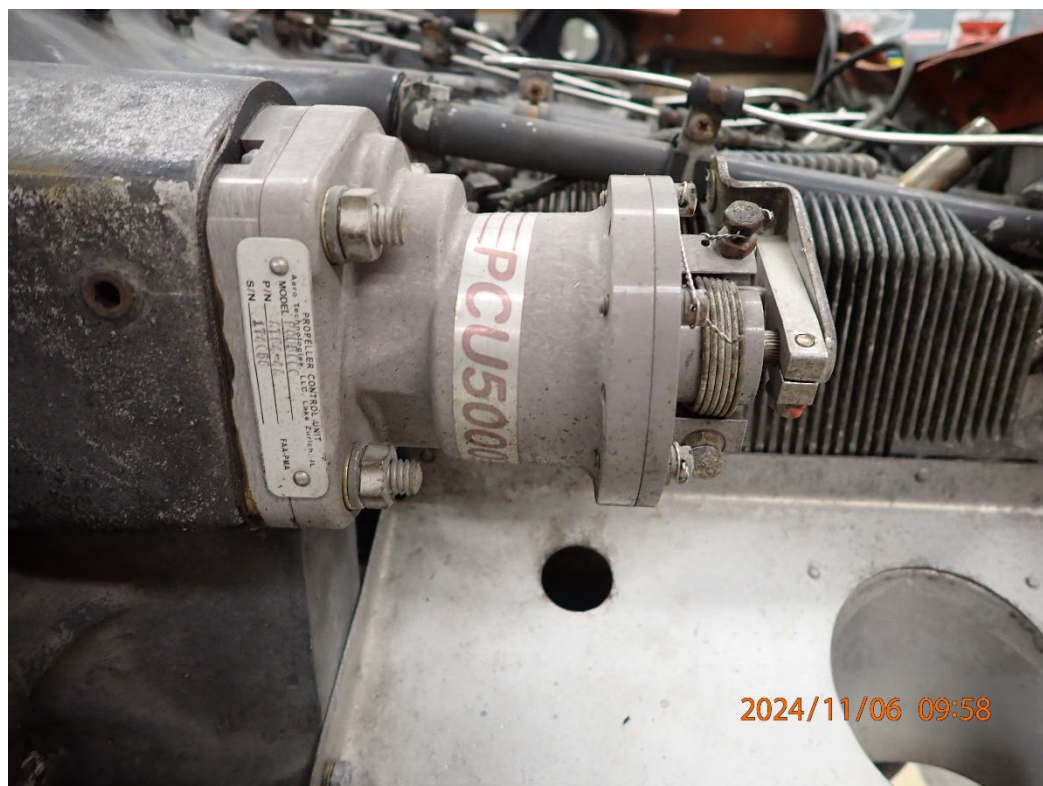
The propeller governor remained attached to the engine and was removed prior to the engine test run. The governor oil screen was removed and inspected and was unobstructed. The governor gurgled oil when the drive shaft was rotated by hand.

**Photo 10: Propeller governor attached to the engine.**

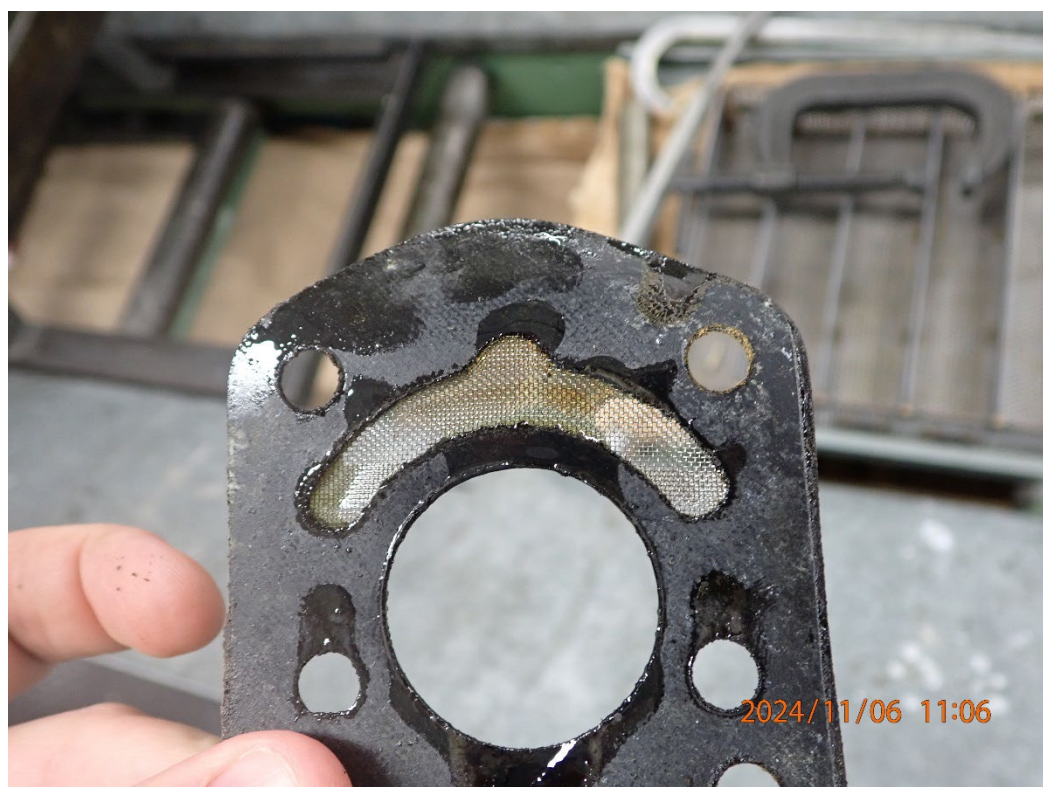
**Photo 11: View of the unobstructed propeller governor oil screen.**

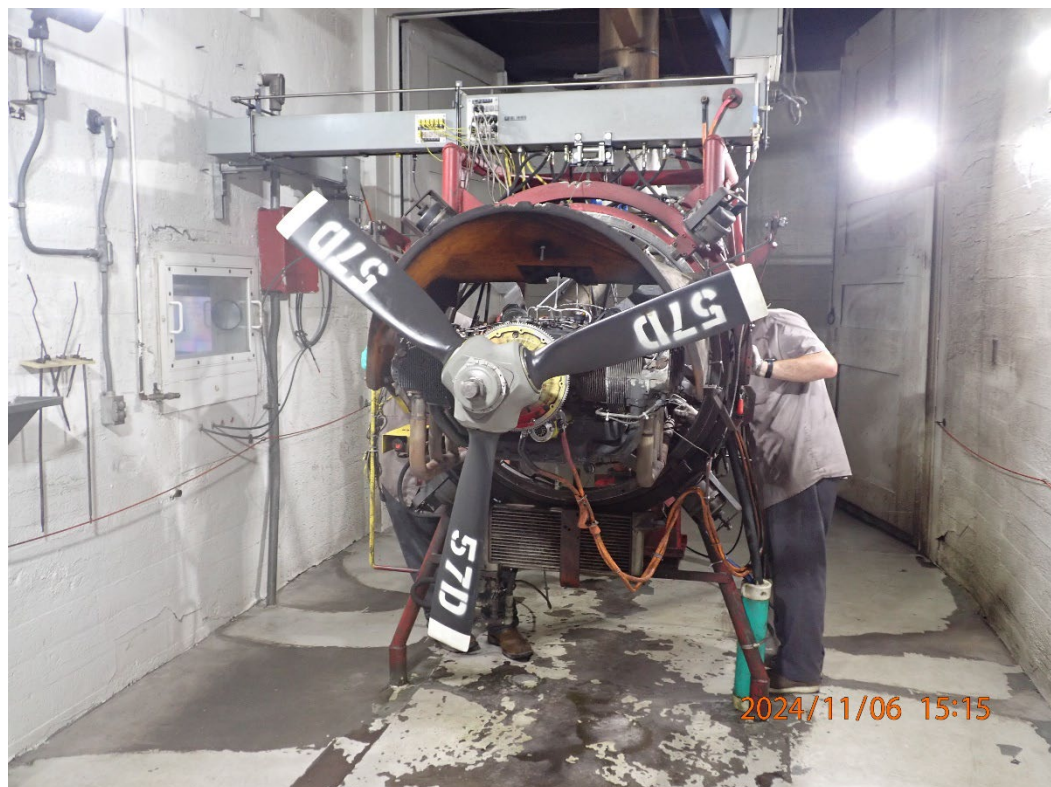
Fresh oil was pumped through the engine to ensure proper lubrication, and that no contamination was present. The engine was started and warmed up. Oil temperature reach approximately 250 degrees F by the time the engine was at about 2000 rpm. The engine was shut down and the original oil filter adapter as removed, and a slave oil filter adapter was installed. The engine was then restarted the following day and oil temperature was normal and the engine was operated through its full power band following Lycoming's standard power and leak engine run test. All areas passed except for the air flow limits at rated, low limit is 1636.6 pph, test result was 1535.3 pph. There is no high limit.

**Photo 12: View of the engine mounted in the test cell prior to engine test run.**

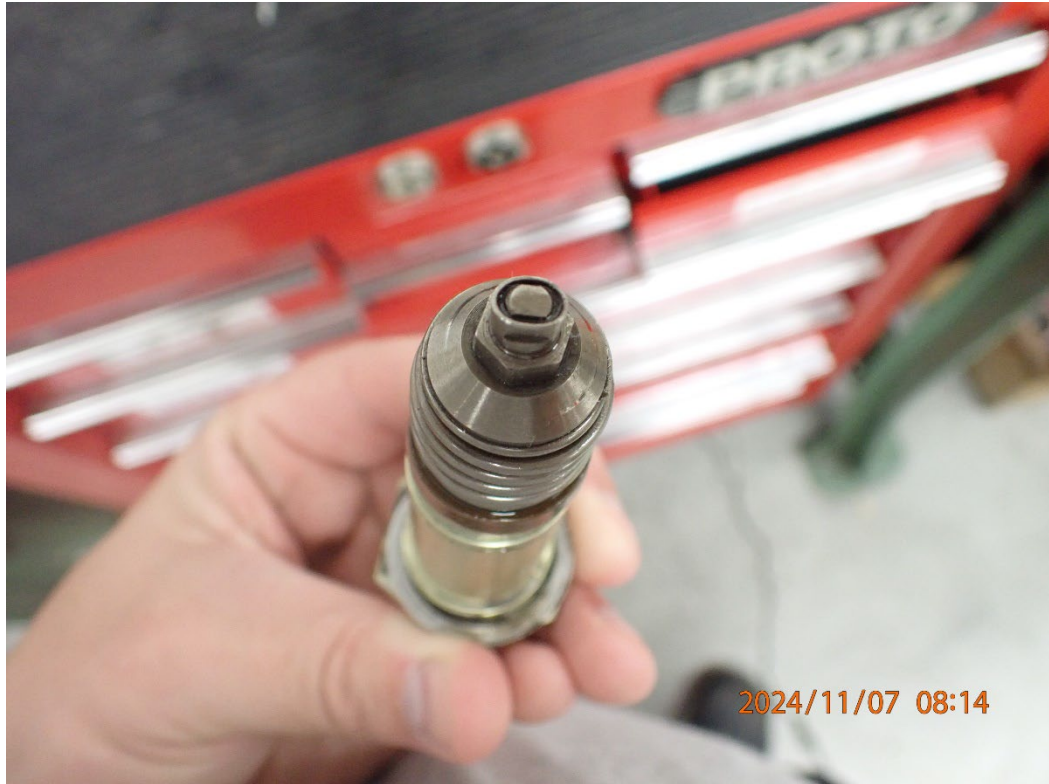
Examination of the original oil filter adapter found the thermostatic oil cooler bypass valve was not seating properly and was likely allowing hot oil to bypass the oil cooler resulting in the excess oil temperatures found when the engine was run on the test stand with the original oil filter adapter.

**Photo 13: View of the thermostatic oil cooler bypass valve with inconsistent wear.**
