# National Transportation Safety Board

ERA24LA211

## **WRECKAGE EXAMINATION**

Location: Apopka, FL  
Date: May 8, 2024  
Time: 1130 EDT  
1530 UTC  
Airplane: N908DK; Piper PA-32-300

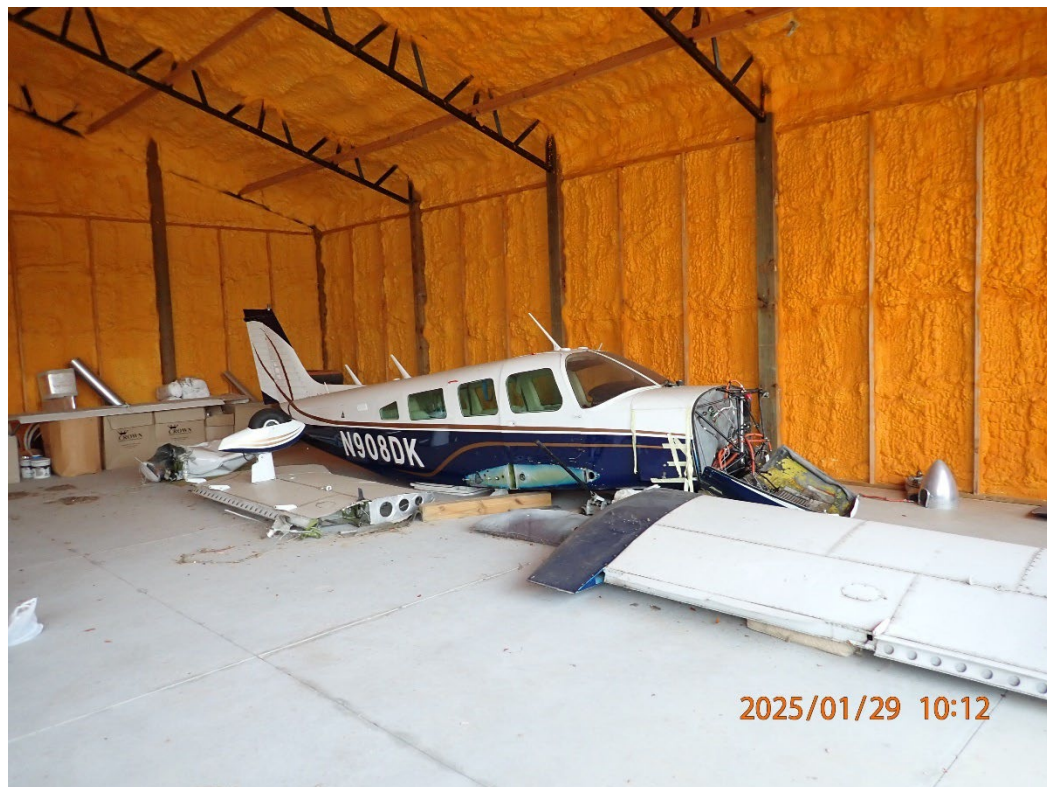
The main fuselage revealed deformation of the firewall, engine mount and nose landing gear. The balance of the fuselage revealed some minor impact related deformation. Due to the duration that the wreckage had been stored

**Photo 1: View of the fuselage as first seen at the owner's hangar.**

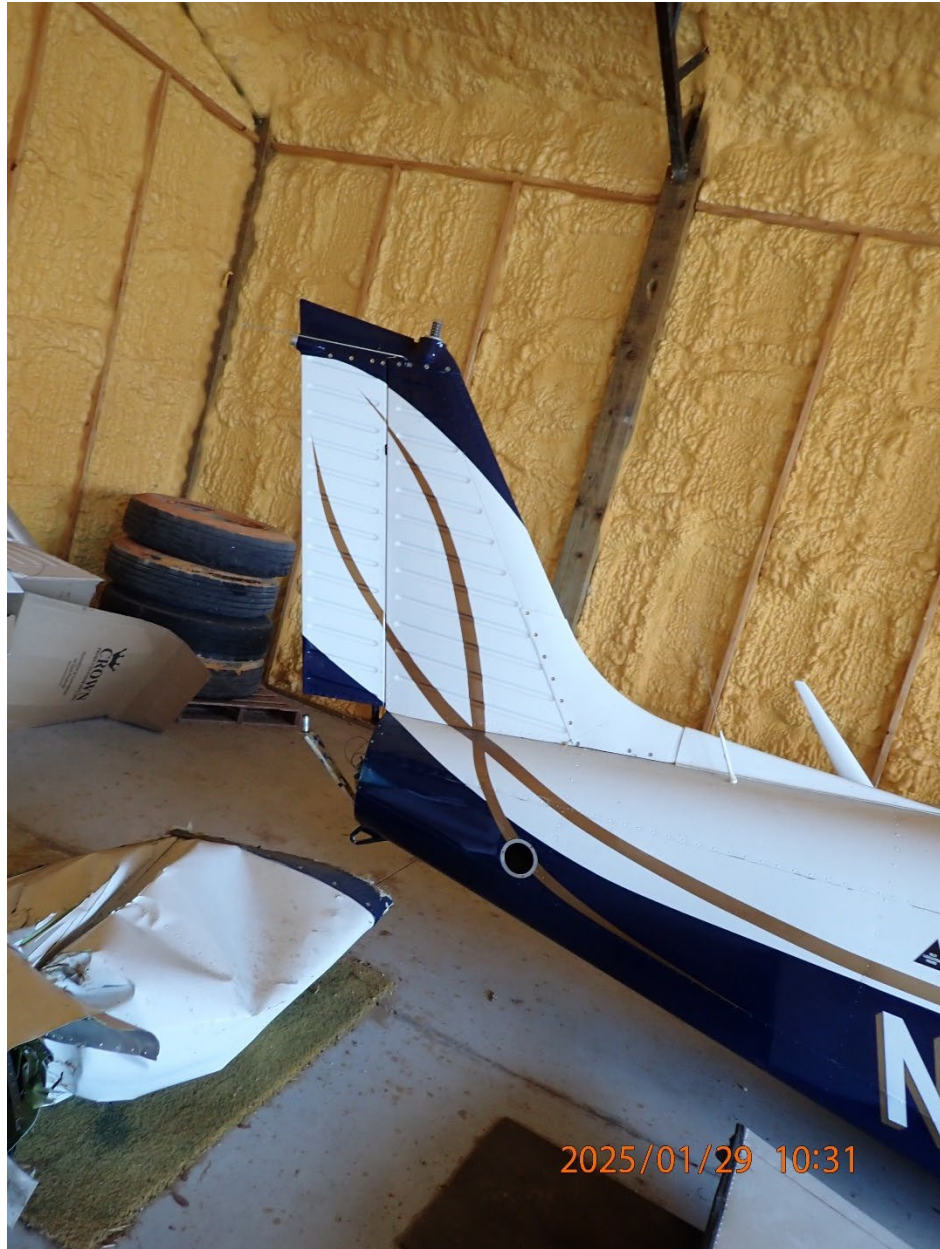
The vertical stabilizer and rudder remained attached to the aft fuselage and did not reveal any damage. The rudder remained attached to the vertical stabilizer at all hinges. Both rudder control cables remained attached to the rudder horn. Rudder control continuity was confirmed from the rudder to the rudder pedals in the forward fuselage. The stabilator was attached to the empennage on-site but had been removed by recovery personnel. The stabilator balance weight remained attached to the stabilator control tube. Control continuity for the stabilator was confirmed from the cable ends that attach to the control tube to the base of the control column in the forward cabin. The stabilator trim cables and the threaded rod portion of the actuator had been removed from the trim actuator drum during recovery. Stabilator trim cable continuity was confirmed from the cable ends at the empennage to the trim control wheel in the forward cabin.

**Photo 2: View of the vertical stabilizer and attached rudder.**

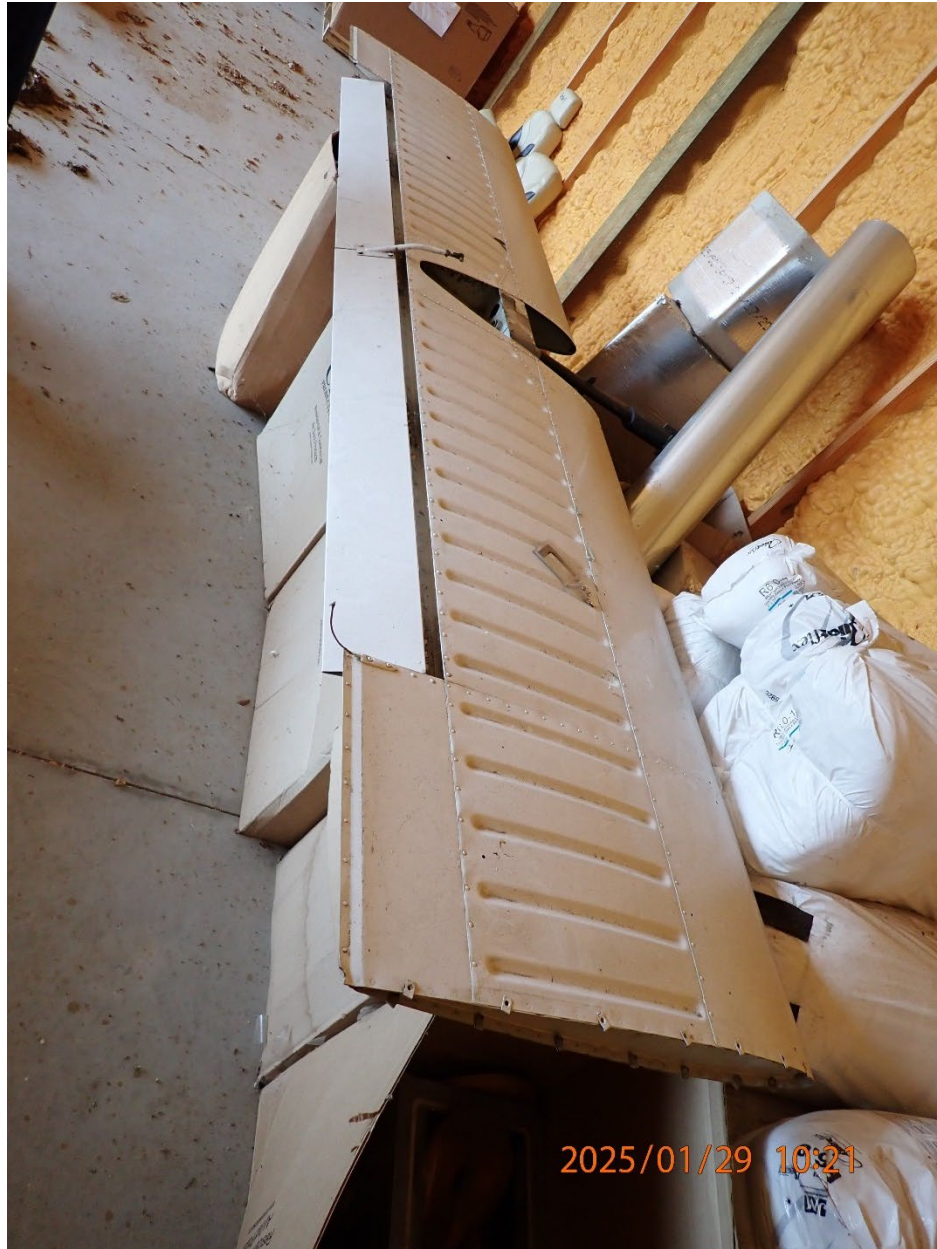
**Photo 3: View of the stabilator with attached stabilator trim.**

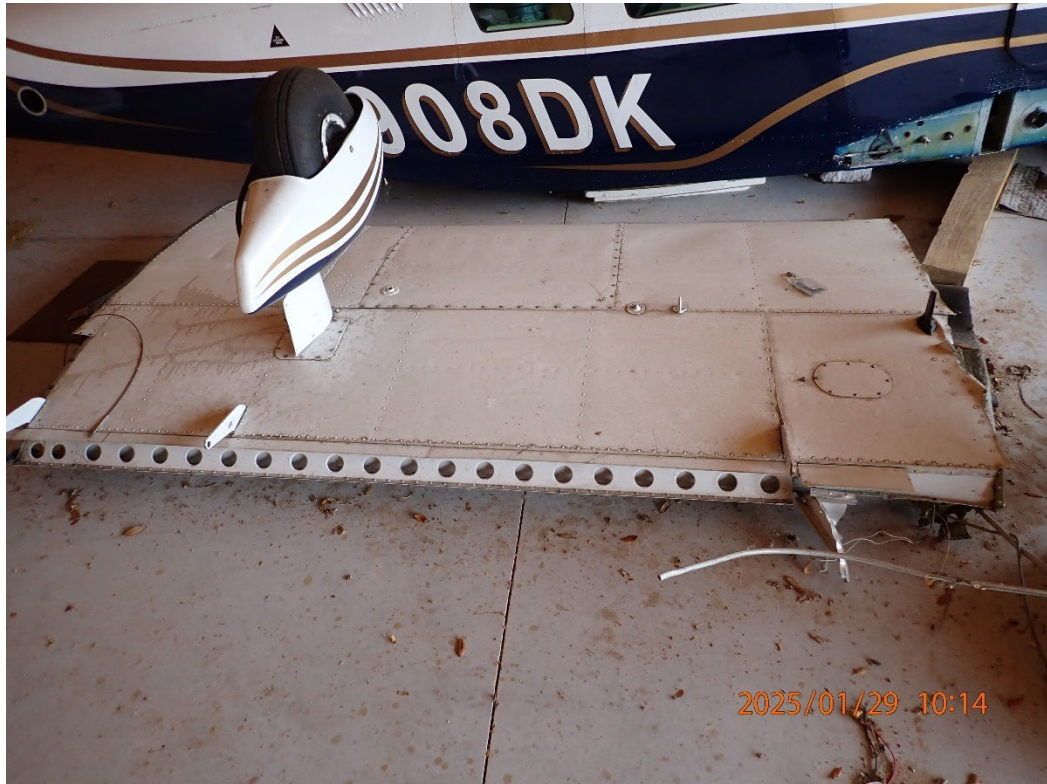
The left-wing separated just outboard of the pitot static mast due to a collision with an approximately four-inch diameter tree during the landing sequence. The left-wing inboard section, inboard of the pitot static mast, remained attached to the fuselage on-site, but had been removed from the airframe by recovery personnel. The left-wing flap and aileron remained attached to the wing on-site. The flap was removed by recovery personnel and revealed some impact related deformation near the second hinge. The left aileron

**Photo 4: View of the inboard section of the left wing.**

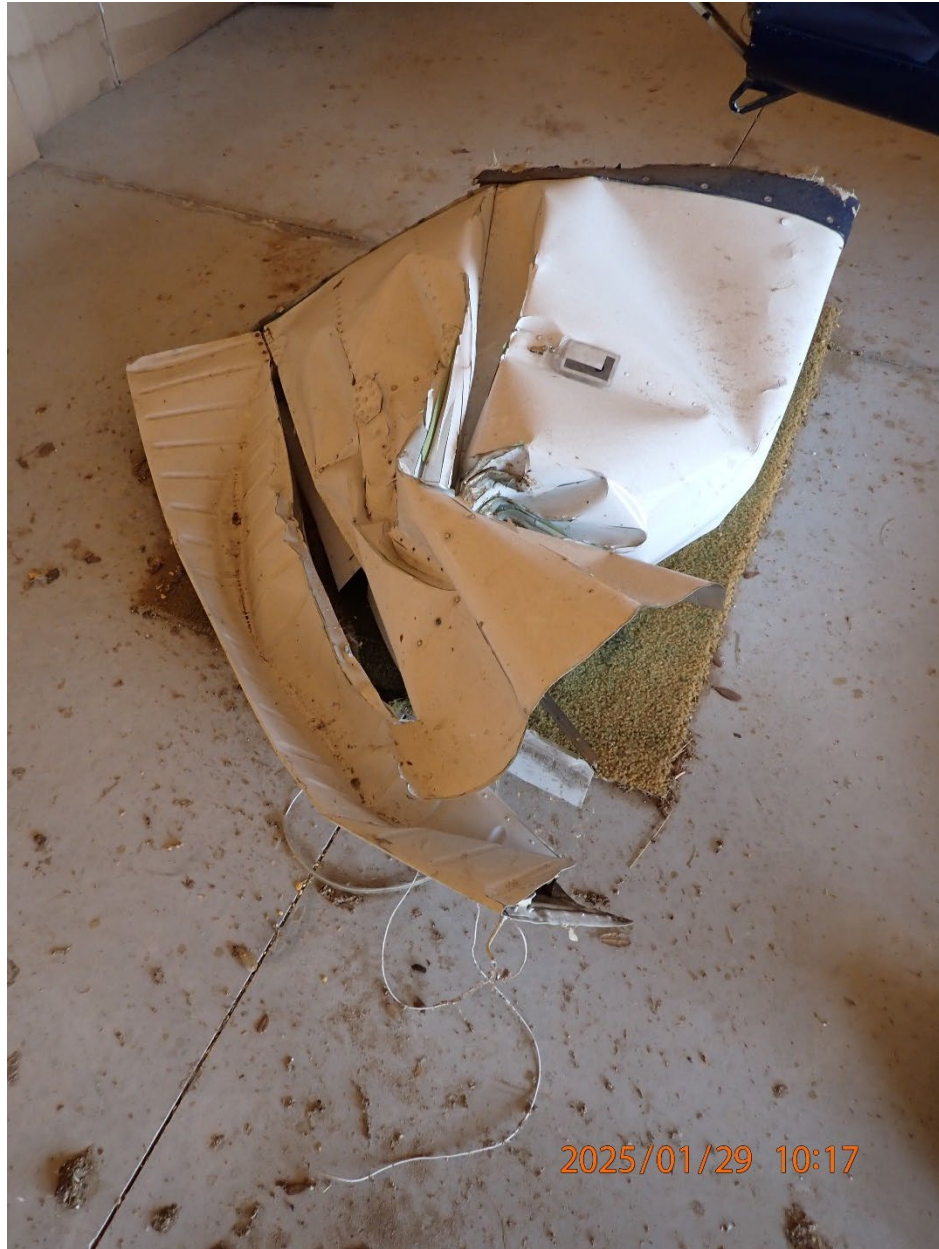
remained attached to the outboard portion of the wing and was deformed by impact forces. The left aileron balance weight remained attached to the aileron. The left aileron bellcrank remained attached and in-place inside the wing with both aileron cables attached. Left wing aileron continuity was confirmed from the wing root to the bellcrank. The left-wing fuel tip tank was shattered by impact forces. The pitot static mast remained attached to the left wing and was not damaged. The left-wing leading edge lift detector was intact and did not appear to be damaged.

**Photo 5: View of the impact separated outboard section of the left wing.**

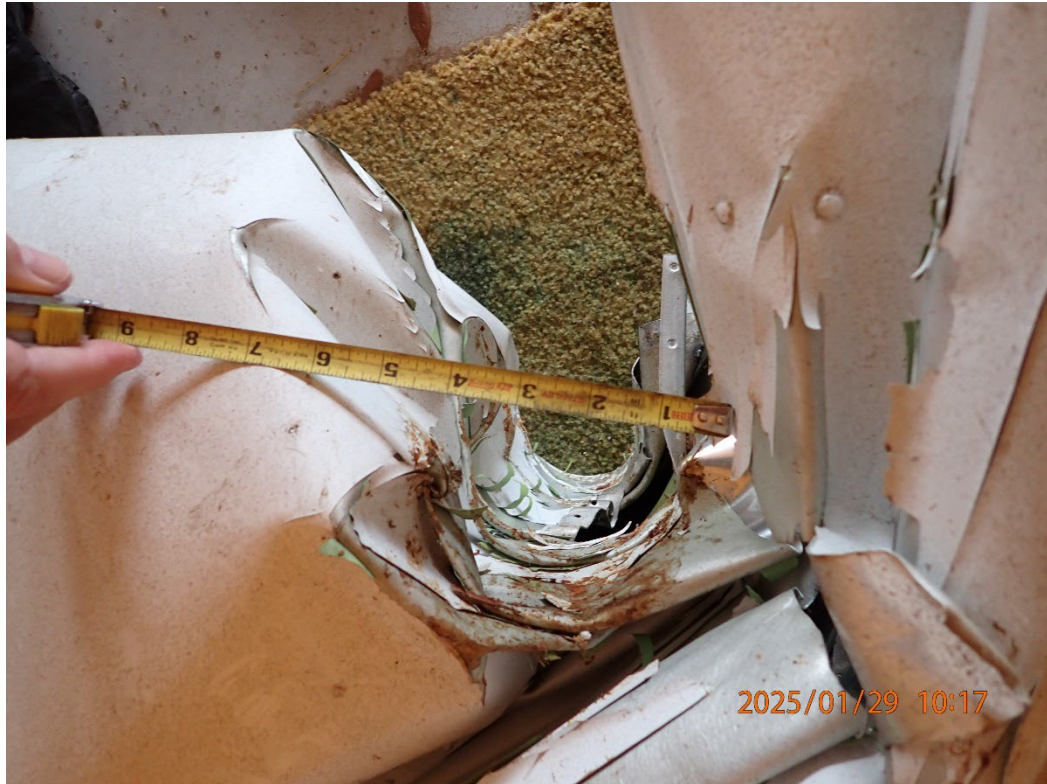
**Photo 6: View of the impact on the leading edge of the left wing.**

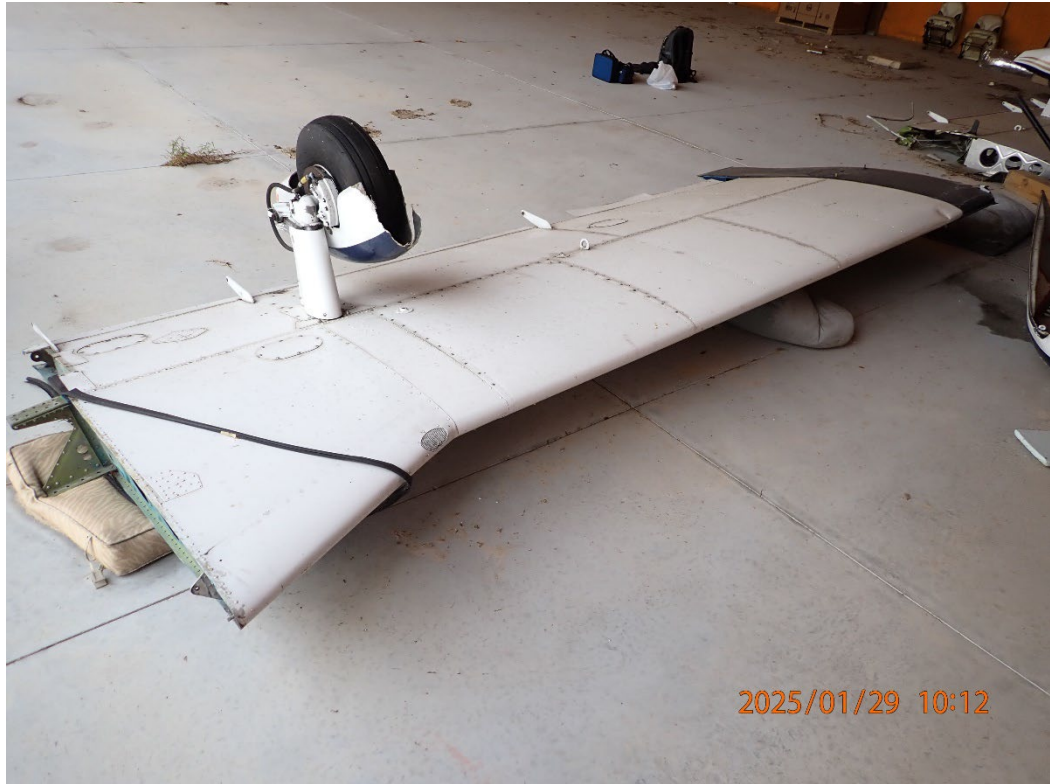
The right wing remained attached to the fuselage on-site and was removed from the fuselage by recovery personnel. The wing was intact and displayed a small dent on the underside of the wing near the attachment point of the tip tank. The right flap and aileron remained attached to the right wing at all hinges on-site but were removed from the wing by recovery personnel. Aileron cable continuity was confirmed from the right-wing root to the aileron bellcrank and pushrod.

**Photo 7: Overview of the right wing.**

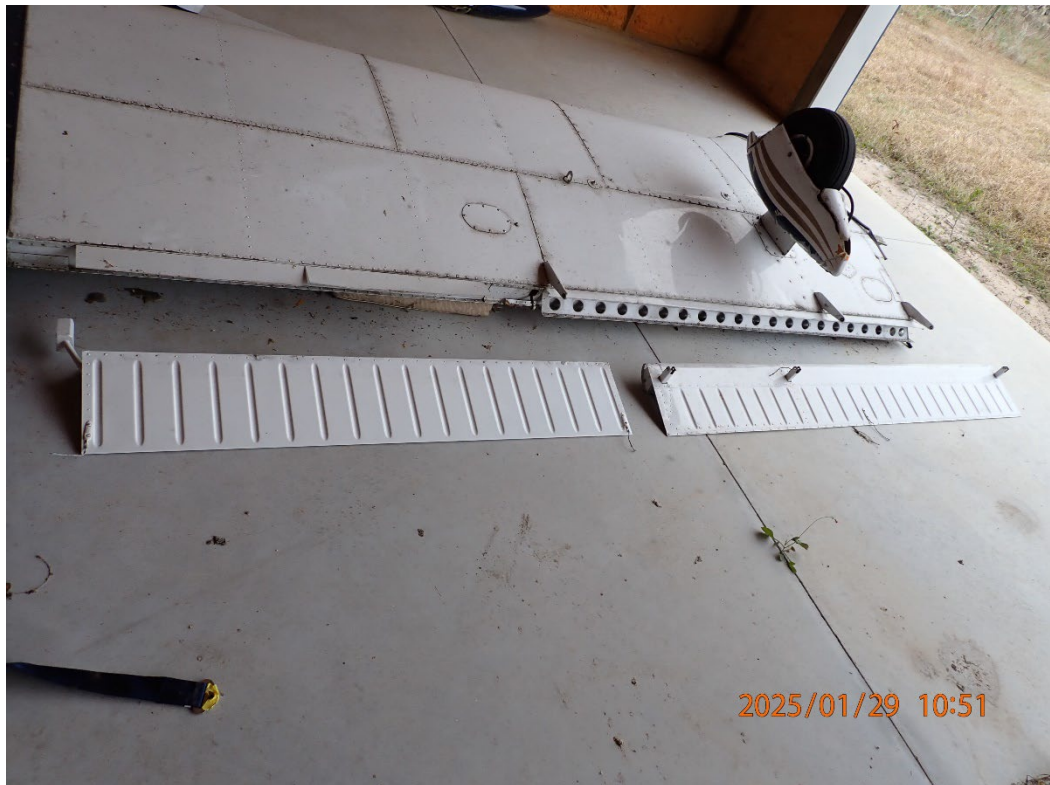
**Photo 8: View of the right wing with flap and aileron laid out.**

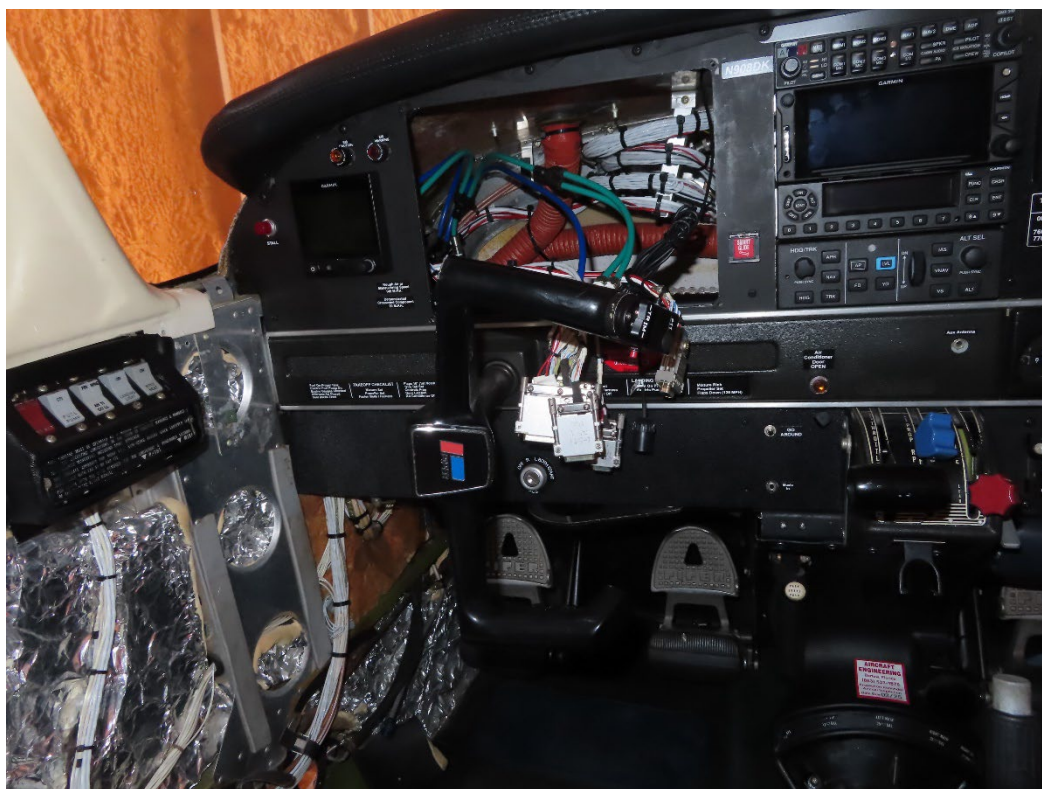
The throttle and mixture controls were found in a position close to full aft. The propeller control was found at about mid-range. The alternate air door was closed. Throttle, propeller control and mixture control cable continuity and function were confirmed. Alternate air control cable continuity and function was also confirmed. The hour-meter read 00757.0. The fuel selector was in the left main tank selected position and was in a tactile detent.

**Photo 9: View of the left side of the cockpit. (Piper Photo)**

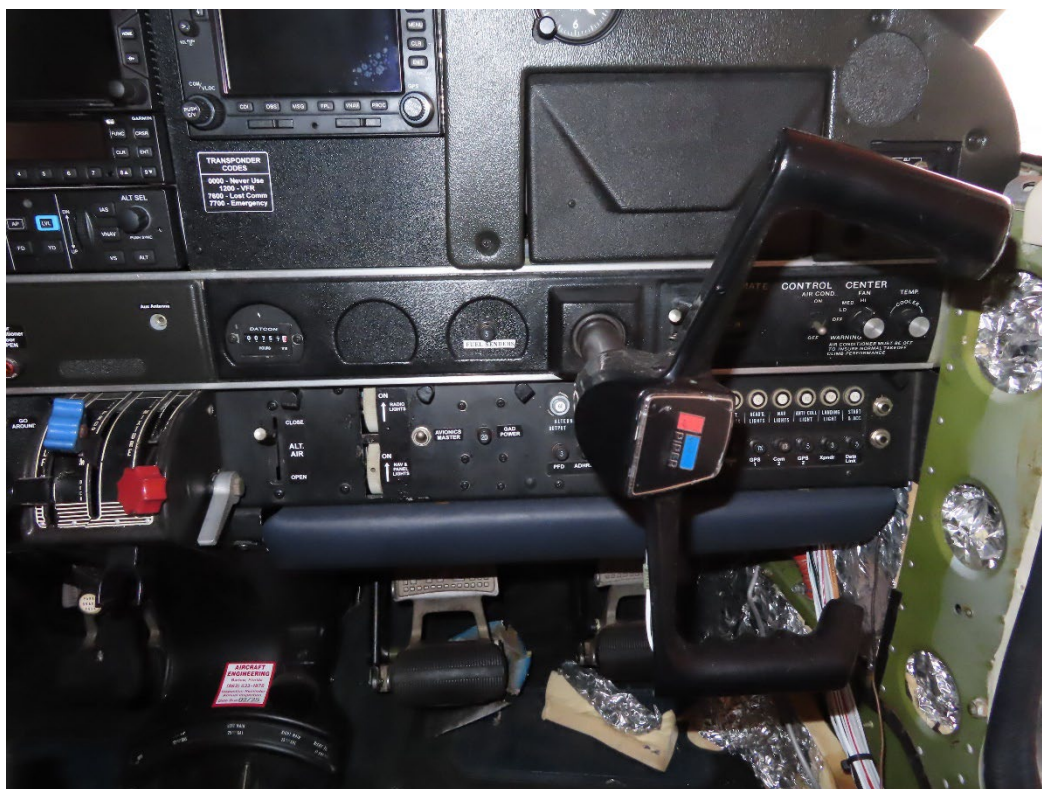
**Photo 10: View of the right side of the cockpit. (Piper Photo)**

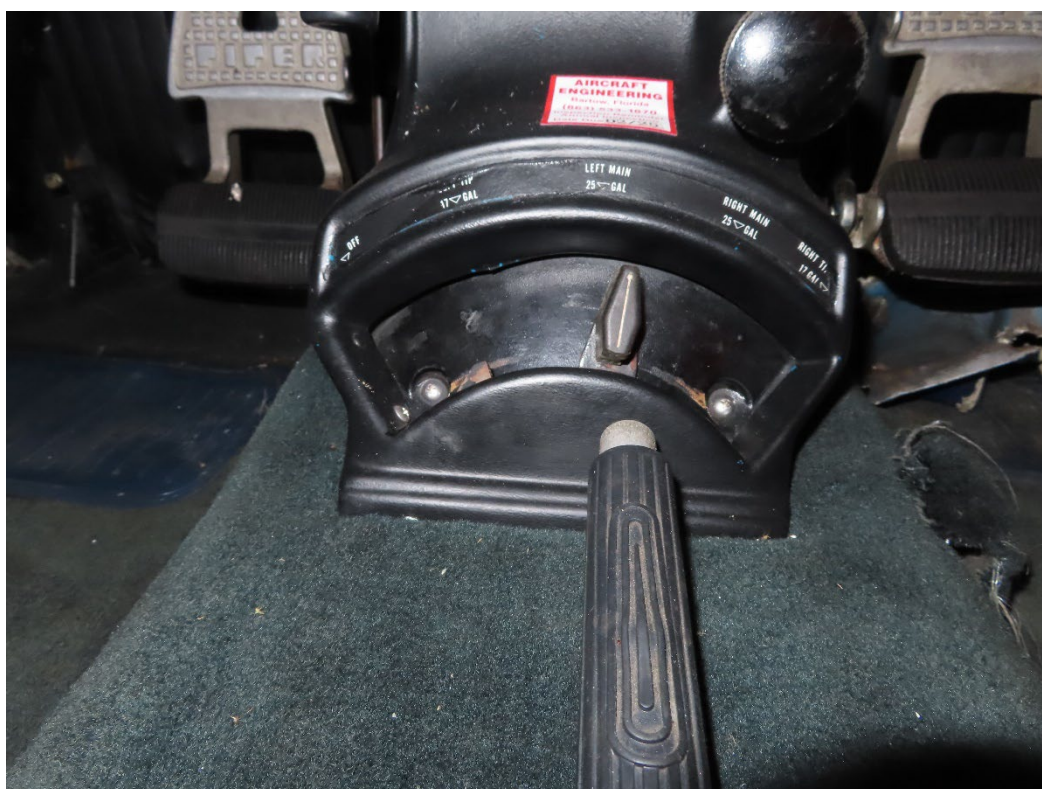
**Photo 11: View of the fuel selector in the cockpit. (Piper Photo)**

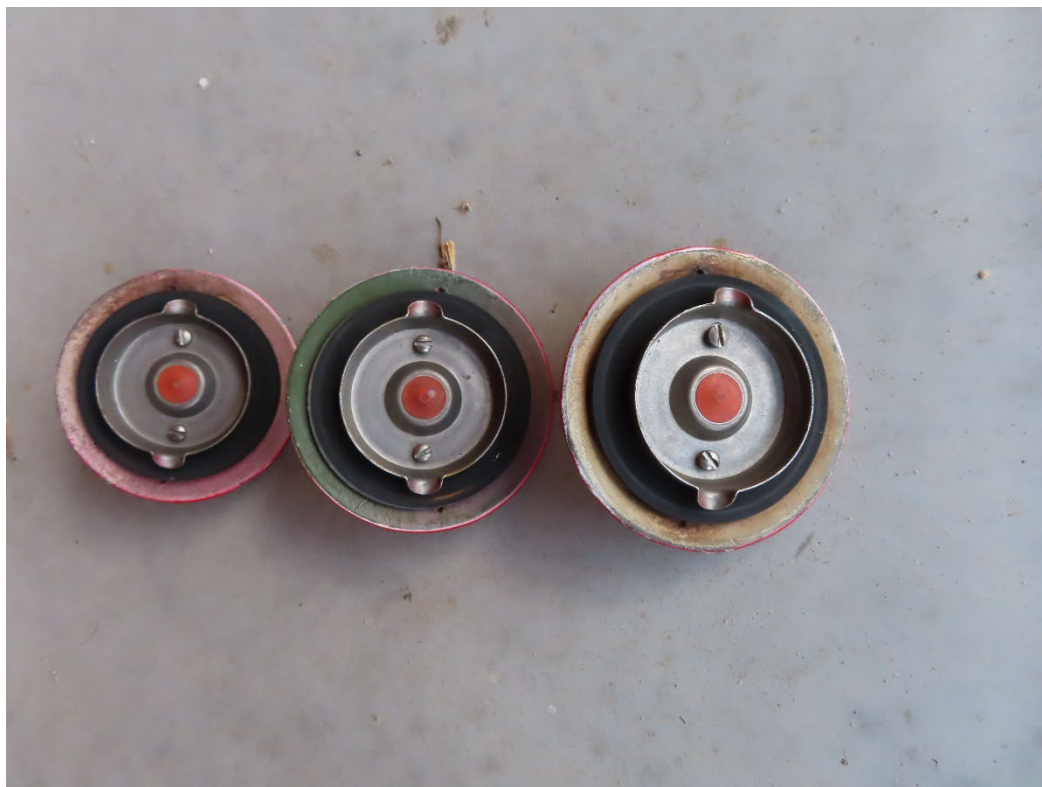
Three fuel caps were observed during the off-site investigation. They were located in the fuselage. All three displayed gaskets that were pliable. No fuel remained in the left-wing fuel tanks during the off-site investigation. The main tank and tip tank fuel screens were clean and unobstructed. No fuel was present in the right-wing fuel tanks during the off-site investigation. The main and tip fuel tank screens were clean and unobstructed.

**Photo 12: Overview of the three fuel caps found in the fuselage. (Piper Photo)**

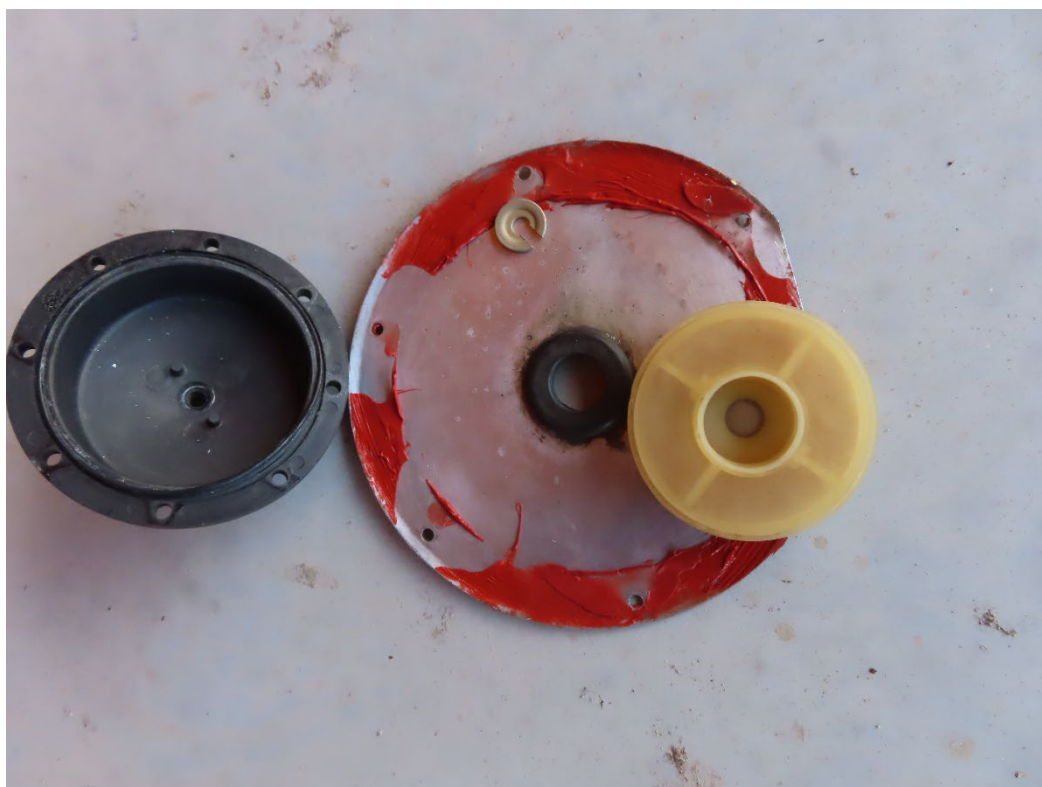
No fuel remained in the fuel selector valve / fuel strainer. The fuel selector valve/fuel strainer fuel screen was clean. The electric fuel boost pump was tested using a 12-volt power source. The pump motor was observed to run smoothly during this test.

**Photo 13: Disassembled fuel strainer. (Piper Photo)**

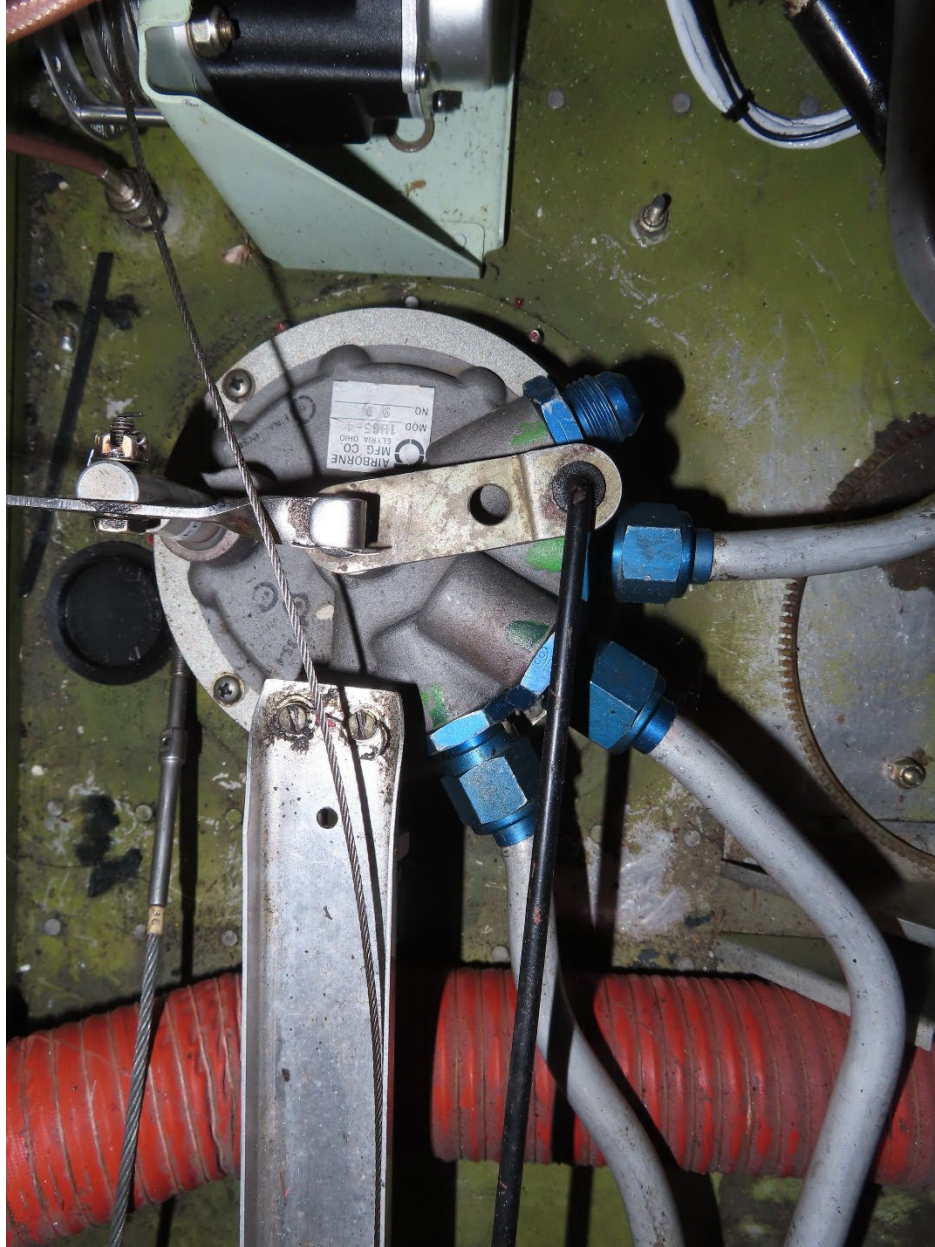
The engine fuel feed line at the firewall revealed the presence of mud wasp nesting material. This was cleaned from the line and from other fuel lines to enable low pressure air testing of the fuel system. The left main fuel tank line at the wing-root displayed some white material that appeared consistent with Styrofoam. Styrofoam blocks were used during the recovery of the airplane. This white material was removed from the fuel line prior to low pressure air testing. Using low pressure air, all fuel lines were found to be clear. Air was flowed through the entire fuel system, including confirmation of appropriate flow in all of the fuel selector positions. Each fuel selector position exhibited a tactile detent. Breached fuel line portions were tested separately and were found to be clear.

**Photo 14: View of the fuel selector valve. (Piper Photo)**

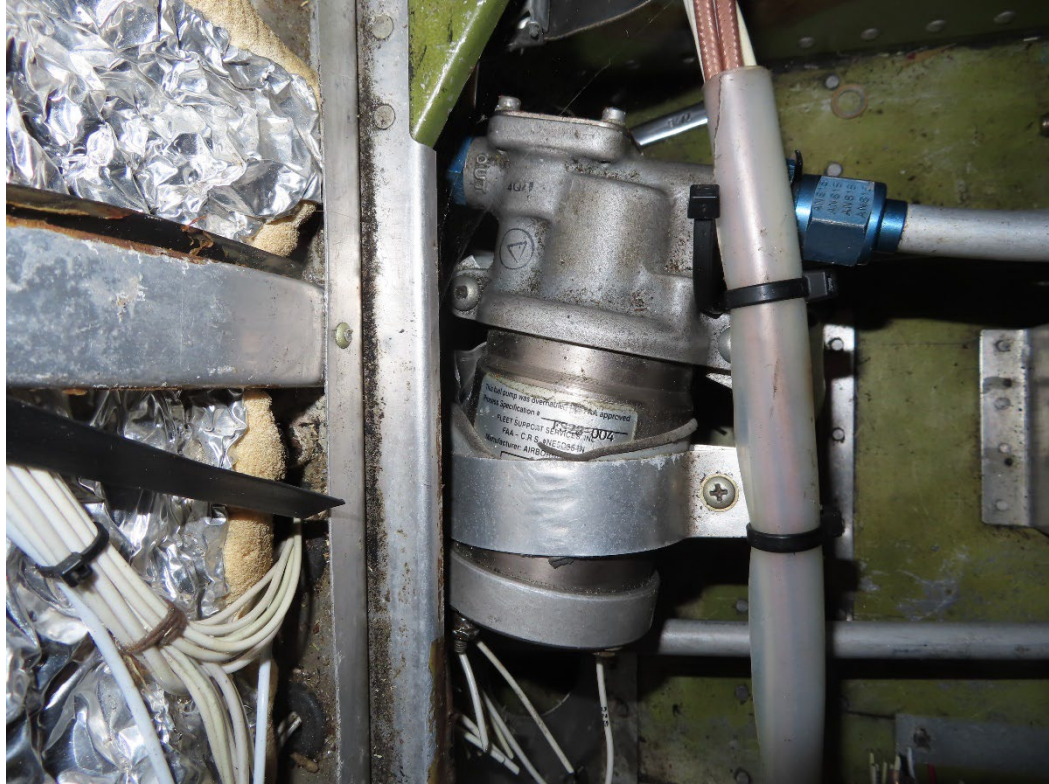
**Photo 15: View of the electric fuel pump. (Piper Photo)**

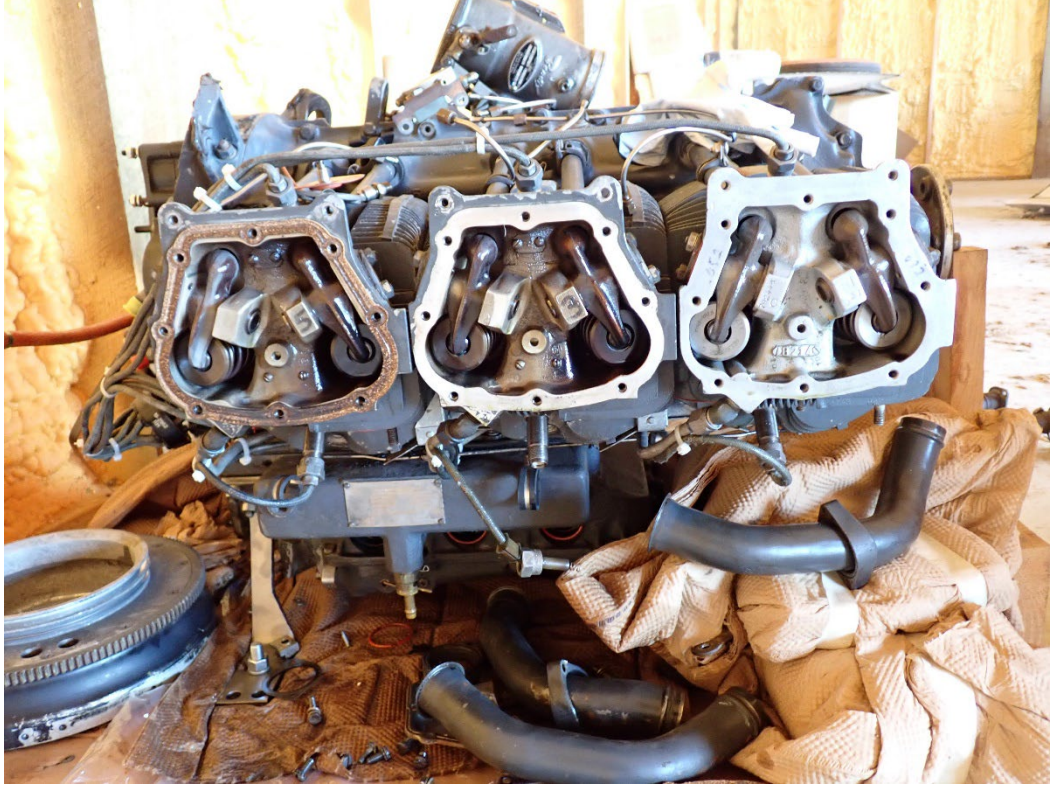
Due to the mounting of the engine, the crankshaft was unable to be rotated at the time of the examination. The rocker box covers were removed and the rocker arms, valve stems, and valve springs were visually examined. The components displayed normal operating and lubrication signatures.

**Photo 16: View of the Nos. 1, 3, and 5 cylinder heads with rocker covers removed.**

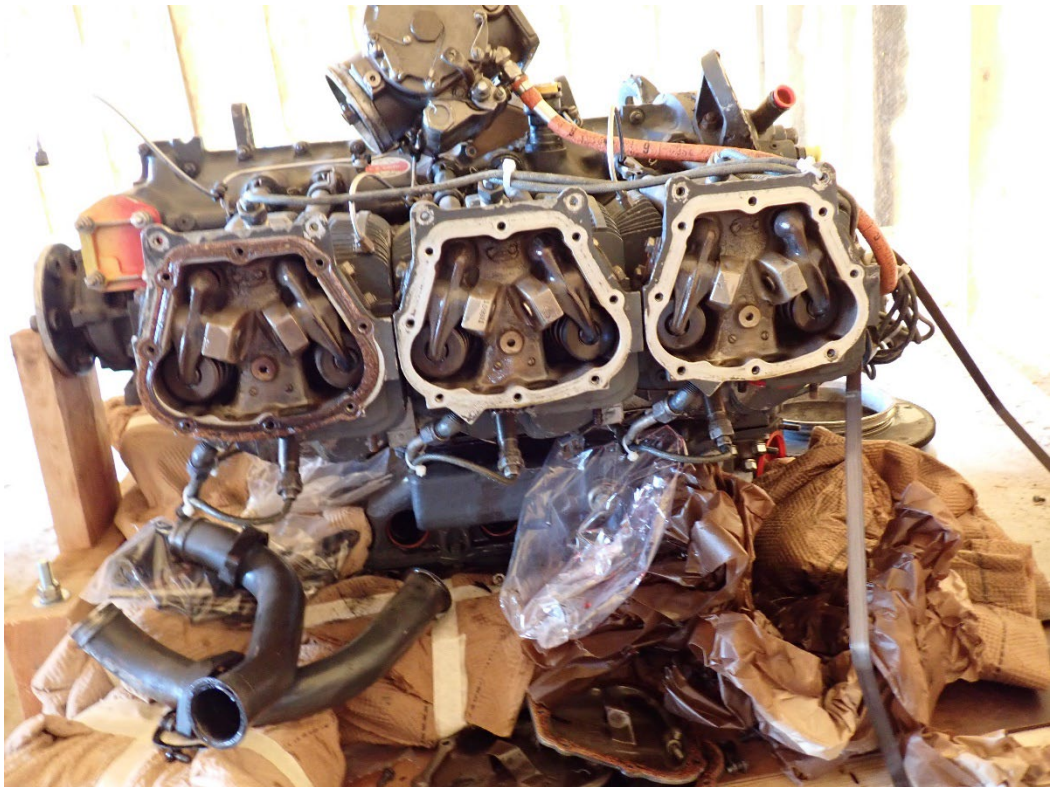
**Photo 17: View of the Nos. 2, 4, and 6 cylinder heads with rocker covers removed.**

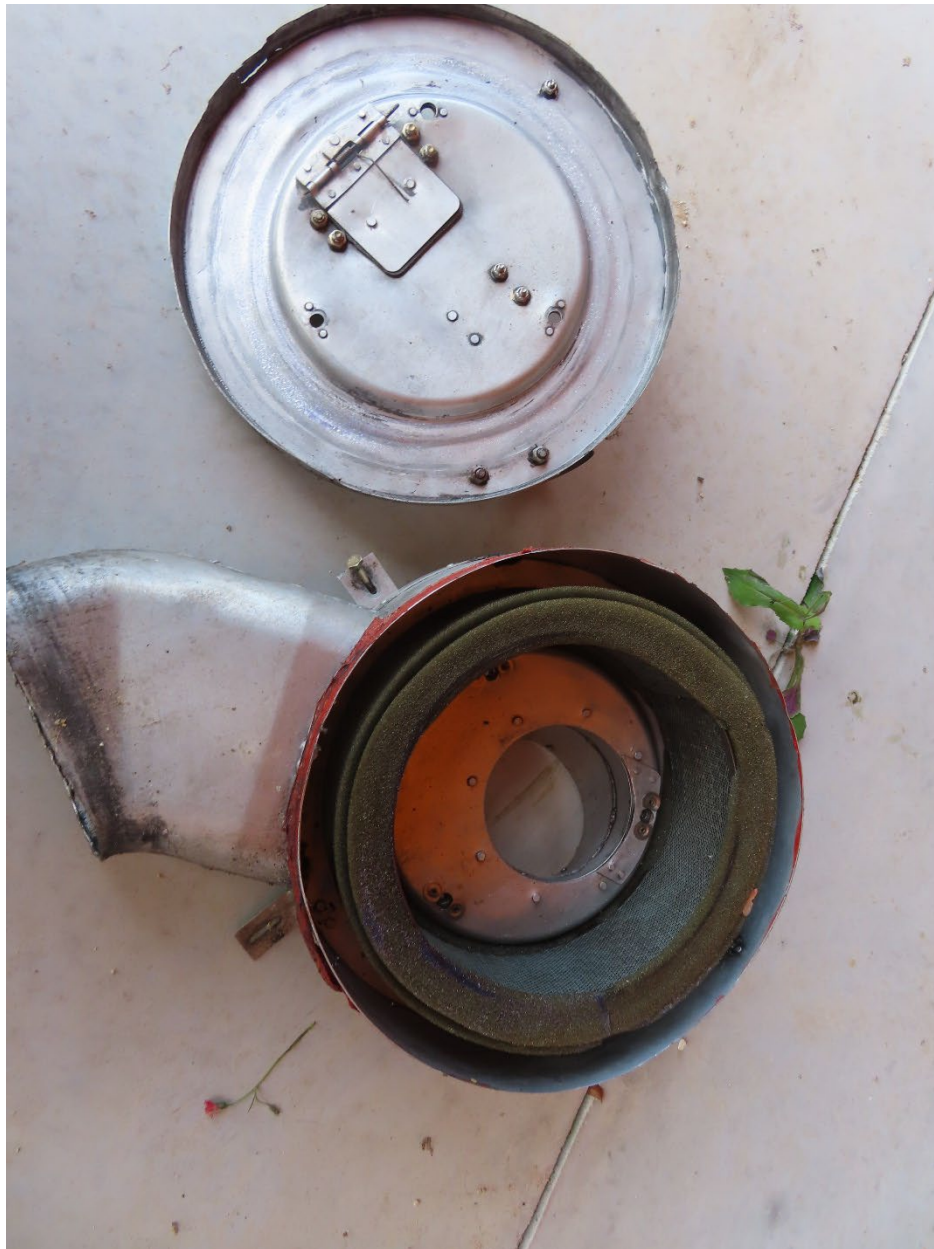
The induction system was examined and there were no signs of induction leaks. The induction tubes were removed and there were no obstructions or anomalies found. The throttle body was intact, and the throttle valve operated normally when actuated manually. The engine air filter appeared clean. The engine induction air tubing revealed an impact related crease but remained open.

**Photo 18: View of the engine air filter. (Piper Photo)**

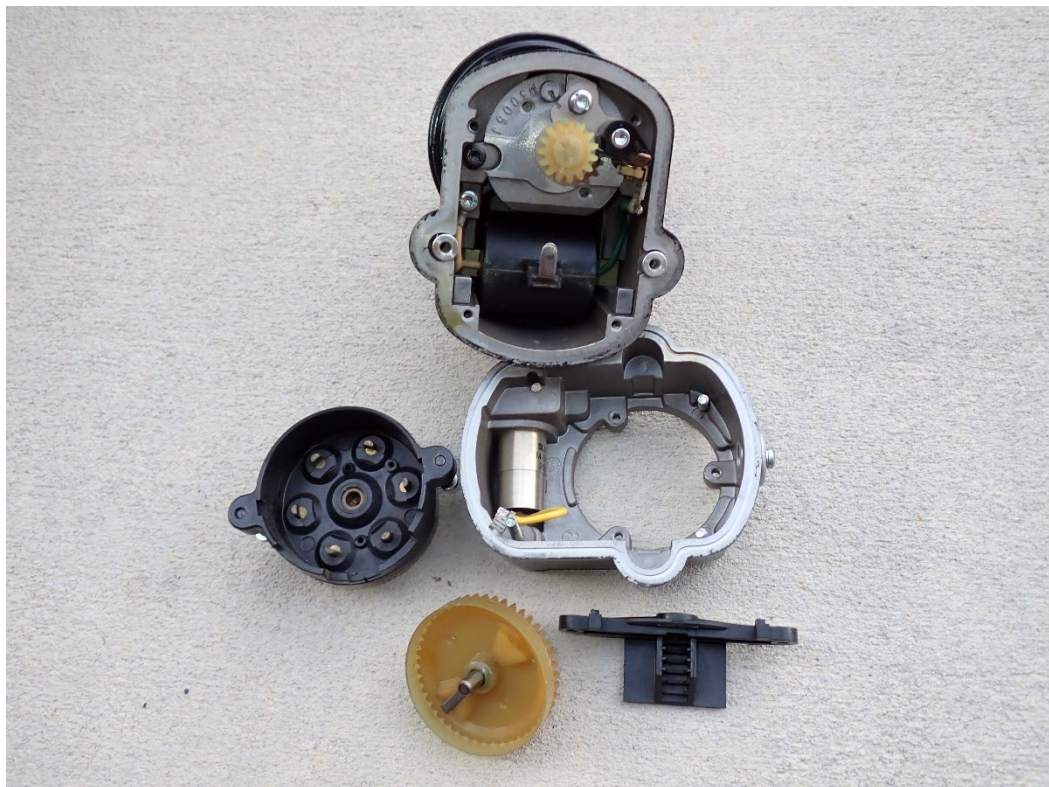
The right magneto was disassembled, and the internal components were visually inspected. The internal timing was verified to be correct and all the internal components displayed normal operating signatures. During magneto drive rotation the points were noted to open and close normally.

**Photo 19: View of the disassembled right magneto.**

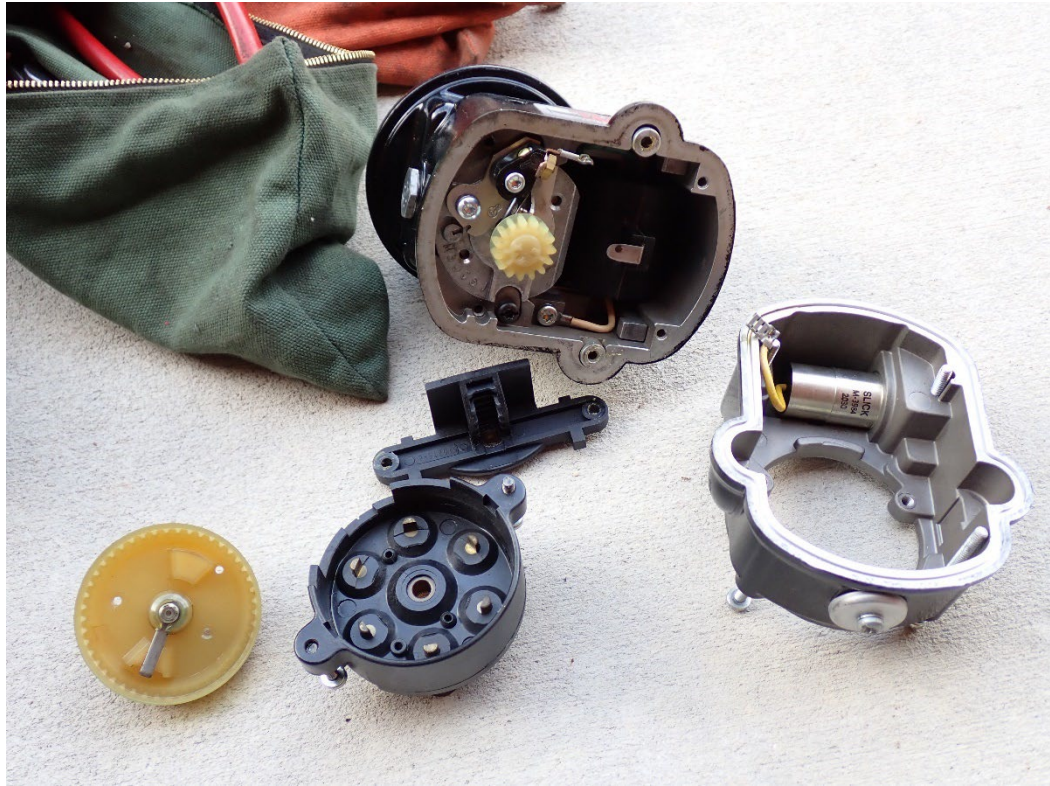
**Photo 20: View of the disassembled left magneto.**

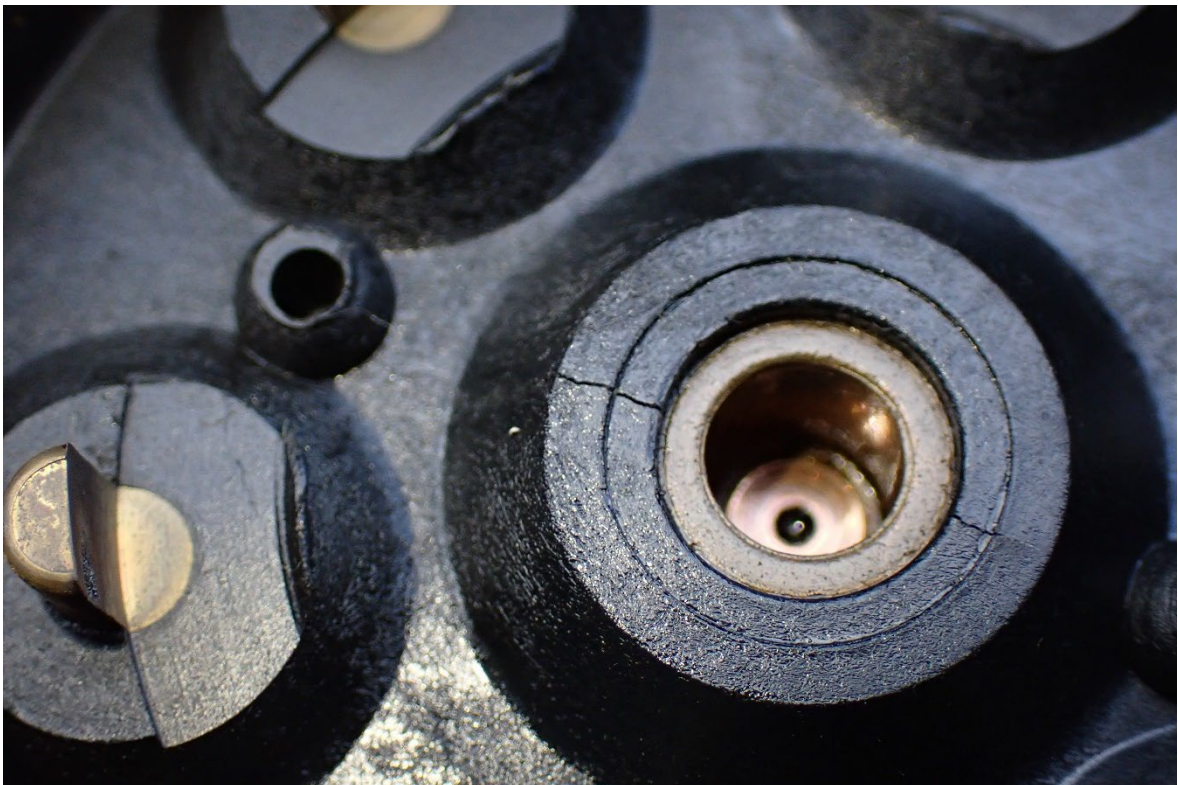
The left magneto was disassembled, and the internal components were visually inspected. The internal timing was verified to be correct and during magneto drive rotation the points opened and closed normally. Visual examination of the internal components revealed that the distributor block was cracked near the gear bushing; however, the crack did not extend the entire radius of the distributor block. The rest of the internal components displayed normal operating signatures and there were no signs of arcing.

**Photo 21: View of the cracked left magneto distributor block.**
