Joshua Young  
Air Safety Investigator  
AS-ERA

**Date:** 10/7/2025

**Subject:** ERA24LA211, Exhaust Valve Examination

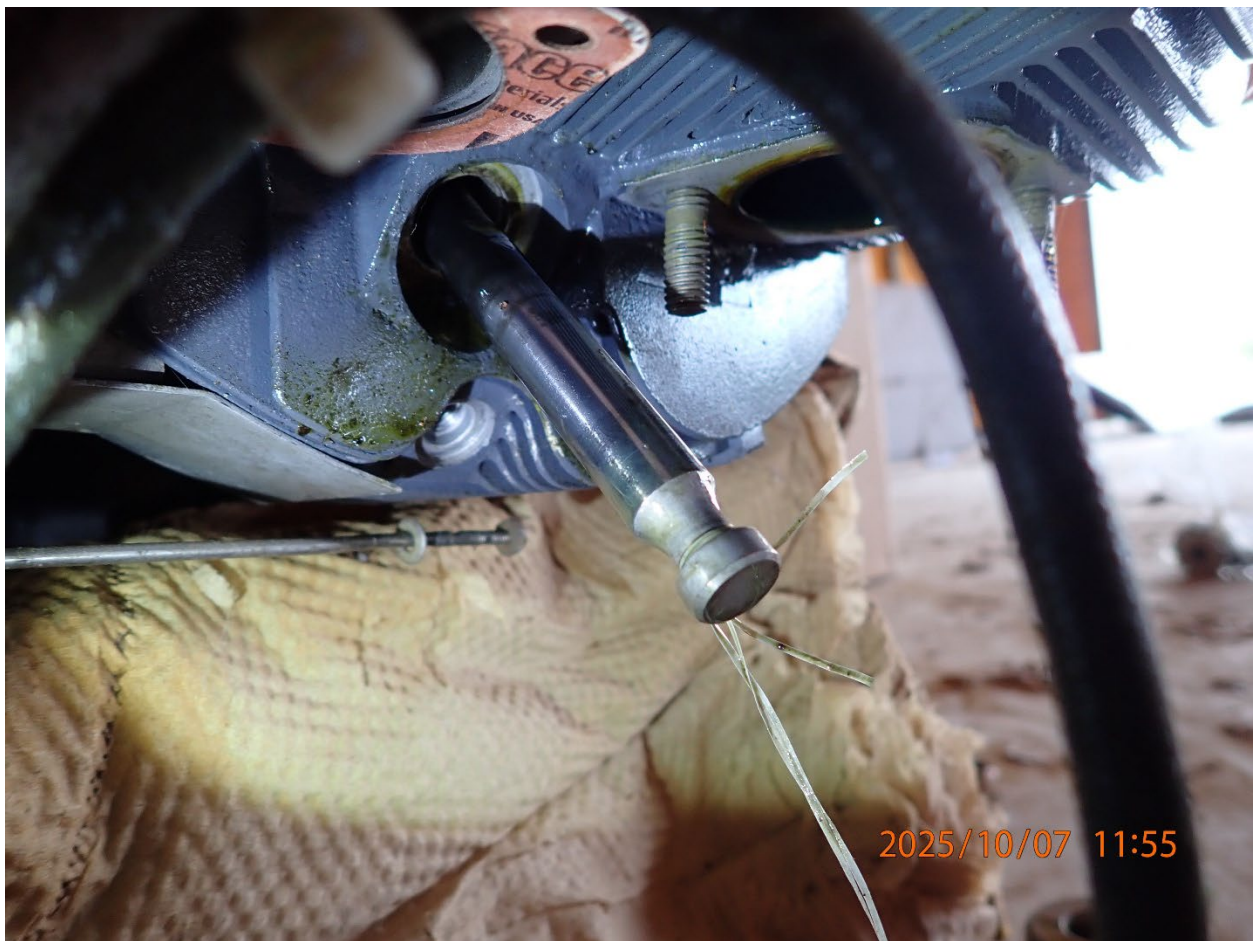
piston movement, but were documented through the spark plug holes. The exhaust valve stem of cylinder 1 appeared clean with no build up or residue noted. The exhaust valve stems for cylinders 2, 3, 4, 5, and 6 visually had moderate buildup of carbon at the combustion chamber side of the exhaust guide. The exhaust valve stem of cylinder 4 caught and was tight when it was pushed into the cylinder head. A material similar to coked oil was observed in the exhaust valve guide of cylinder 4.

*Photo 1: View of the No. 1 exhaust valve stem.*

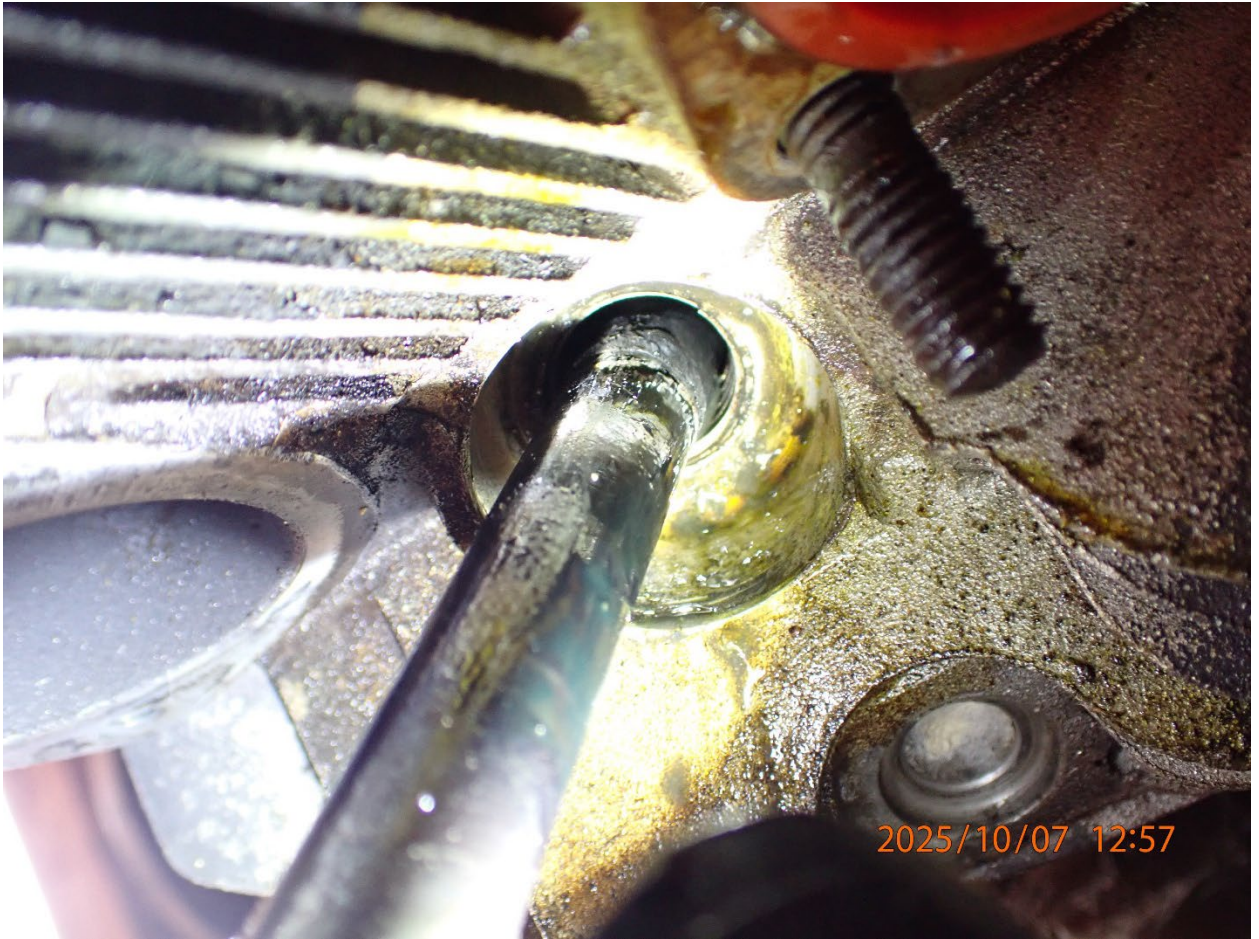
*Photo 2: View of the No. 2 exhaust valve stem.*

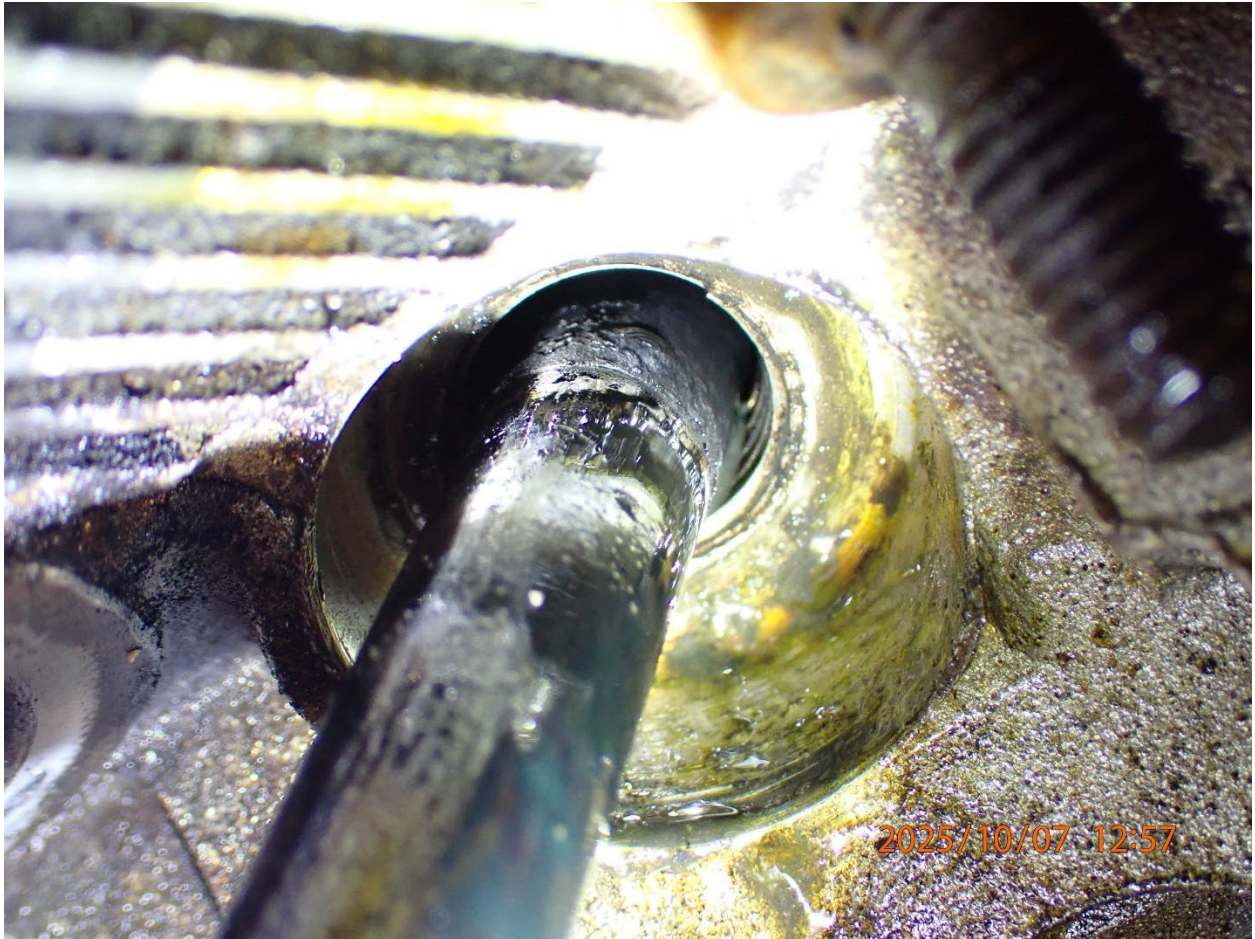
*Photo 3: View of the No. 2 exhaust valve stem.*

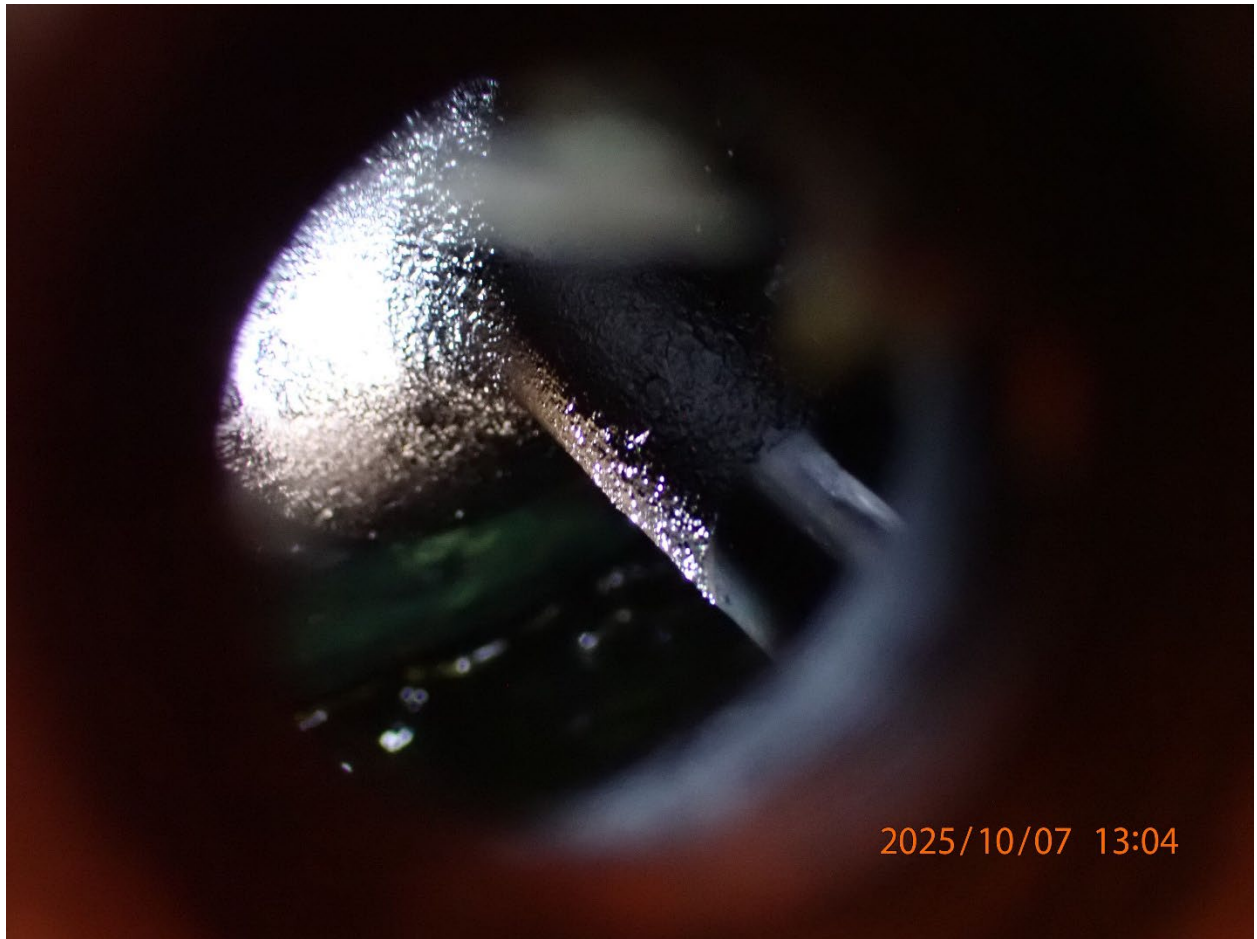
*Photo 4: View of the No. 3 exhaust valve stem.*

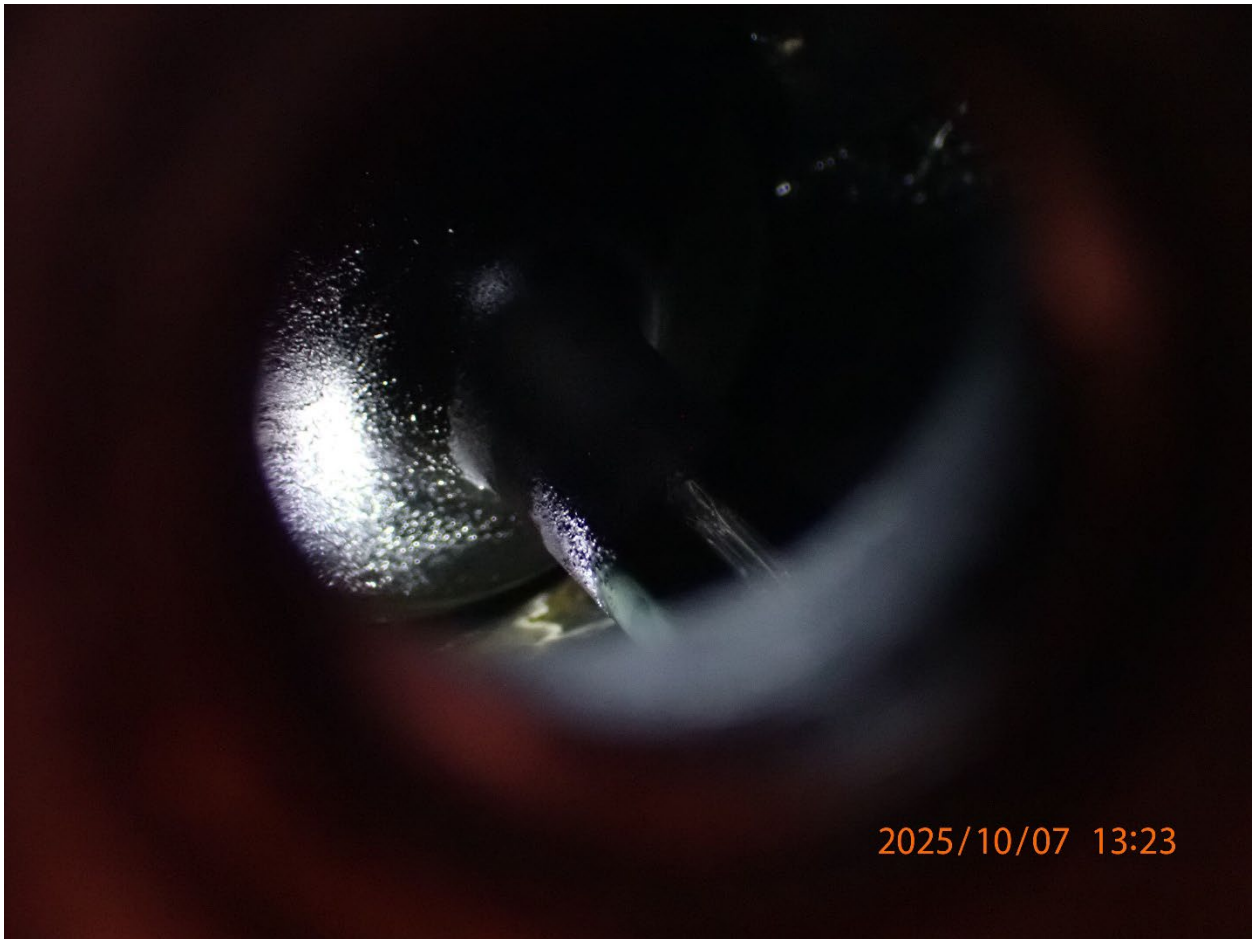
*Photo 5: View of the No. 4 exhaust valve stem.*

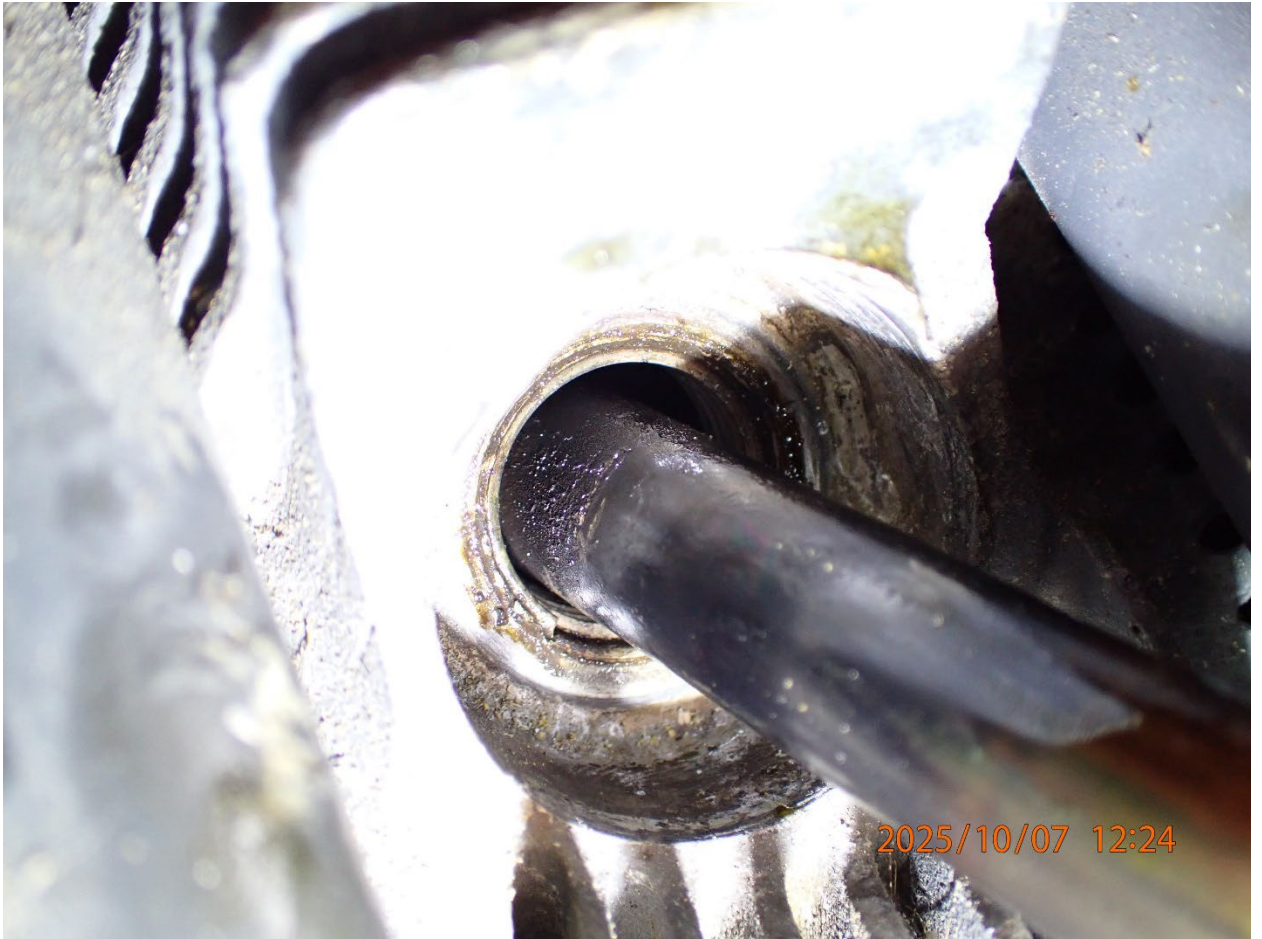
*Photo 6: View of the No. 5 exhaust valve stem.*

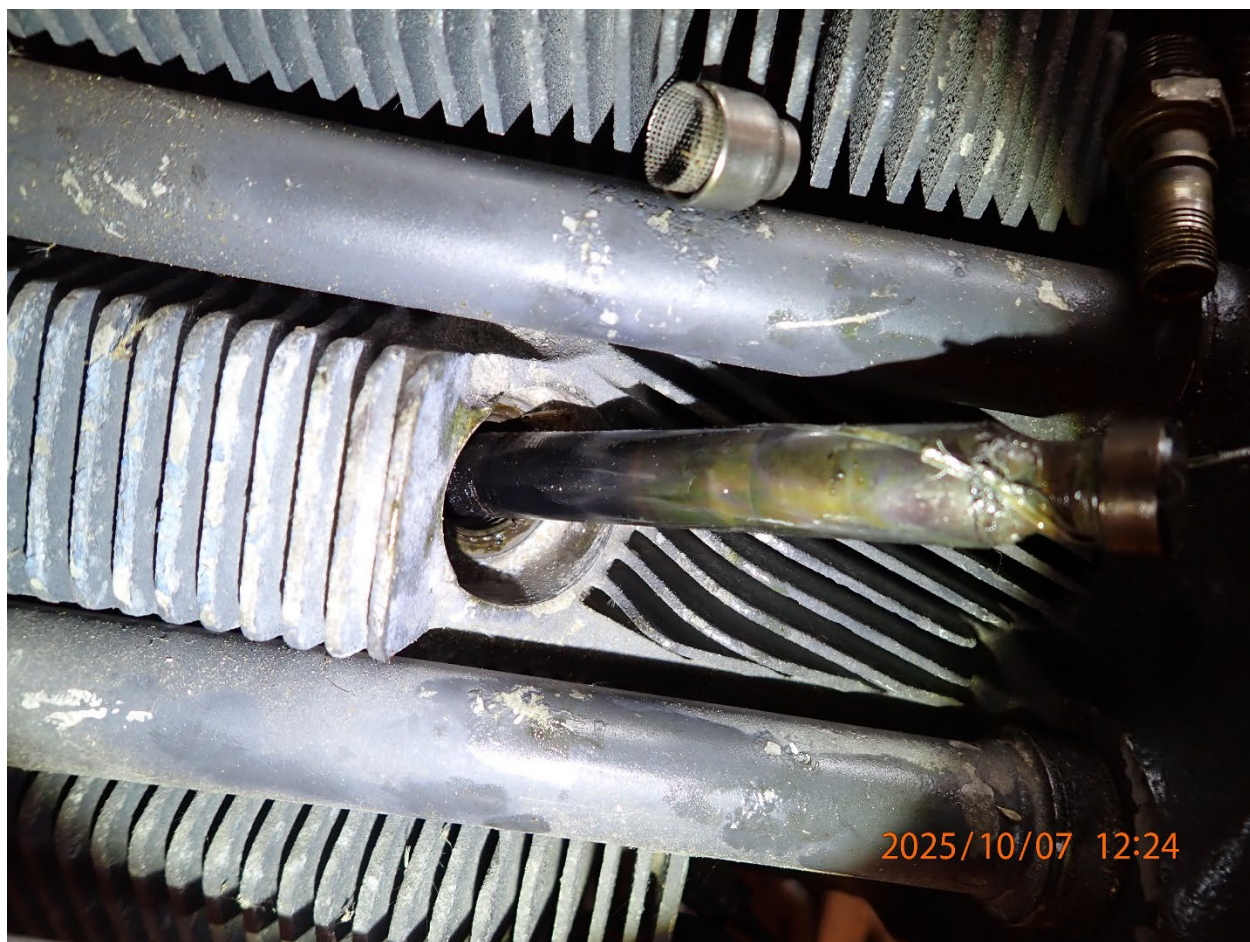
*Photo 7: View of the No. 5 exhaust valve stem.*

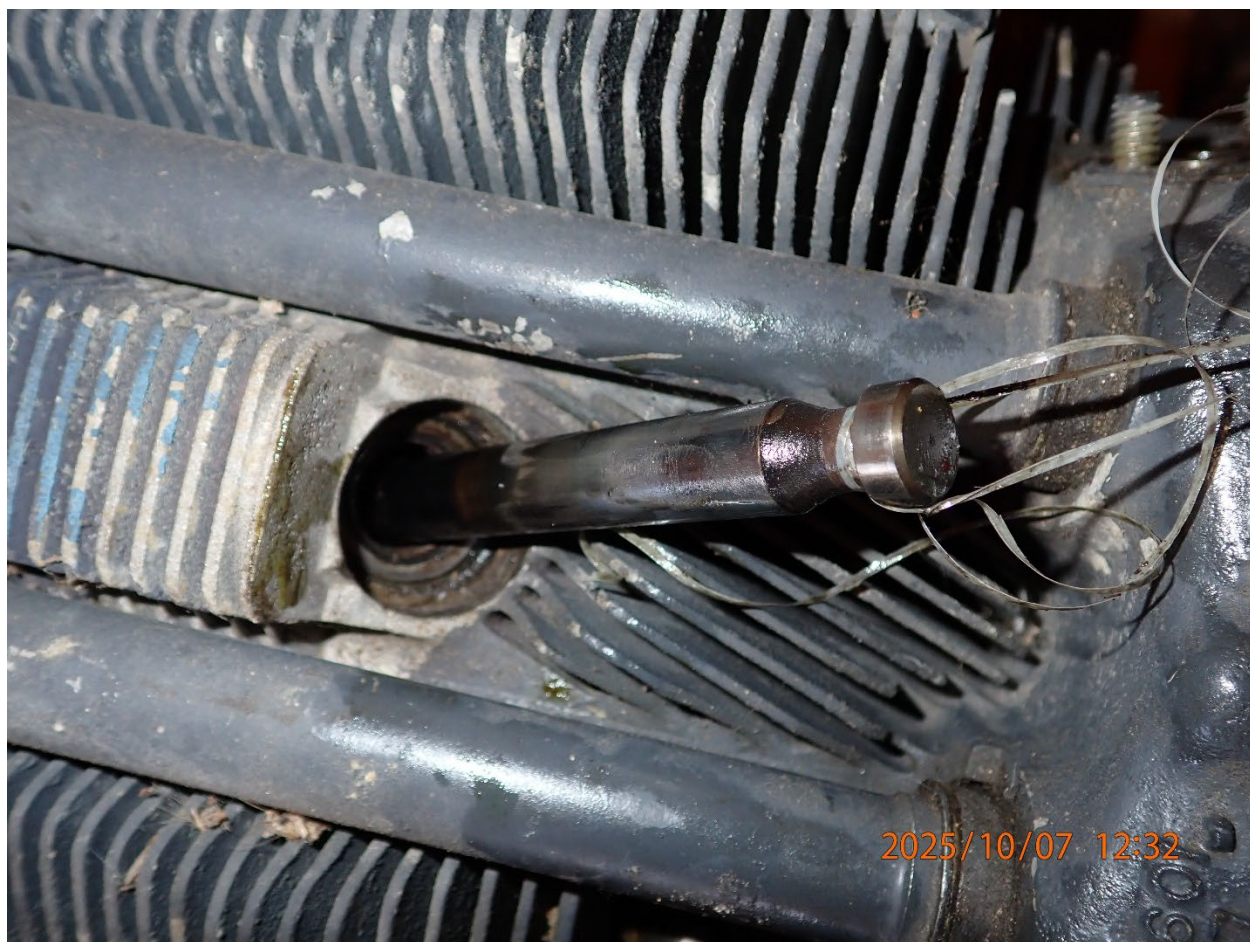
*Photo 8: View of the No. 6 exhaust valve stem.*

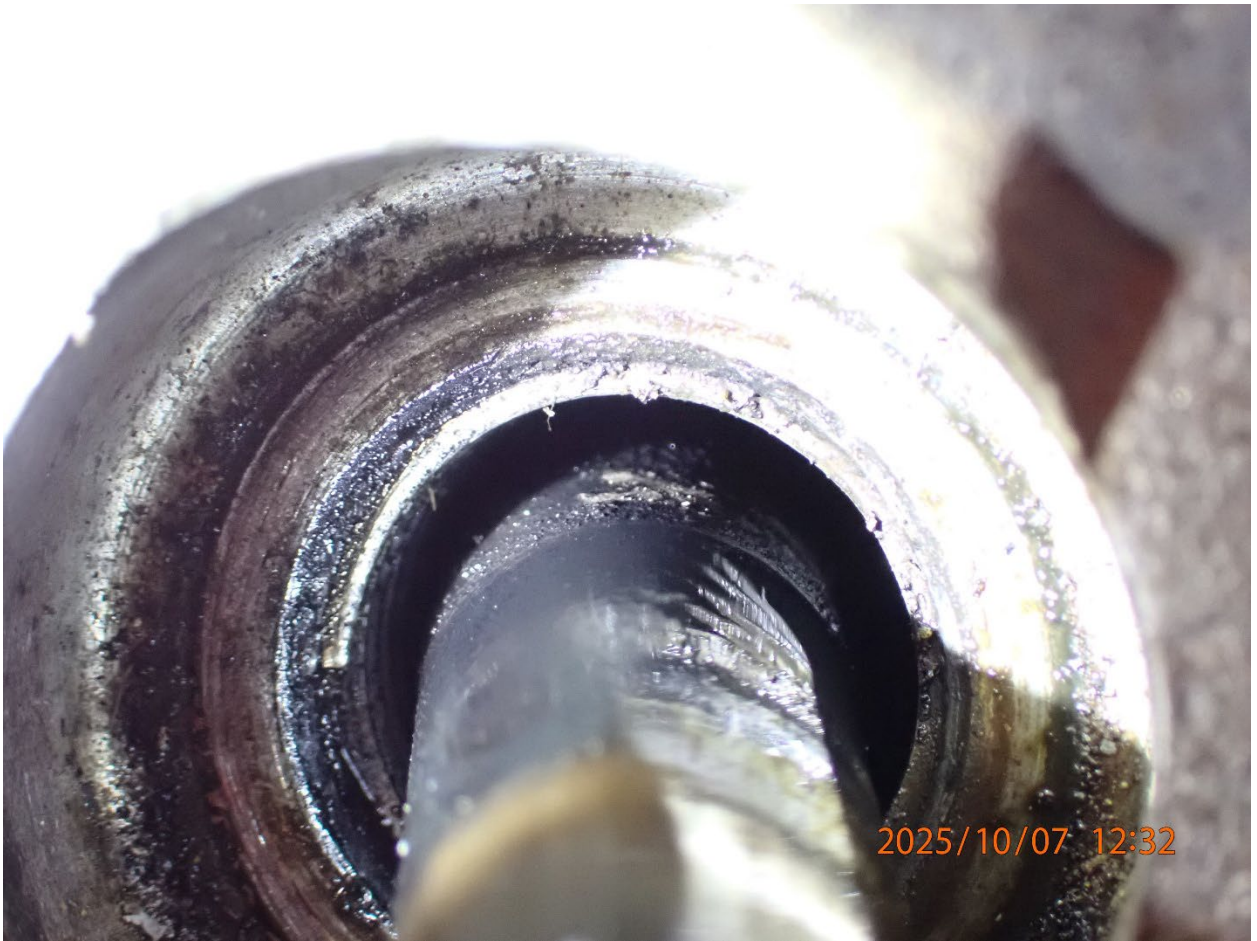
*Photo 9: View of the No. 6 exhaust valve stem.*

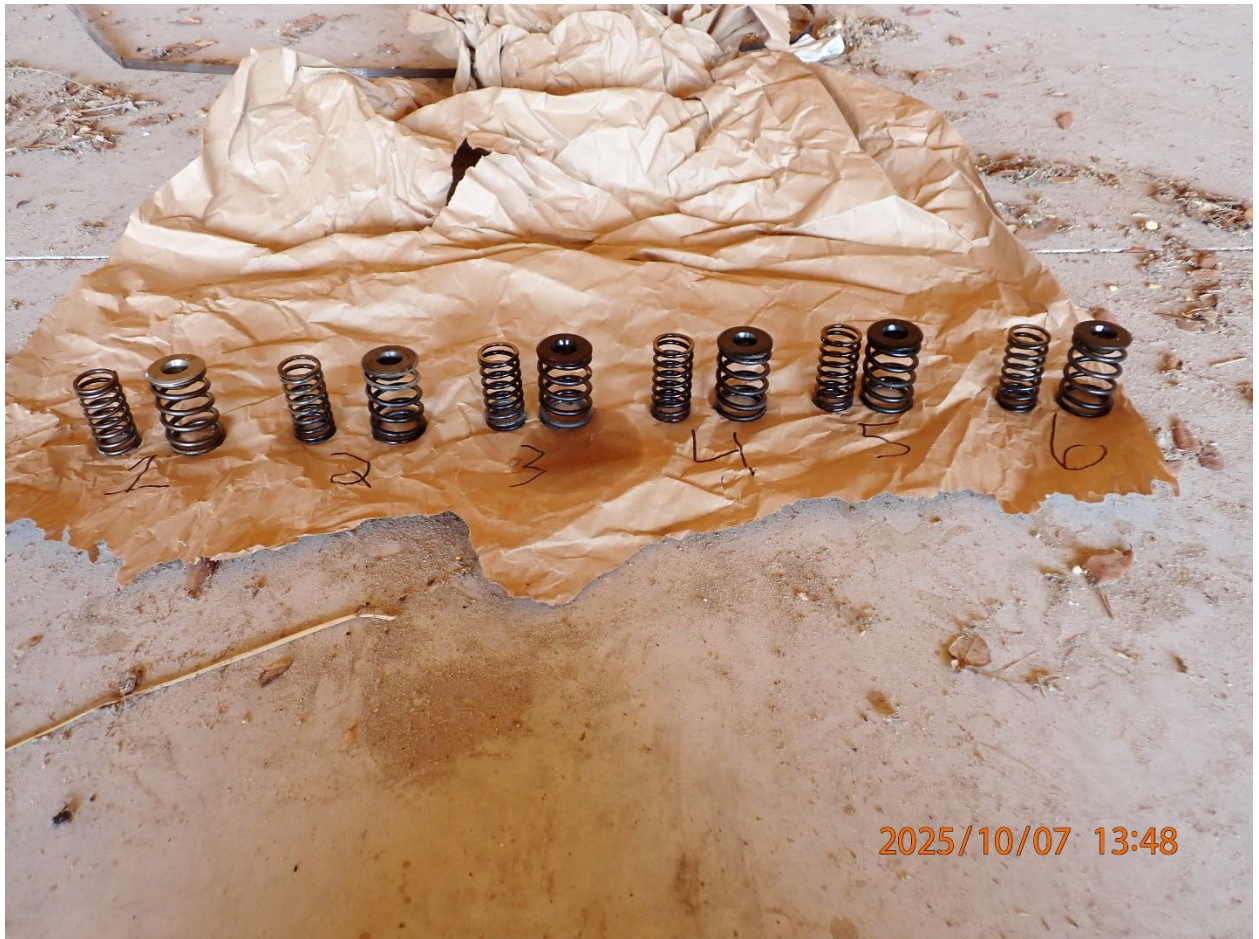
The rocker arms were removed from all cylinders, and the exhaust valve rotating caps were in place. Using compressed air, the exhaust valve keepers were removed, and the exhaust valve springs were also removed. The exhaust valve springs were dark in color and were intact on all cylinders. The exhaust valves were pushed into their respective cylinder heads and pulled through a spark plug hole on cylinder 1, 2, 5, and 6. The exhaust valves for cylinders 3 and 4 were not fished through the spark plug holes due to limited rotation of the crankshaft from the already removed exhaust valves, which were impeding

*Photo 10: View of the exhaust valve springs.*
