# National Transportation Safety Board

ERA24LA223

## **CONSTANT SPEED UNIT EXAMINATION AND TESTING SUMMARY**

Location: Lehigh Acres, Florida  
Date: May 20, 2024  
Time: 1008 EDT  
1408 Coordinated Universal Time (UTC)  
Airplane: N762MC, Beechcraft TC-12B

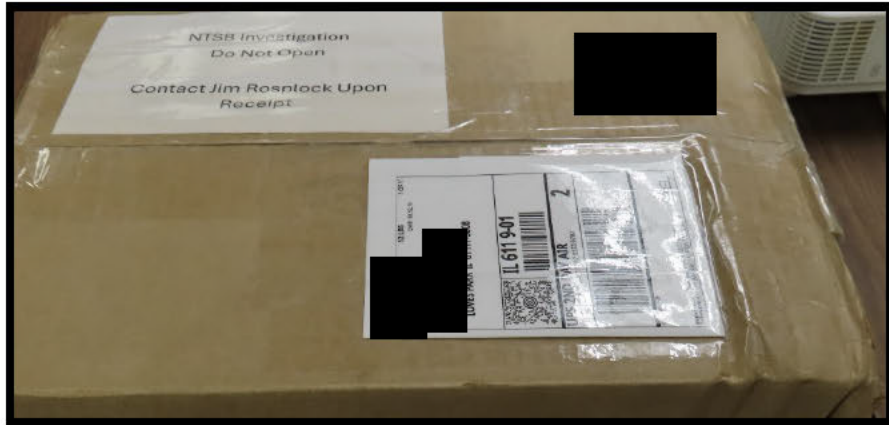
**Figure 1: View of Unopened Box**

At the start of the Virtual Examination on October 2, 2024, at 0900 EDT, the box was presented unopened (Figure 1). It was noted that one end of the box was damaged but there was no tear in the box. The box was opened, and the units were removed from their respective plastic zip top bags and individually visually inspected and then operationally tested.

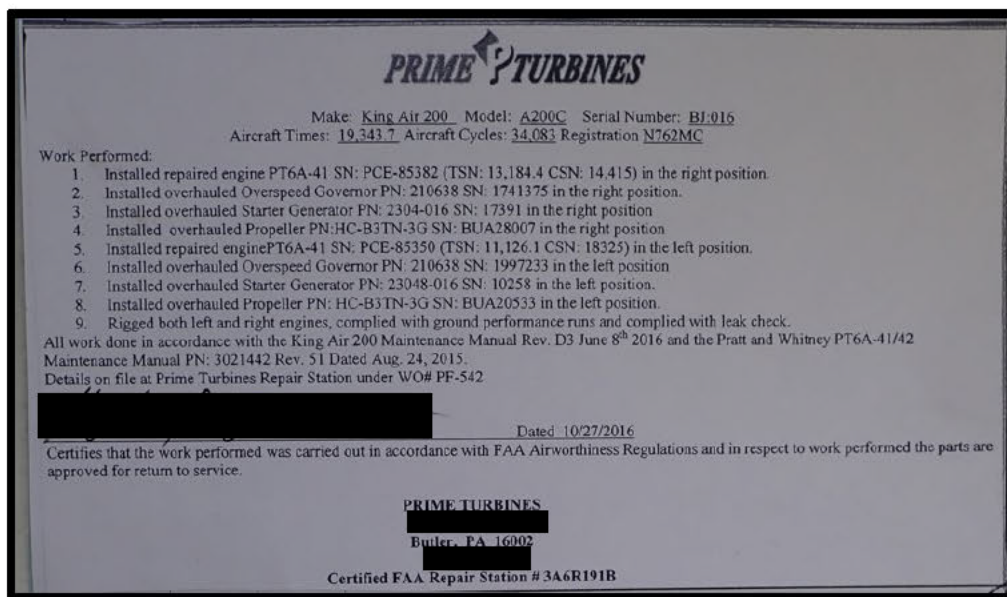
**Figure 4: Airframe Logbook Entry.**

The airframe maintenance record entry for October 27, 2016 specified that the airplane total time and aircraft cycles were 19,343.7 and 34,083, respectively (Figure 4).

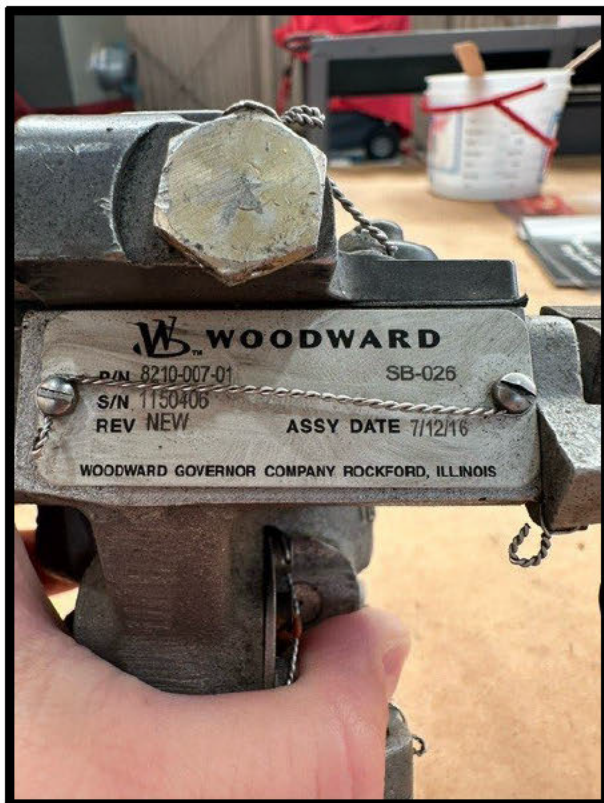
**Figure 5: Right Constant Speed Unit Data Plate.**

Although FAA Form 8130-3 was not provided, the right CSU dataplate was marked with an Assembly Date of July 12, 2016 (Figure 5) at Revision "New"<sup>6</sup>. An entry in the engine maintenance records specified that CSU SN 1150406 which had 0.0 hours since overhaul was installed on August 30, 2016 (Figure 6).

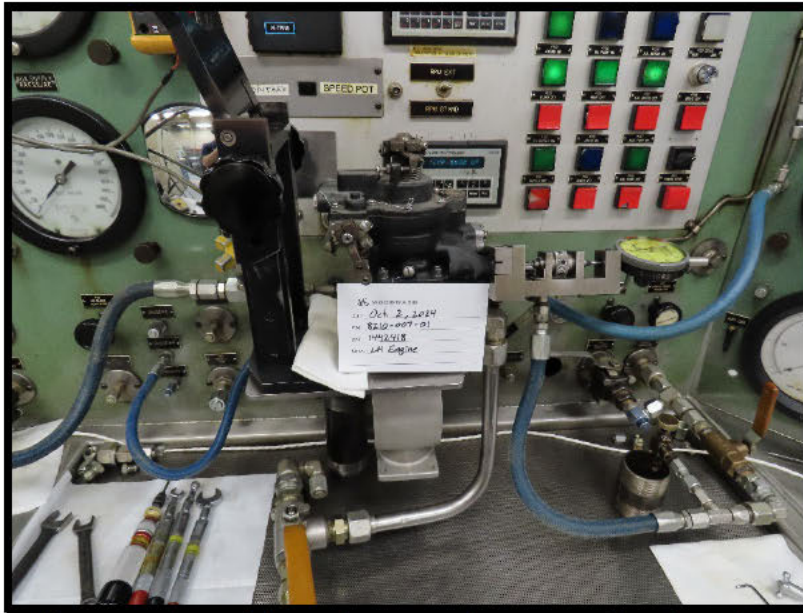
**Figure 7: View of the Left CSU During Operational Testing.**

Visual inspection of the left CSU revealed no cover on the mounting base plate. A customer fitting was noted in the Py port. A lockwire seal likely associated with overhaul was not theirs. Also noted was no torque sealant on the maximum speed lever and at the air bleed set screw. Non Woodward lockwire was present at the Beta valve, pressurizing valve, cover, and maximum speed adjustment screw. Surface corrosion was noted on the pressurizing valve cap and on the air bleed lever, the later of which did not return on its own to the set screw position, and appeared to be less than ¼ inch away, although this was not measured. The maximum speed lever did return normally to the maximum stop after release. The lockwire at the eccentric screw and nameplate appeared a smaller diameter than what Woodward, Inc., uses on OEM builds. The drive shaft was noted to rotate freely and the Beta valve was fully extended (normal). The Beta valve was exercised by hand and moved normally.

Although noted during visual examination that the air bleed lever did not return normally to the set screw position, it did return to that position during operational testing. The unit passed all tests except the maximum speed setting, feather stop, pneumatic control valve for overspeed, underspeed reset setting, and control arm angle at maximum rpm setting. The maximum speed setting was 65 governor rpm higher than the highest allowed value, which equates to about 34 propeller rpm. The underspeed reset setting was 1 psid below the set point value at 3,620 governor rpm with the governor in an underspeed condition. The out of specification values were consistent with typical field adjustments. Adjustments to the propeller governor were performed and the unit was again operationally tested. All values were then within limits with the exception of the control lever angle at max speed and on the feather stop. This could be further adjusted by moving the control lever relative to the splined shaft if desired, however, this was not performed and did not affect overall CSU performance. Disassembly examination of the CSU was not performed. There was nothing mechanically wrong with the CSU that precluded going into Beta range if commanded while in an underspeed condition.

Comparing in part the maximum set rpm values for the left and right CSU revealed both were above the maximum specified limit for production testing, and the value for the right was 19 rpm greater than the value for the left<sup>7</sup>.

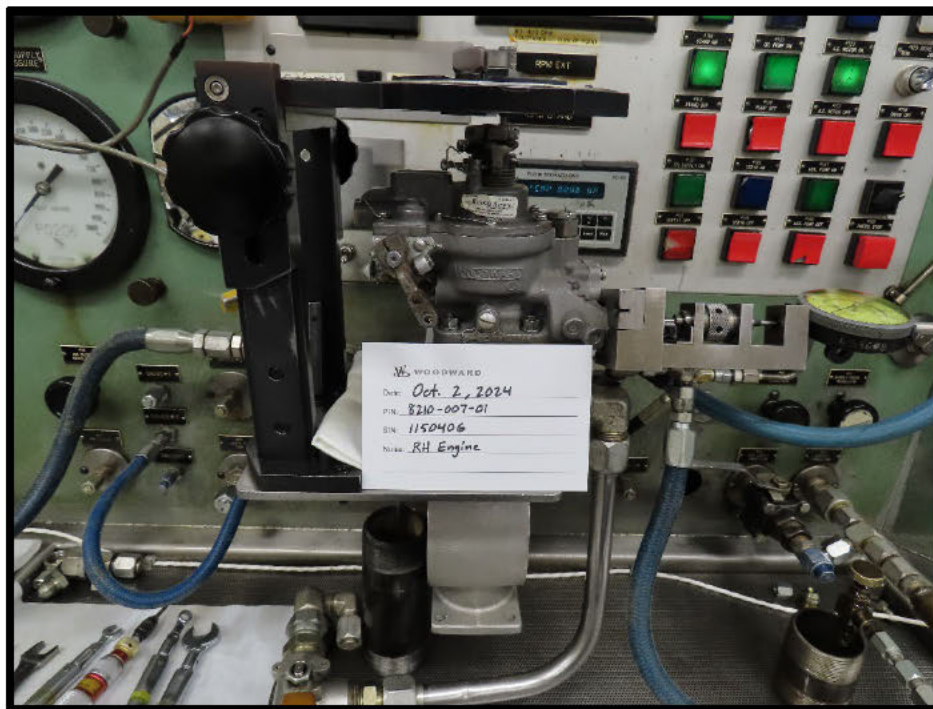
**Figure 8: View of the Right CSU During Operational Testing.**

Visual inspection of the right CSU revealed no cover on the mounting base plate. A customer fitting was noted in the Py port. A lockwire seal likely associated with overhaul was not theirs. A lockwire was missing at the maximum speed lever securing screw. Non Woodward lockwire was present at the Beta valve, pressurizing valve, cover, and maximum speed adjustment screw. Surface corrosion was noted on the air bleed lever and maximum speed lever. The air bleed and maximum speed levers returned to their normal position after release. The drive shaft was noted to rotate freely, and the Beta valve was fully extended (normal). The Beta valve was exercised by hand and moved normally.

The unit passed all tests except maximum speed setting, feather stop, pneumatic control valve overspeed setting, feather stop, underspeed reset setting, and control arm angle at maximum rpm setting. The maximum speed setting was 84 governor rpm higher than the highest allowed value, which equates to about 44 propeller rpm. The underspeed reset setting was 2 psid below the set point value at 3,620 governor rpm with the governor in an underspeed condition. The out of specification values were consistent with typical field adjustments. Adjustments to the propeller governor were performed and the unit was again operationally tested. All values were then within limits with the exception of the feather stop. Disassembly examination of the CSU was not performed. There was nothing mechanically wrong with the CSU that precluded going into Beta range if commanded while in an underspeed condition.
