# National Transportation Safety Board

ERA24LA223

## WRECKAGE EXAMINATION SUMMARY

Location: Lehigh Acres, Florida  
Date: May 20, 2024  
Time: 1008 EDT  
1408 coordinated universal time (UTC)  
Airplane: N762MC, Beechcraft UC-12B

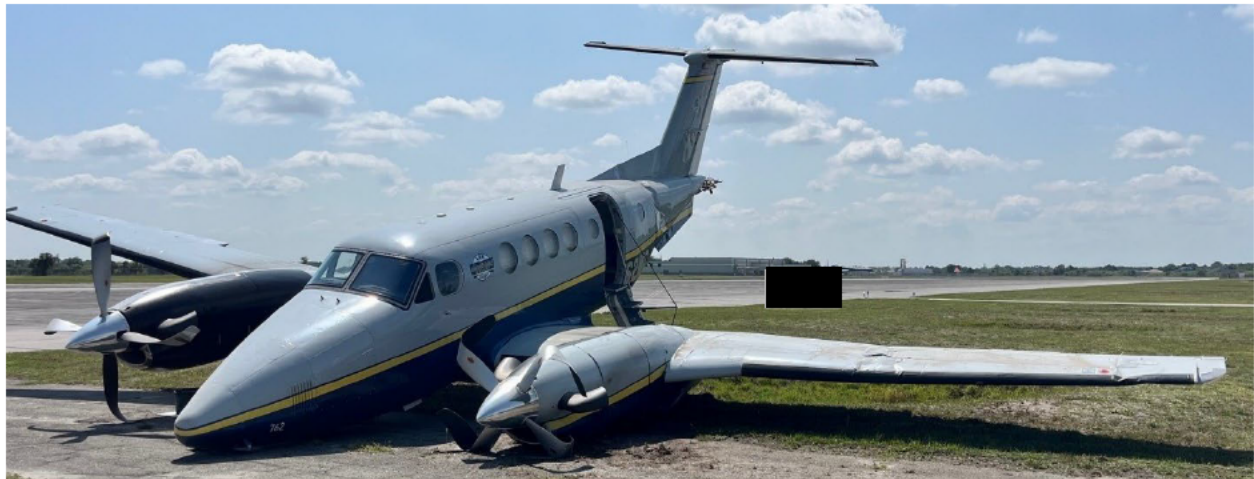
After an uneventful training mission, the flight returned for landing on runway 32 at Buckingham Field Airport (FL59), Lehigh Acres, Florida. The pilot flying (PF) landed the airplane on runway 32 with both power levers at idle, then after touchdown lifted them over the gate into beta and then farther aft into reverse. The airplane veered to the left which neither flightcrew member was able to correct, and the airplane travelled off the left side of the runway into a 5 ft deep depression causing the left main and nose gears to collapse. The airplane came to rest upright (see Figure 1).

**Figure 1 Left Forward Quartering View of the Airplane Where it Came to Rest**

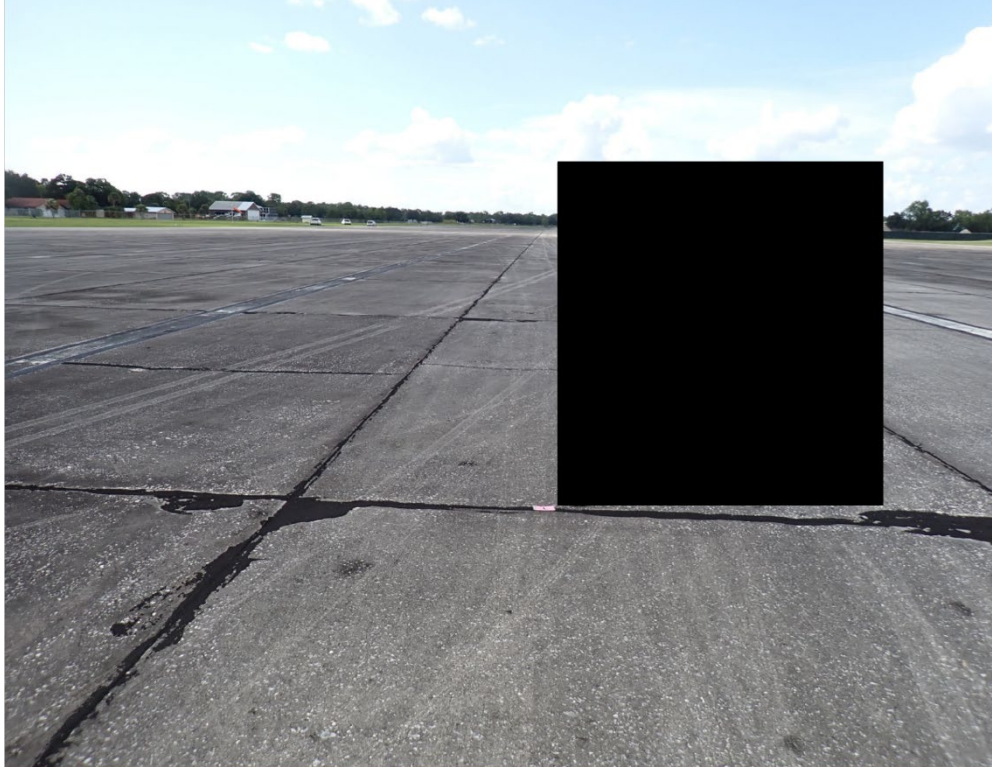
Examination of the runway in the direction of landing (runway 32) revealed tire marks from the left main landing gear were observed first<sup>1</sup> (see Figure 8), while tire marks from the right main landing gear were noted farther along the runway<sup>2</sup>. The tire marks from the left and right gear tires were noted left of runway centerline. Using Google Earth, the tire marks from the left main were noted about 1,716 ft from the approach end of the runway.

**Figure 8 View of Runway in Direction of Landing With Pink Marker on Runway Showing Marks From Left Main Landing Gear Tires**

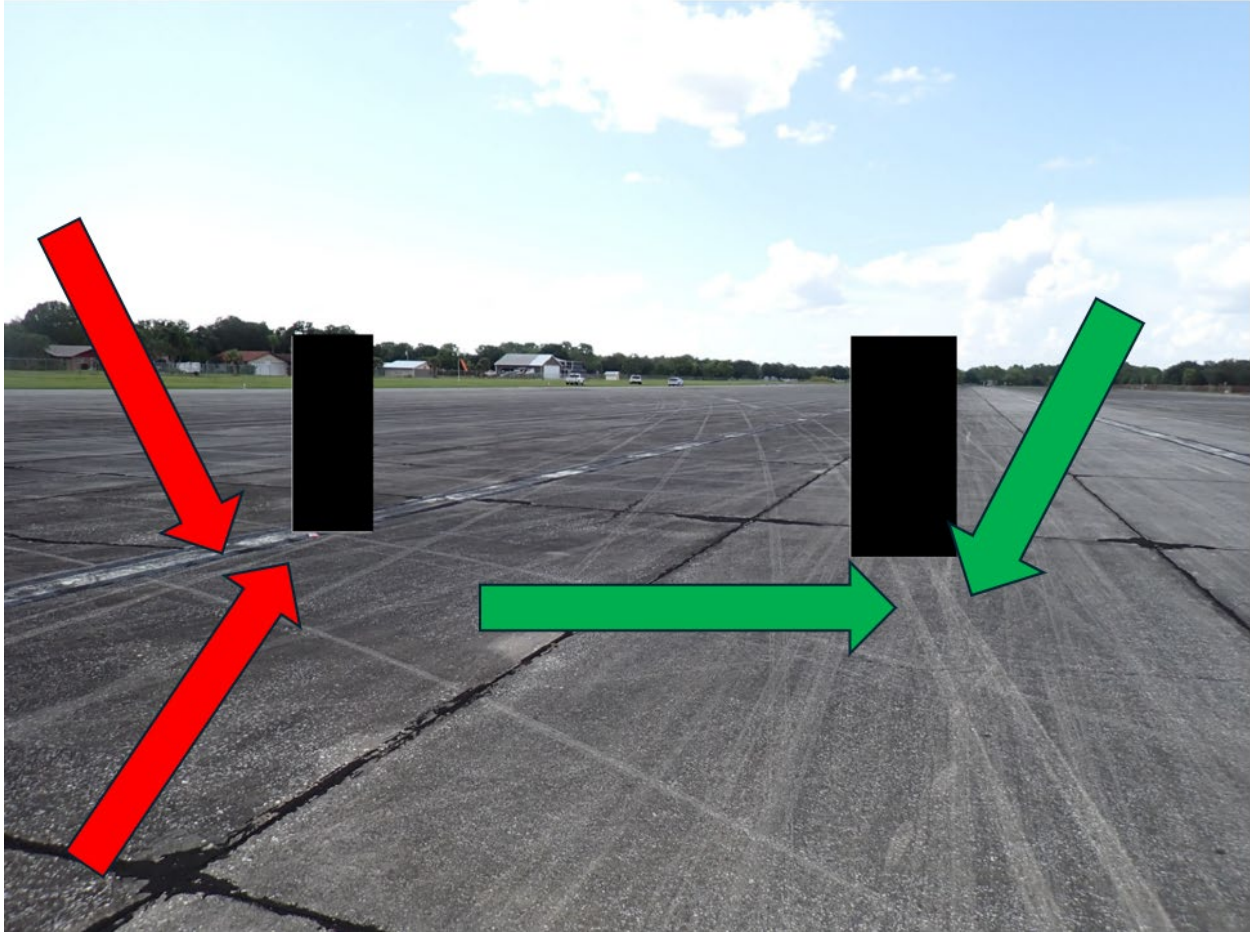
While the tire marks from the right tires were noted about 1,795 ft from the approach end of the runway. The first tire marks show a gentle drift to the left followed by an aggressive veer to the left that began about 1,900 ft from the approach end of the runway (see Figure 9). The airplane came to rest in a fish pond/depression which was about 5 ft deep about 2,450 ft from the approach end of the runway.

**Figure 9 Red Arrows Point to Tire Marks from Left Main Landing Gear While Green Arrows Point to Tire Marks From Right Main Landing Gear**

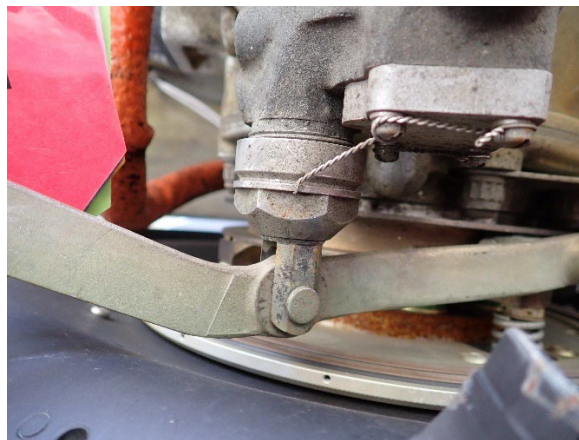
Testing of the left engine Power Lever – Adjustment/Test was performed in accordance with (IAW) the airplane maintenance manual 76-10-03 Revision E2, steps 1 and 2 (Figure 10). While no adjustment was performed, the left Beta Valve was found about 3/32 inch forward of the Beta Valve Cap Nut (Figure 11) but it should have been flush with the Cap nut. No further adjustments or checks were made of the system.

**Figure 11 View of the Tested Position of the Left Beta Valve**

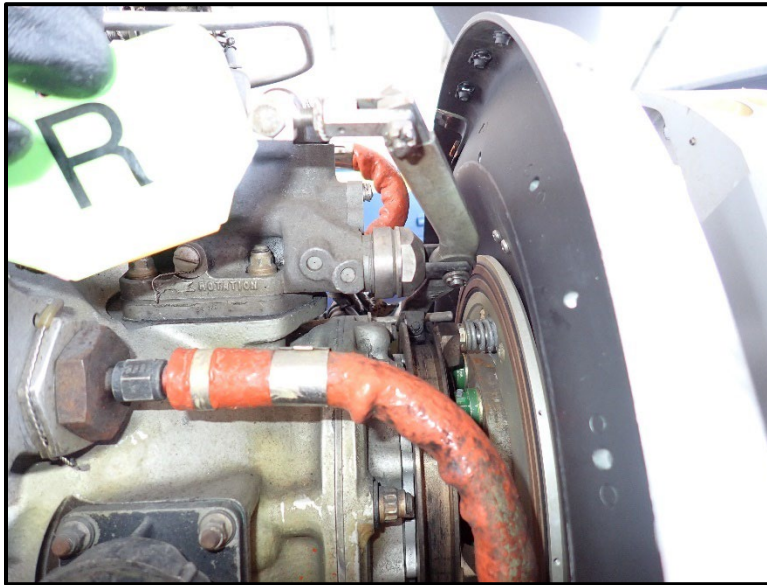
Examination of the right engine revealed the Beta ring was in the home position, the carbon block in the guide, the beta lever was under the retention arm (normal), but the Beta valve was positioned slightly below the normal flush point (Figure 12). The air conditioning compressor, the fuel control unit, and the starter generator were fractured from the accessory gearbox but remained attached by

**Figure 12 View of the Right Beta Valve at the Start of the Examination**

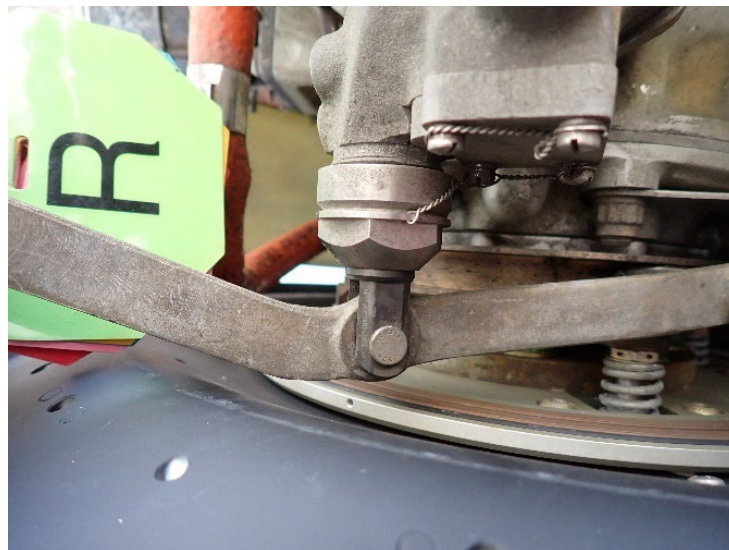
Testing of the right engine Power Lever – Adjustment/Test was performed IAW the airplane maintenance manual 76-10-03 Revision E2, steps 1 and 2 (see Figure 10). While no adjustment was performed, the right Beta Valve was found about 4/32 inch forward of the Beta Valve Cap Nut (see Figure 13), but it should have been flush with the Cap nut. No further adjustments or checks were made of the system.

**Figure 13 View of the Tested Position of the Right Beta Valve**

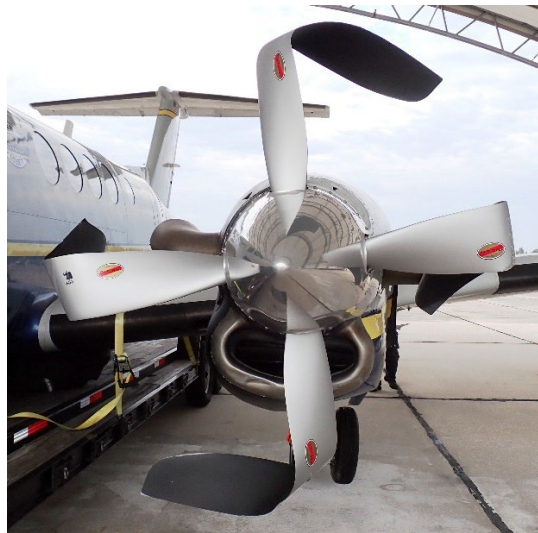
**Figure 14 Left Propeller**

Examination of the left propeller (see Figure 14) revealed all blades exhibited leading edge nicks, were bent aft midblade and also bent opposite direction of rotation, were twisted towards low pitch with chordwise rotational scoring on the cambered side of the blade. The L2 and L4 blades were found rotated beyond the reverse position, indicating internal damage. Blades L1 and L3 were at approximately flight idle/ground idle position. The pitch change rod was displaced forward 1.87 inches from the feather stop. The low pitch stop sleeves were displaced 0.26 inches forward of the home position. There was no evidence of preimpact failure or malfunction of the left propeller.

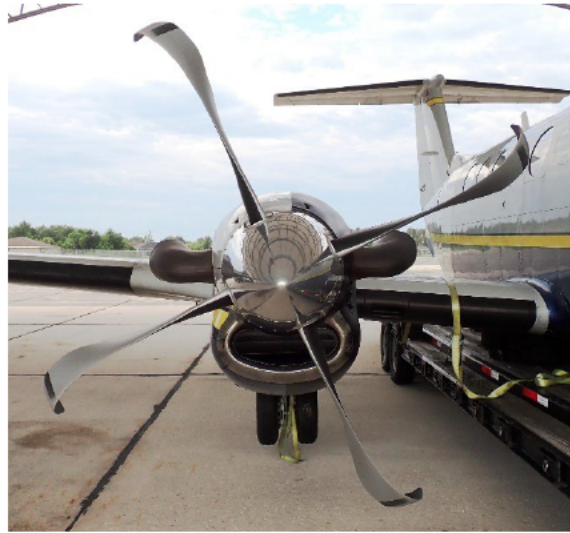
**Figure 15 Right Propeller**

Examination of the right propeller (see Figure 15) revealed all four blades appeared to be in the feathered position and exhibited leading edge nicks. All blades were bent aft and also bent opposite the direction of rotation in the outboard 1/3 of the blade. All blades were twisted towards low pitch and exhibited rotation chordwise scoring on the cambered side of the blade. The

pitch change rod was displaced 0.11 inch forward of the feather stop. There was no evidence of preimpact failure or malfunction of the right propeller.

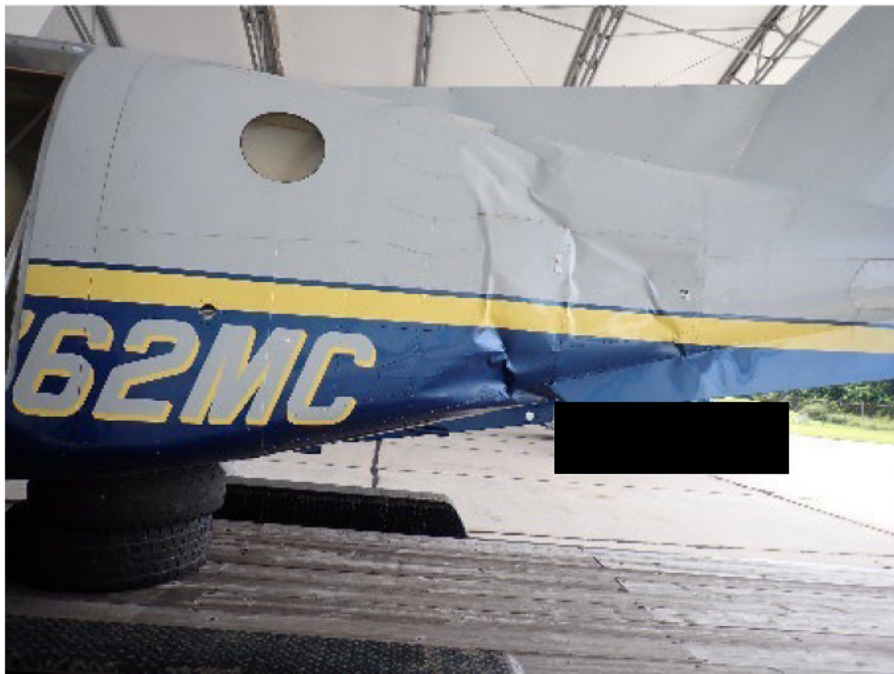
Examination of the fuselage revealed the left aft portion exhibited compression buckling at fuselage station 348 (see Figure 16).

**Figure 16 Fuselage Damage**

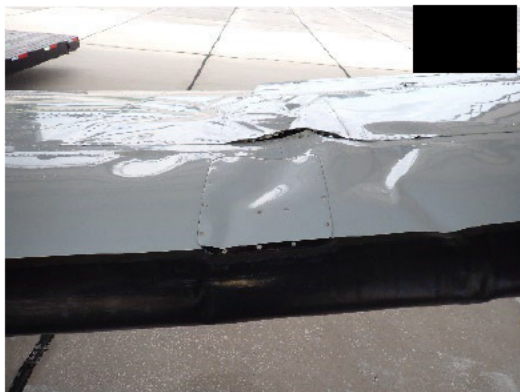
The left wing exhibited compression buckling on the upper wing skin at wing station (WS) 195 (see Figure 17) and also just outboard of the wing fuel filler cap at WS 306 (see Figure 18).

**Figure 17 Left Wing Damage**

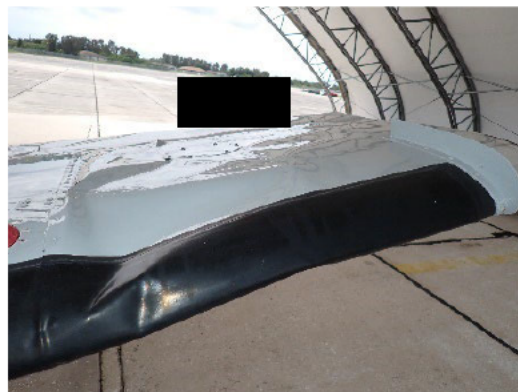
**Figure 18 Left Wing Damage**

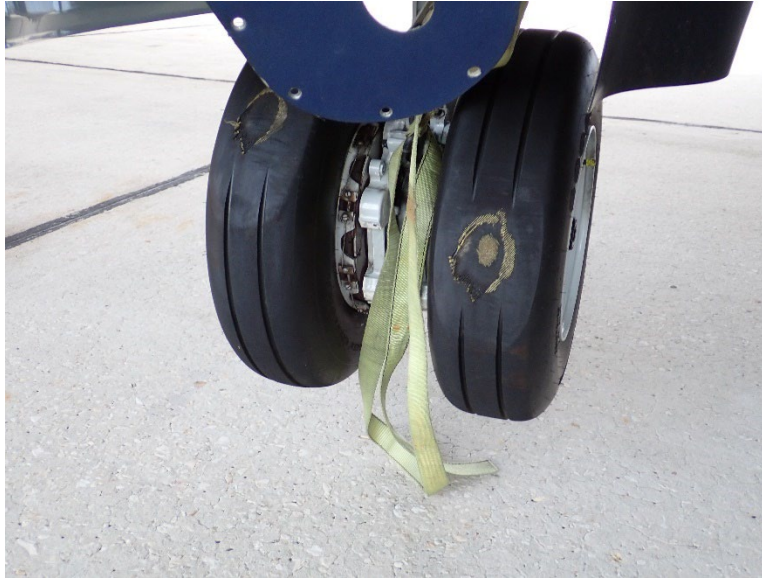
Examination of the right main landing gear revealed that the drag brace was cut. Both tires exhibited flat spots consistent with sliding (see Figure 19). The inboard tire had 0 psi air pressure while the outboard tire was at 46 psi.

**Figure 19 Right Main Landing Gear Tires**

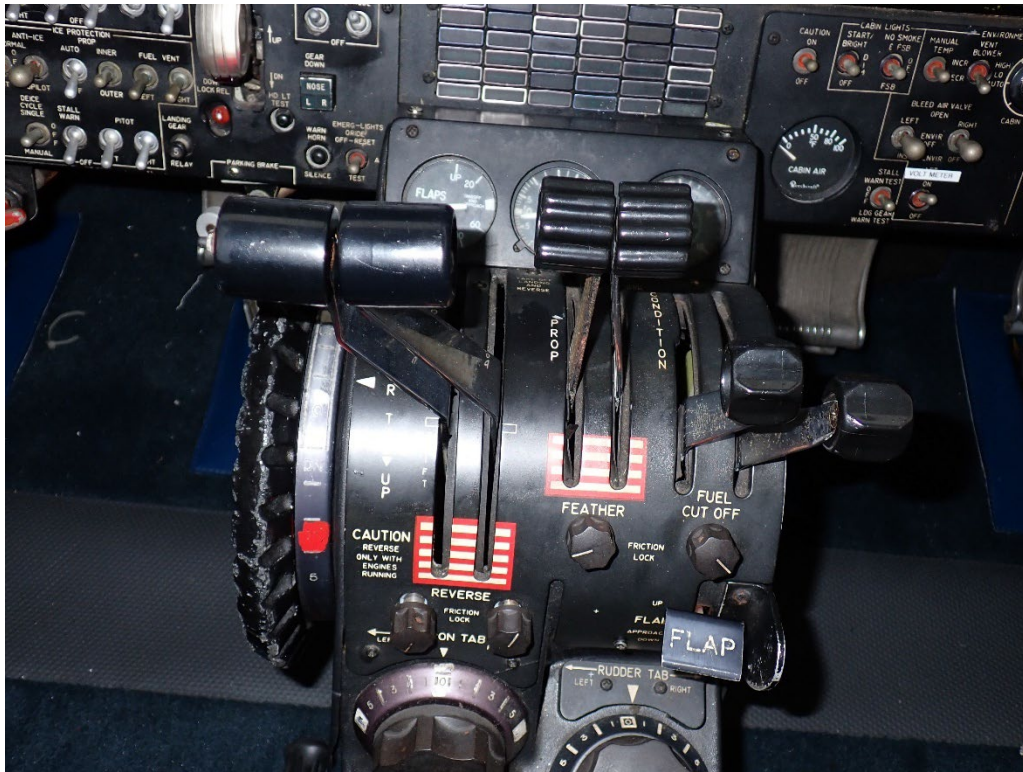
**Figure 20 View of the Throttle Quadrant**

**Pedestal** (see Figure 20) –

Left Power Lever- Flight Idle

Right Power Lever - Flight Idle

Left Propeller Lever - 1 inch forward of Feather

Right Propeller Lever - 1 inch forward of feather

Left Condition Lever - Past Low Idle Detent

Right Condition Lever - Past Low Idle
