**Investigation Report**

**VSE MFG010.R0****DETAILS OF REQUEST**

| <b>NTSB Investigation Number</b> | ERA24LA223 |
| <b>Unit Type</b> | Fuel Control Unit |

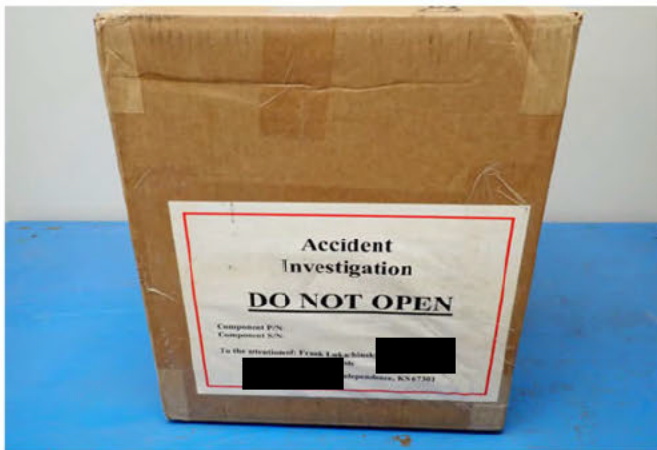
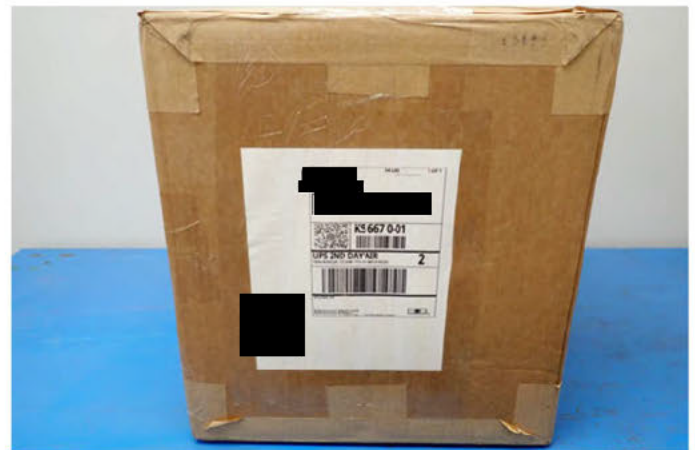
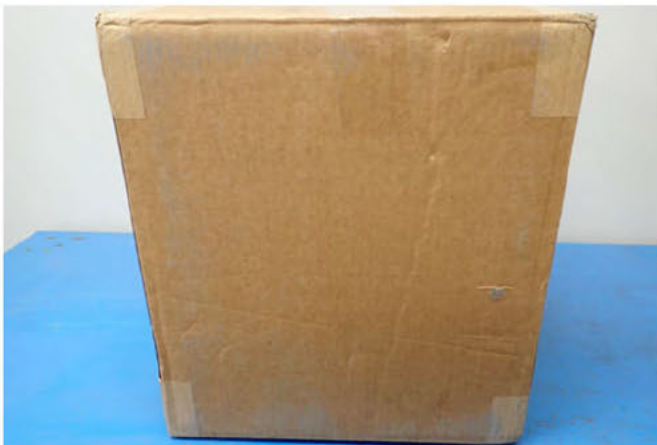
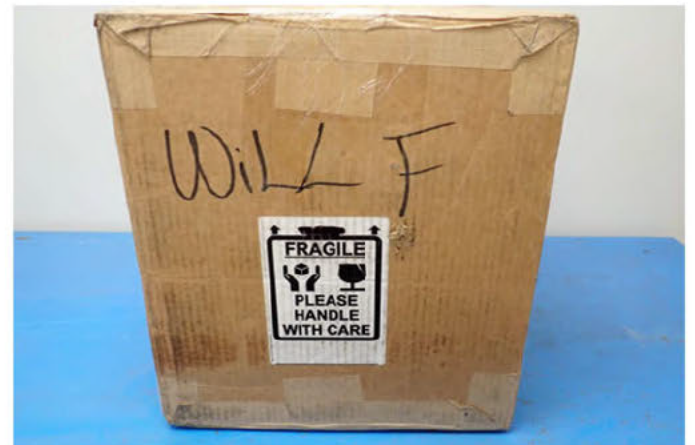
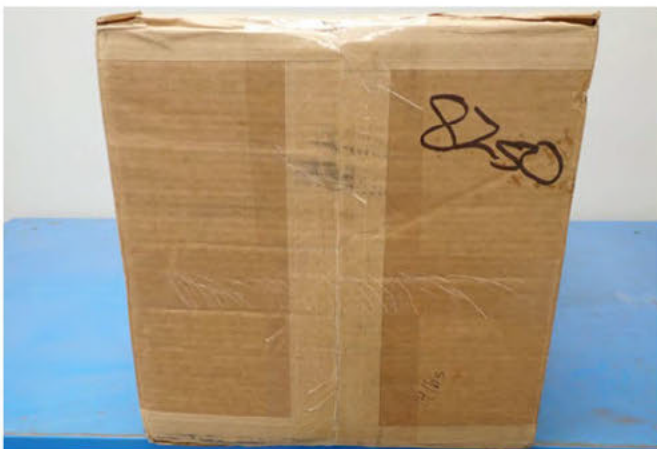
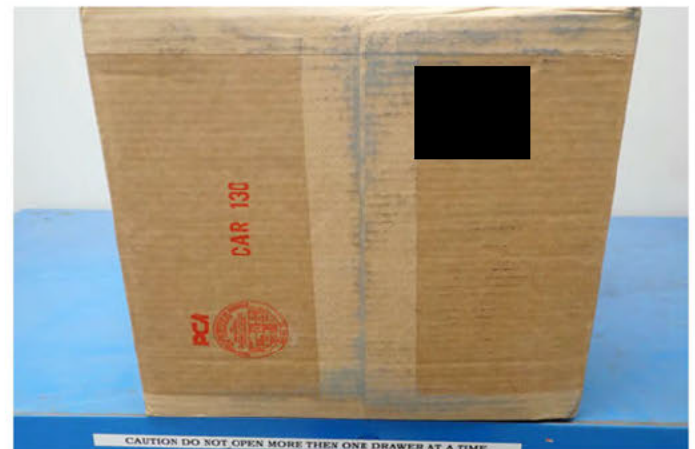
1. Boxed unit was removed from secure cabinet and visually inspected for damage to box prior to opening. No damage noted. Reference Images 1A, 1B, 1C, 1D, 1E, 1F.

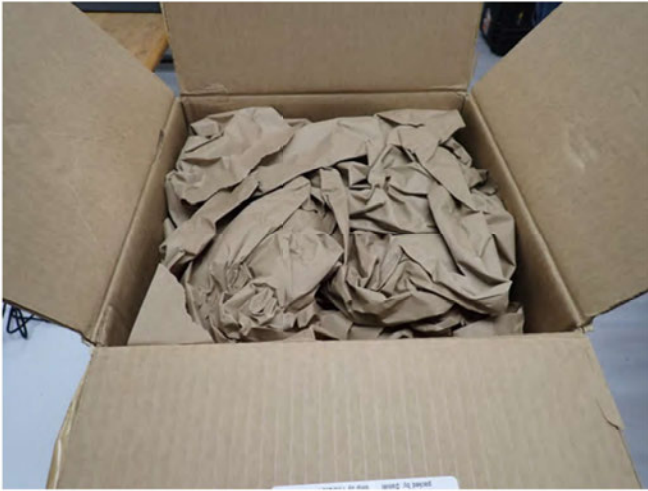
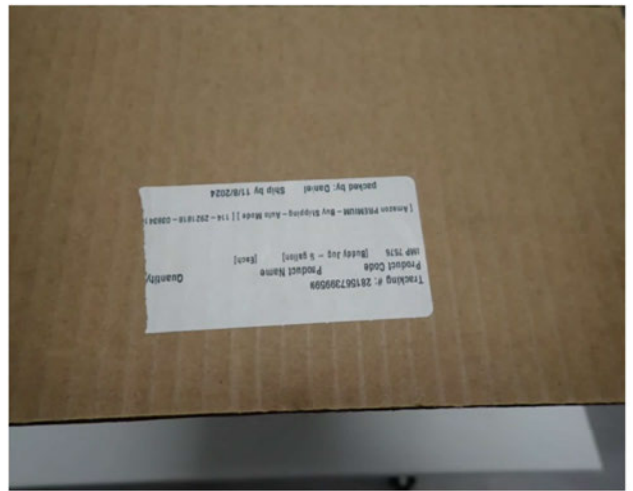
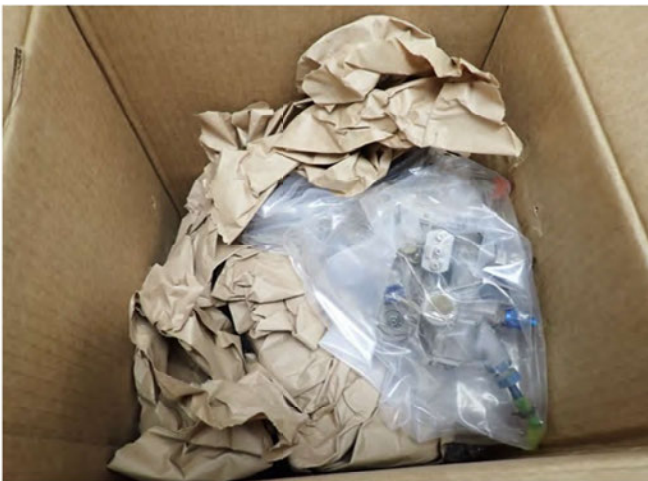
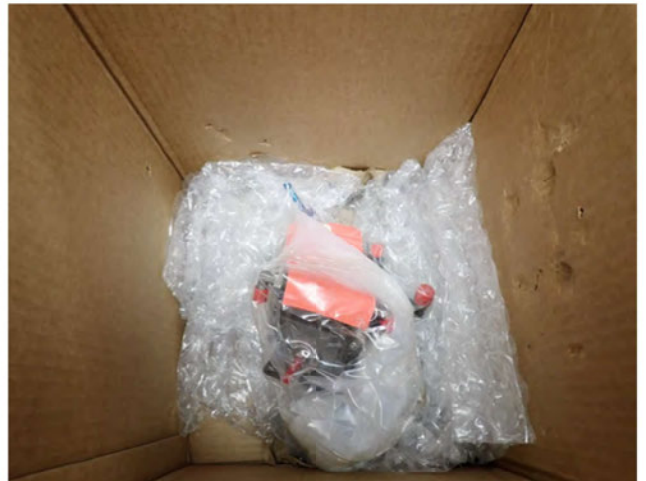
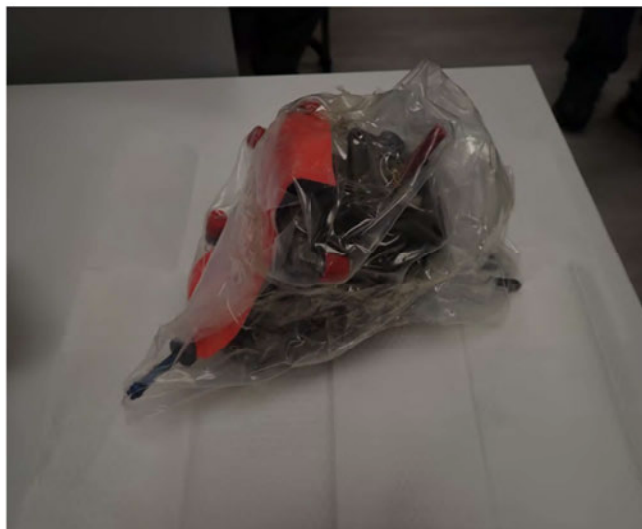
2. Box was opened, packaging material removed. Unit was observed to be in a plastic bag. Reference Images 2A, 2B, 2C, 2D, 2E.
3. Unit was removed from the bag, photographed, Receiving Inspection was performed to include inducing the unit and acquiring pictures of the outside surfaces. Protective caps present on Air/Fuel fittings. No protective cap on drain fitting. Drive Coupling was present on the drive shaft, no damage noted. A Lee County Mosquito Control District Unserviceable Tag was wired to the unit. Data Plate present. Reference Images 3A, 3B, 3C, 3D, 3E, 3F, 3G, 3H, 3I, 3J, 3K, 3L.

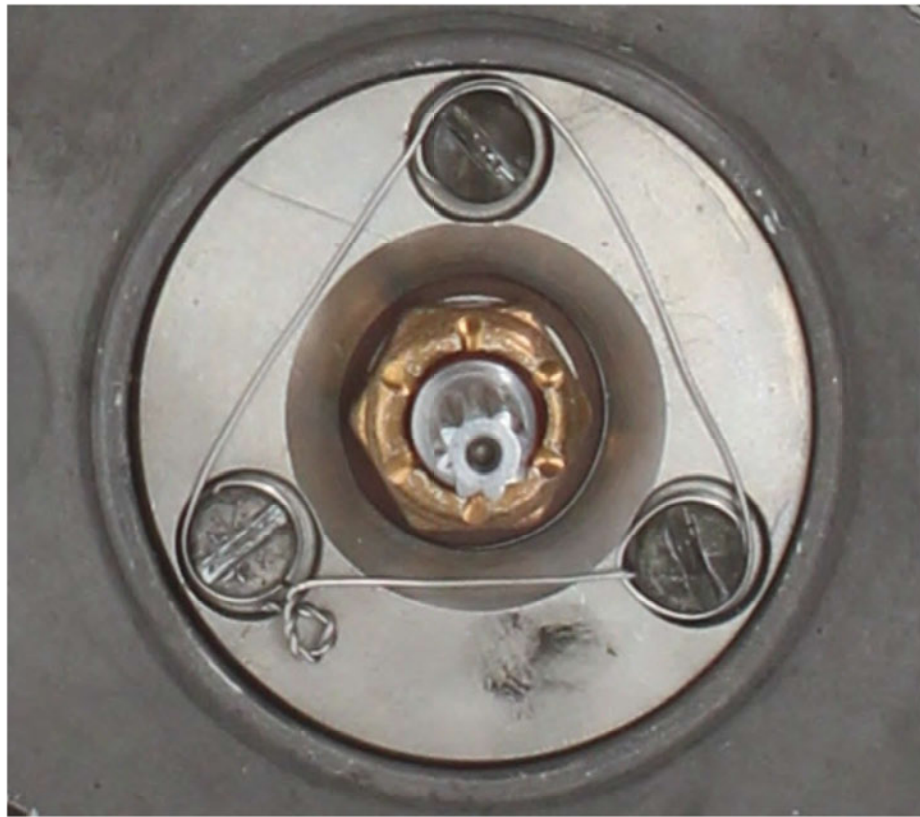
Image 4A

4. The following were observed prior to unit tested.
  - A. The drive shaft moved freely (no binding) with no visible damage. Reference Image 4A.
  - B. The Idle Speed Stop Adjustment Screw and Throttle Link appear to be Field Adjusted. Reference Image 4B.

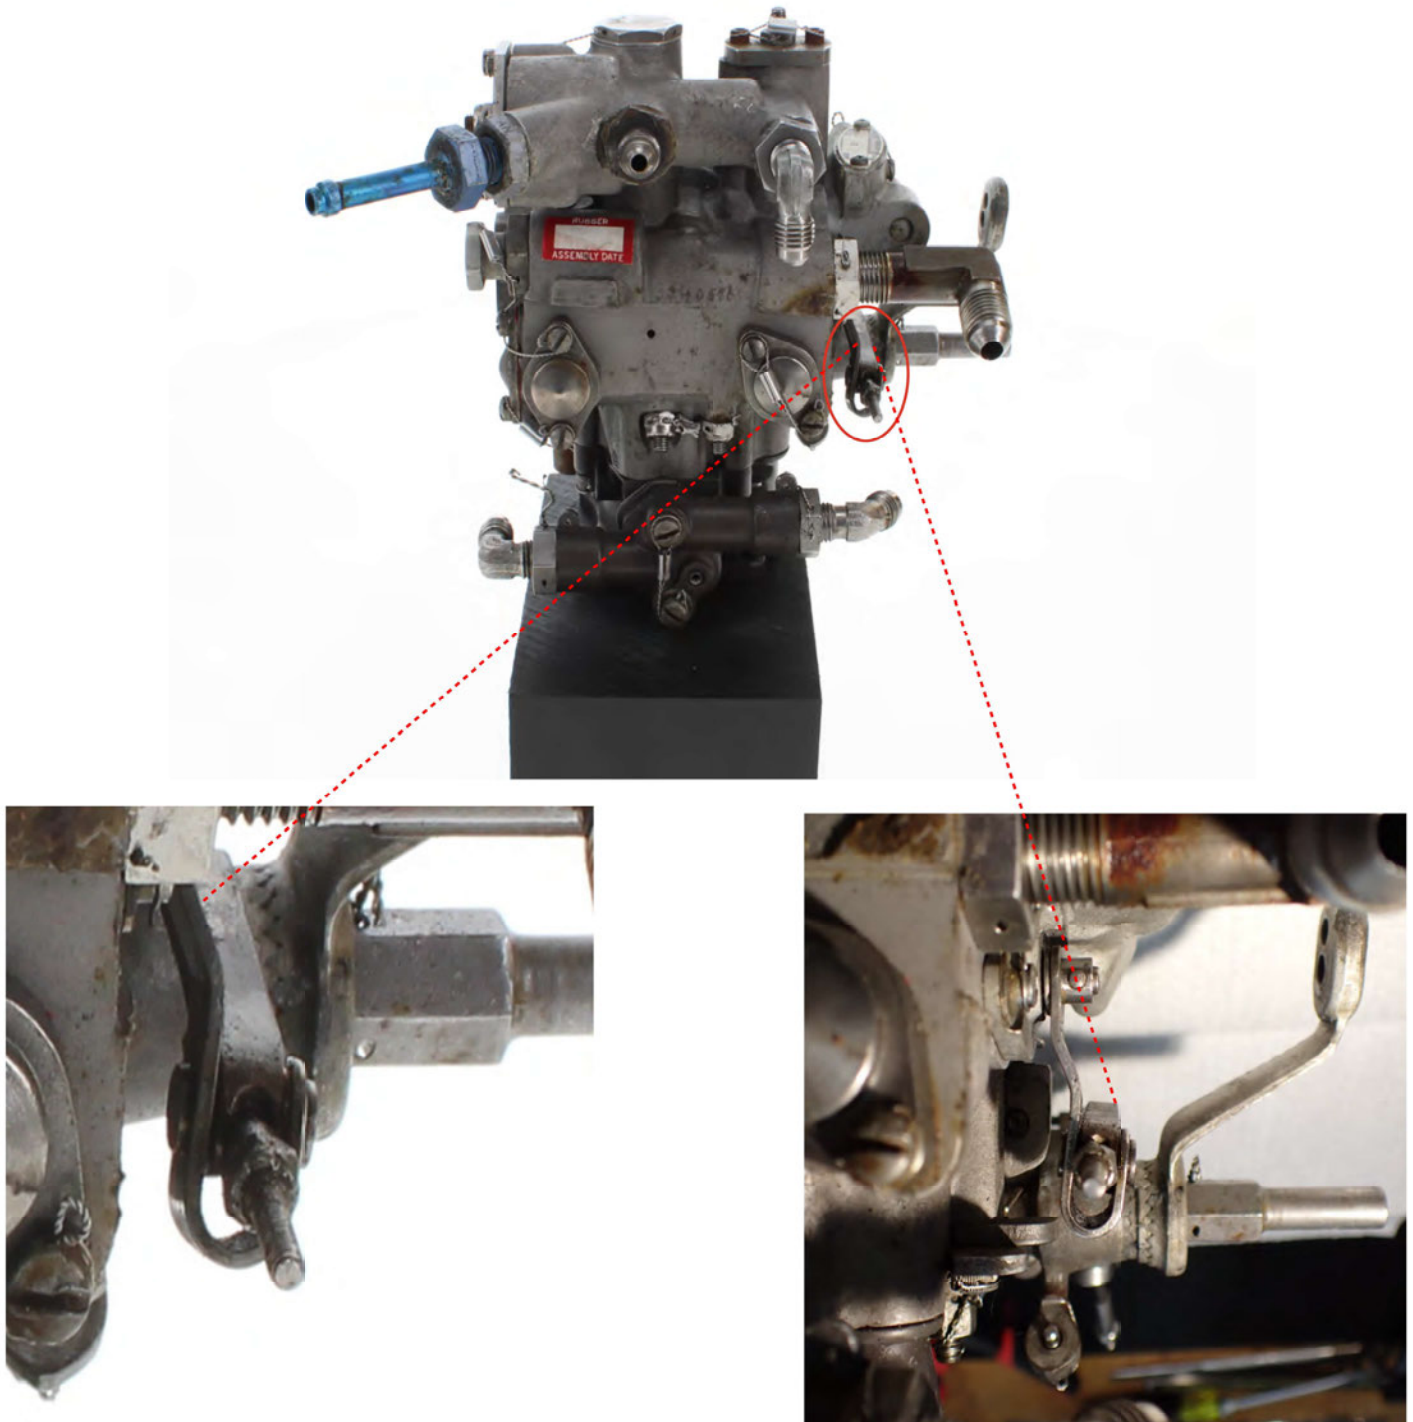
**Image 4C**

- C. Visually inspected fuel and air fittings, found to be clear, no debris.
  - D. Cut-off lever/shaft appears bent. Reference Image 4C.
  - E. Removed ratio lever covers. Visually inspected for contamination/debris, no contamination/debris present. Retained fluid sample from fuel section. Reference Images 5A, 5B.

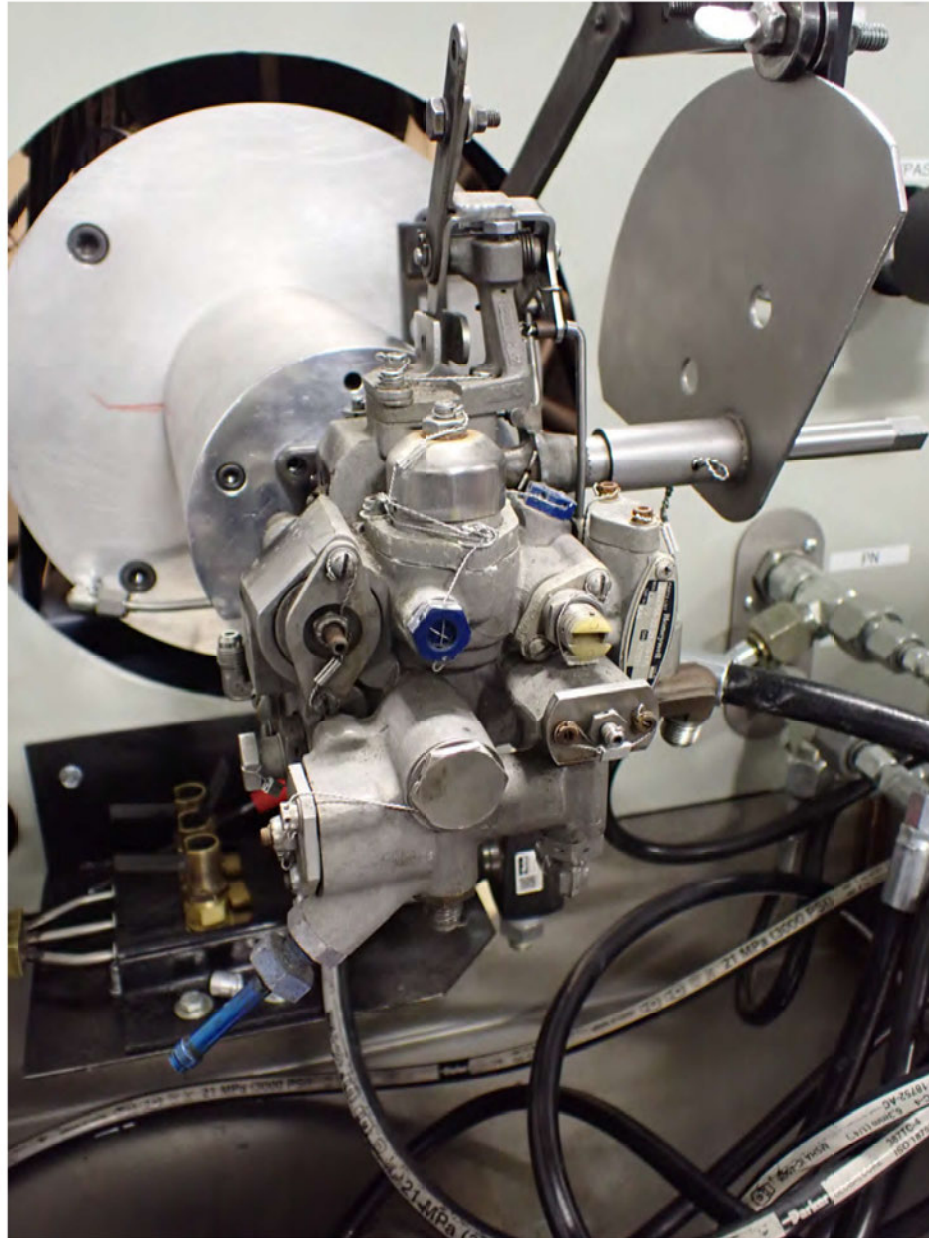
**Image 6A**

Unit was tested on Test Stand VSETS-009 (Independence, Kansas).  
Configured stand and unit IAW Test Specification AETS 14275. Reference Image 6A.  
Performed an Air Leak test, no leaks were observed.  
Test Point 1.02 Pressurizing Valve Opening measured at 50 PSI.  
Test Point 3.01 Nozzle Flow, PPH measured at 460 PPH.  
Test Point 4.01 Nozzle Flow, PPH measured at 181 PPH.  
Test Point 5.02 Nozzle Flow, PPH measured at 134 PPH.  
Test Point 6.01 Nozzle Flow, PPH measured at 322 PPH.  
Test Point 7.02 Fuel Cut-Off 7 degrees delayed.  
Remaining Test Points within limits.
6. Unit removed from test bench.

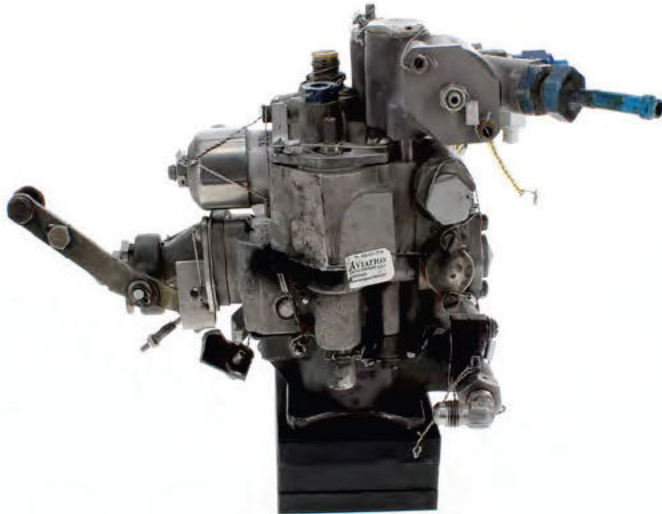
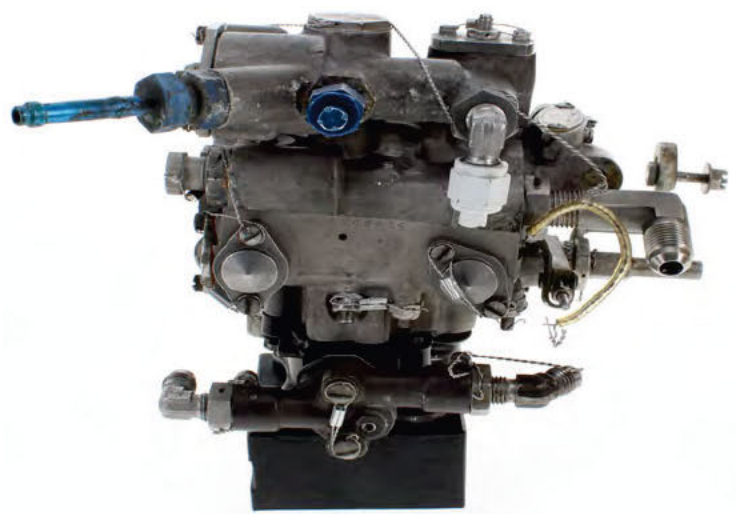
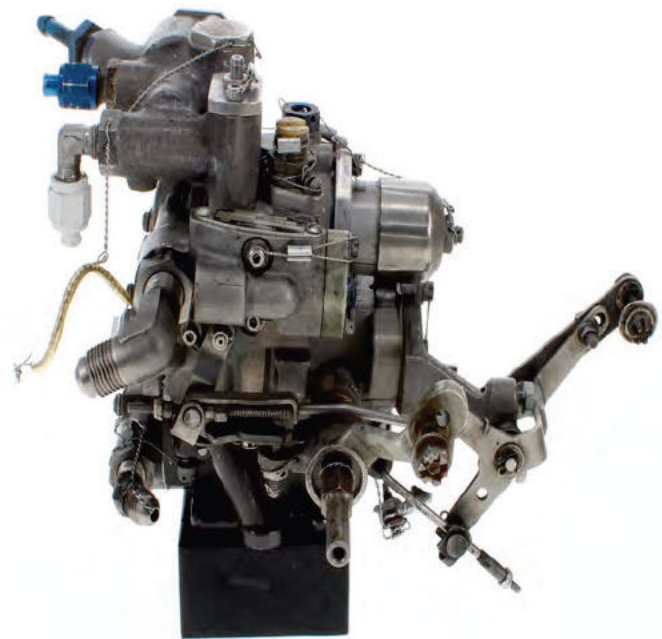
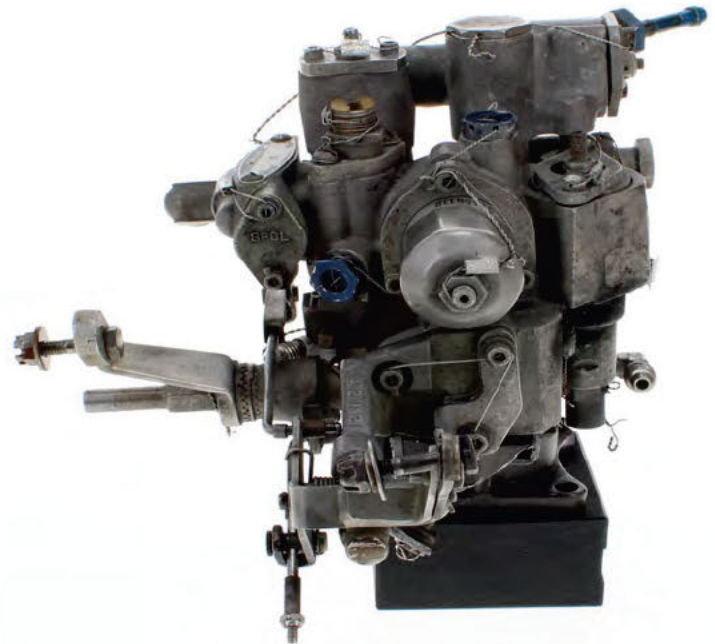
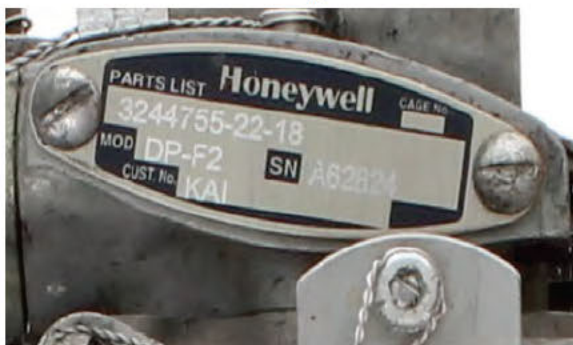
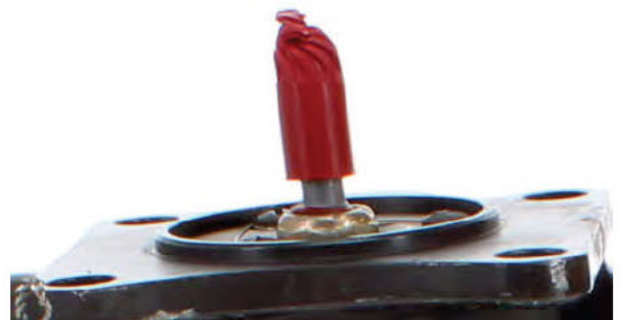
2. Box was opened, packaging material removed. Unit was observed to be in a plastic bag. Reference Images 2A, 2B, 2C, 2D. Unit was removed from the bag, photographed, Receiving Inspection was performed to include inducing the unit and acquiring pictures of the outside surfaces. Protective caps present on Air/Fuel fittings. Section of drain line attached to the drain fitting. Data Plate present. Drive Coupling was present on the drive shaft (appears torsionally broken). Reference Images 3A, 3B, 3C, 3D, 3E, 3F.

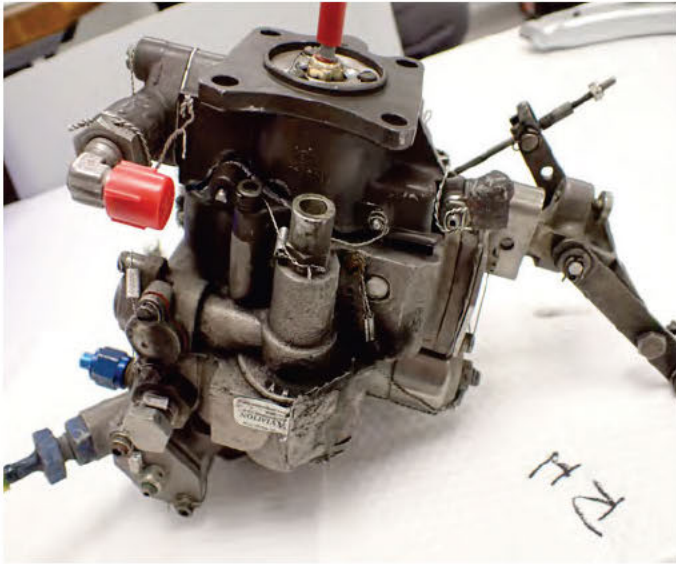
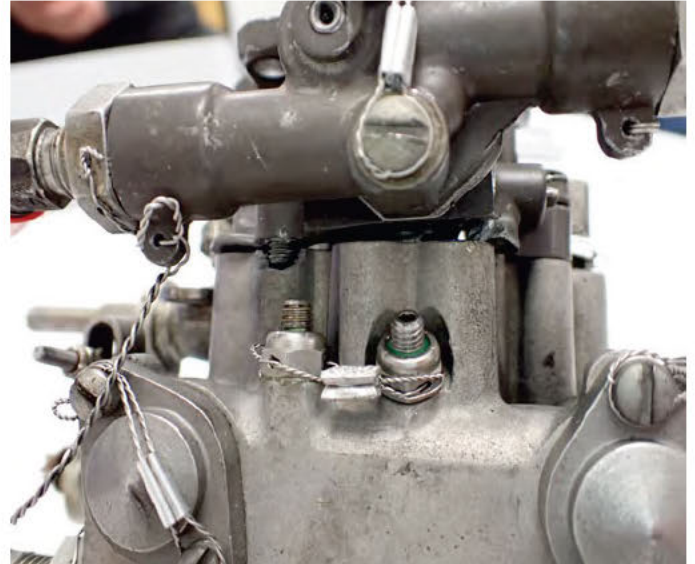
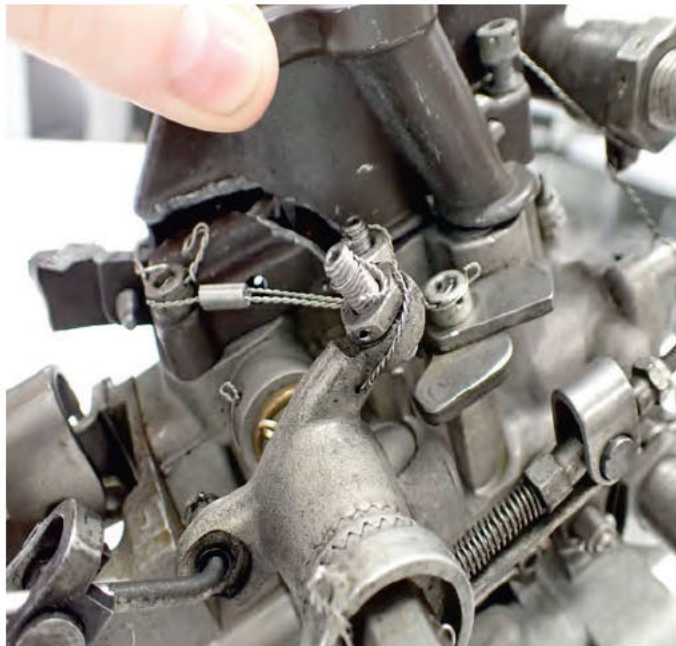
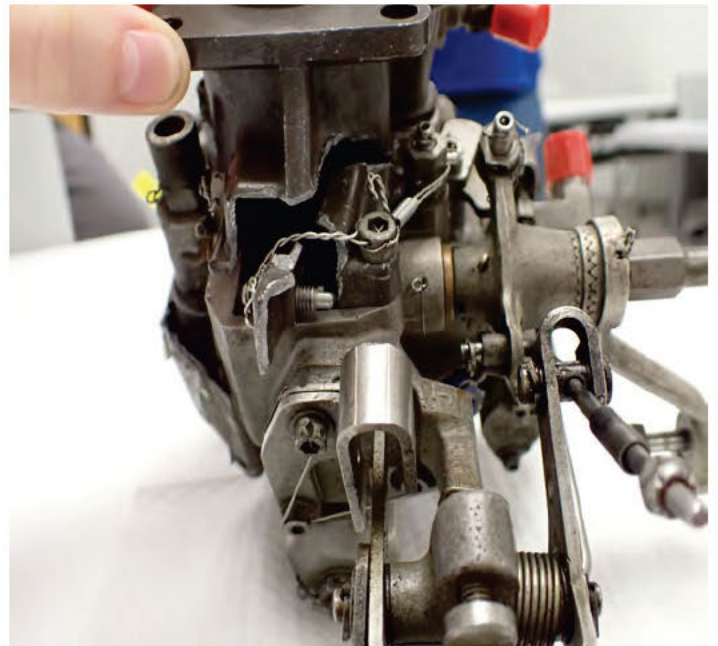
3. The following were observed prior to unit tested:
  - A. Drive body damaged. Reference Images 4A, 4B, 4C, 4D.
  - B. Eccentric Shaft missing. Portion of the threaded section of shaft and nut present in the drive body. Reference Images 5A, 5B.

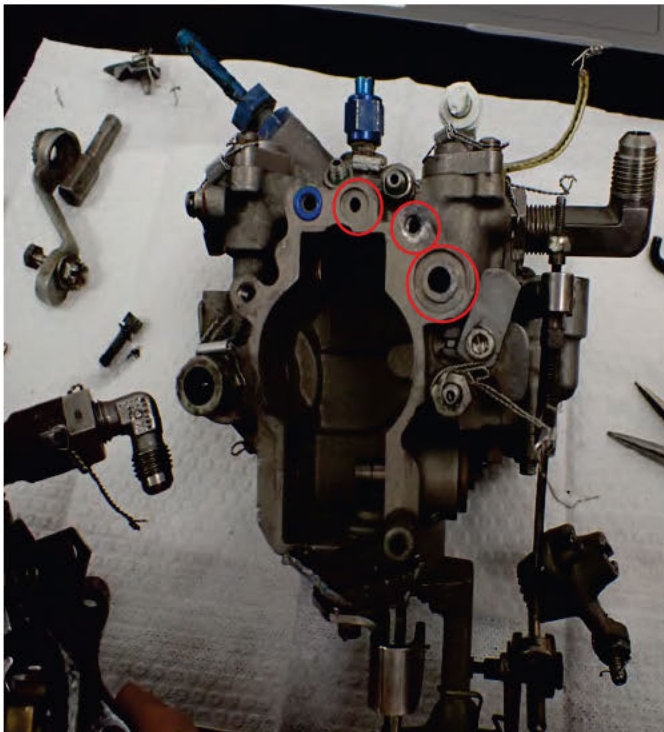
Image 6A

- C. Governor Cam Lever Assembly and Governor Spring missing.
  - D. Px port Packing, Preformed missing. Reference Image 6A.
  - E. Po port Packing, Preformed missing. Reference Image 6A.

- F. Damaged Drive Body mounting screw hole in the Main Body. Reference Image 6A, 6B.
  - G. Removed ratio lever covers. Visually inspected for contamination/debris, none present. Reference Images 7A, 7B, 7C.
