ERA24LA224

## INVESTIGATION PHOTOGRAPHS

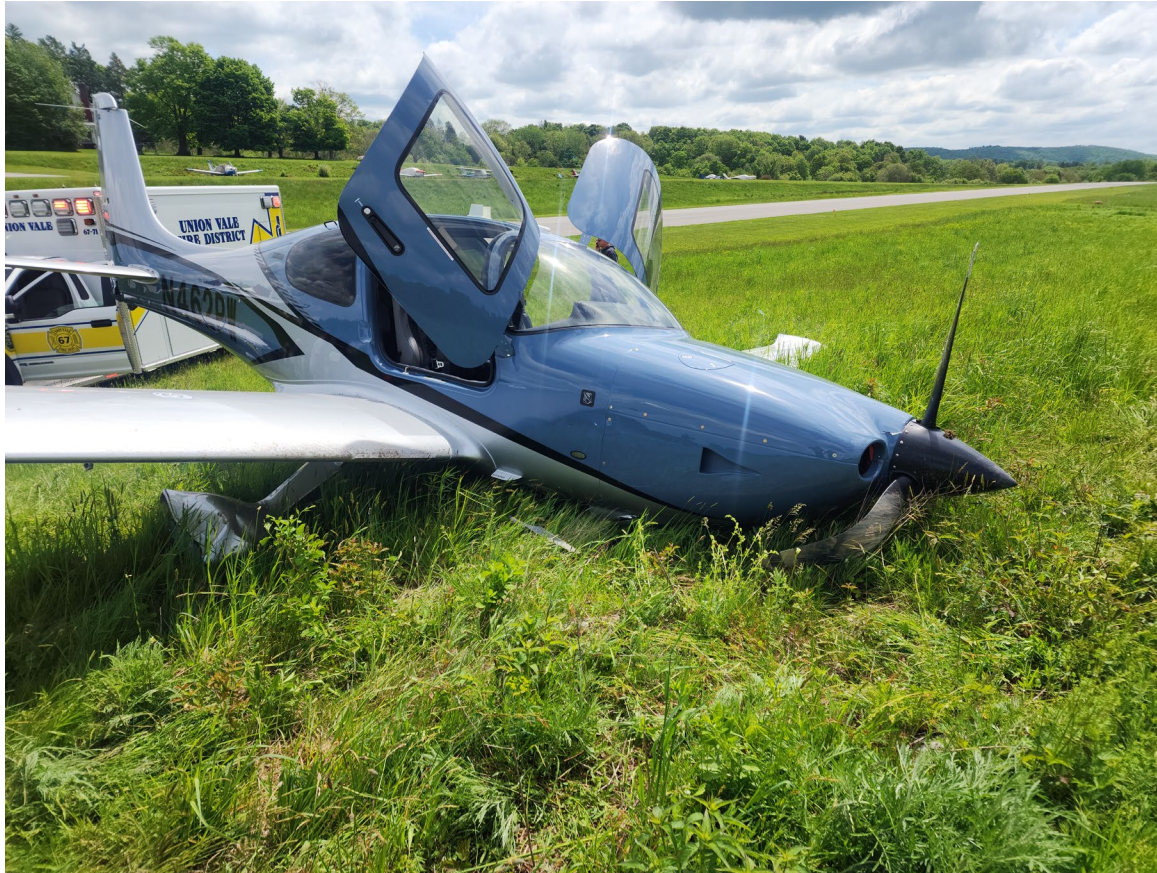
**Photograph 1 - New York State Police Digital Photograph. Right Forward Quartering View of the Airplane At the Accident Site**

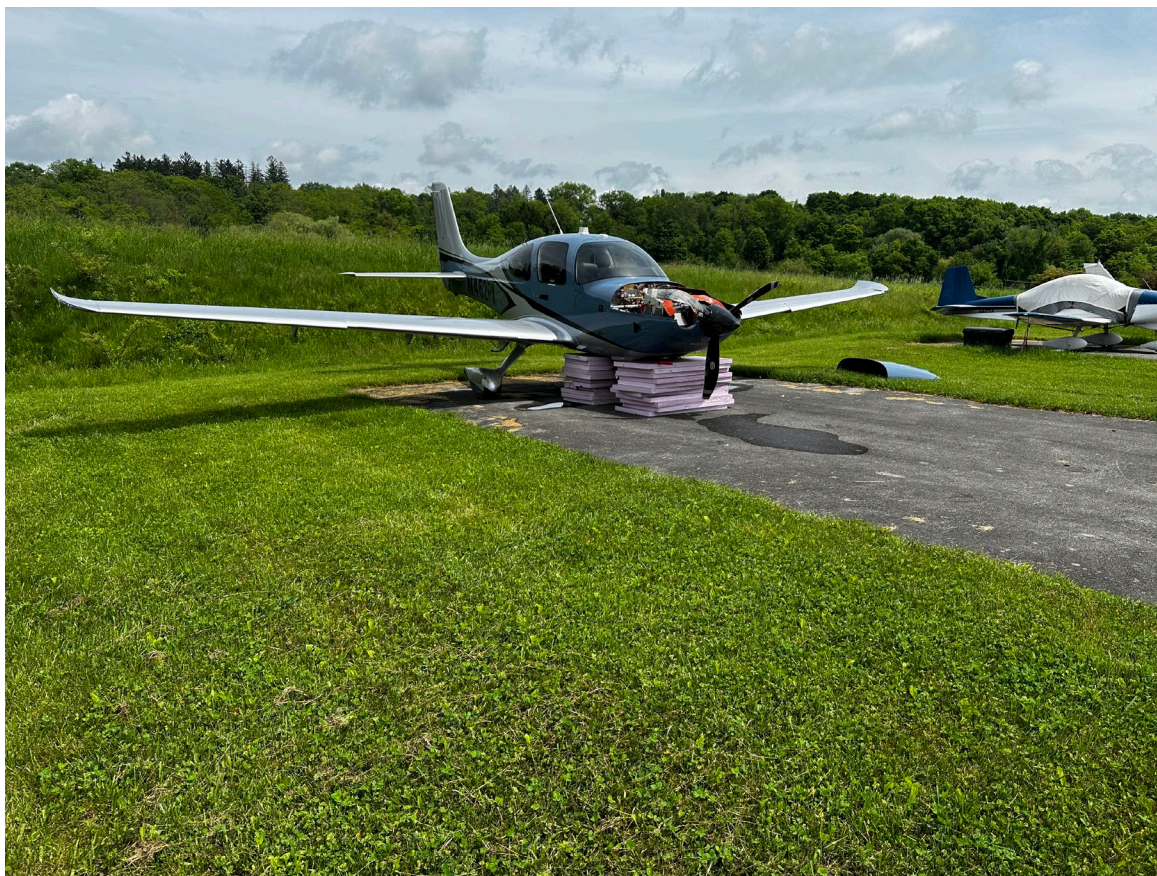
**Photograph 2 - Digital Photograph From Repair Facility. Right Forward Quartering View of the Airplane Following Recovery**

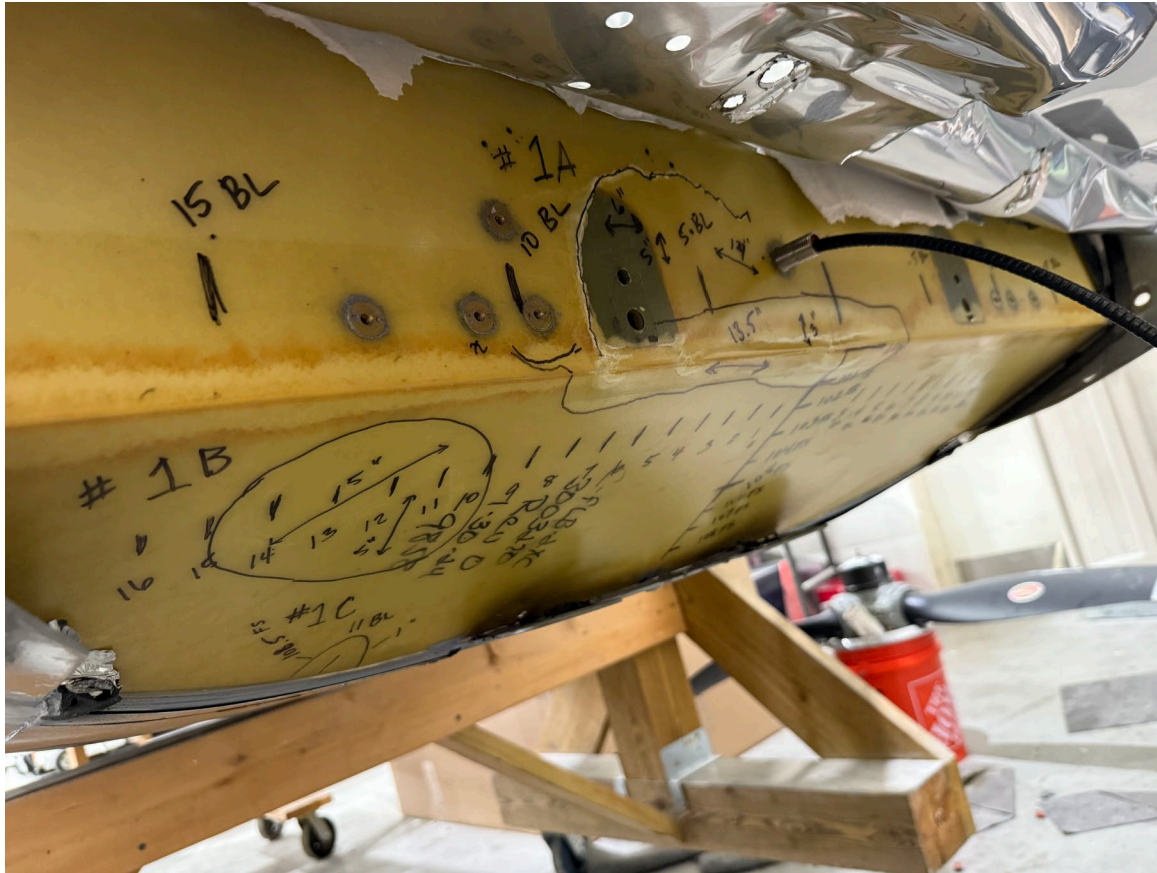
**Photograph 3 - Digital Photograph From Repair Facility. View Depicting Cracks in the Structural Firewall**

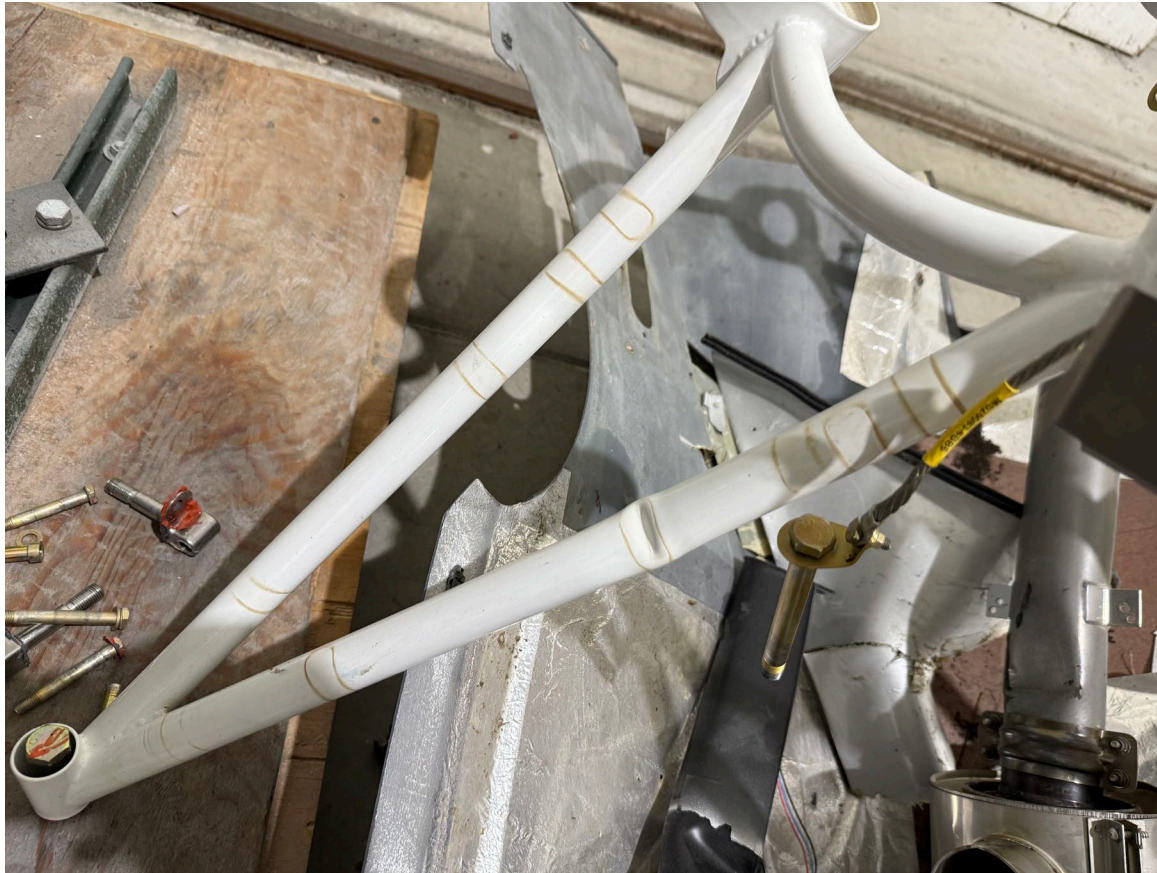
**Photograph 4 - Digital Photograph From Repair Facility. View Depicting Compression Buckle in Engine Mount Tube Requiring Major Repair/Replacement**

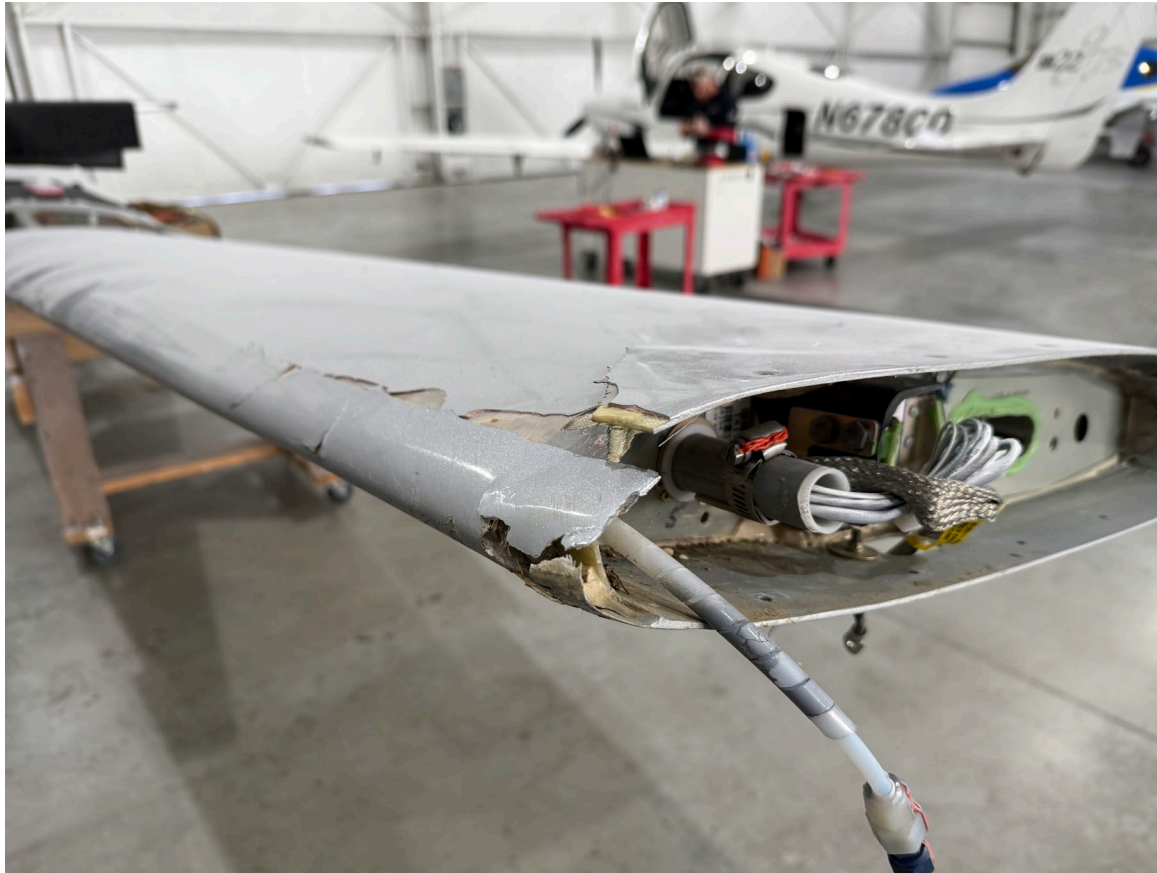
**Photograph 5 - Digital Photograph From Repair Facility. View Depicting The Outer Portion of the Left Wing. Note the Damage along the Leading Edge and Also Chordwise**
