# National Transportation Safety Board

ERA24LA227

## **WRECKAGE EXAMINATION SUMMARY**

Location: Gulf of Mexico, ENE of Alligator Point, Florida  
Date: May 25, 2024  
Time: 2155 EDT  
0155 coordinated universal time (UTC), UTC date May 26, 2024  
Airplane: N446KW, Glasair 1

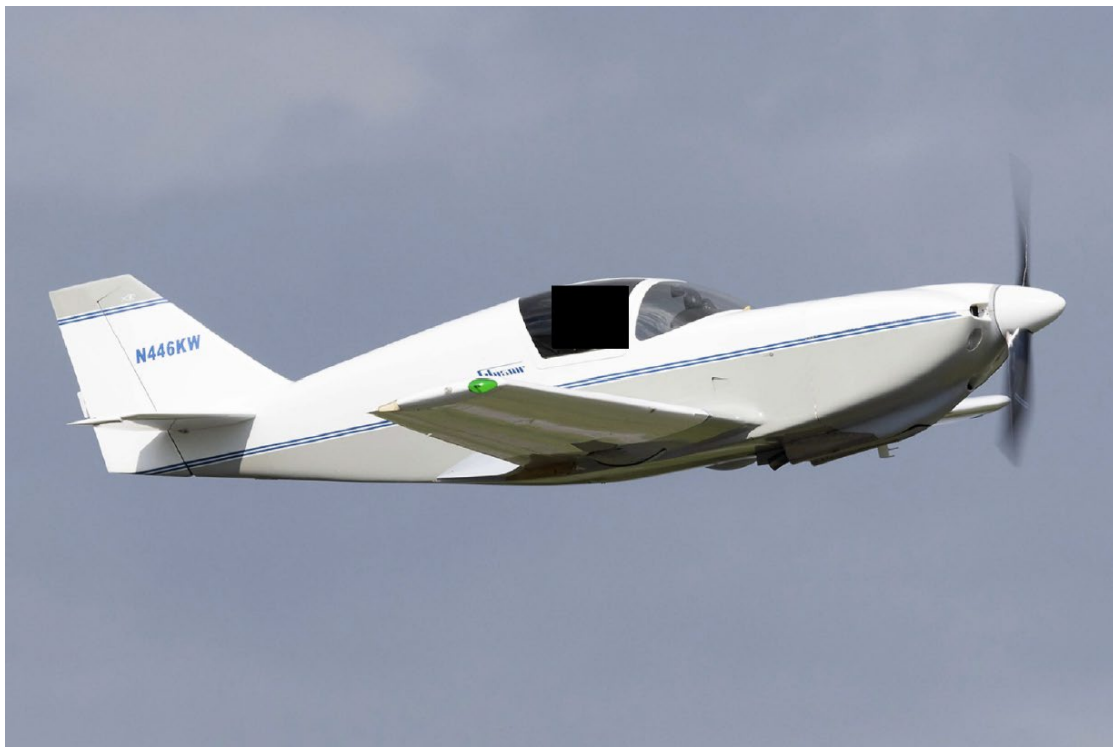
The two-place, retractable landing gear, experimental amateur built, Scott Glassair 1 airplane (Figure 1), serial number 1474R, was built in 2011. It was equipped with a Lycoming O-320-E2D engine, and a two-bladed propeller.

**Figure 1 Image Courtesy of Jeremy D Dando<sup>2</sup>. Right Side View of the Airplane In-Flight taken September 9, 2023**

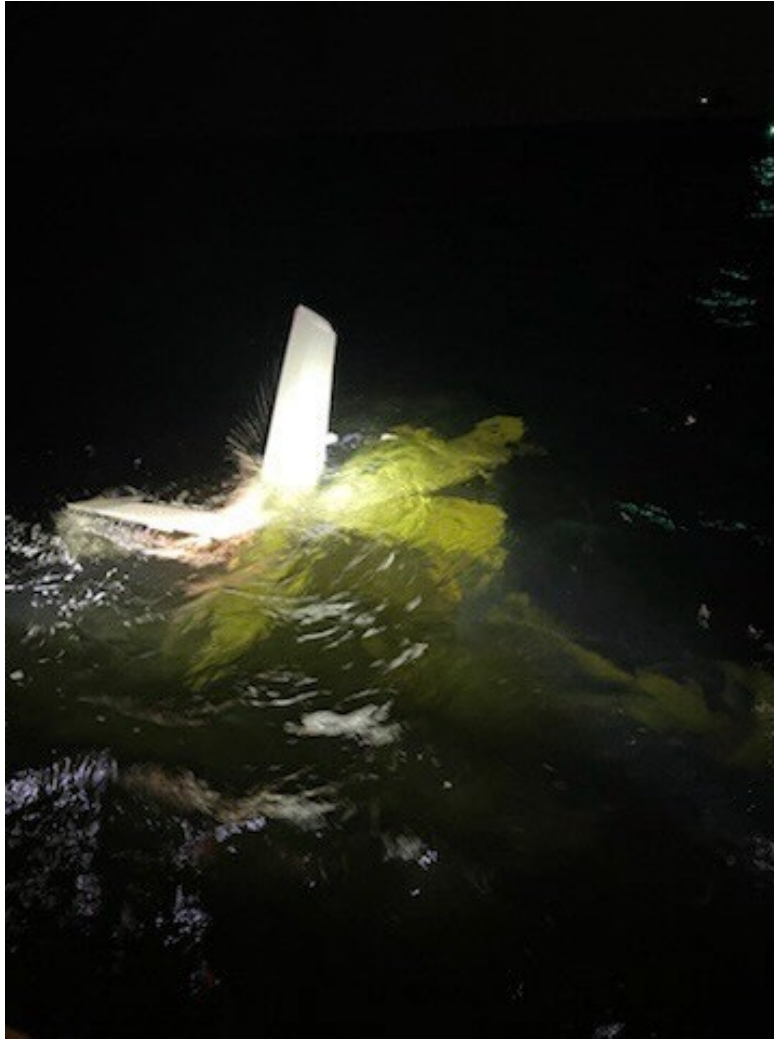
The wreckage was located in 13 to 15 ft of water. A marker buoy was placed on the wreckage, which came to rest on a sand shoal in a nose and left wing down position, with the empennage being visible above the water (Figure 2).

**Figure 2 Courtesy of United States Coast Guard. View of the Empennage Before Recovery**

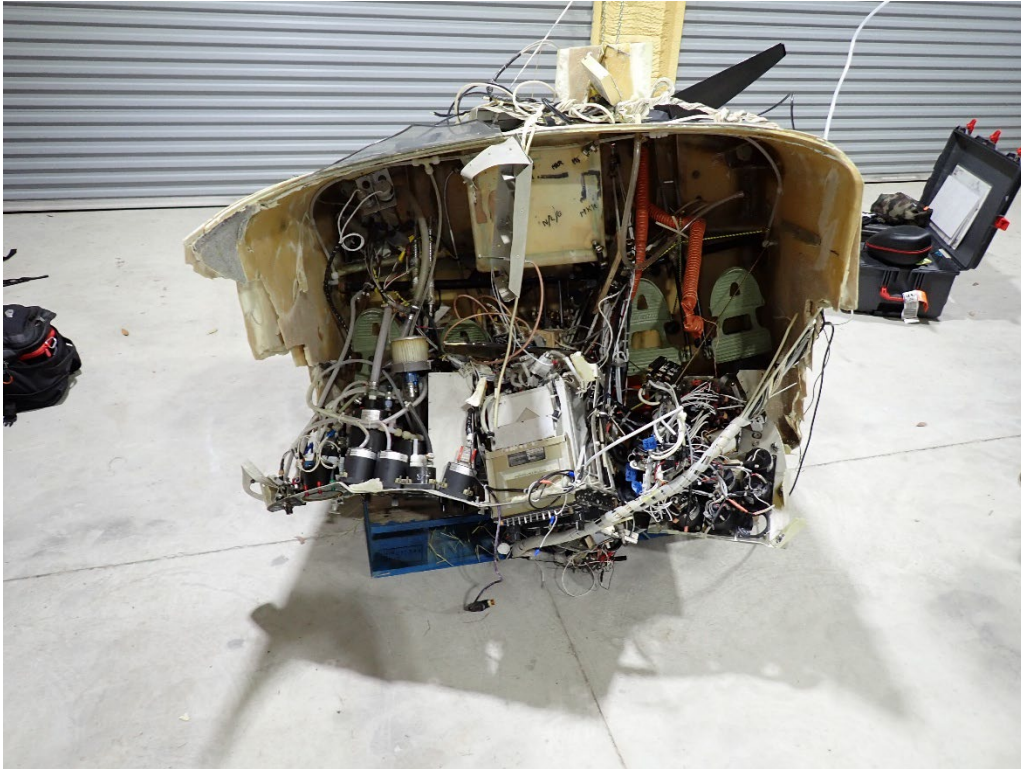
Examination of the airplane revealed that the aft fuselage (with the empennage still attached) had separated from the rest of the fuselage structure just aft of the instrument panel (Figure 3).

**Figure 3 View of the Fuselage with Attached Engine and Propeller, and Instrument Panel**

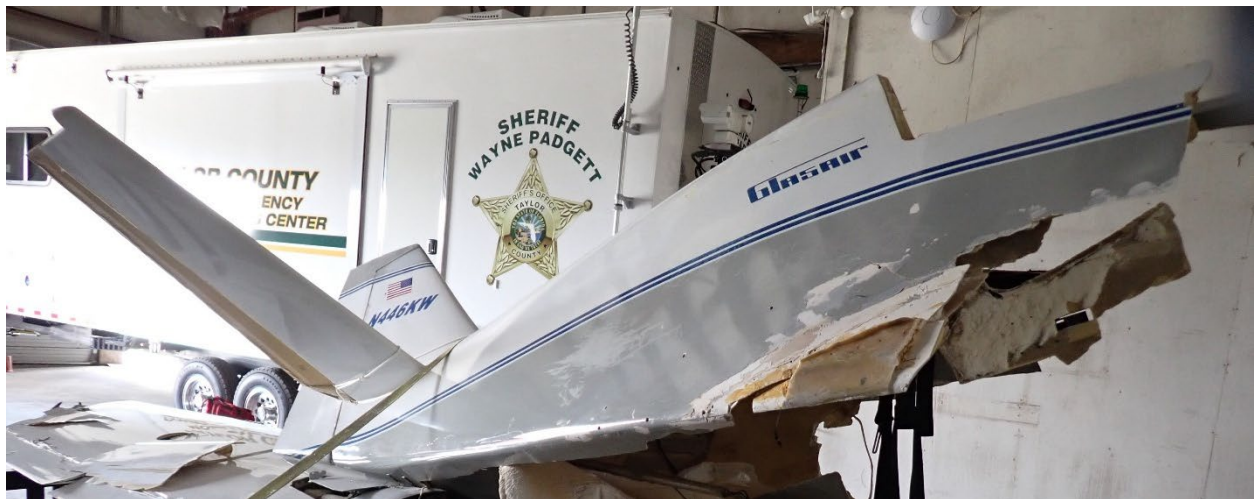
As previously described in section 4.2, the fuselage with attached aft fuselage was structurally separated at the cockpit area (Figure 4).

**Figure 4 Right Side View of Fuselage/Empennage**

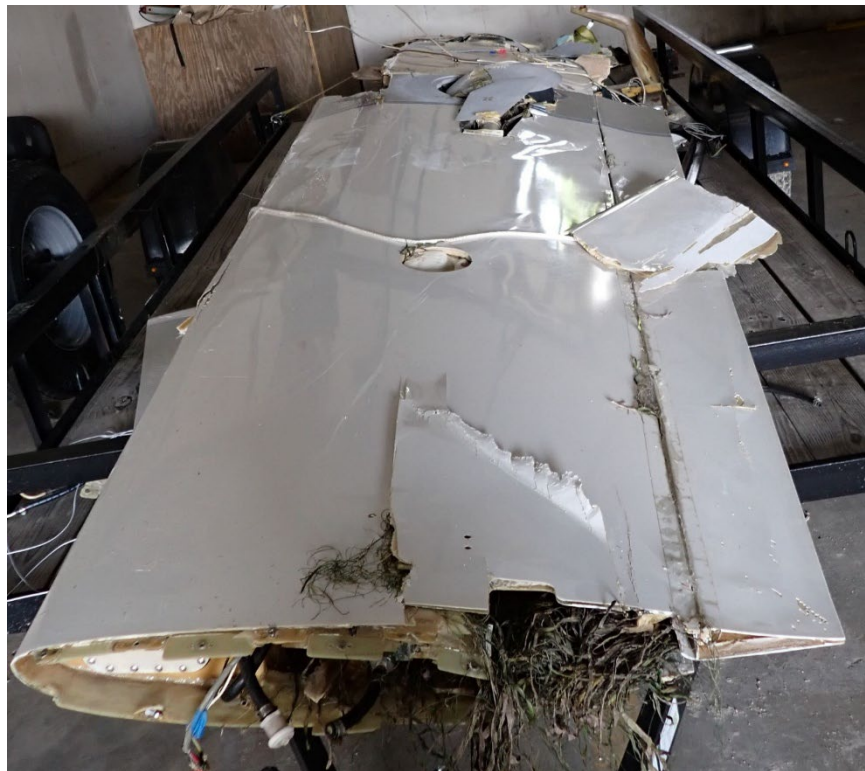
Both wings and the carry through structure were separated from the fuselage (Figure 5). The left and right winglets were separated from the left and right wings, and the pitot tube mast was separated from the bottom of the left wing. The left wing outboard fuel filler port was also missing, with its mounting location displaying evidence of the filler port having been hydraulically separated from the wing. The left wing's inboard fuel filler port was still intact, but an approximate 4-foot section of the left wing's upper composite surface near the inboard fuel filler port was missing.

**Figure 5 View of Nearly the Entire Span of the Wing and Carry-Thru Structure**

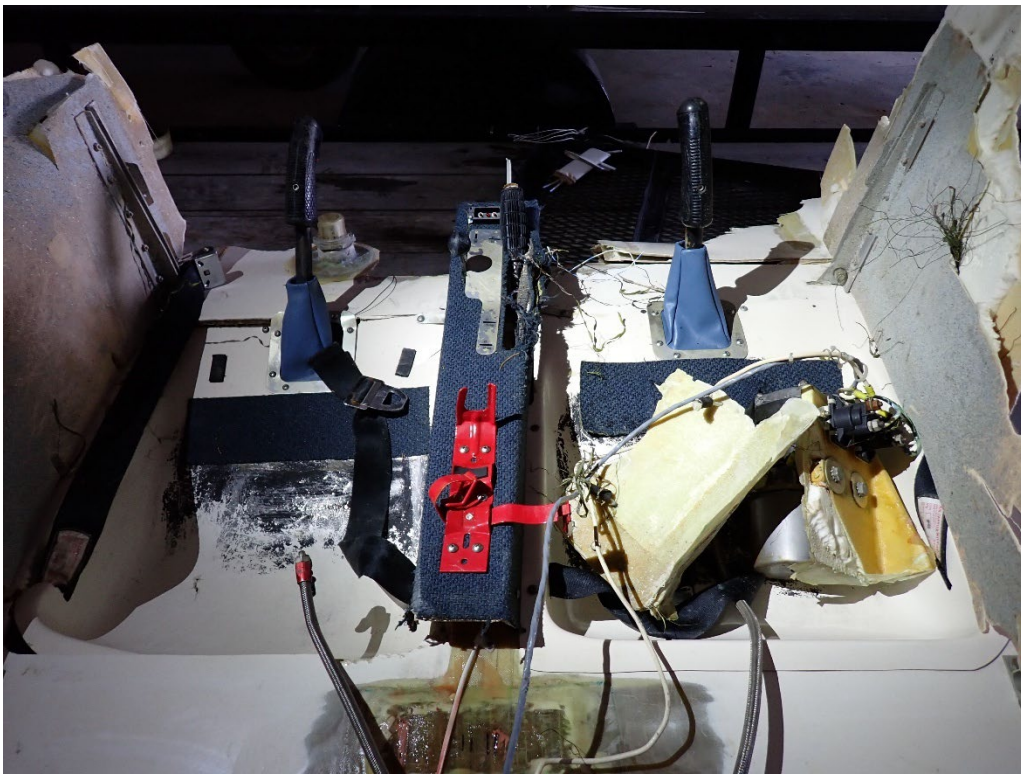
The cockpit was fragmented (Figure 6). The instrument panel was separated but remained attached by electrical wires and hoses. Both seats were structurally separated.

**Figure 6 View of the Lower Section and Sides of the Cockpit**

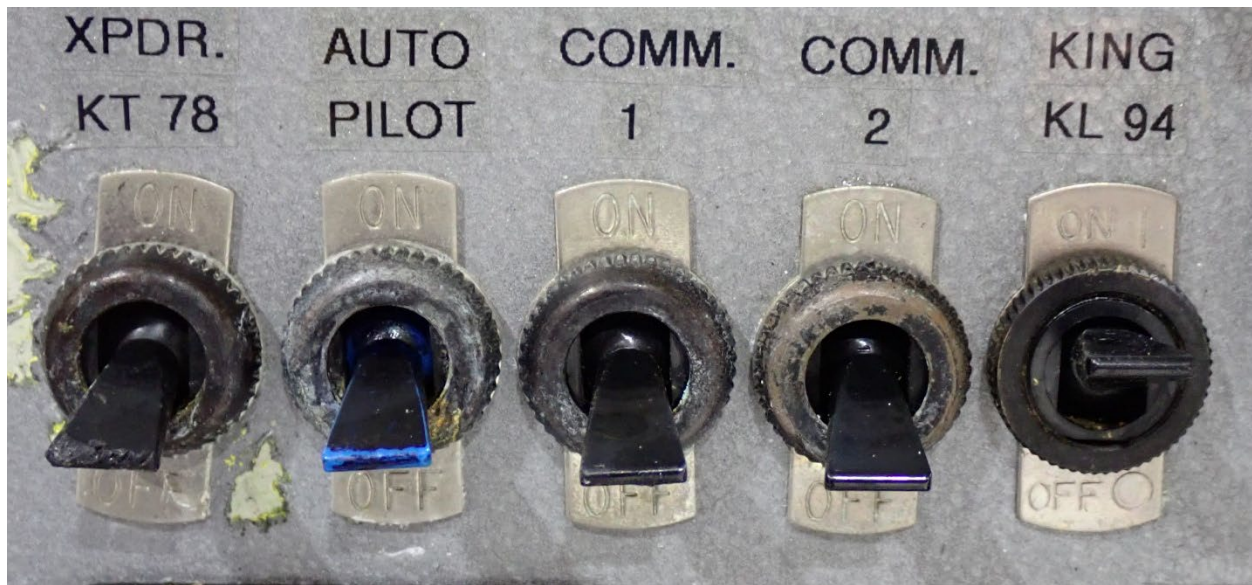
The selector switches were visually inspected for position, documented, then tactically checked. The switches for the navigation lights, electric fuel pump, and turn coordinator<sup>3</sup> were all on. The autopilot switch was in the off position (Figure 7).

**Figure 7 View of the Autopilot Switch in Off Position**

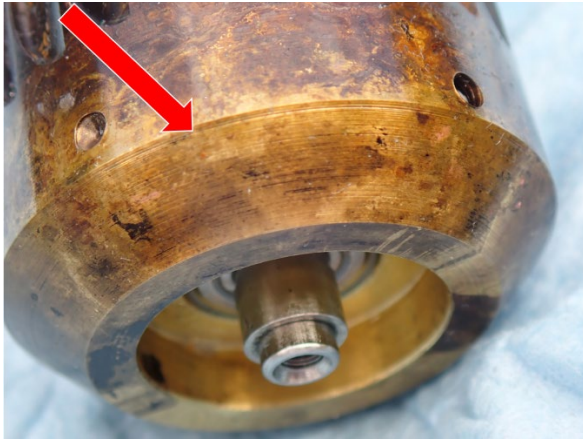
Disassembly examination of the attitude gyro revealed the rotor exhibited very light scoring on the top of the rotor near one end (Figure 8), and light scoring was also noted at one end of the rotor housing (Figure 9). This was consistent with rotation at impact.

**Figure 8 Arrow Points to Light Scoring Near End of Rotor**

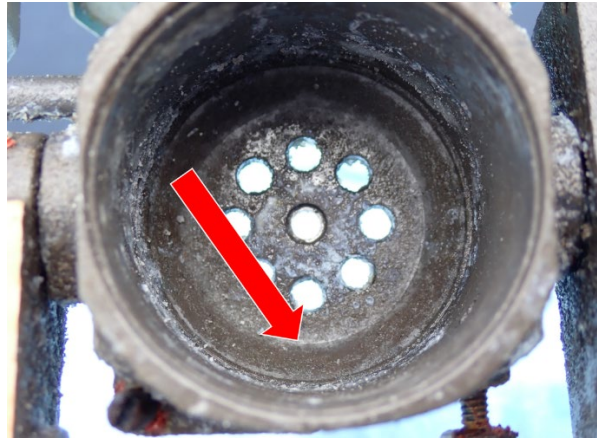
**Figure 9 Arrow Points to Scoring at End of Rotor Housing**

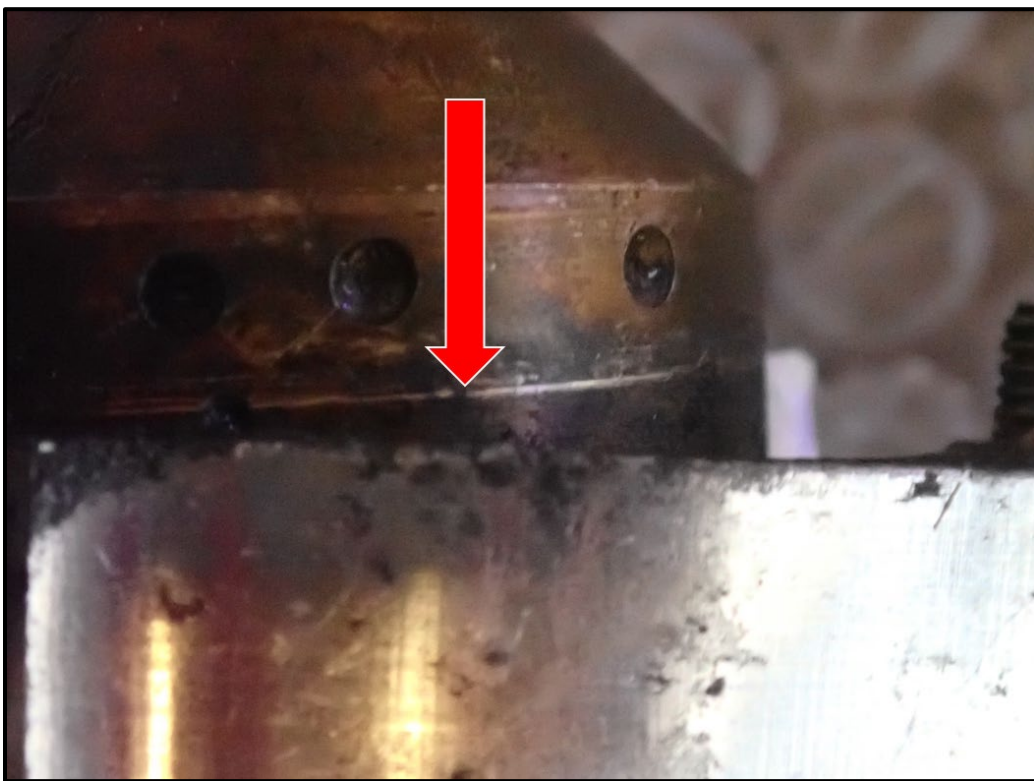
Disassembly examination of the turn coordinator revealed the rotor exhibited light scoring on top near one end consistent with rotation at impact (Figure 10).

**Figure 10 Arrow Points to Light Scoring on the Rotor**

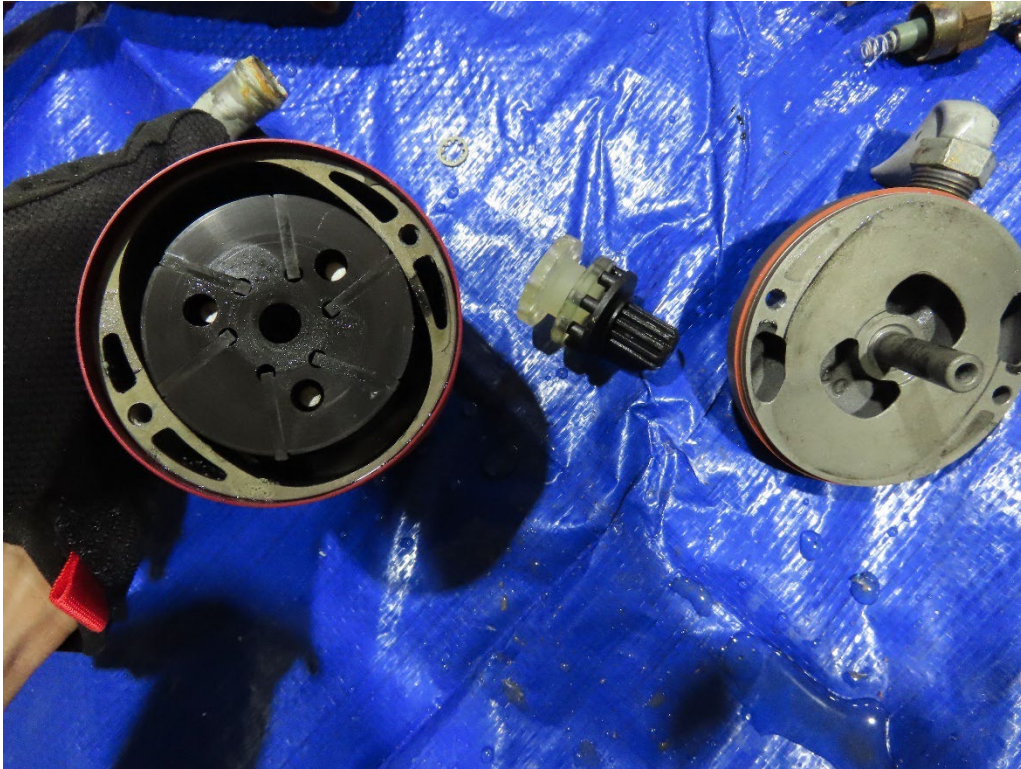
The engine-driven vacuum pump, a RAPCO, Inc., part number RAP215CC, SN A77207, remained attached to the engine. Disassembly inspection following removal from the engine revealed the drive and driven couplings, as well as the rotor and vanes were intact (Figure 11).

**Figure 11 View of the Partially Disassembled Engine-Driven Vacuum Pump**

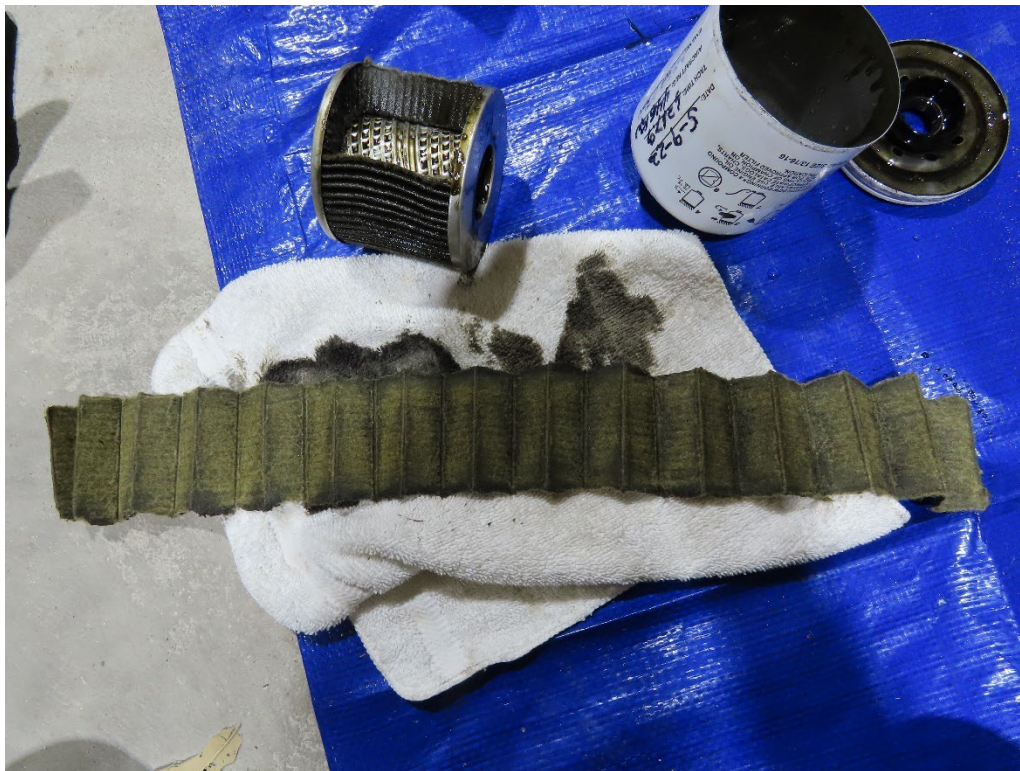
The oil suction screen was found tightly installed and safety wired to the oil sump. The screen was removed and found to be free and clear of debris. The oil filter was also tightly installed, and safety wired to the rear of the engine. A date of May 9, 2022 was written on the oil filter canister. The oil filter was cut open and inspection of the oil filter element after removal revealed it was free of metallic debris; carbon was noted (Figure 12). No discrepancies with the lubricating system were noted.

**Figure 12 View of the Engine Oil Filter Element**

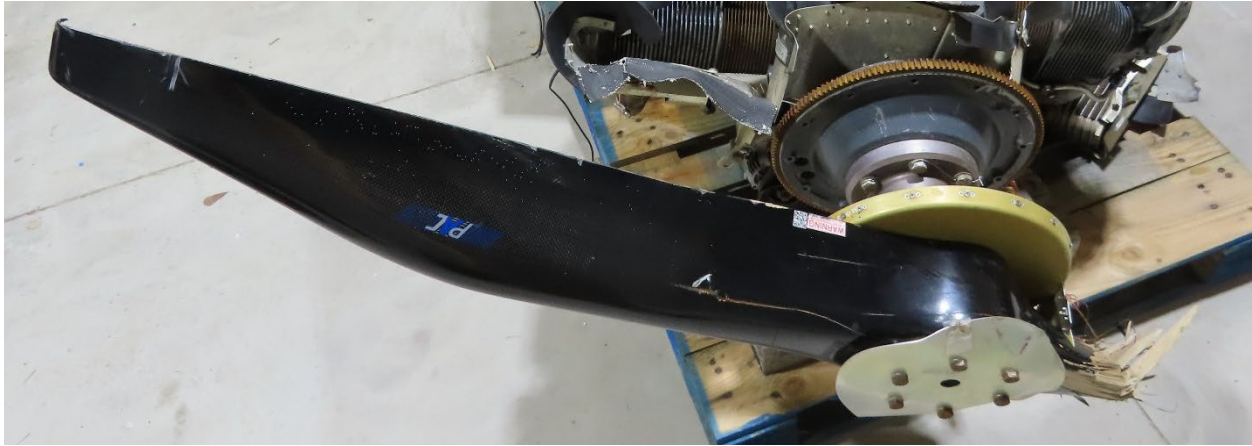
Examination of the propeller which remained attached to the crankshaft flange revealed one blade was fractured near the hub while the other blade was full span but exhibited spanwise damage on the cambered side of the blade near the hub, a chordwise scrape on the cambered side of the blade near the tip at the trailing edge, and damage to the trailing edge near the hub (Figure 13).

**Figure 13 View of the Propeller Assembly**
