# National Transportation Safety Board

ERA24LA229

## EXAMINATION SUMMARY

Location: Salisbury, MD  
Date: May 26, 2024  
Time: 1200 Local  
Airplane: Great Lakes 2T-1 (Menasco Special), N818K

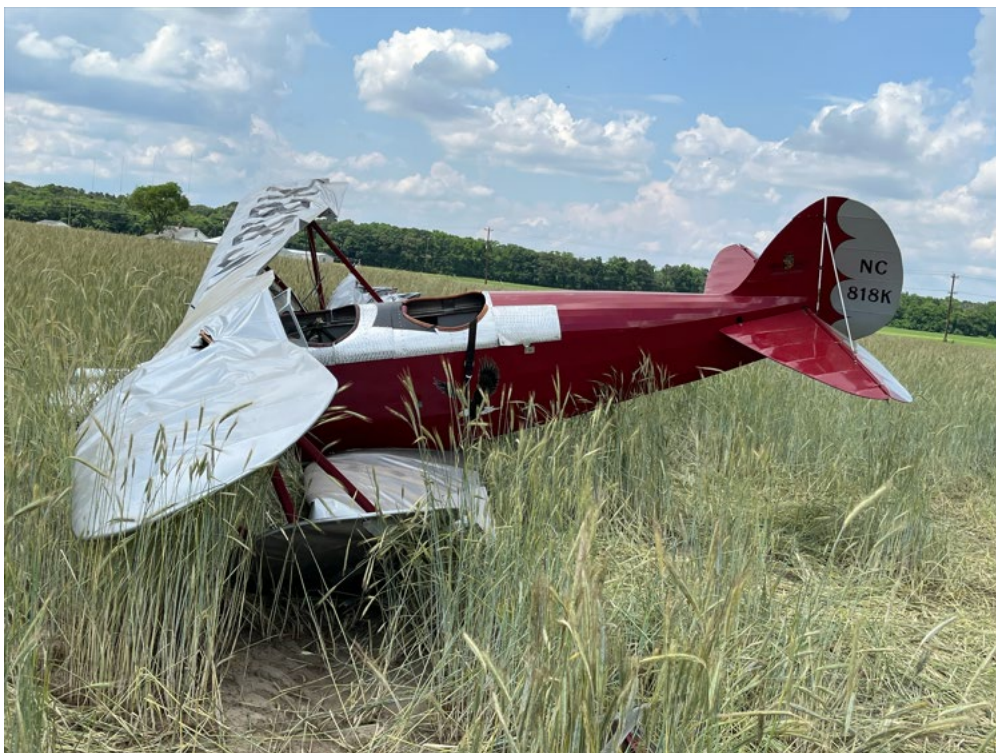
**Accident Site (Courtesy of FAA)**

The airplane impacted a grassy field 0.5NM north of the airfield. The airplane did not generate a debris field travelled roughly 30 feet from the initial point of contact.

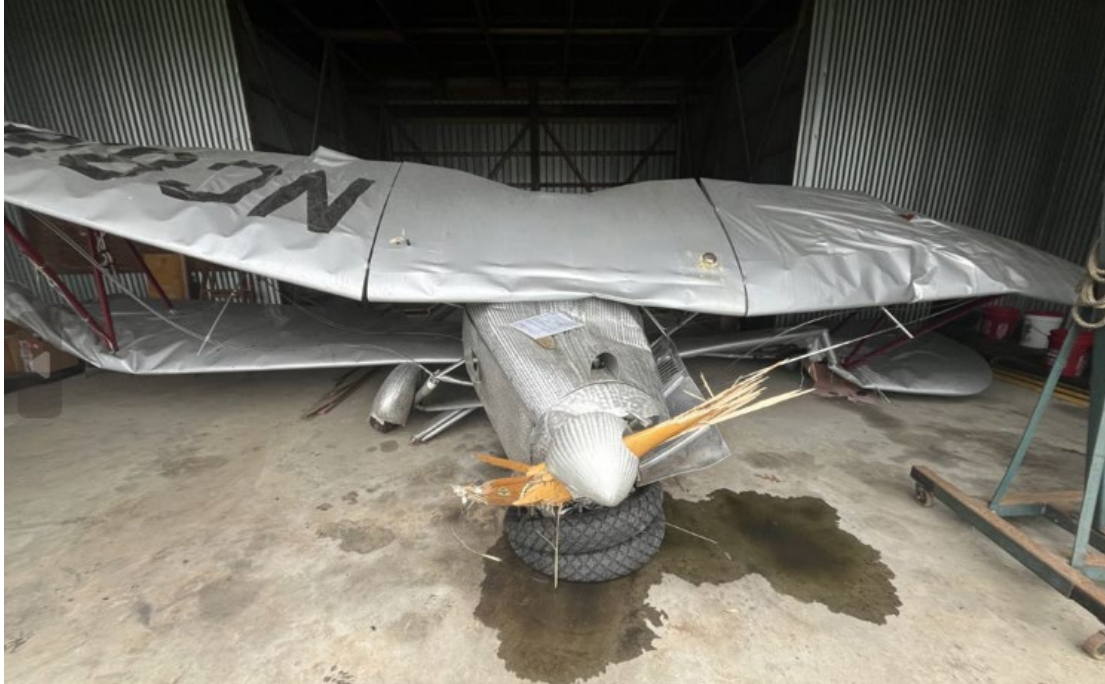
**Airplane Overview**

The airplane sustained substantial damage to the wings, engine mount, and lower forward fuselage. The empennage was mostly undamaged. Nothing was found during the airframe examination that would have precluded normal operation prior to the accident.

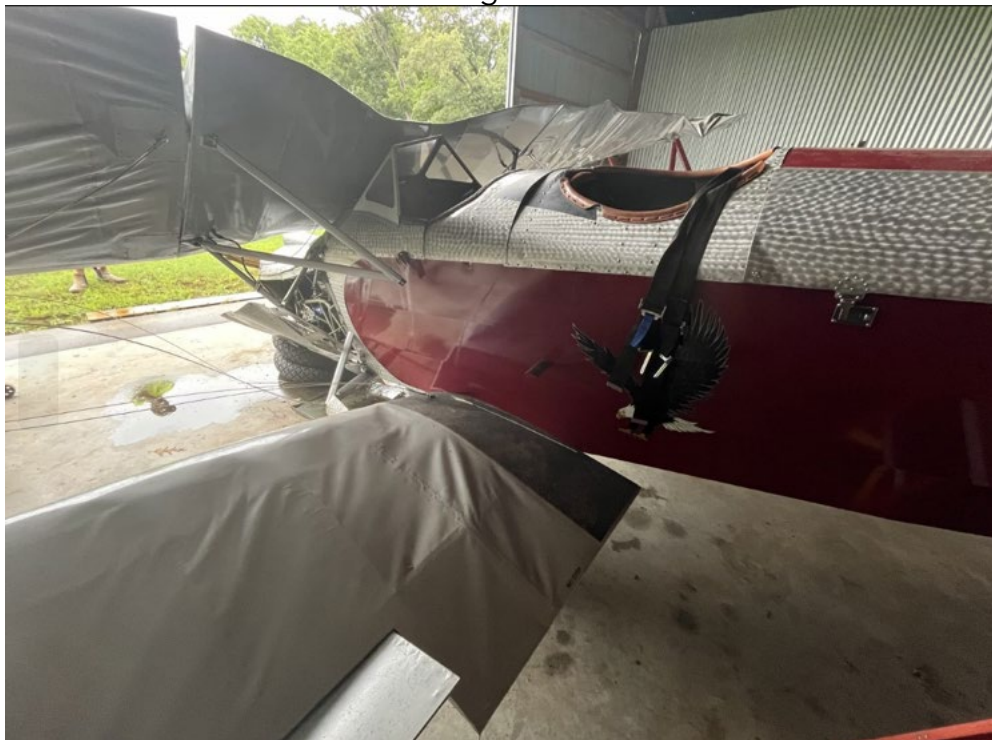
**Left Side Fuselage**

The airplane fuselage received substantial damage to the structure between the front and aft seats, and the structure below the forward seat. The structure was constructed of wood with a fabric covering.

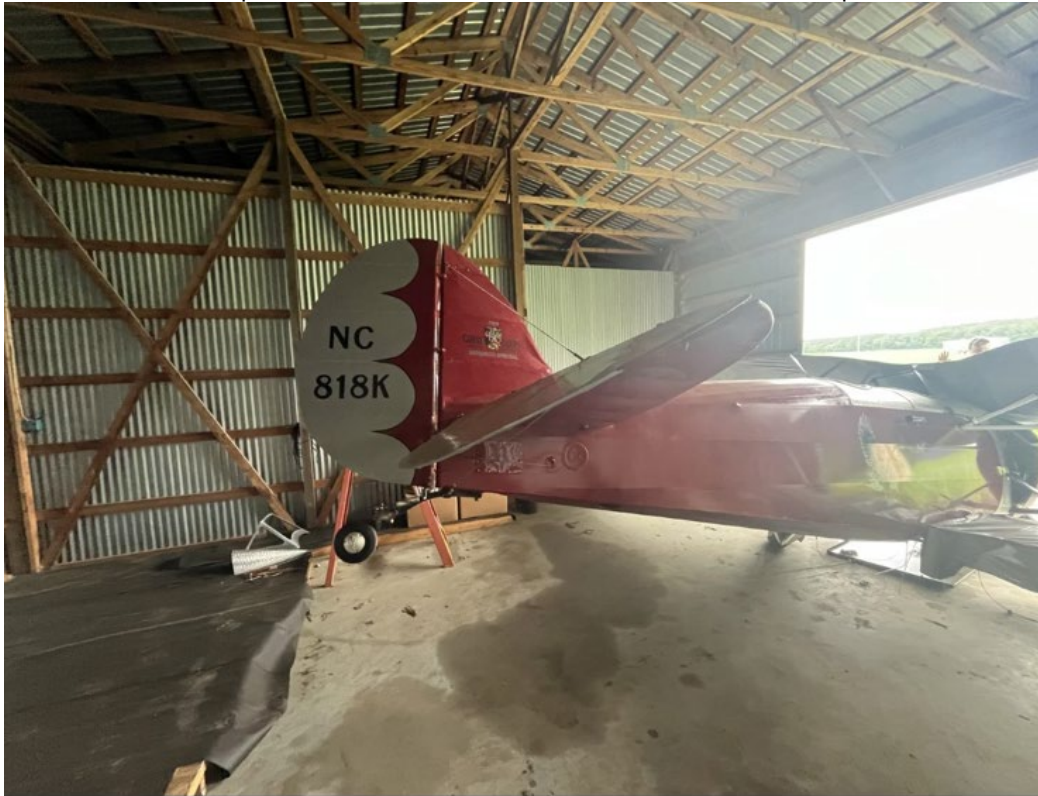
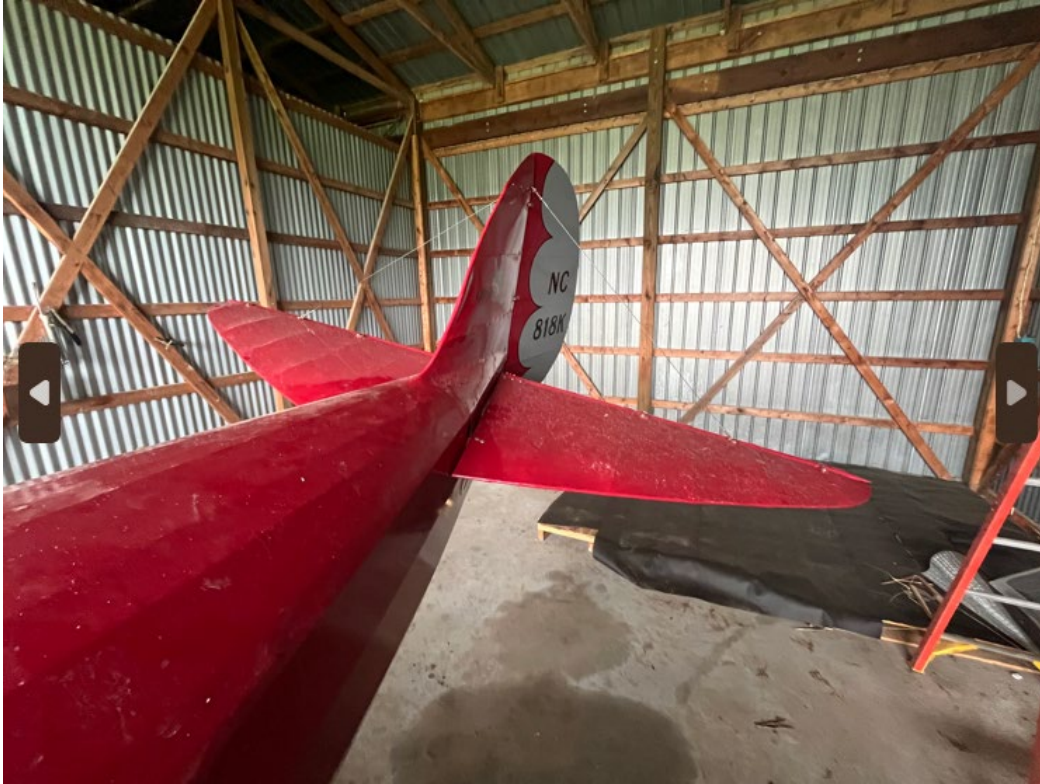
The empennage was mostly undamaged. The leading edge of the vertical stabilizer displayed a dent just above the empennage structure. The rudder cables were slack as a result of the buckling of the lower forward fuselage. Control cable continuity to the rudder, elevator, and stabilator trim were confirmed. The right-hand elevator cable partially tore the empennage fabric at its exit point from the airplane during the accident sequence. An ELT was not installed in the airplane.

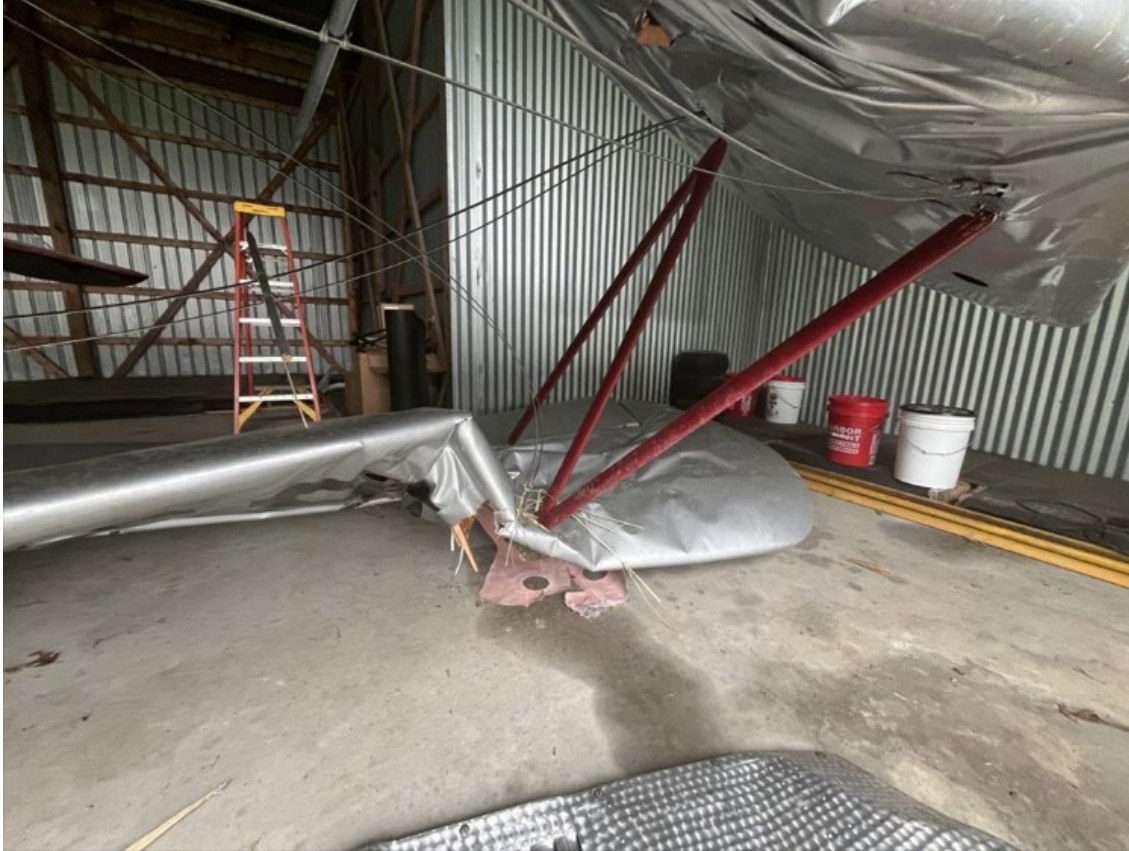
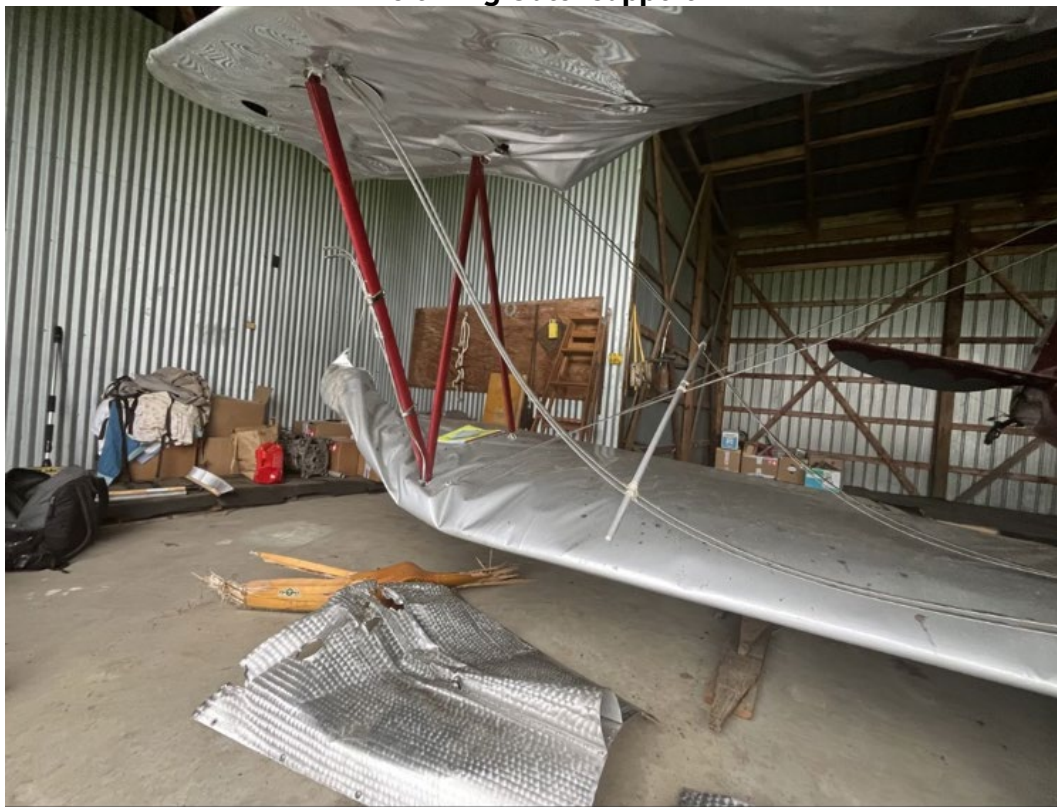
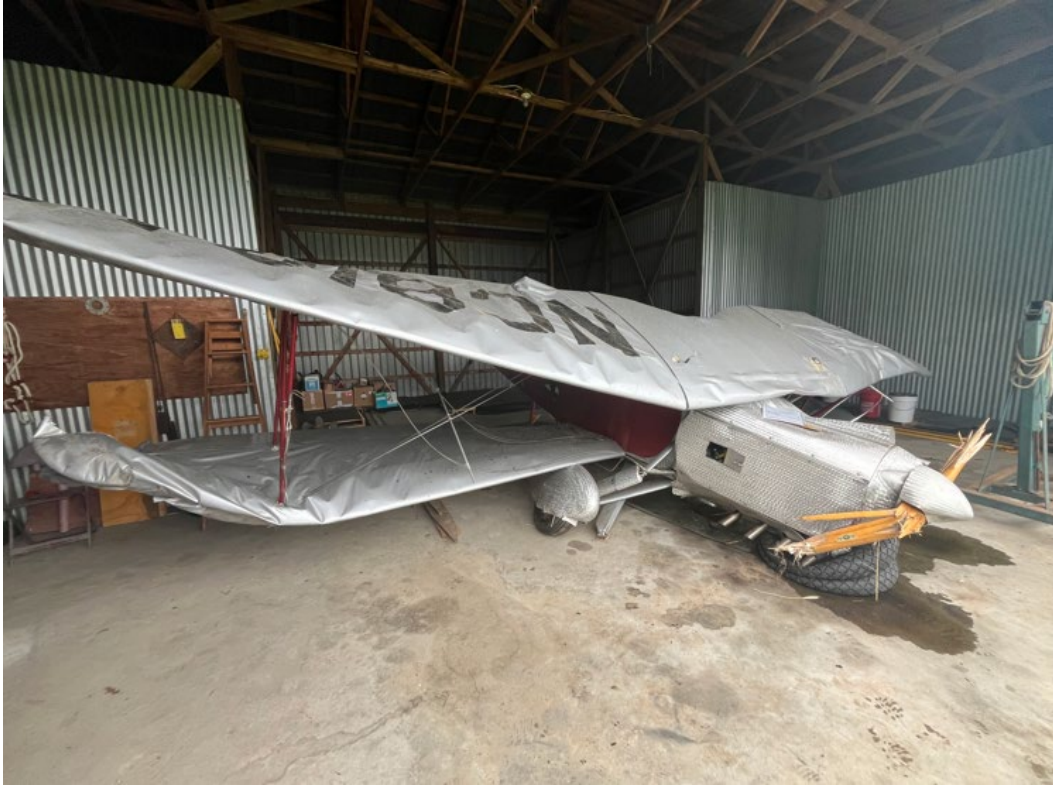
The left and right bi-wings were substantially damaged. Both sets of top wings were displaced forward and, in a left, turning direction. The right set of wings were displaced more forward than the left set of wings. The left-wing assembly had multiple fractures and wrinkles in the fabric covering on the top and bottom wing structures. The left-wing inner support brace folded at the midpoint forward. The left-wing outer support remained attached to the top and bottom wing and was undamaged. The right wing flying and landing wires remained attached but were slack as a result of the damaged wing structure. The right-wing assembly had multiple fractures and wrinkles in the fabric covering on the top and bottom wing structures. The bottom wing was significantly damaged beginning at the outer supporting brace. The outer support brace of the right wing was undamaged. The inner support brace folded at the midpoint forward. The left wing flying and landing wires remained attached but were slack as a result of the damage to the wing structure. The right aileron actuated when the control stick was moved. The left aileron was wedged from the damaged wing structure and control cable continuity was visually established.

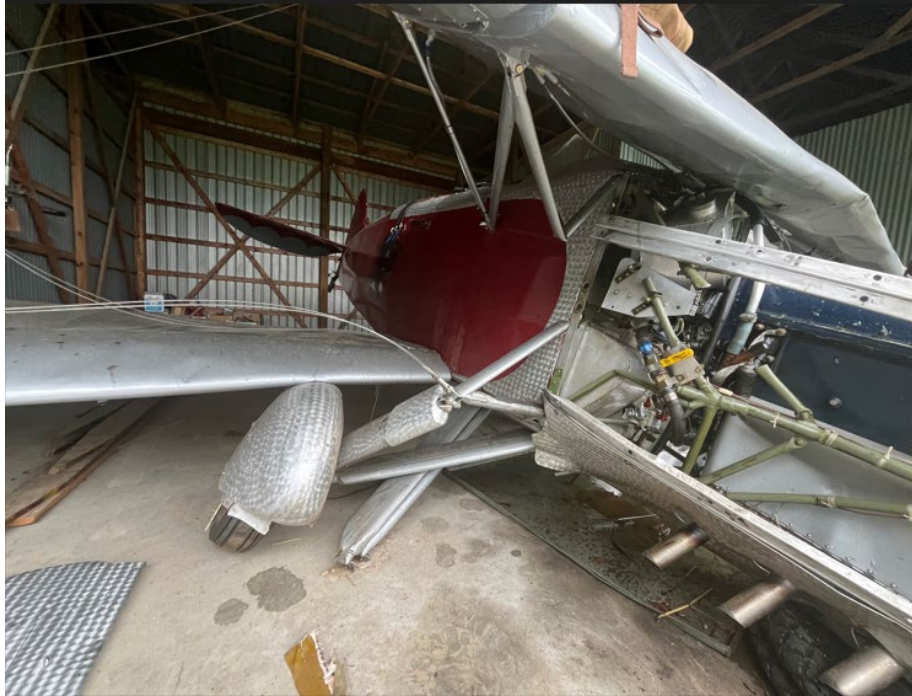
**Right Main Landing Gear**

The airplane was in a tail-wheel configuration. The tail wheel remained attached to the empennage and was undamaged. The right main landing gear was broken at the bottom mount and displaced in an outward, aft, direction. The left main landing gear was broken at the bottom mount and displaced aft.

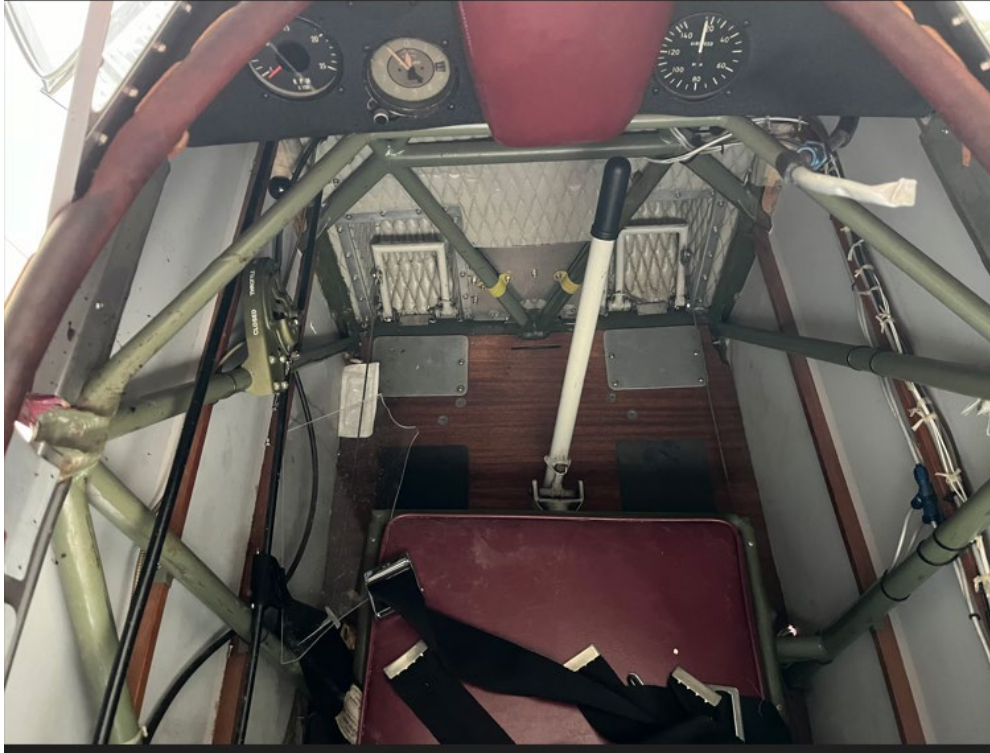
**Forward Cockpit Overview**

The airplane had tandem seating. The pilot rated passenger was sitting in the forward seat and the pilot was in the aft seat. The forward cockpit was intact and undamaged. The forward cockpit was equipped with an engine RPM gauge, reading 0, an altimeter reading 900, altimeter setting of 30.2", an airspeed indicator that read

0, and a turn and bank coordinator. The control stick moved freely and operated the right aileron and elevators. The rudder pedal cables were married to the aft cockpit rudder controls. The forward rudder cables were slack as a result of the damaged fuselage structure. The forward cockpit had a throttle lever that was married to the aft cockpit lever.

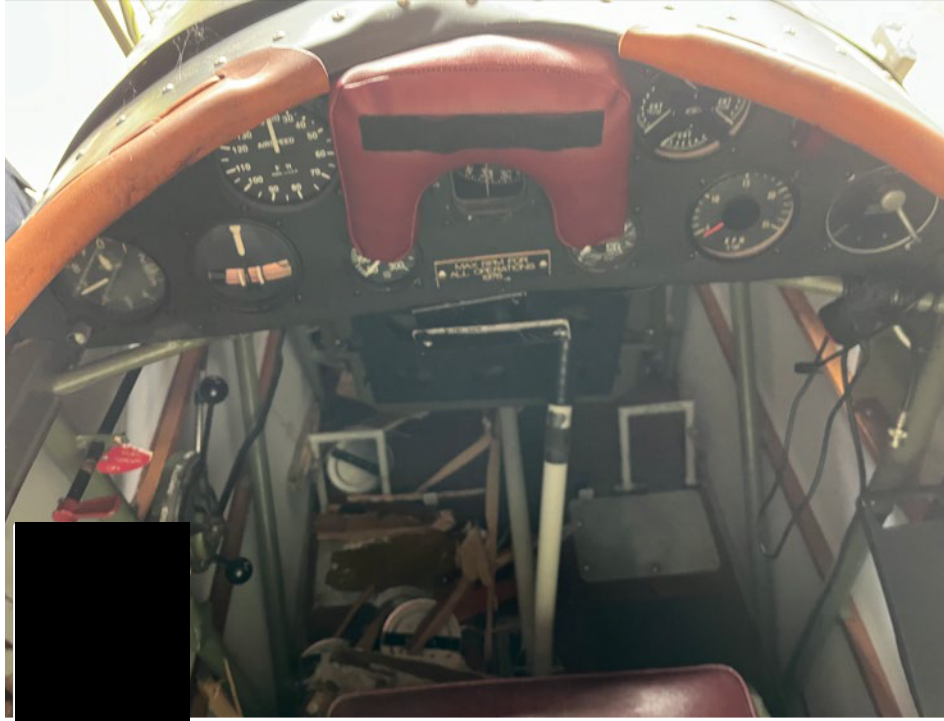
**Aft Cockpit Overview**

The aft cockpit magneto switch was "off". The RPM gauge read "0". The four individual cylinder head temperature gauges read "0". Airspeed read "0". The altimeter read 680' and the altimeter setting read 29.8". The cockpit had a placard that read "max RPM for all operations 1975". The fuel valve was found in the "off" position. The throttle was in the "open" position. Throttle control continuity was established to the engine, but the cable was damaged and bent at the carburetor. The carburetor heat lever was in the "closed" position and continuity was confirmed to the engine. The stabilator trim lever operated normally. The control stick moved freely and operated the right aileron and elevators.

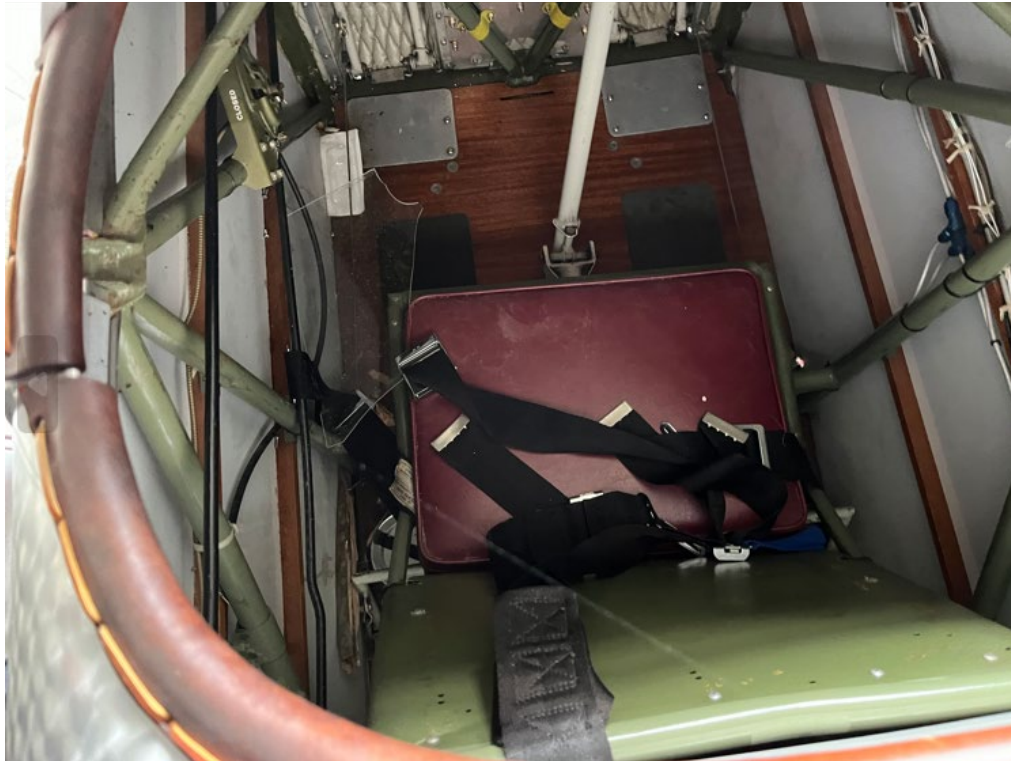
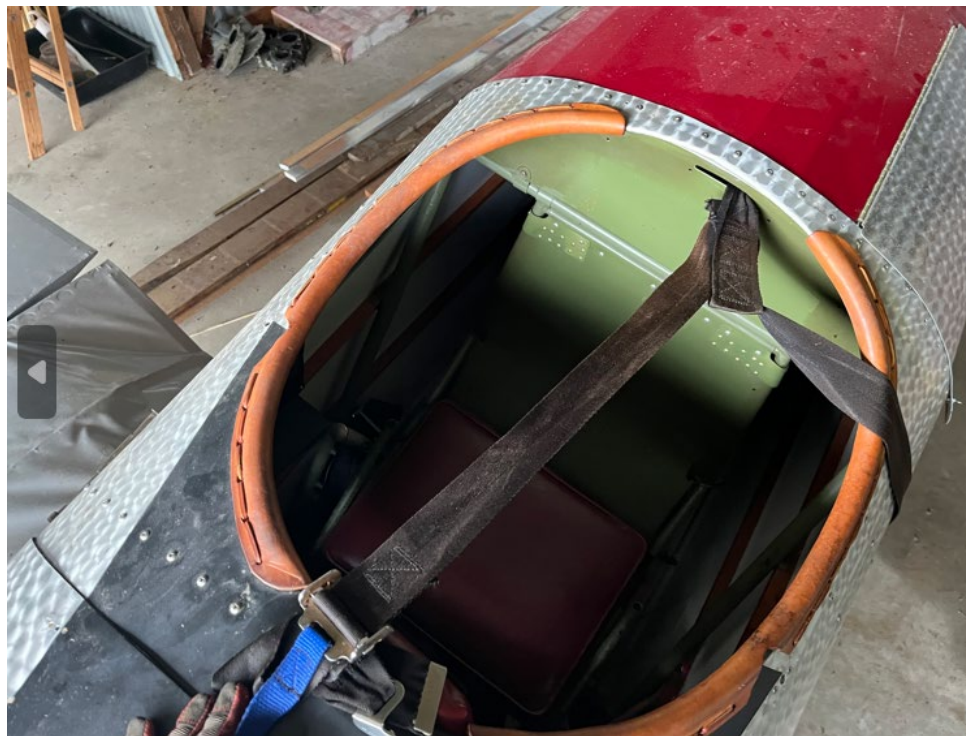
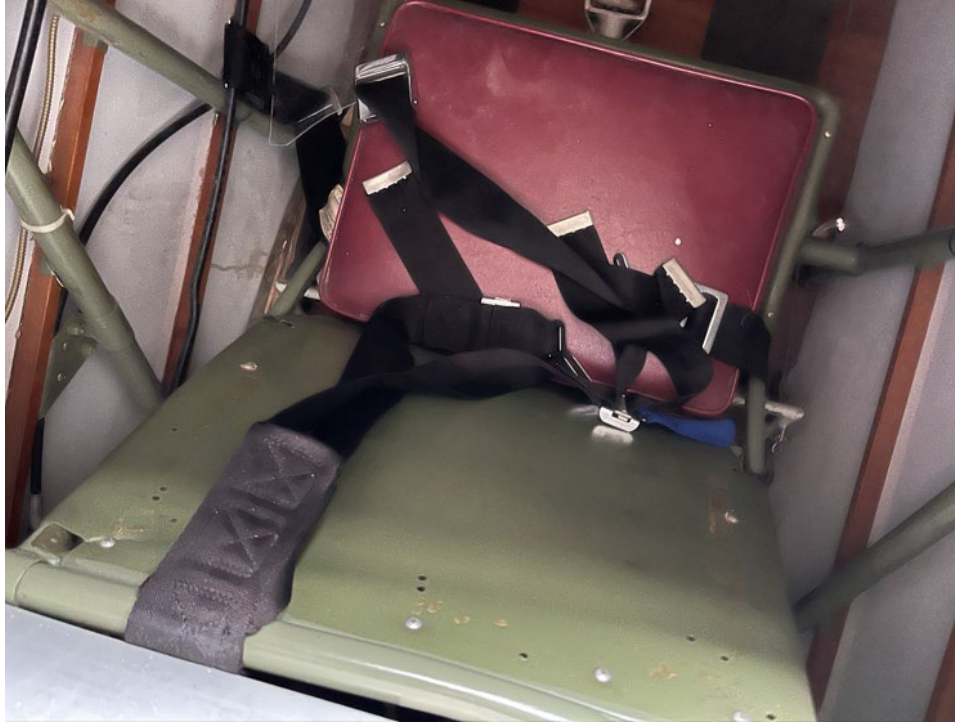
The aft seat was equipped with a four-point harness with two over the shoulder straps. The over the shoulder straps remained in place and were undamaged. The bottom straps anchored to the supporting seat structure. The seat structure was cut on both sides of the seat and the seat belts had been slid from the supporting tubular structure to remove the pilot. The forward seat was equipped with a four-point harness with two over the shoulder straps. The over the shoulder straps remained installed and undamaged. The laps straps remained secured to the seat structure and were undamaged.
